# Phase 1 & Phase 2: Geo-Environmental Assessment

**Lees Hall Road, Dewsbury**

**S190445**

**Solmek Ltd**

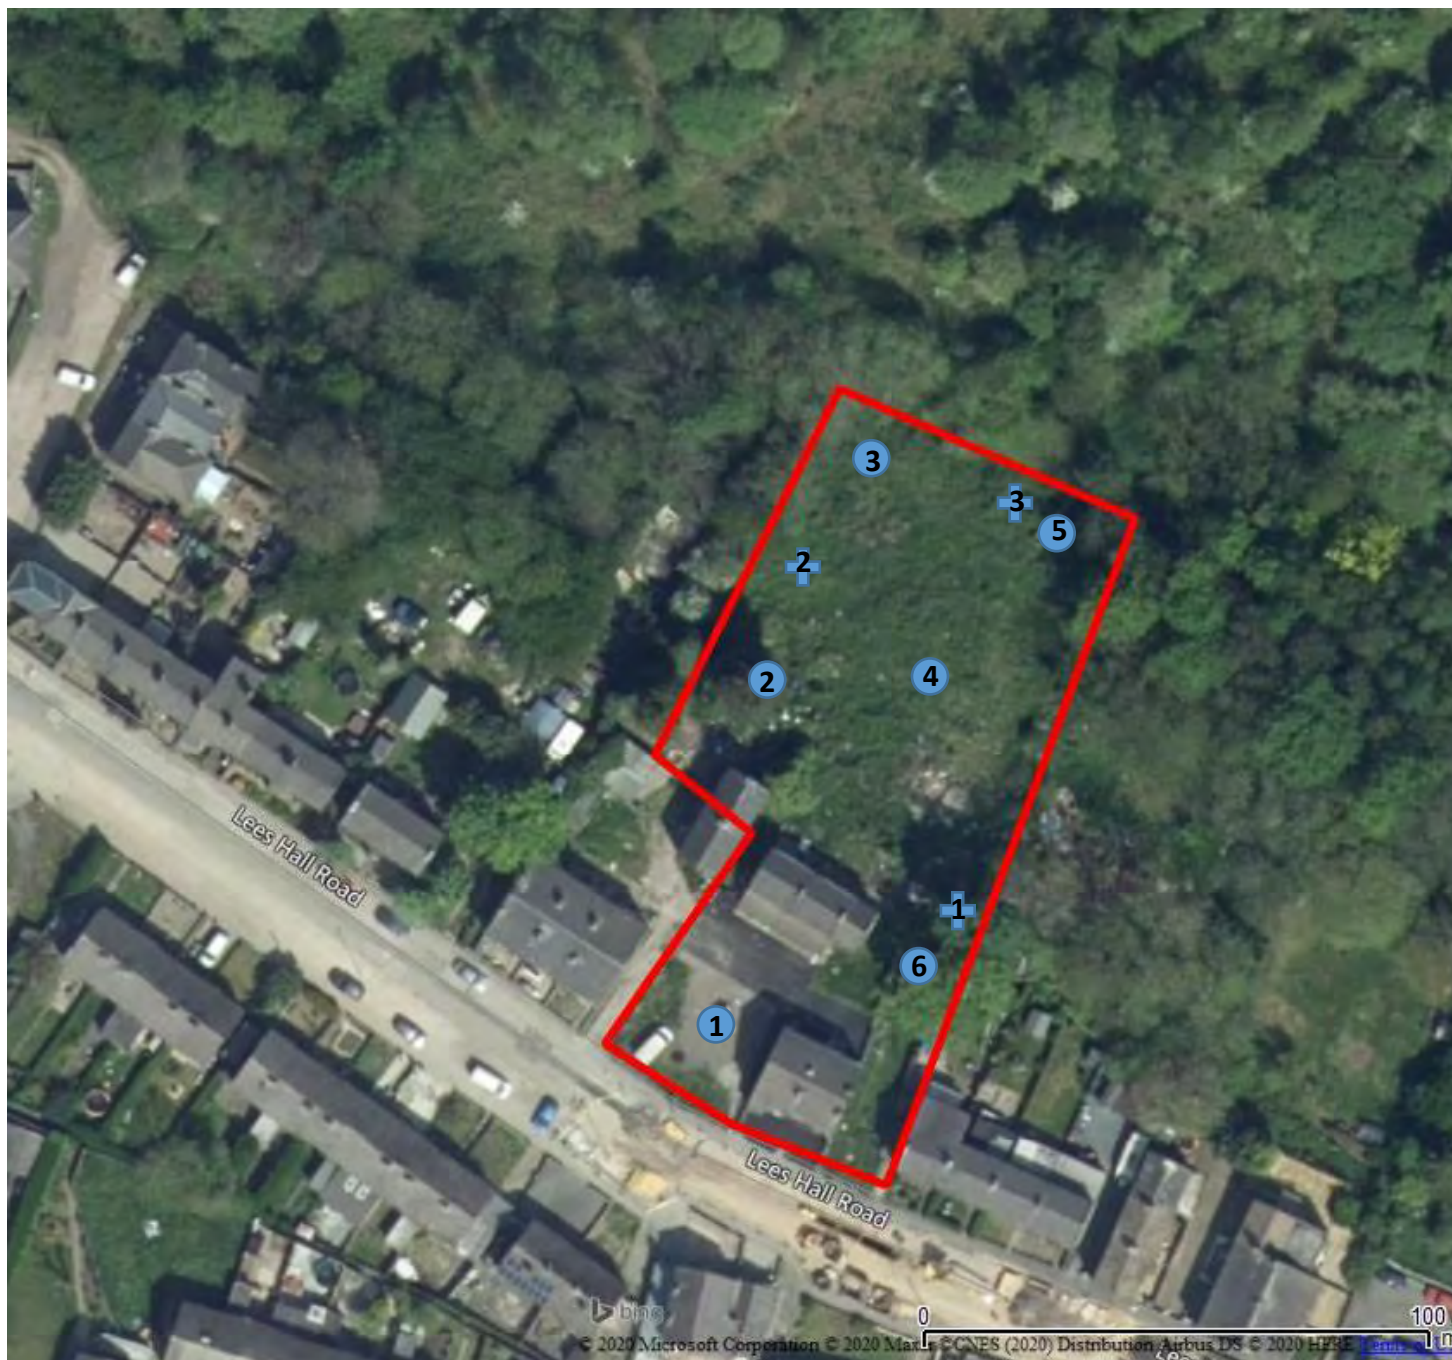
| <b>Key</b> | <div> <div> <div></div> <div>Approx. Site Boundary</div> </div> <div> <div></div> <div>Approx. BH Location</div> </div> <div> <div></div> <div>Approx. RBH Location</div> </div> </div> |

Descriptions of the strata encountered in the boreholes together with details of sampling and groundwater are presented in Appendix B of this report. A plan showing the location of the boreholes can be found in Appendix A (Figure 2).
