VALIDATION REPORT  
OF  
REMEDIATION  
HOUSE PLOTS 22 TO 37  
MIDLOTHIAN, NEW MILL  
HOLMFIRTH, HD9 7LN  
FOR  
SIGNATURE HOMES (Yorkshire) LTD  
REPORT REF: SIG 3500 Val 22 TO 37rev 1

VALIDATION REPORT  
OF

HOUSE PLOTS 22 TO 37  
MIDLOTHIAN, NEW MILL,  
HOLMFIRTH HD9 7LN

FOR  
SIGNATURE HOMES (Yorkshire)LTD

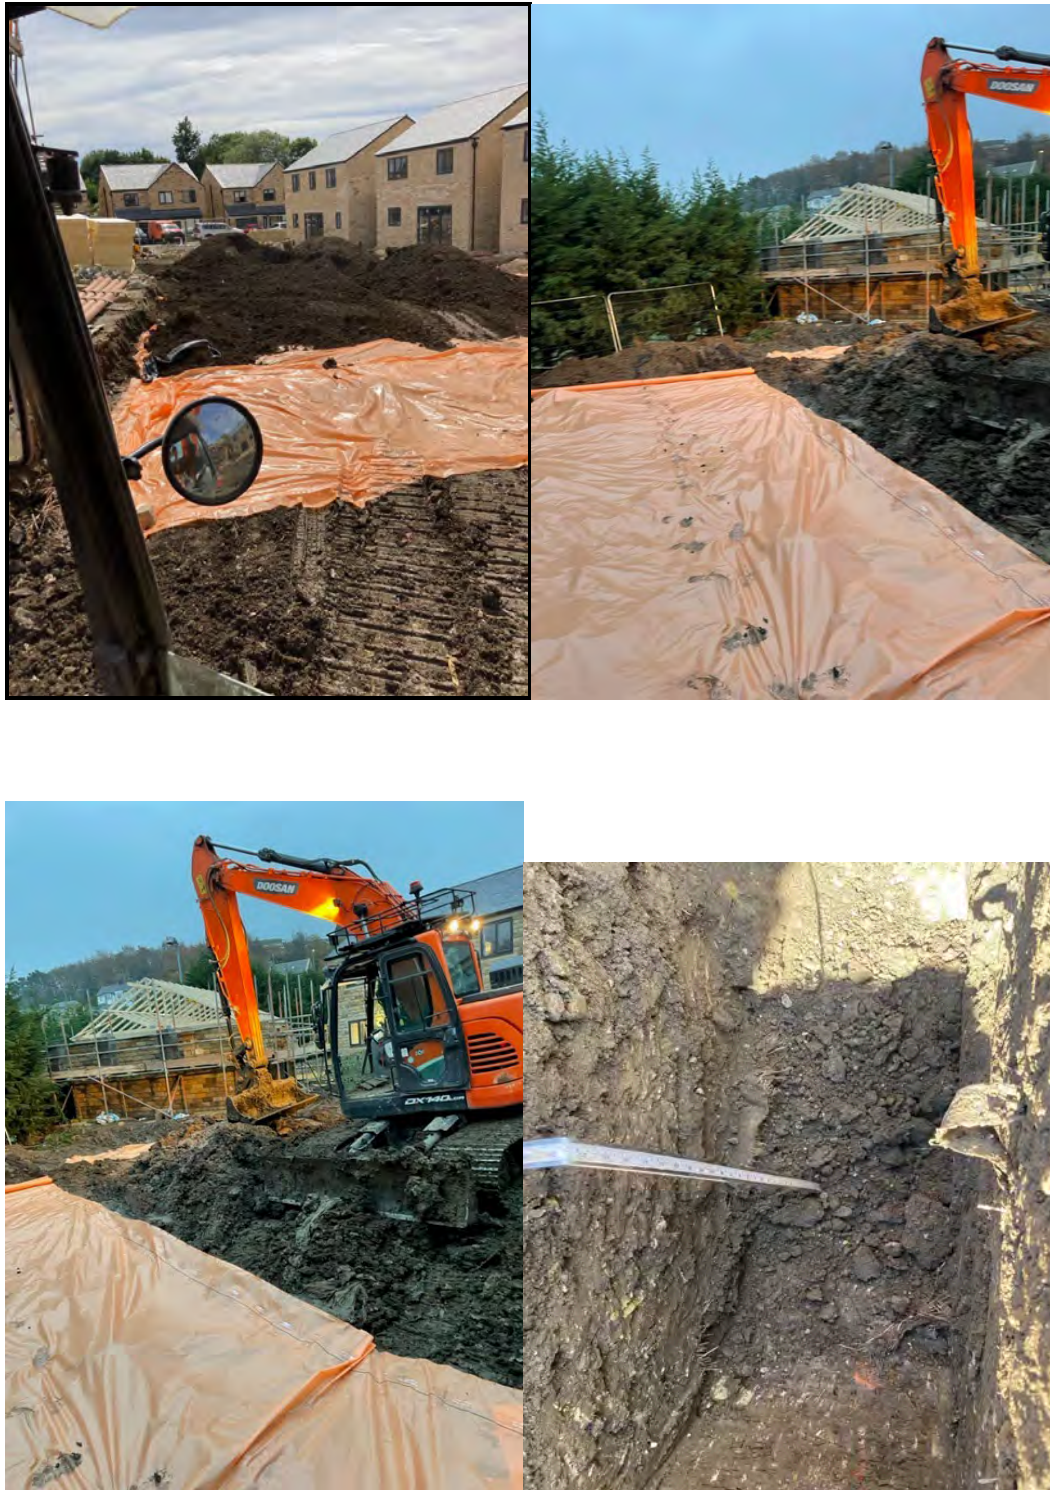
Validation of the geotextile laid in the gardens of house plots 22 to 37 was undertaken by daily inspection during placing and covering in topsoil. The geotextile was laid overlapping between plots. The figure below illustrates an example from the on site of the geotextile laid beneath the first layer of topsoil. All the soil laid was topsoil and the thickness was confirmed by insertion of a graded metal rod of appropriate length, shown below. Photographs for all Plots are presented in Appendix A.

**Figure 5 General View of Geotextile and Topsoil being placed and checked for thickness**

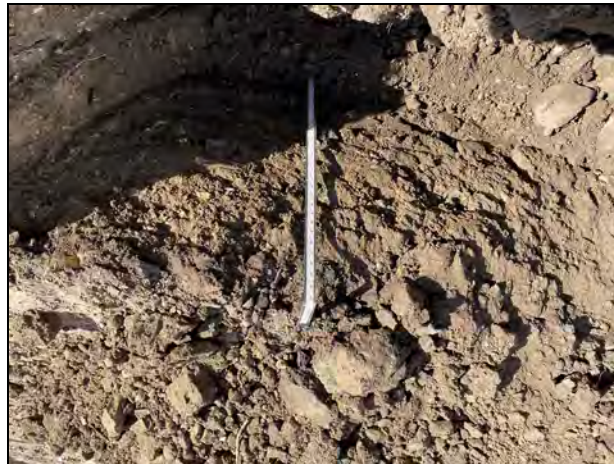
**Figure 8 Sampling Plot 28**

Asbestos fibres, Benzo(a)fluoranthene and Benzo(a)pyrene were detected in Plot 28 and following complete replacement of the 600mm cover in the garden of Plot 28 in October 2022, asbestos and PAHs were not detected in a retest in November 2022.

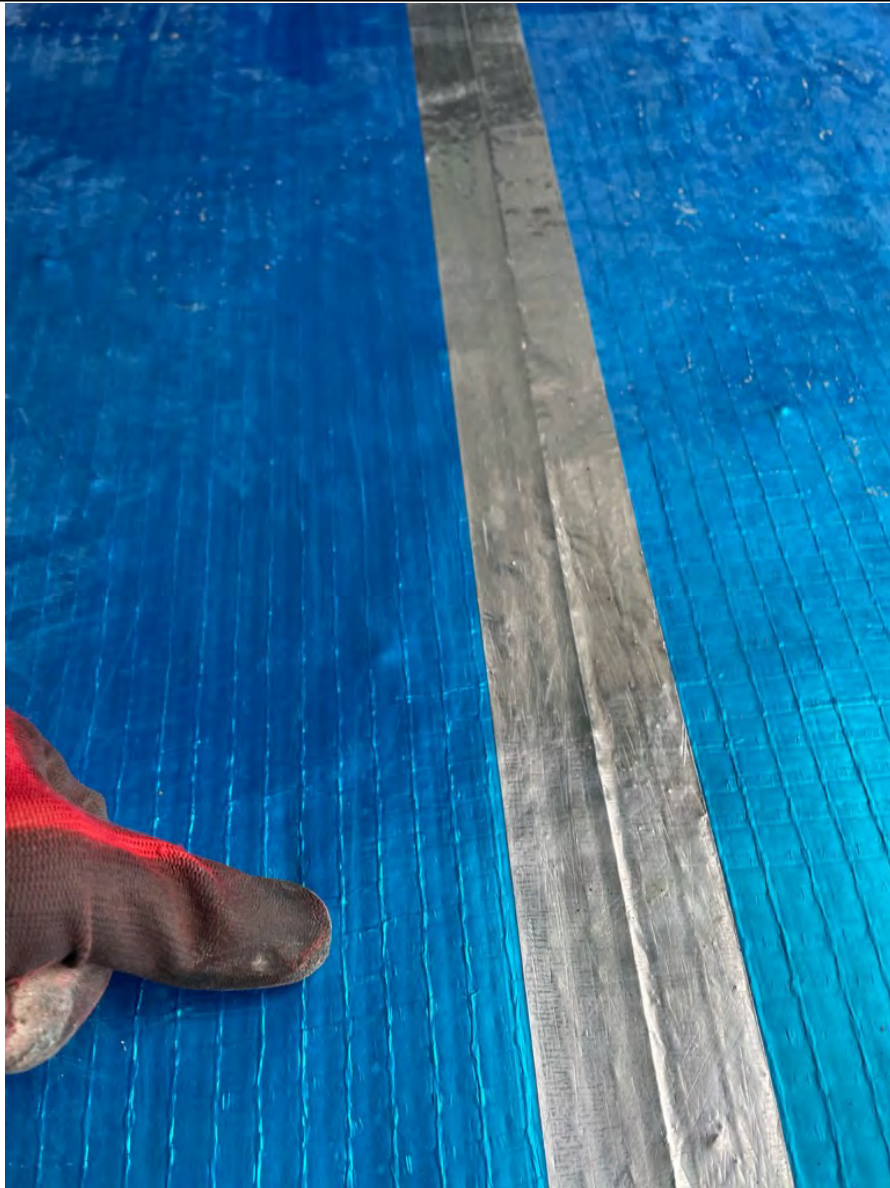
## VERIFICATION ITEM ONE

3. Double sided butyl tape installed inside all joints and correct lap tapes used

throughout. Excellent installation throughout. Passed and verified.

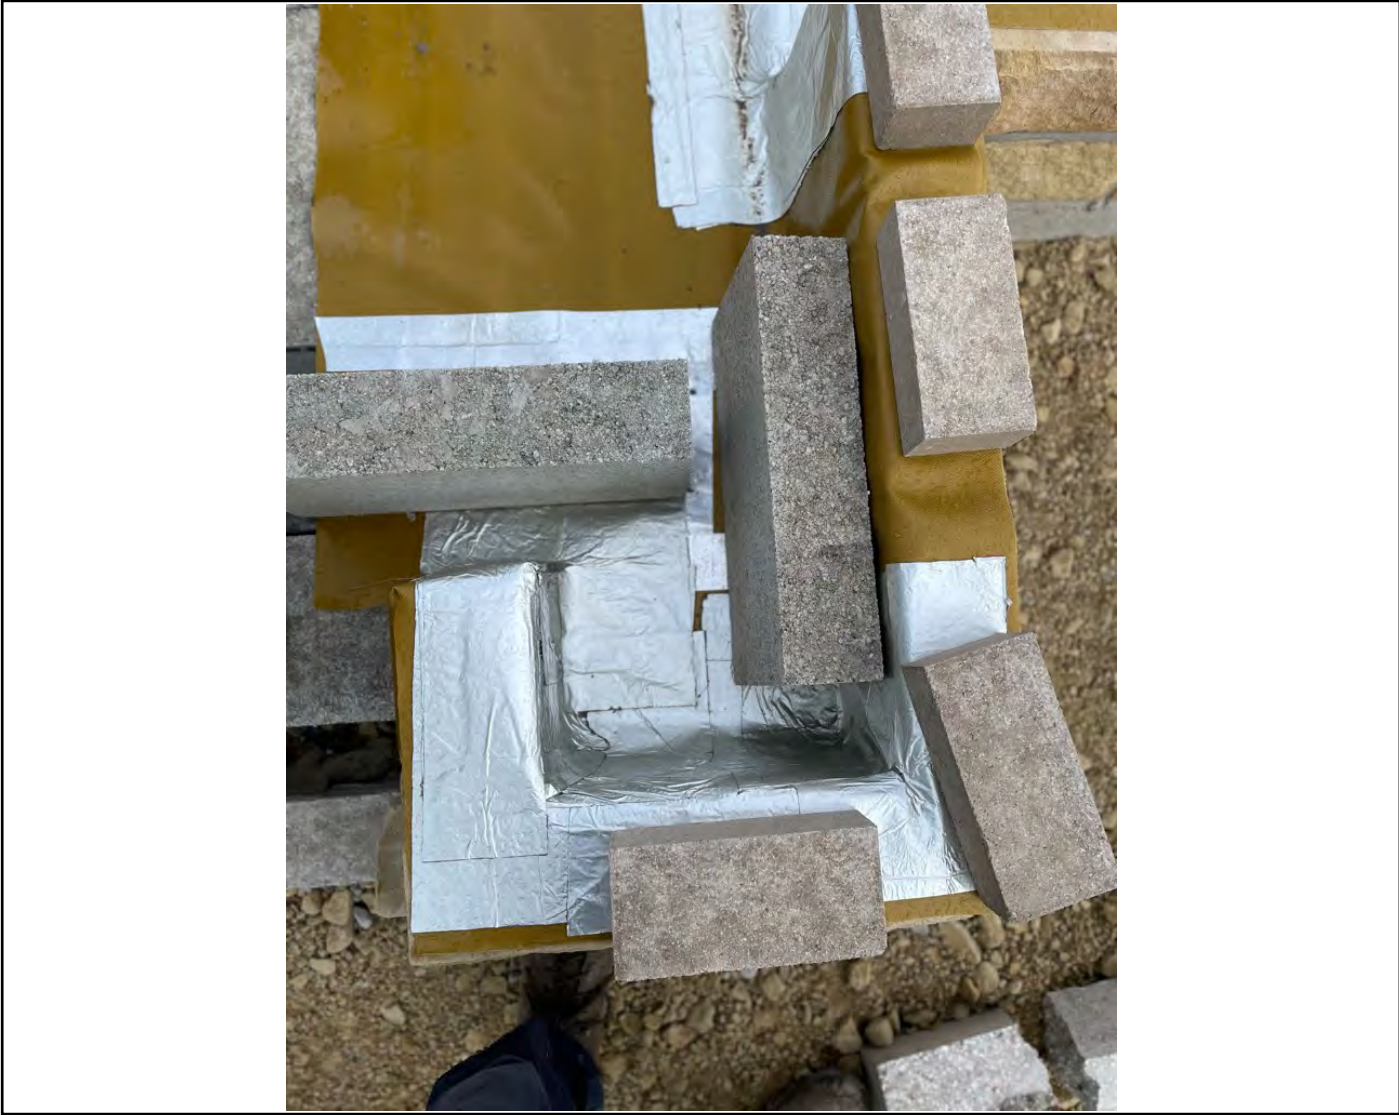
## VERIFICATION ITEM THREE

3. Corner details reinforced with Pro Detailing Tape.

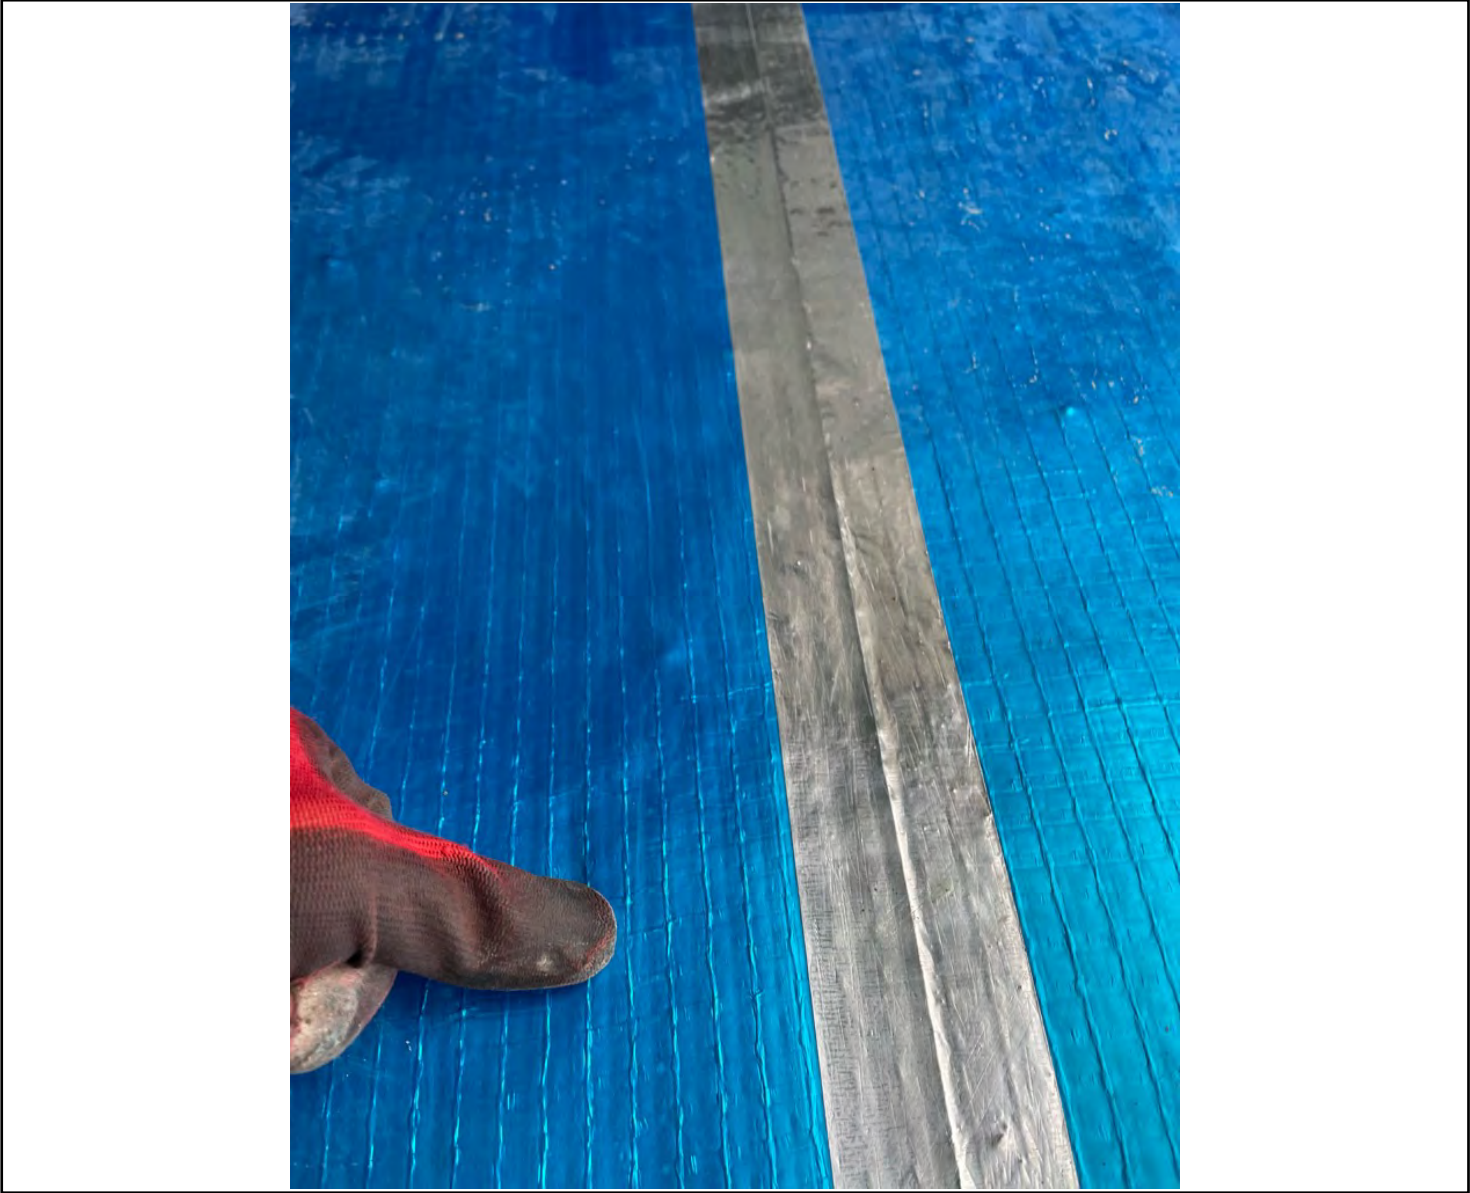
## VERIFICATION ITEM ONE

3. Double sided butyl tape installed inside all joints and correct lap tapes used

throughout. Excellent installation throughout. Passed and verified.

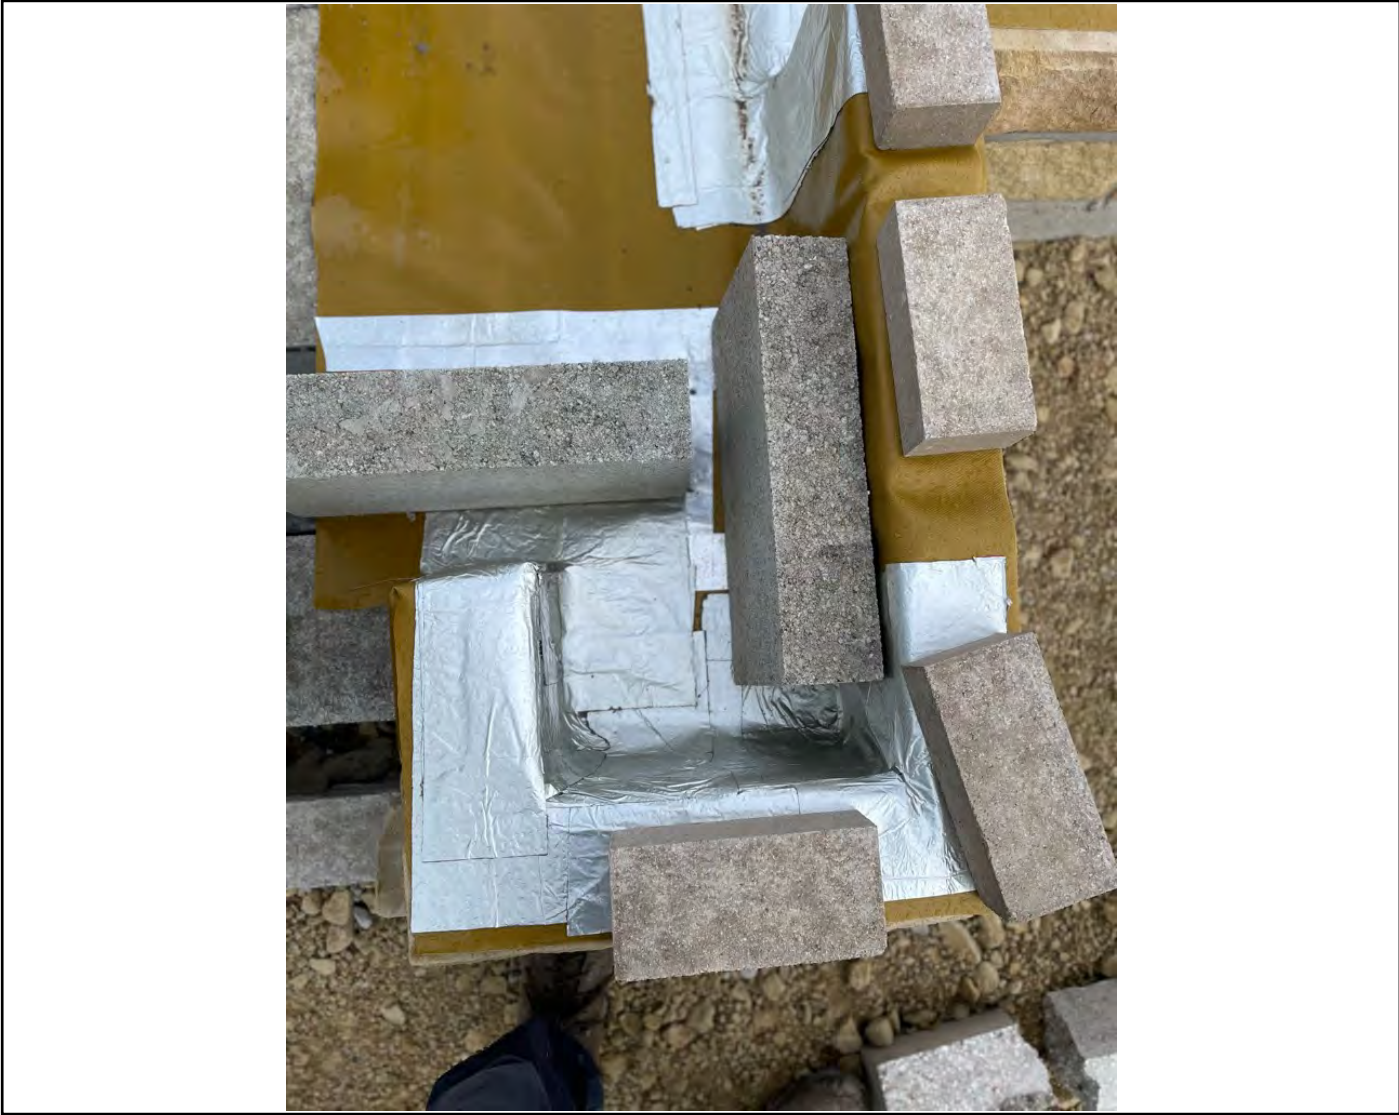
## VERIFICATION ITEM THREE

3. Corner details reinforced with Pro Detailing Tape.

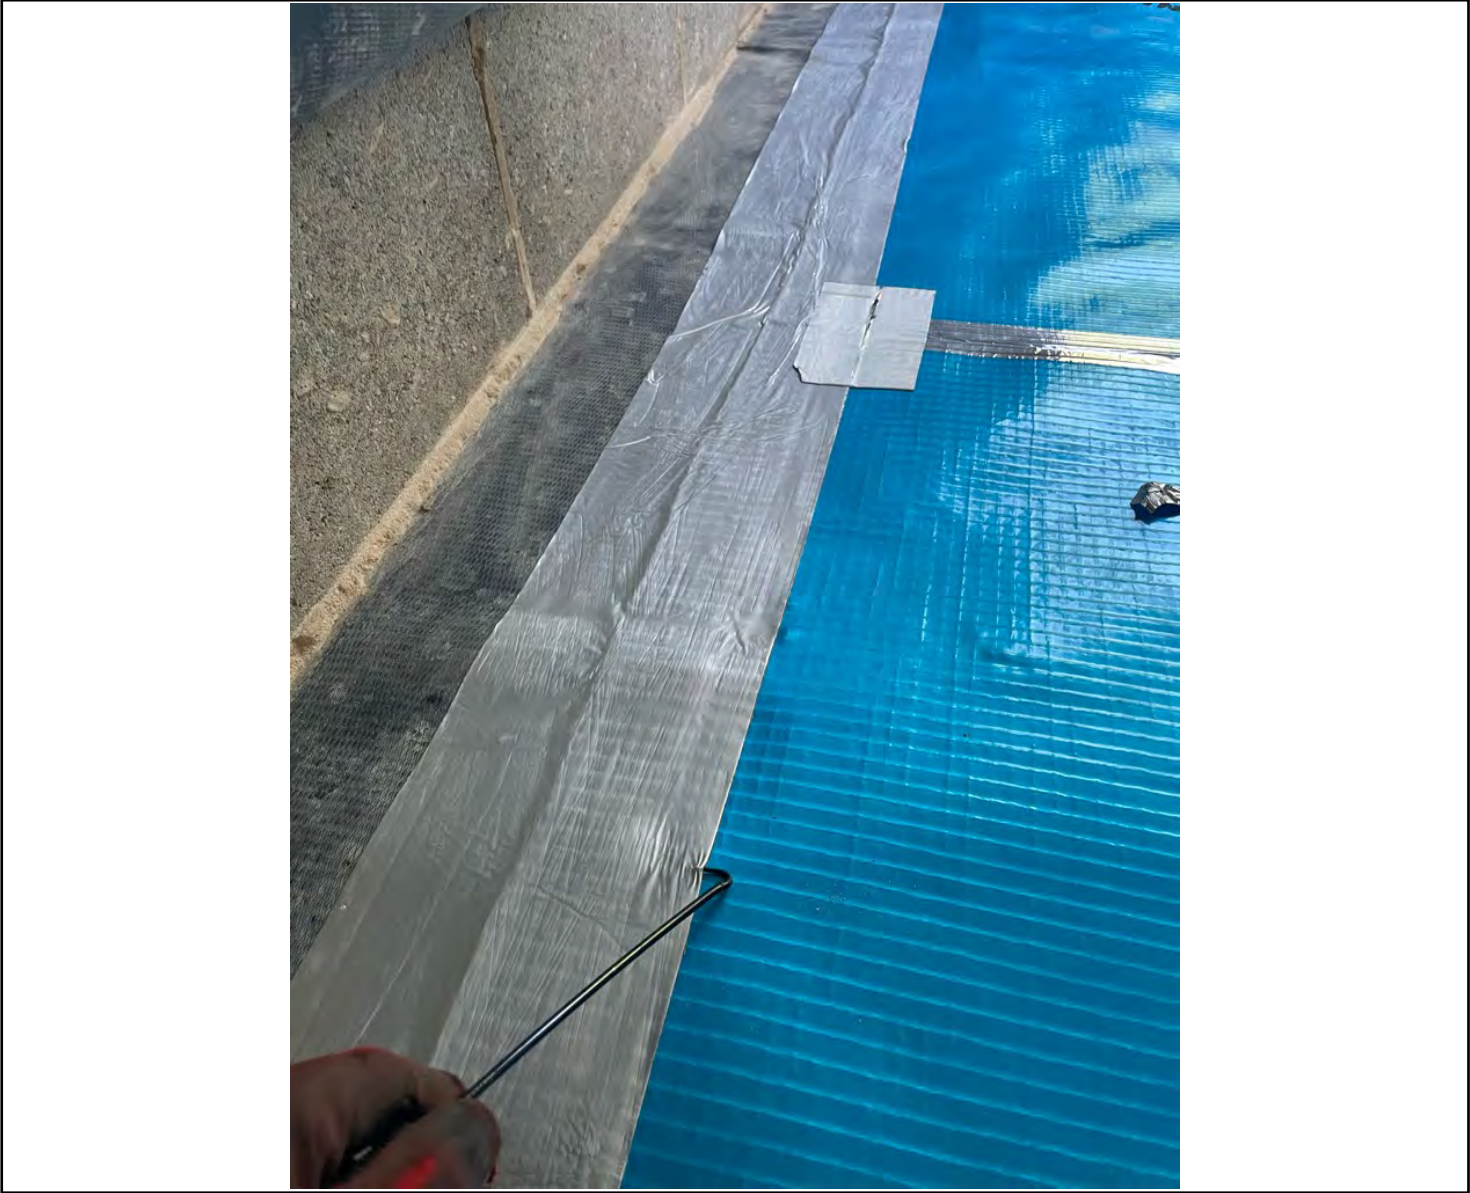
## VERIFICATION ITEM ONE

3. Pick and probe carried out and good bond achieved throughout. Passed and

verified. No faults found.

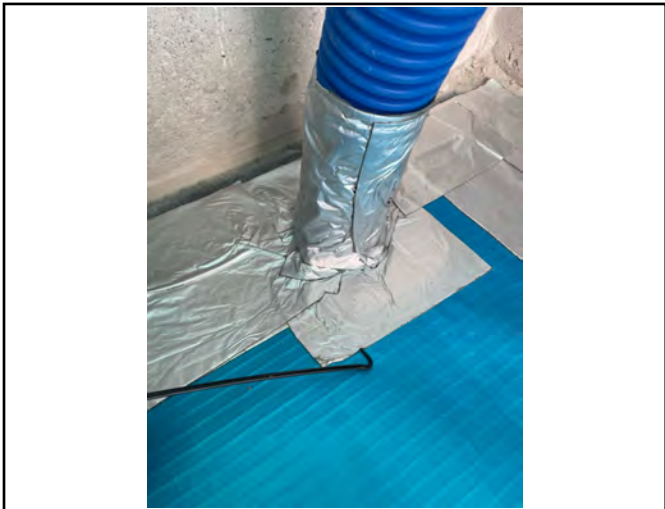
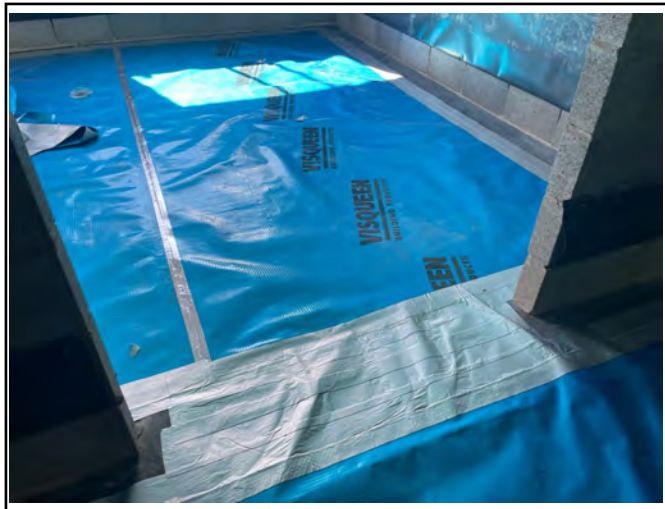
1. Pipe penetrations sealed to good standard. All other pipes to come in through the walls.

2. Damaged GR DPC fully sealed and Pro Detailing Tape.

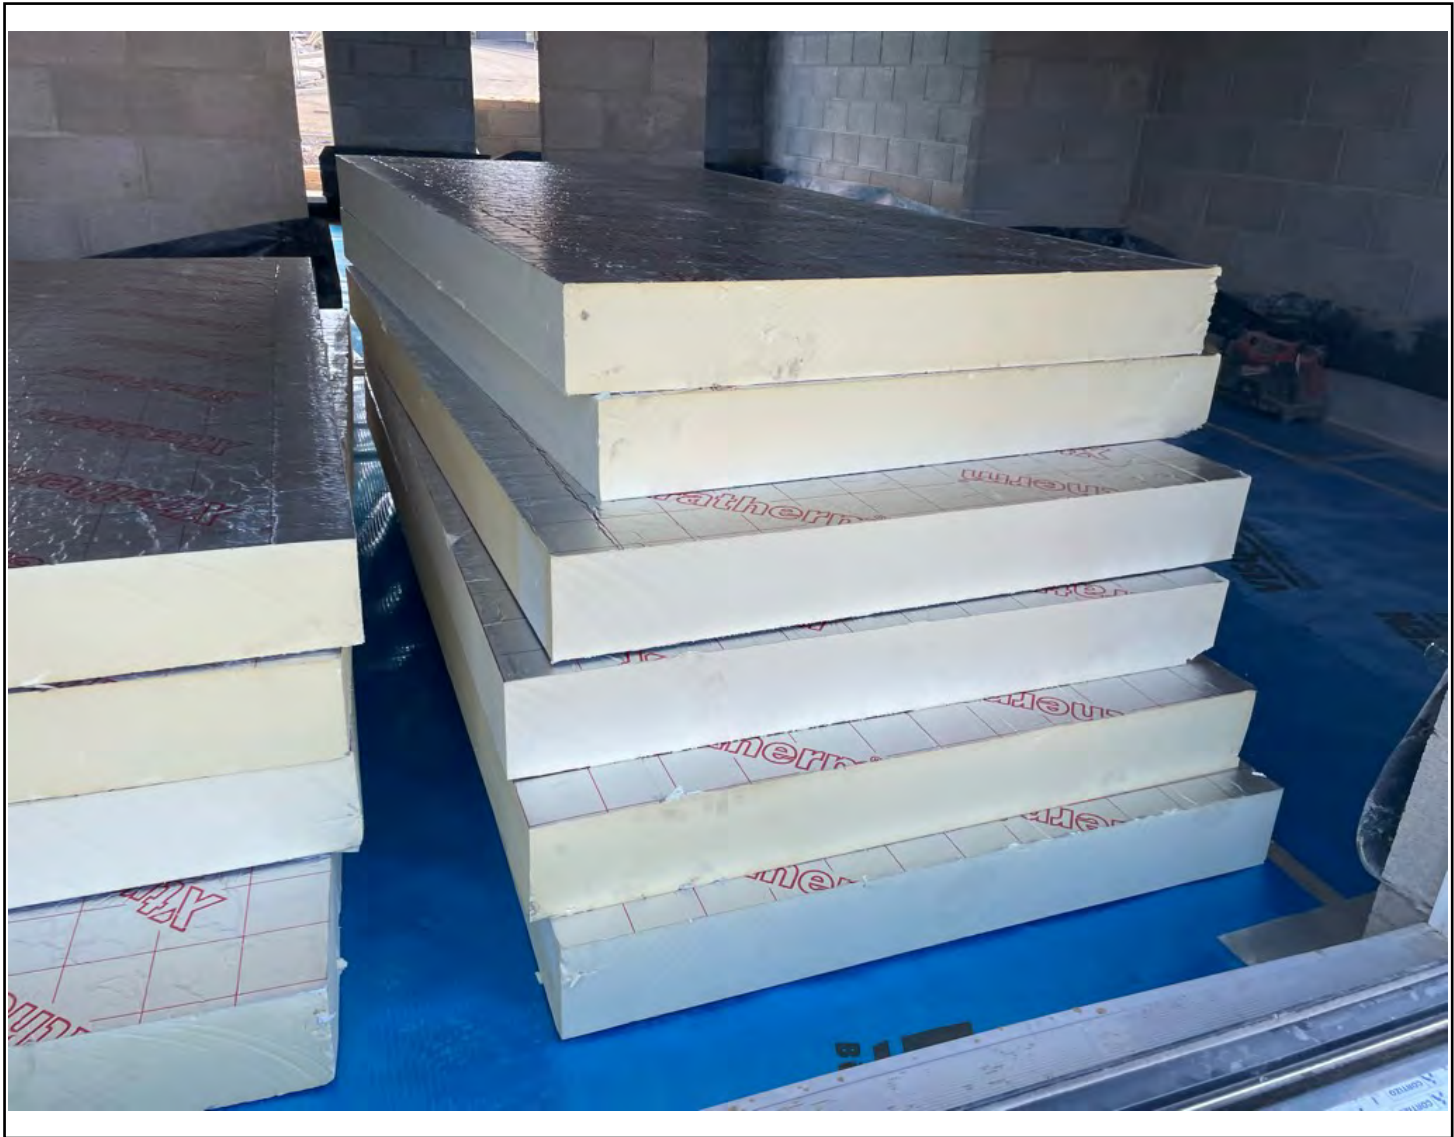
## VERIFICATION ITEM TWO

3. Insulation brought in to install before any other trades have access to the plot.

This will protect the membrane from damage. Passed and verified.

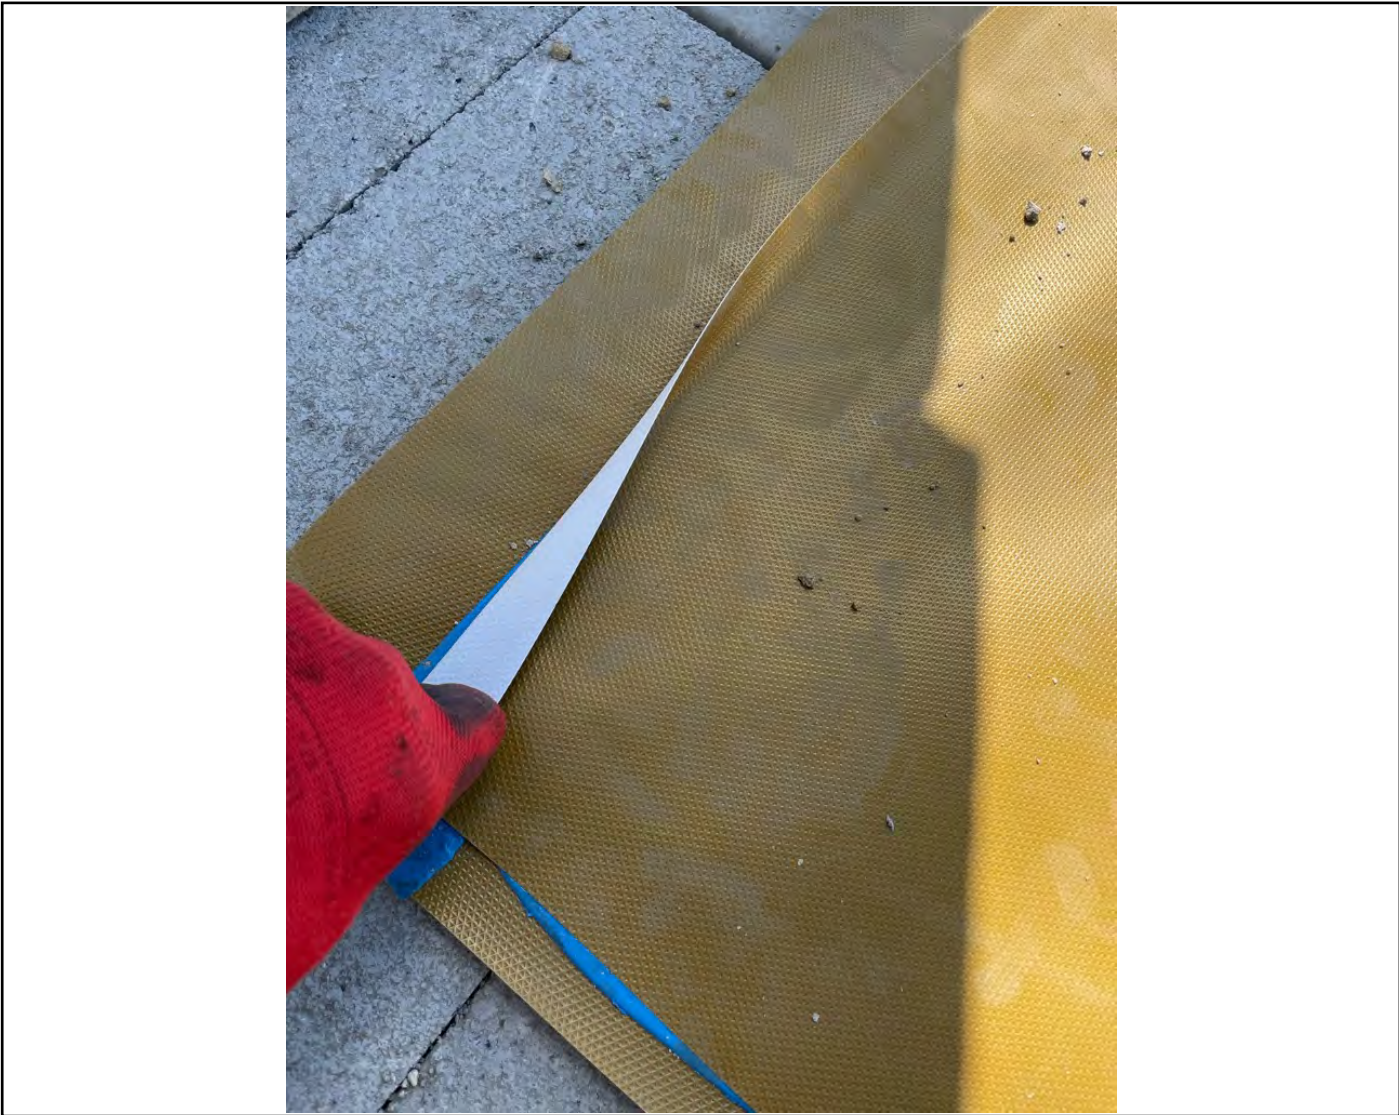
## VERIFICATION ITEM THREE

3. Butyl tape inside all joints.

Lap Tape then applied. Good installation throughout. Passed and verified.

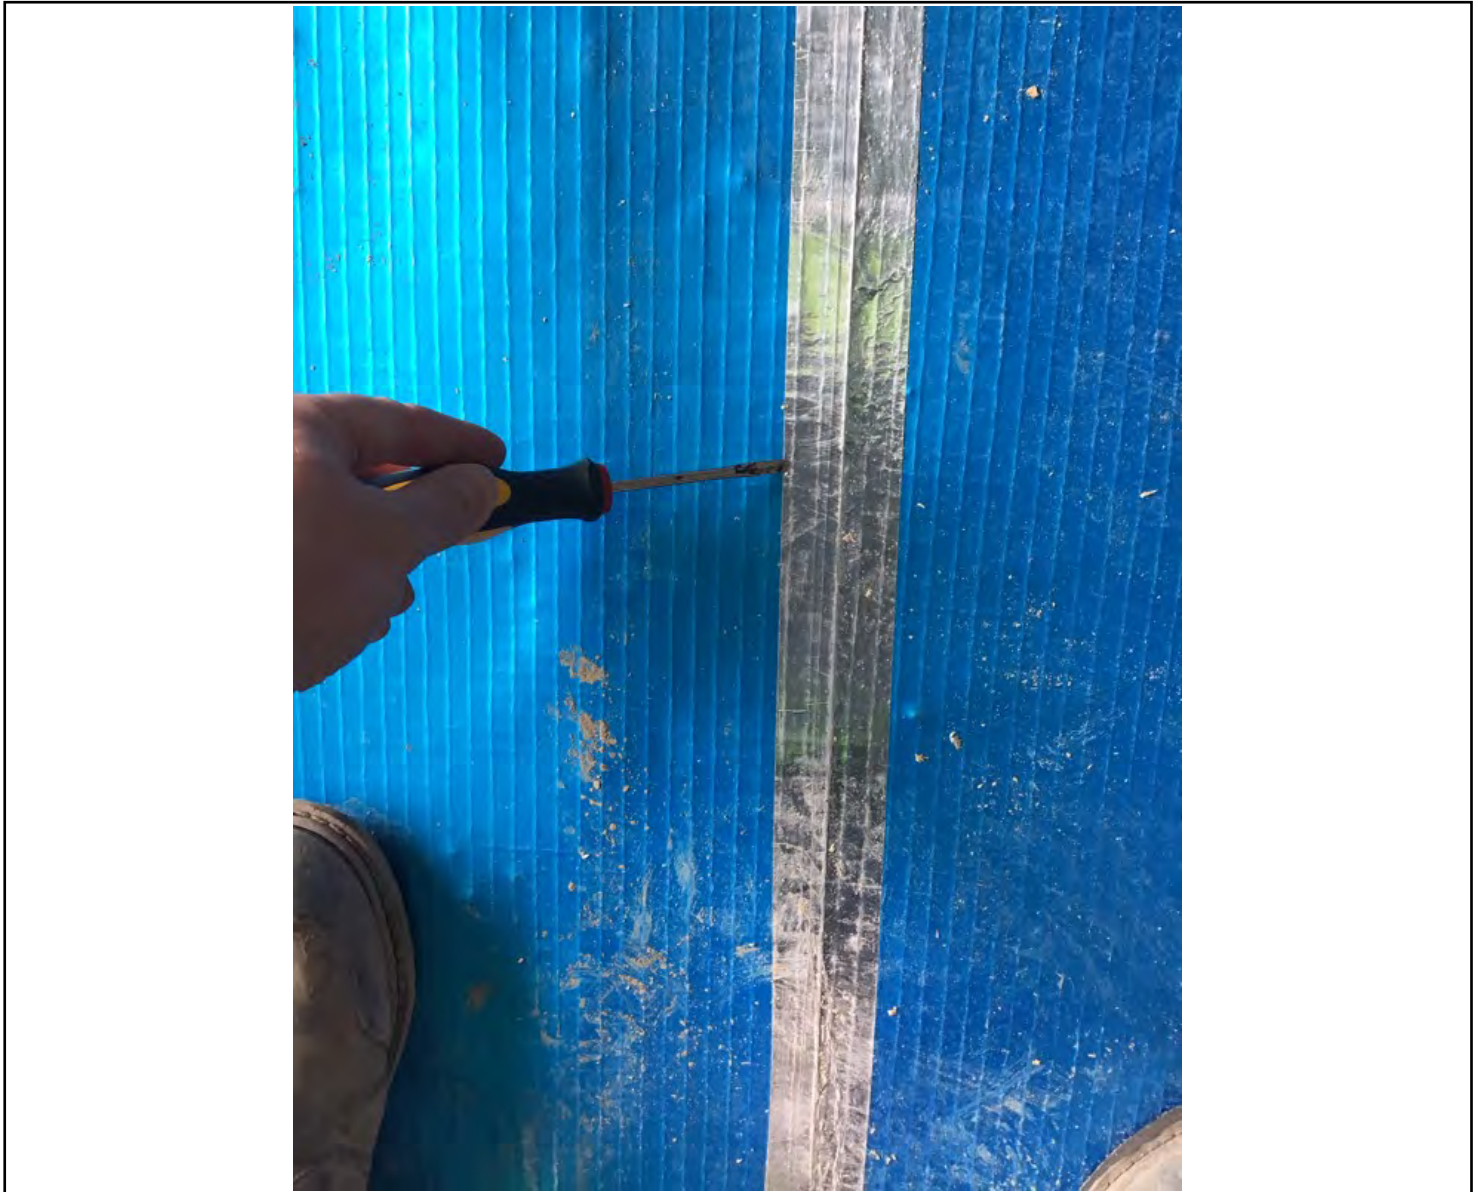
## VERIFICATION ITEM ONE

A thorough pick and probe test was carried out on all taped lap joints to ensure a strong

bond has been created between the materials. No faults found during the verification.

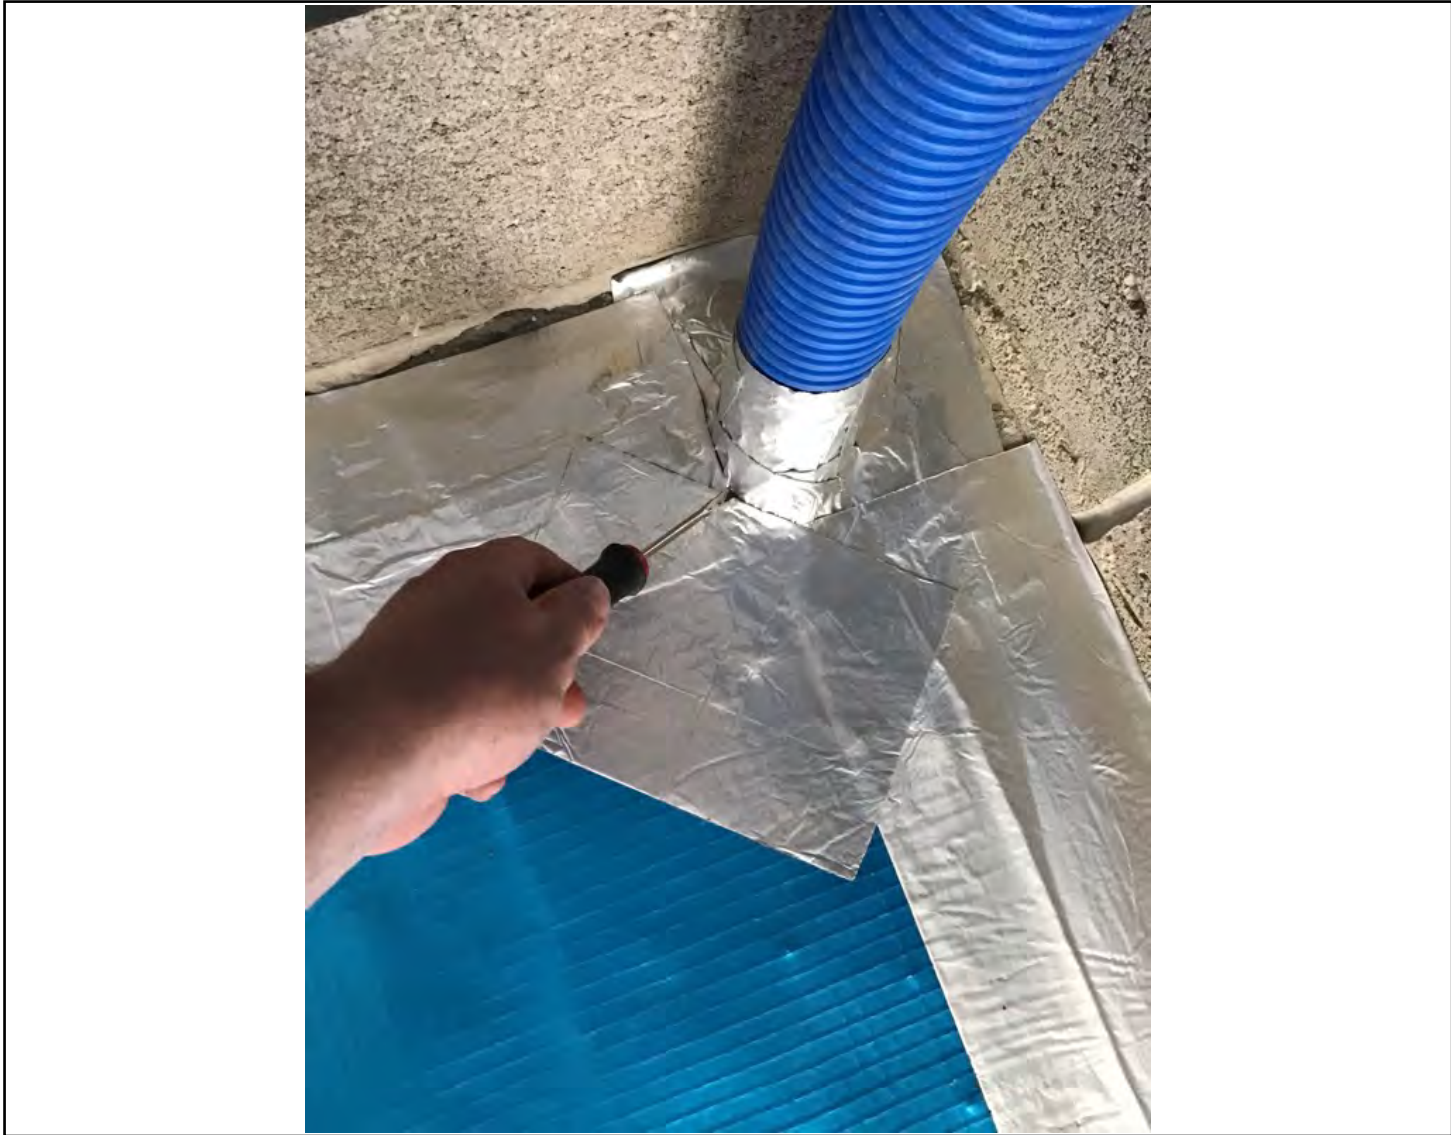
## VERIFICATION ITEM TWO

Pick and probe testing found no faults on any service entry with material installed

to manufacturers specification.

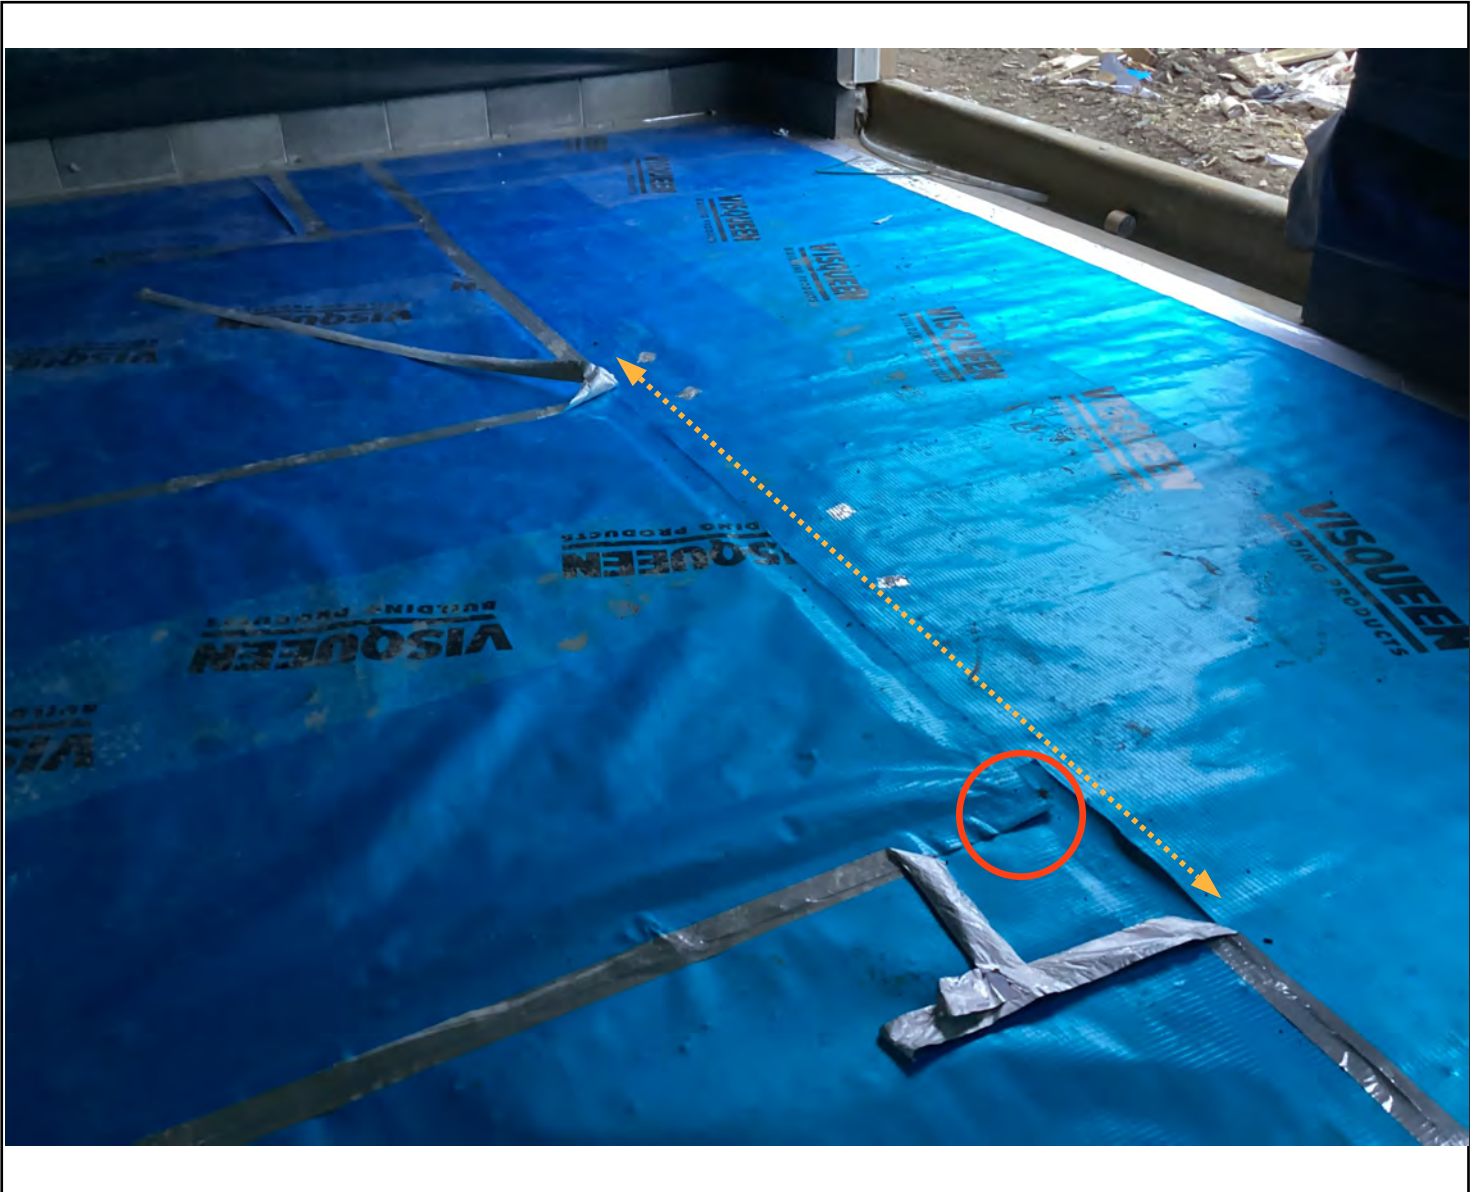
## VERIFICATION ITEM ONE

The overview image shows the extent of the sampled Visqueen Lap Joint (yellow arrow)

The Mechanical Point Stress Test was undertaken along the exposed lap joint but on

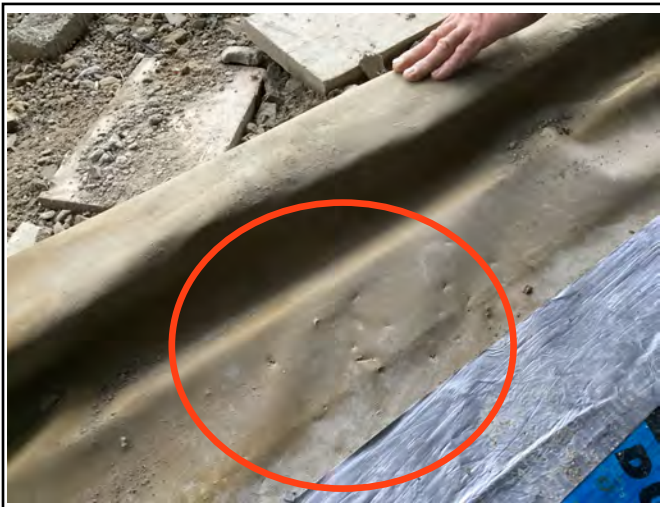
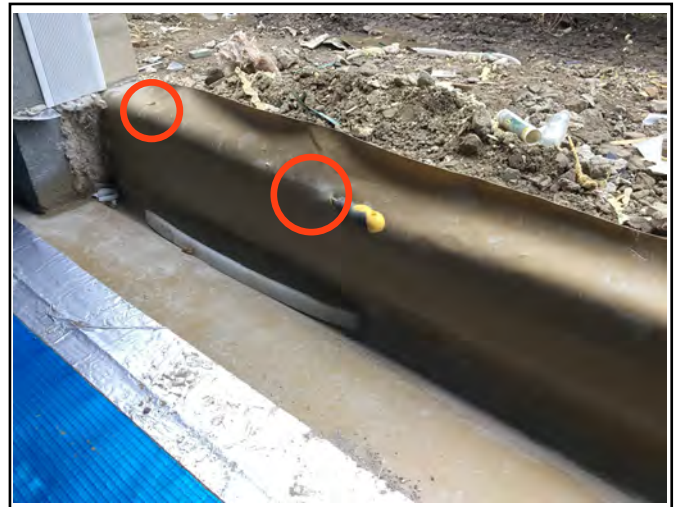
Ultimate DPC. A visual inspection identified damage which was likely caused by

follow on trades. The image on the left shows initially that the Visqueen Ultimate DPC

is effective in that it fully crossed to the garage perimeter edge. It was noted however

that there was a small number of punctures (red circle) and required remediation.

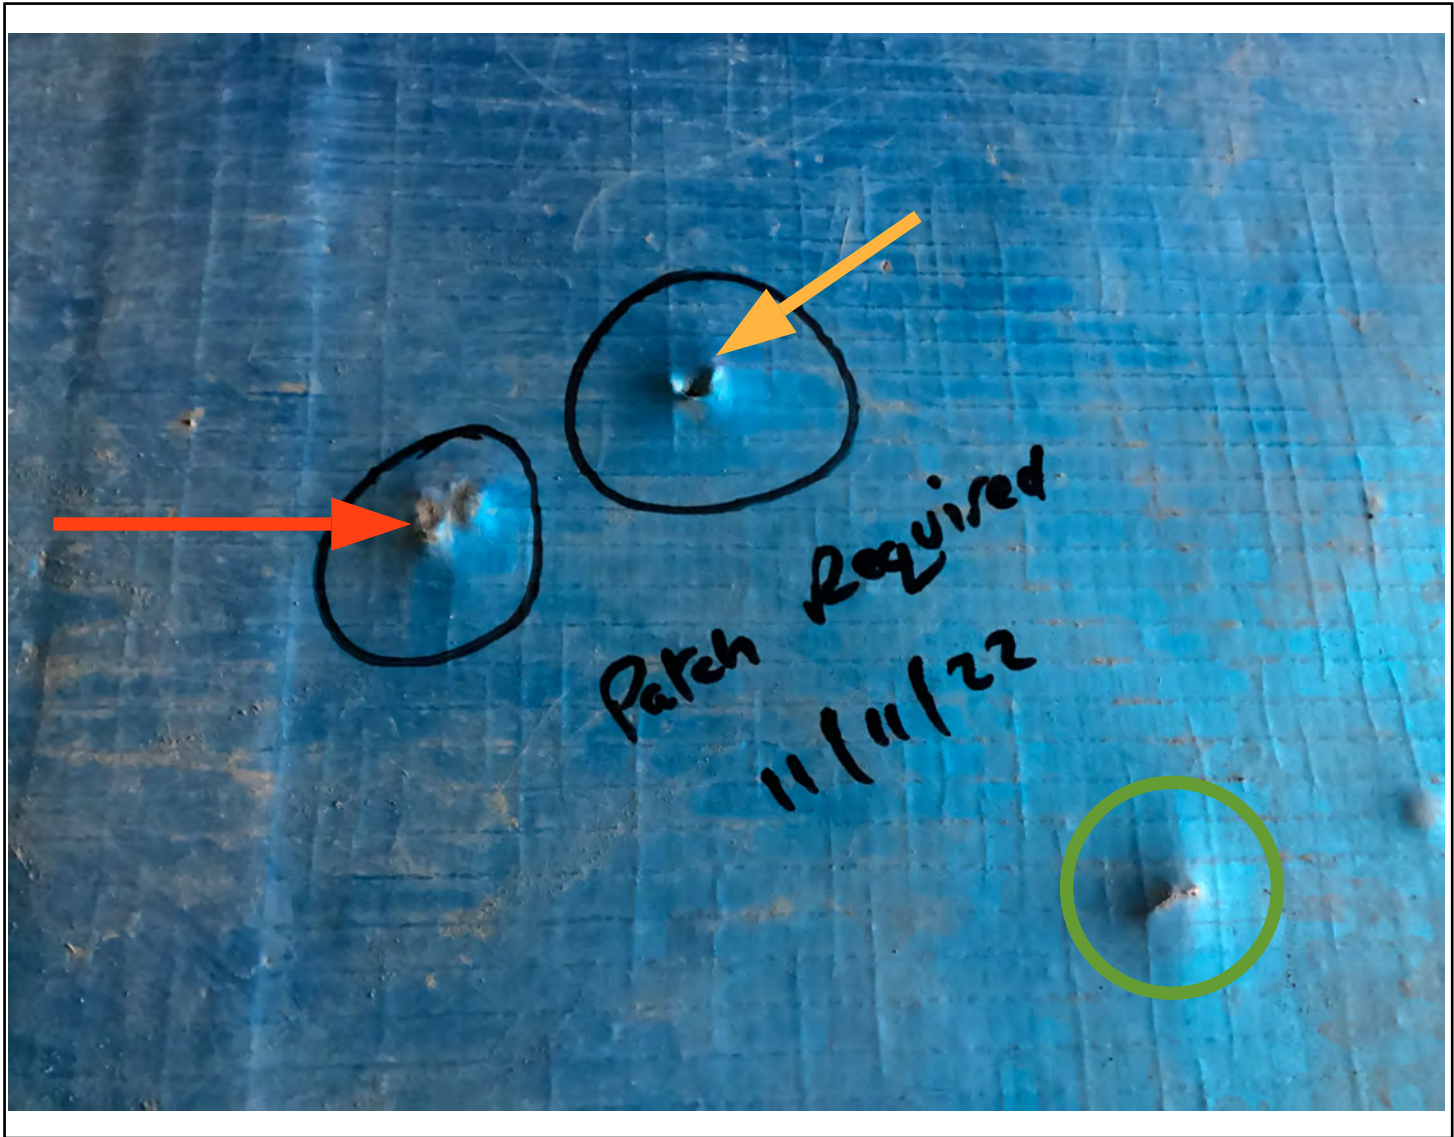
## VERIFICATION ITEM TWO

The image shows three areas identified during the inspection. The red arrow

identifies a potential puncture due to some debris beneath the Visqueen Gas Barrier

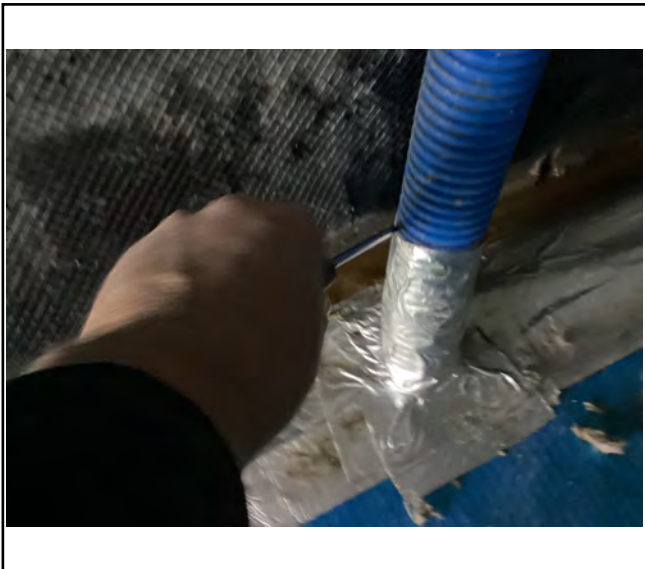
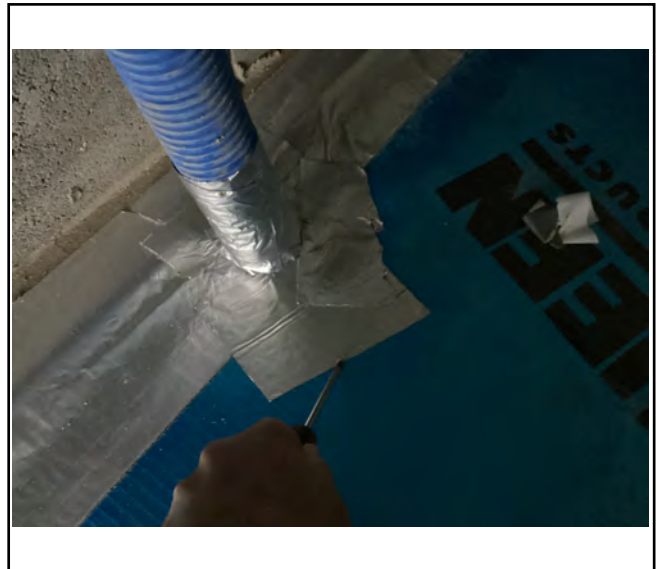
The various pipe penetrations had all been sealed using strips of the Visqueen Pro Detailing Tape ensuring a seal with both the pipe and the Visqueen Gas Barrier.

The image on the right shows the Mechanical Point Stress Test being undertaken

along the edges checking there was full adhesion but also there were no potential

capillary leaks. The image on the right shows the Mechanical Point Stress Test
