VALIDATION REPORT  
OF  
REMEDIATION  
HOUSE PLOTS 22 TO 37  
MIDLOTHIAN, NEW MILL  
HOLMFIRTH, HD9 7LN  
FOR  
SIGNATURE HOMES (Yorkshire) LTD  
REPORT REF: SIG 3500 Val 22 TO 37rev 1

VALIDATION REPORT  
OF

HOUSE PLOTS 22 TO 37  
MIDLOTHIAN, NEW MILL,  
HOLMFIRTH HD9 7LN

FOR  
SIGNATURE HOMES (Yorkshire)LTD

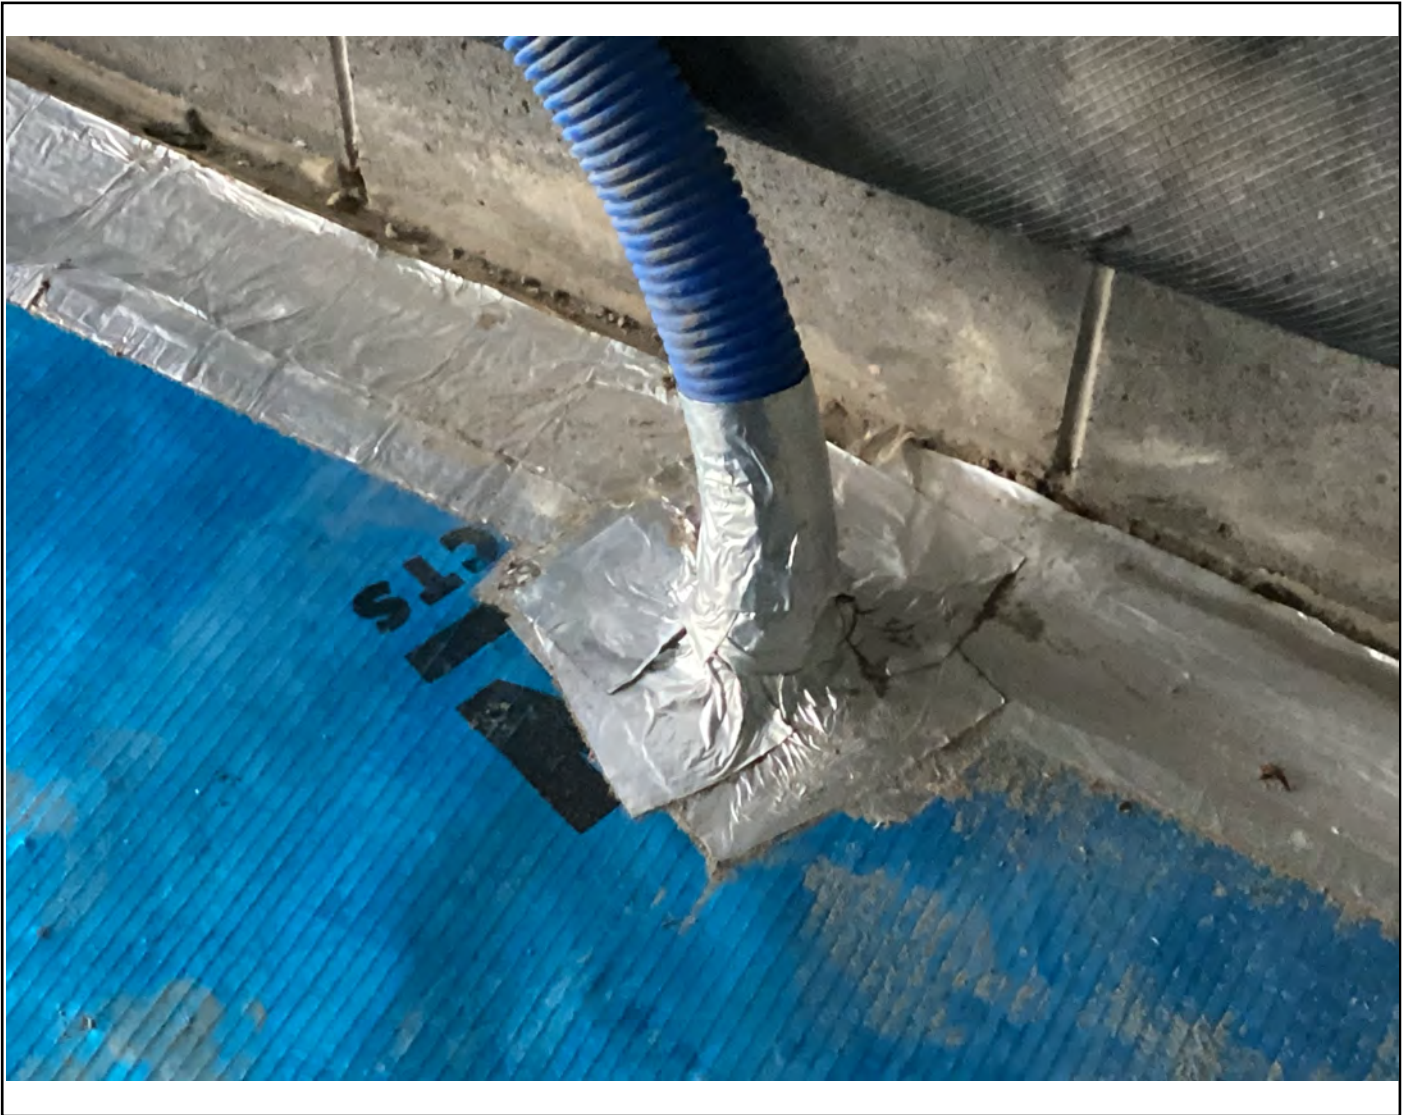
## VERIFICATION ITEM THREE

the overview image shows a typically installed pipe penetration this report.

The Visqueen Pro-Detailing Tapes had been cut and secured by combining

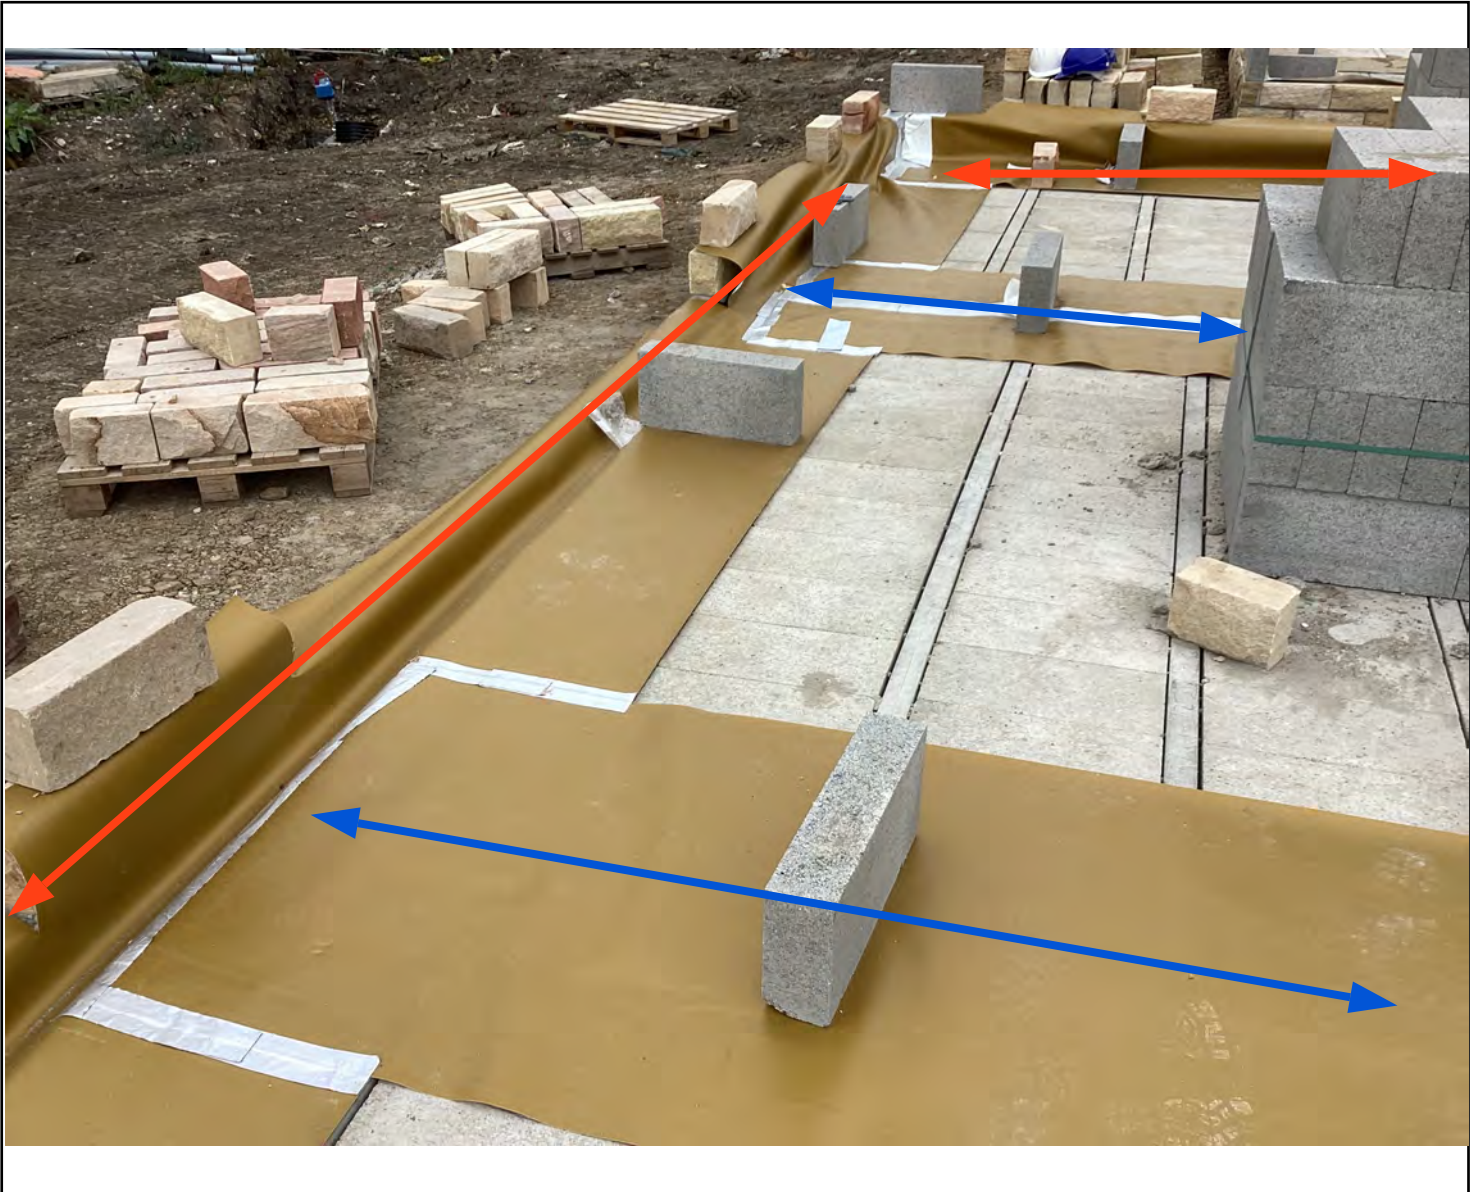
## VERIFICATION ITEM ONE

Overview showing the extent of the typical installation of the Visqueen Ultimate Damp

Proof Course to both the perimeter (red arrow) and internal wall positions (blue arrow).

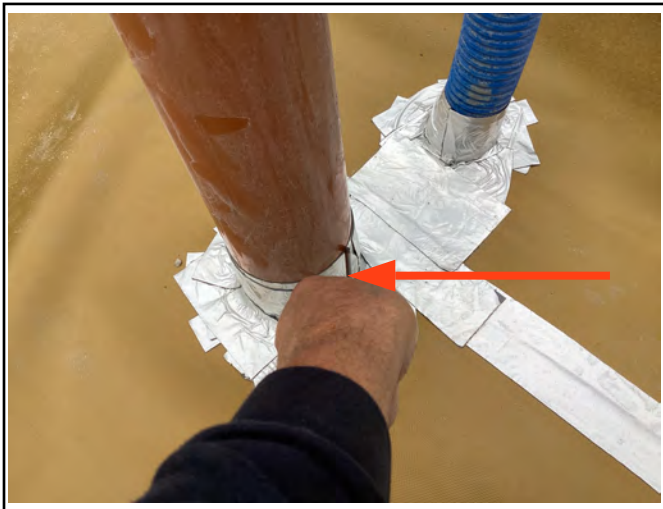
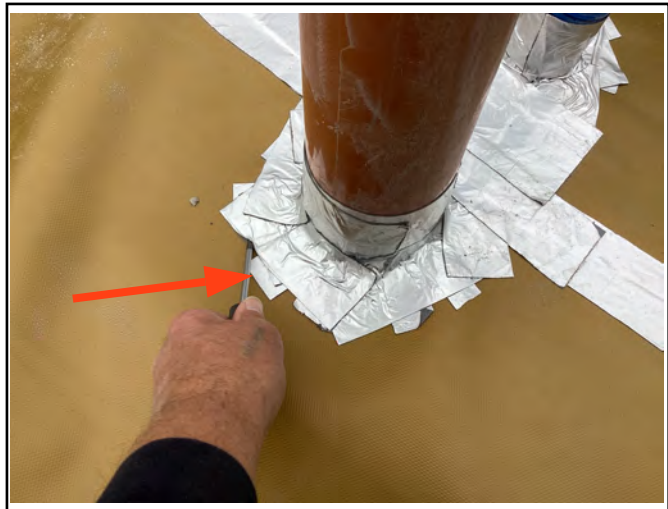
The pipe penetrations were typically sealed using Visqueen Gas Resistant Self

Adhesive Membrane to the Visqueen Ultimate Damp Proof Course.

Photos showing that the edges of the Visqueen Gas Resistant Self Adhesive

Membrane being checked for potential capillary leaks using the Mechanical Point

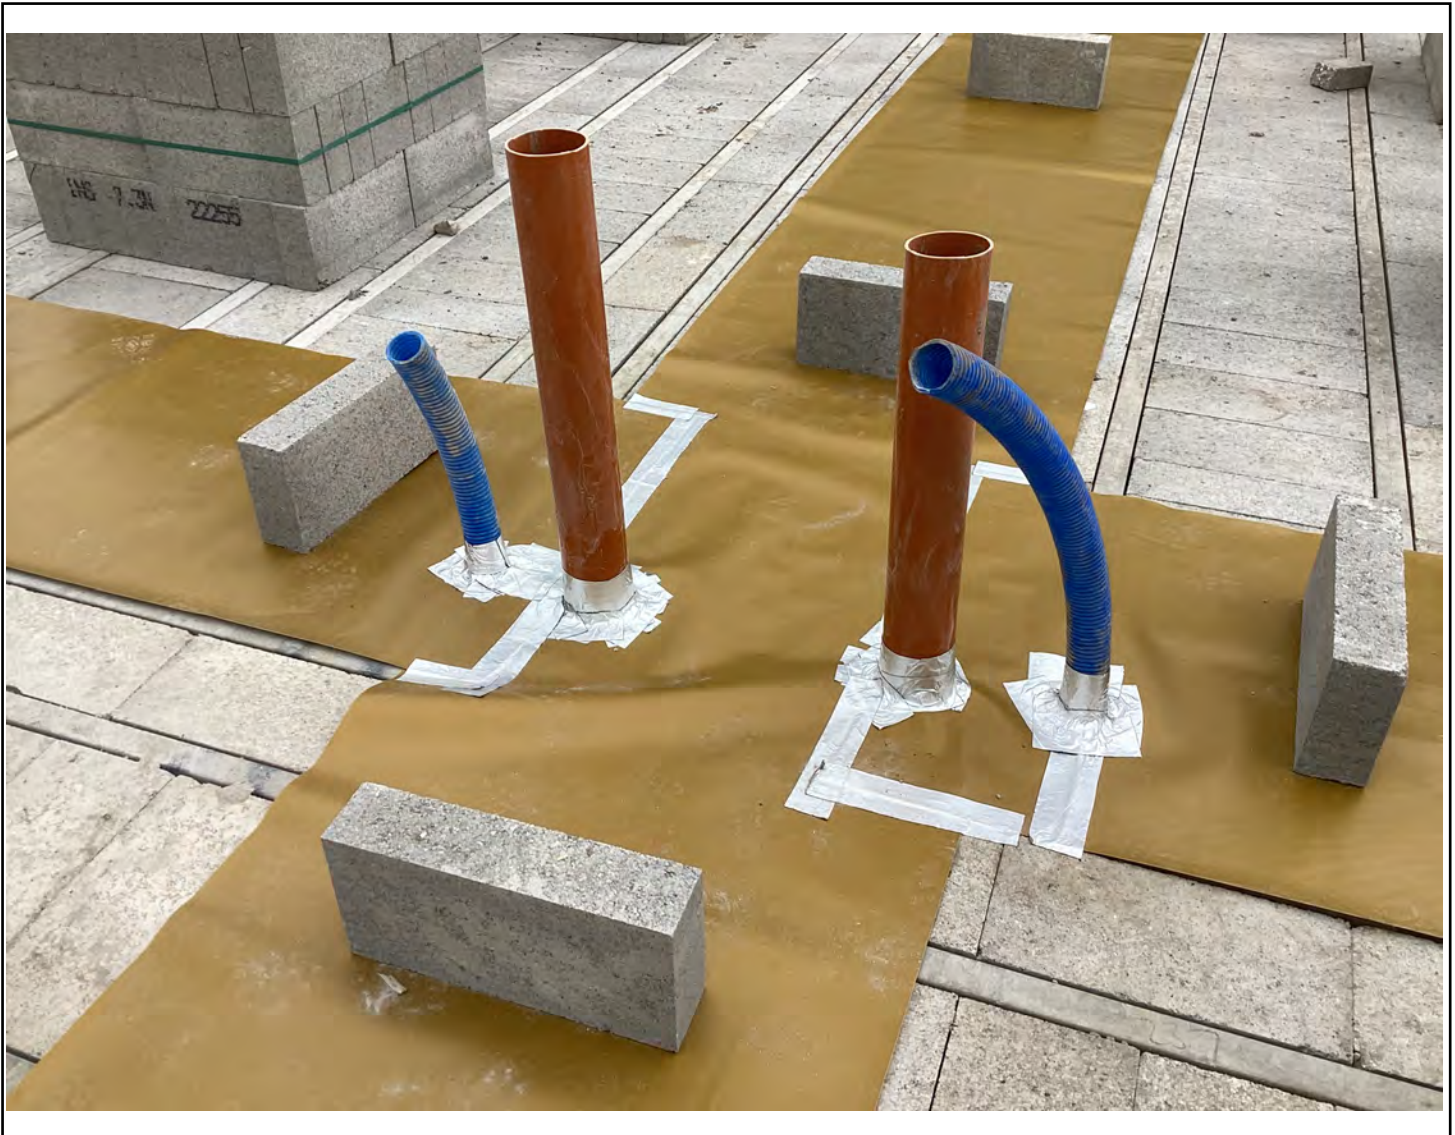
## VERIFICATION ITEM TWO

Overview of the typical pipe penetration installation where all pipes were fully

sealed to the Visqueen Ultimate Damp Proof Course using Visqueen Gas

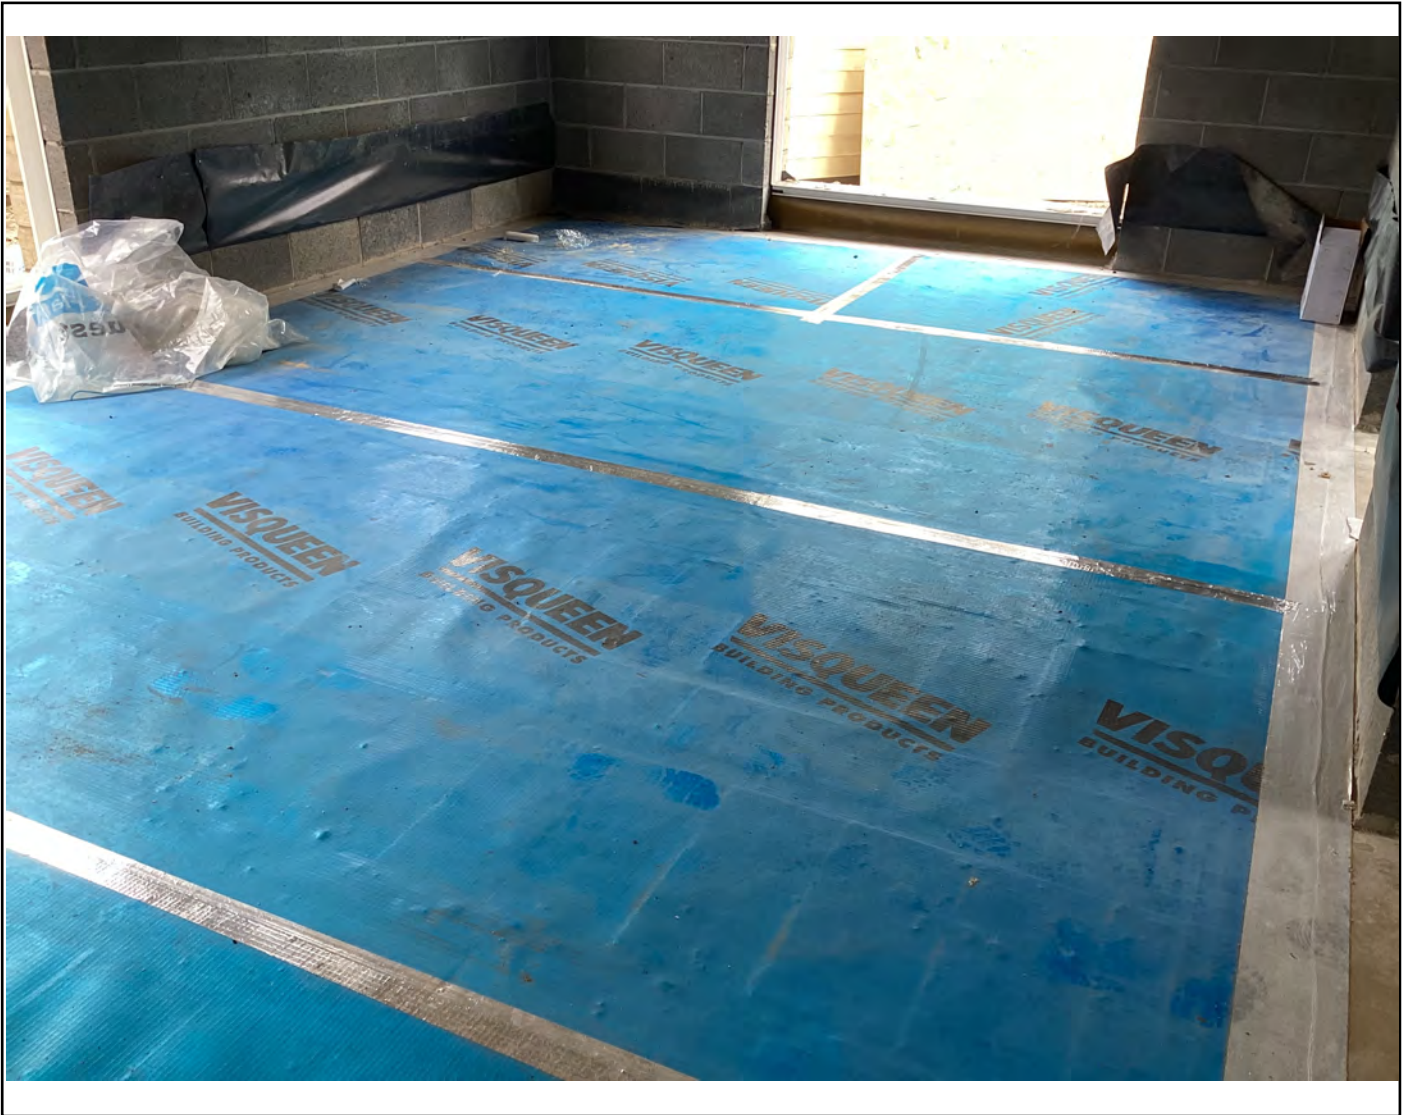
## VERIFICATION ITEM THREE

Overview showing the typical infill installation of the Visqueen Gas Barrier

to the various rooms within the plots.

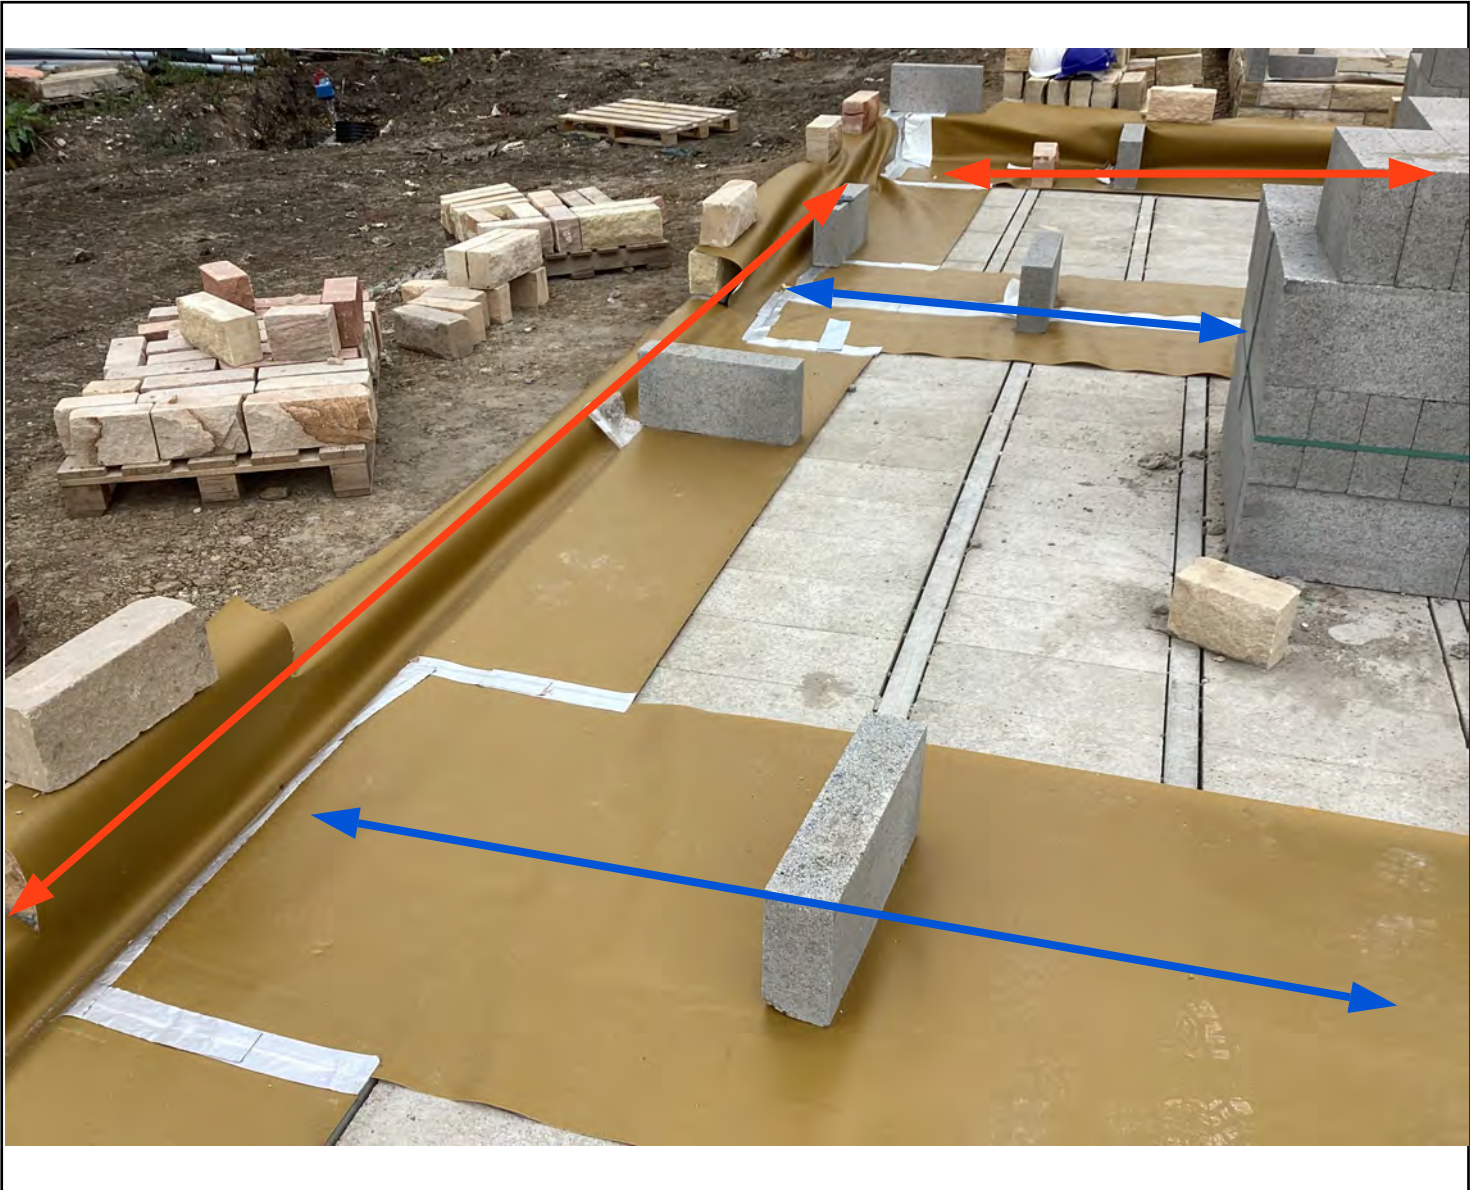
## VERIFICATION ITEM ONE

Overview showing the extent of the typical installation of the Visqueen Ultimate Damp

Proof Course to both the perimeter (red arrow) and internal wall positions (blue arrow).

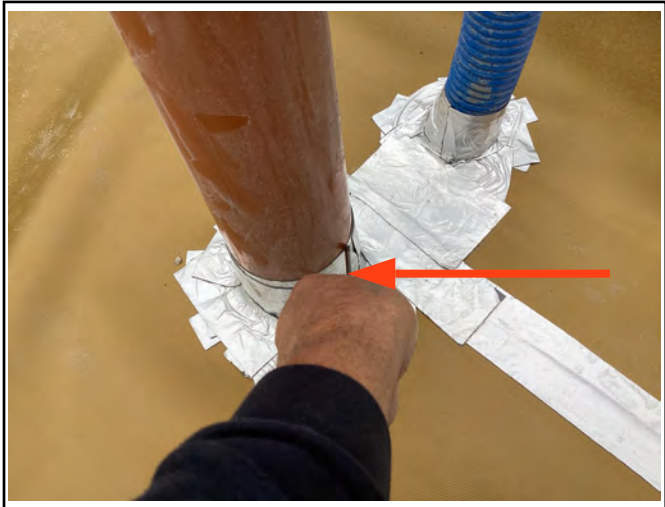
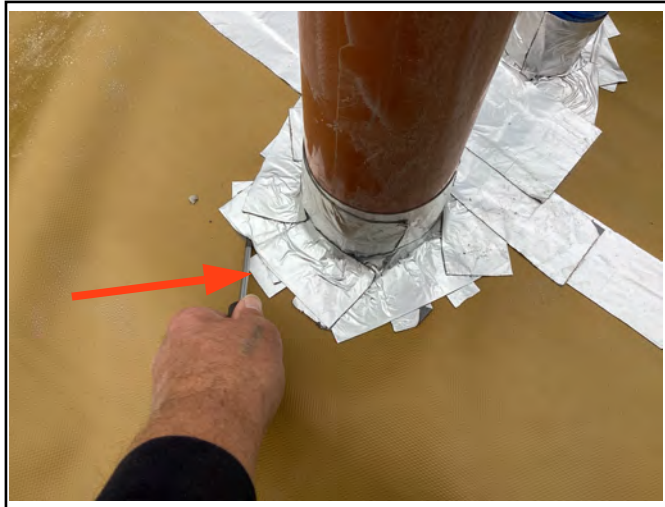
The pipe penetrations were typically sealed using Visqueen Gas Resistant Self

Adhesive Membrane to the Visqueen Ultimate Damp Proof Course.

Photos showing that the edges of the Visqueen Gas Resistant Self Adhesive

Membrane being checked for potential capillary leaks using the Mechanical Point

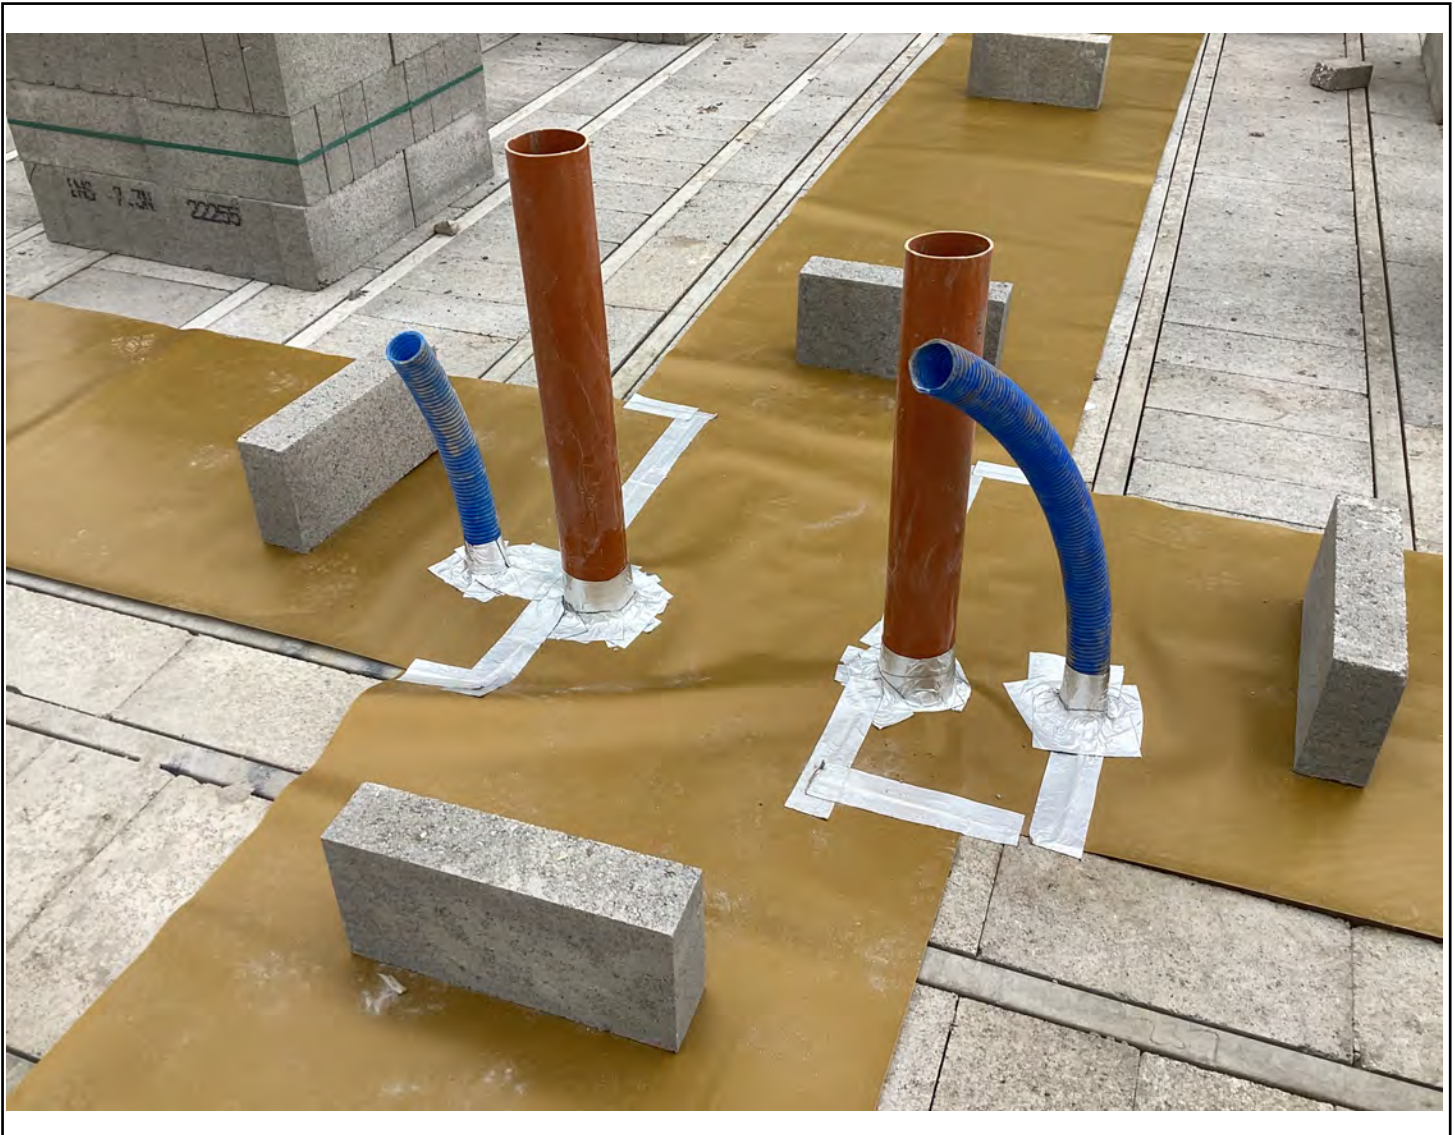
## VERIFICATION ITEM TWO

Overview of the typical pipe penetration installation where all pipes were fully

sealed to the Visqueen Ultimate Damp Proof Course using Visqueen Gas

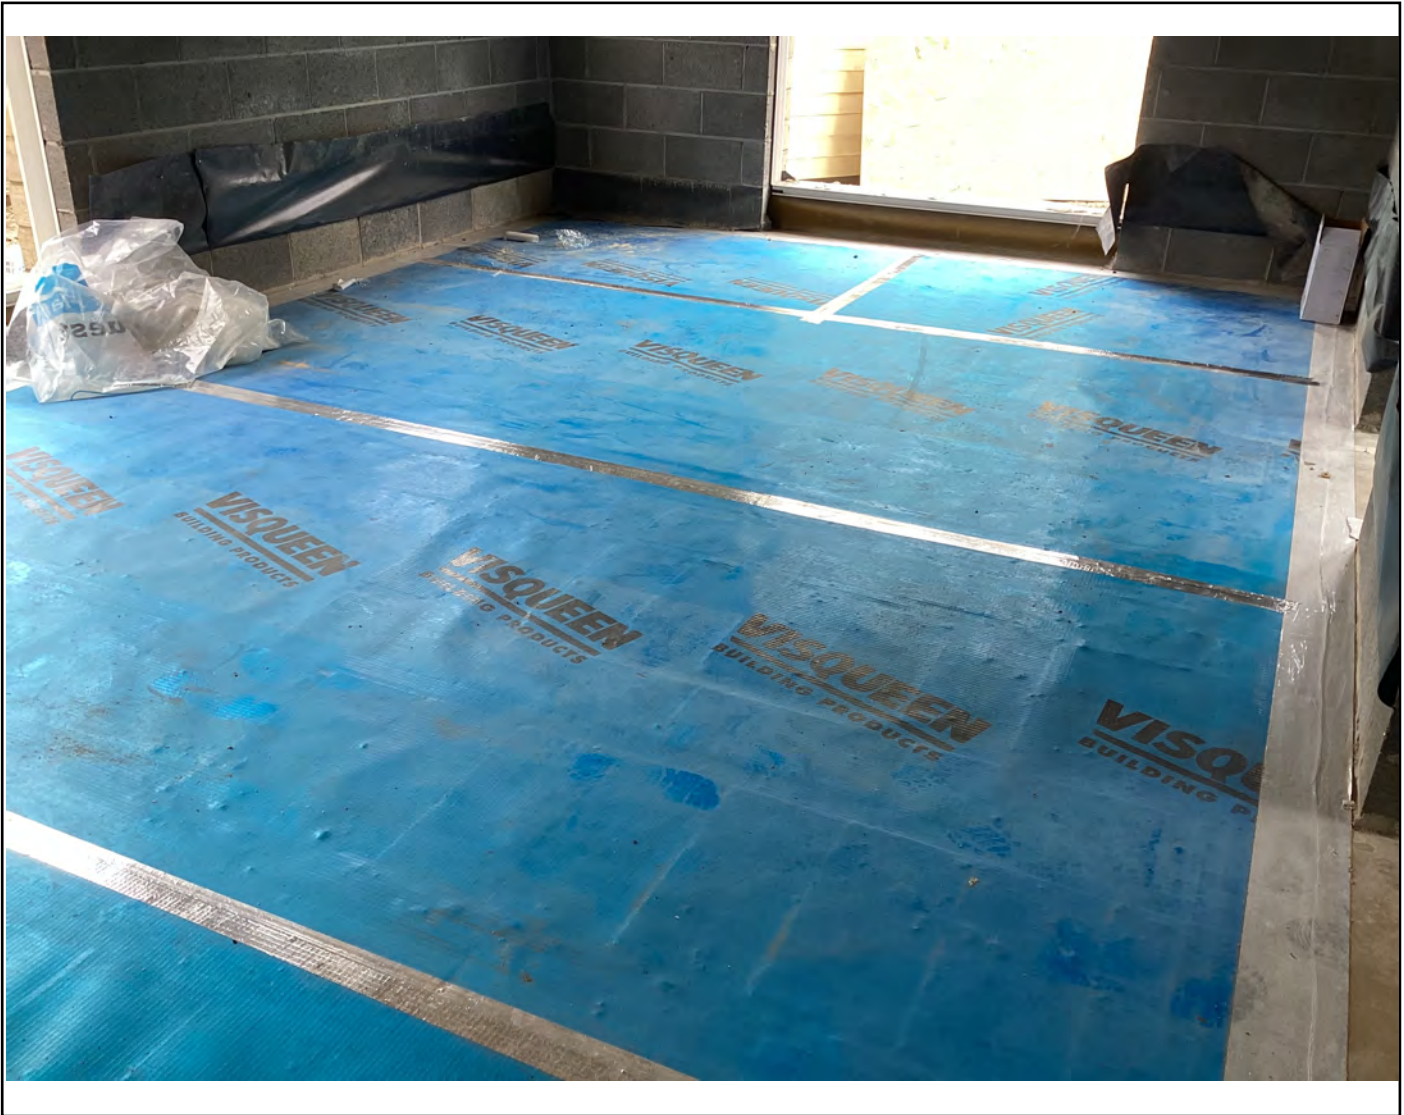
## VERIFICATION ITEM THREE

Overview showing the typical infill installation of the Visqueen Gas Barrier

to the various rooms within the plots.
