VALIDATION REPORT
OF
REMEDIATION
HOUSE PLOTS 14 to 21
MIDLOTHIAN, NEW MILL
HOLMFIRTH, HD9 7LN
FOR
SIGNATURE HOMES (Yorkshire) LTD
REPORT REF: SIG 3454 VAL 14-21

VALIDATION REPORT
OF

HOUSE PLOTS 14 to 21
MIDLOTHIAN, NEW MILL,
HOLMFIRTH HD9 7LN

REPORT REF: SIG 3454 VAL 14-21

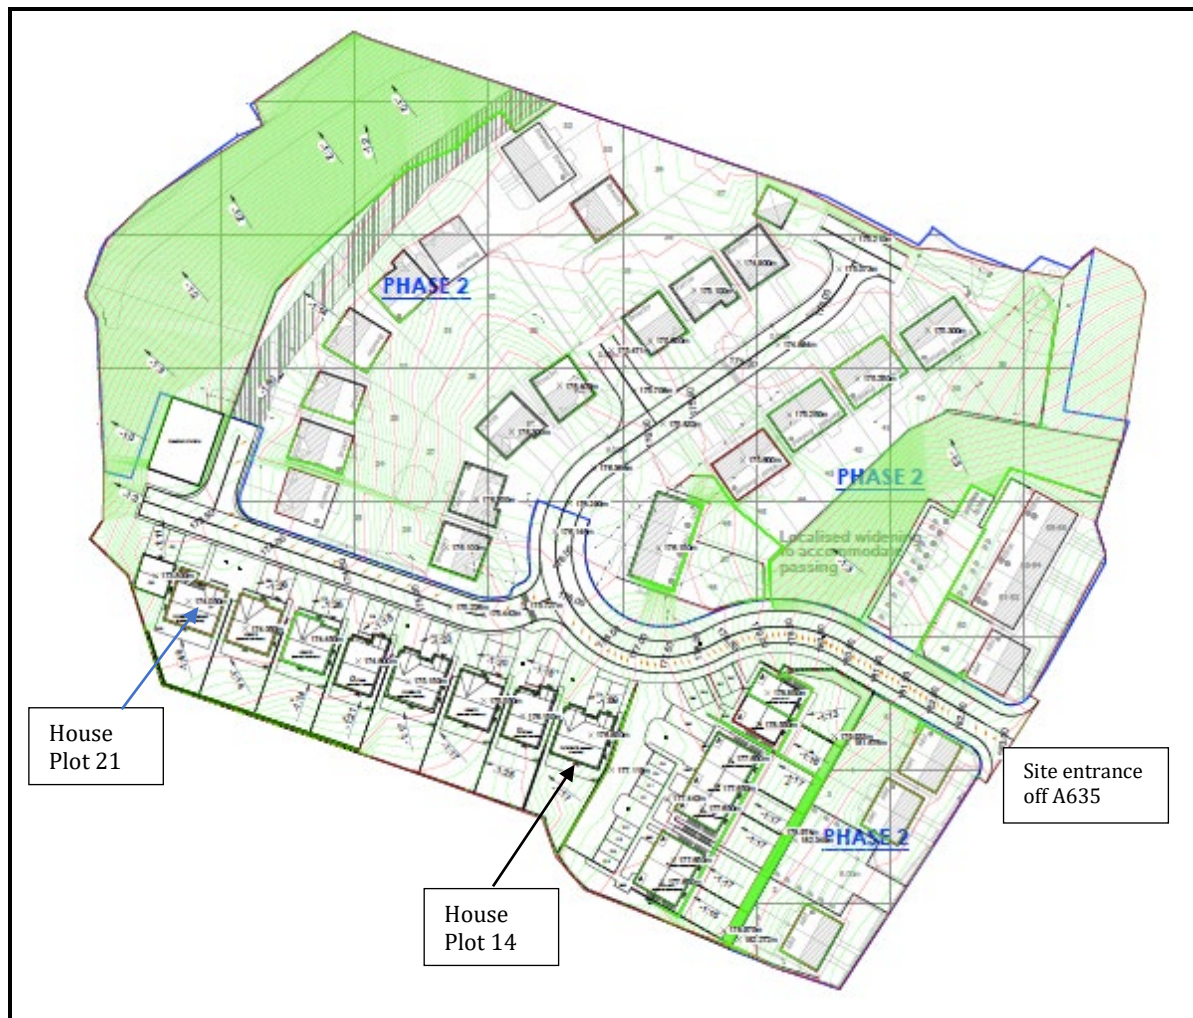
Figure 3 Site Plan

The project involves the demolition of all existing buildings on the site and construction of 56 houses in two phases of development as detailed on Figure 3.

The subject of this report is the validation of remediation and mitigating measures for House Plots 14 to 21 inclusive within Phase I of the development.

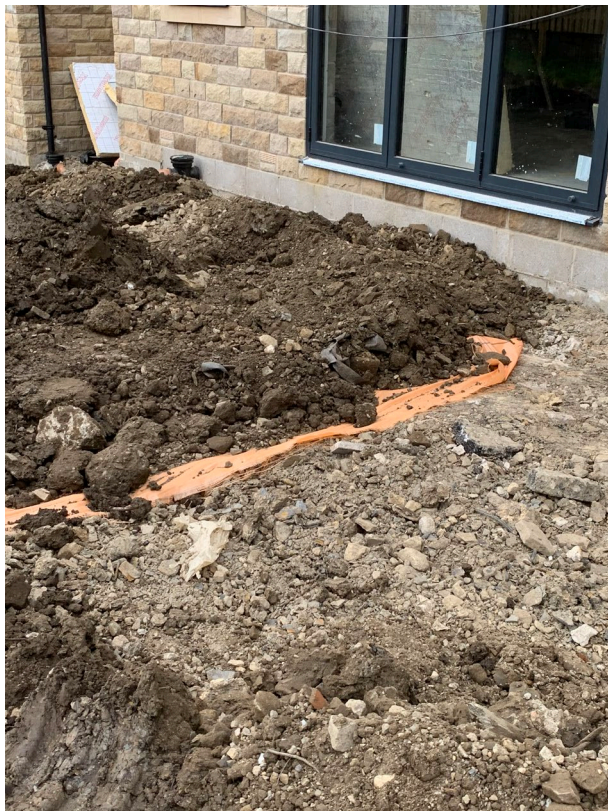
Figure 5 Geotextile

The front gardens will be hard covered. In the rear gardens an orange geotextile was laid on natural ground, overlain by 600mm of topsoil tested as uncontaminated, and covered in turf.

The geotextile was an Abtex Orange, a permeable split tape woven polypropylene geotextile for use as a separator and marker layer in civil engineering. It has a mass of 62g/m² and a tensile strength of 10/9kN.m², it is 1500N CBR puncture resistant. A full specification is presented in Appendix B.

Validation of the geotextile laid in the rear gardens of house plots 14 to 21 was undertaken by daily inspection during placing and covering in topsoil. The geotextile was laid overlapping between plots. Figure 5 illustrates the geotextile beneath the first layer of topsoil. All the soil laid was topsoil and the thickness was confirmed by insertion of a metal rod of appropriate length. Photographs are presented in Appendix A.

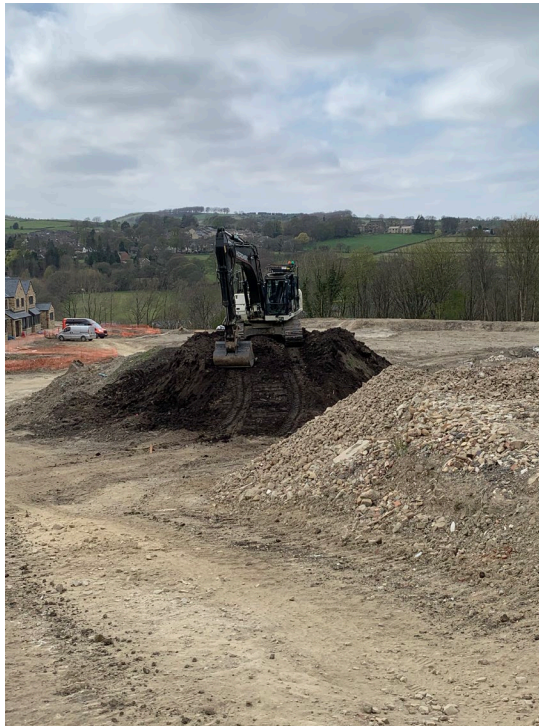
Figure 6 Topsoil stockpile

The stockpile was tested for heavy metals, PAH speciated, TPH CWG UK, pH, sulphate and asbestos fibres. Test results are presented in Tables 4, 5 and 6 and detailed in full in Appendix B.

All tests undertaken for heavy metals, pH and sulphate were within guidelines for residential use of the site with plant uptake. No asbestos fibres were detected in the samples.

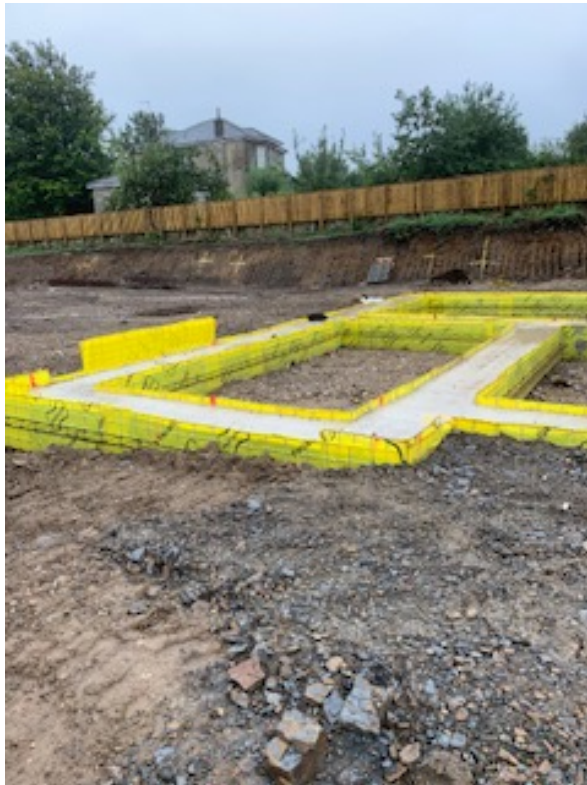
Figure 7 Underfloor Venting Areas

The NHBC Amber '2' gas protection system requires 4.5 points and compliance is achieved by building a suspended block and beam floor with a ventilated subfloor void with a gas membrane on top. The ground gas membrane must meet the requirements of BS8485:2019 Table 7 and also the products specified in the plan. The 4.5 points were achieved with 2.5 points for the venting and 2 points for the gas membrane.

The validation of the installation of the gas membrane, taping and validation of the underfloor venting area was undertaken by GeoShield with all photographs and validation sheets presented in Appendix C.
