VALIDATION REPORT
OF
REMEDIATION
HOUSE PLOTS 7 TO 13
MIDLOTHIAN, NEW MILL
HOLMFIRTH, HD9 7LN
FOR
SIGNATURE HOMES (Yorkshire) LTD
REPORT REF: SIG 3454 VAL 7 TO 13

HOUSE PLOTS 7 TO 13
MIDLOTHIAN, NEW MILL,
HOLMFIRTH HD9 7LN

REPORT REF: SIG 3454 VAL 7 to 13

September 2021

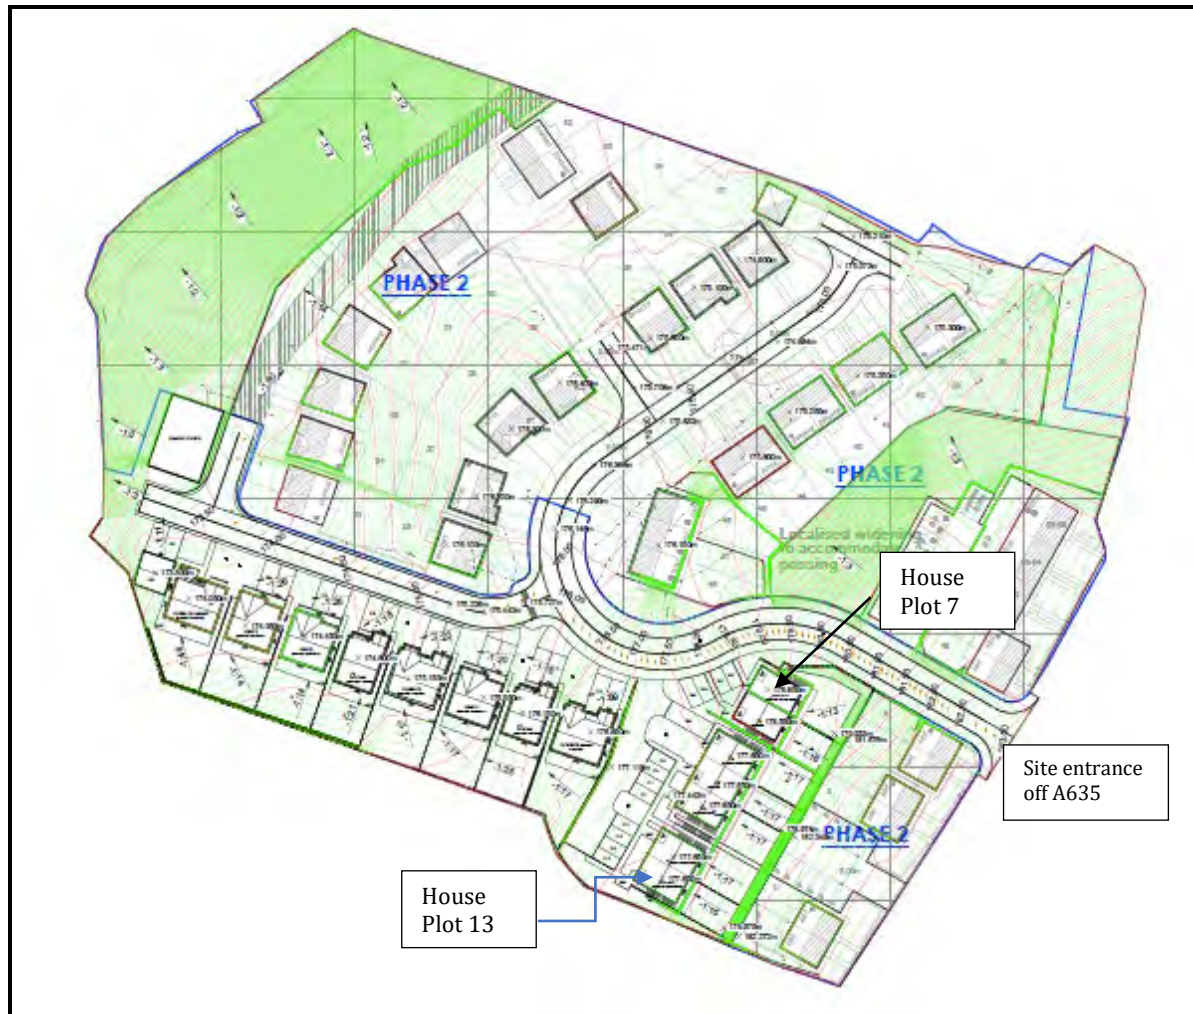
Figure 3 Site Plan

The project involves the demolition of all existing buildings on the site and the construction of 56 houses in two phases of development as detailed on Figure 3.

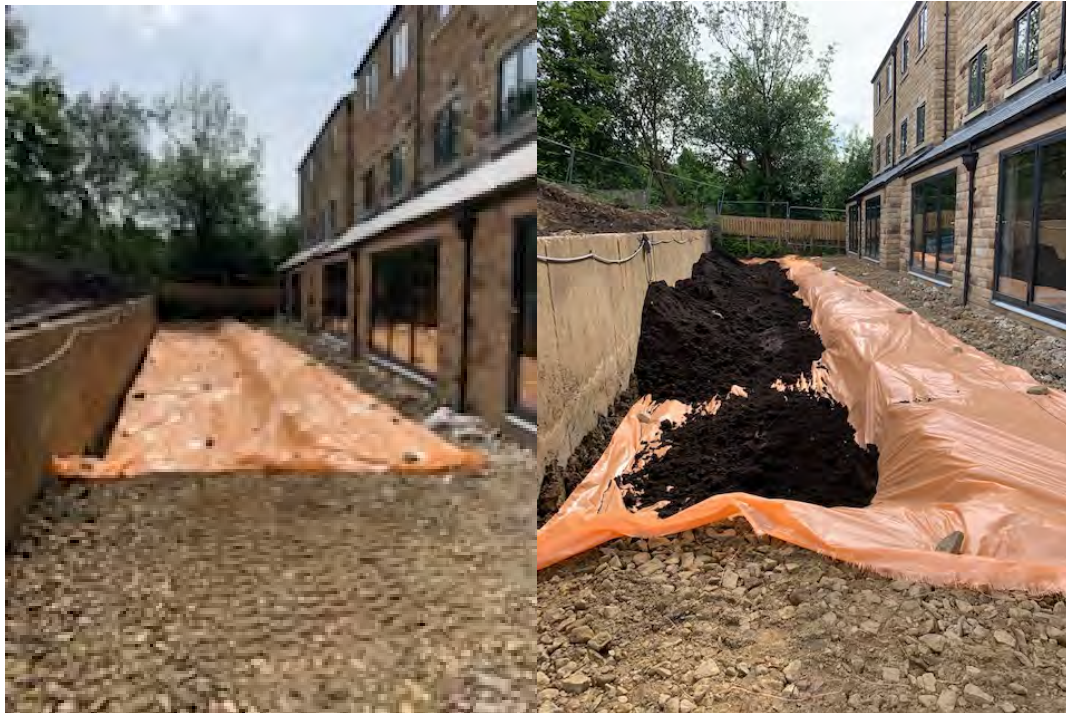
Validation of the geotextile laid in the rear gardens of house plots 7 to 13 was undertaken by daily inspection during placing and covering in topsoil. The geotextile was laid overlapping between plots. Figure 5 illustrates the geotextile beneath the first layer of topsoil in the lower garden area. Figure 6 illustrates the geotextile and topsoil being laid in the upper garden areas. All the soil laid was topsoil and the thickness was confirmed by insertion of a metal rod of appropriate length and measuring tape. Photographs are presented in Appendix A.

Figure 5 Geotextile and first layer of topsoil laid in lower rear gardens

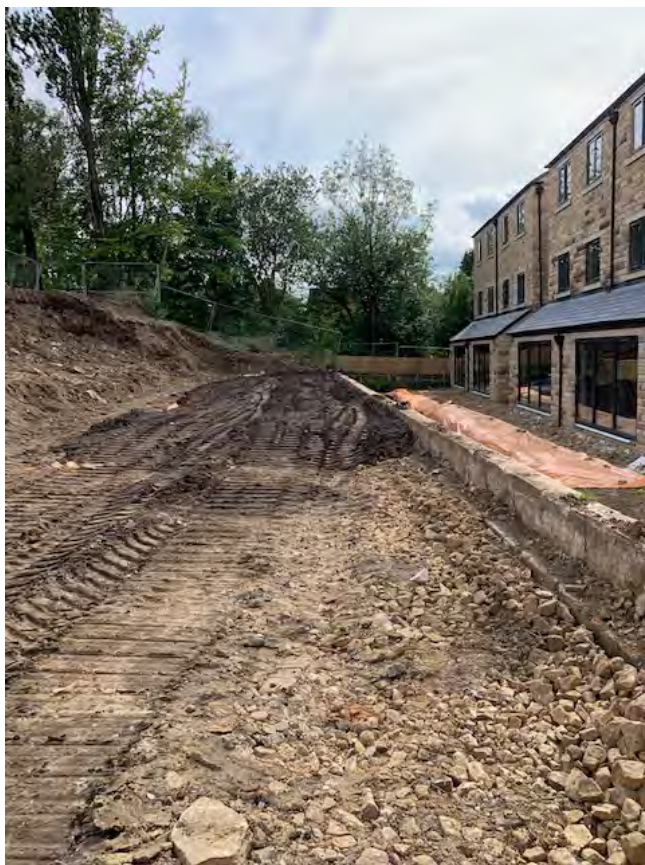
Figure 5 Geotextile and first layer of topsoil laid in upper rear gardens

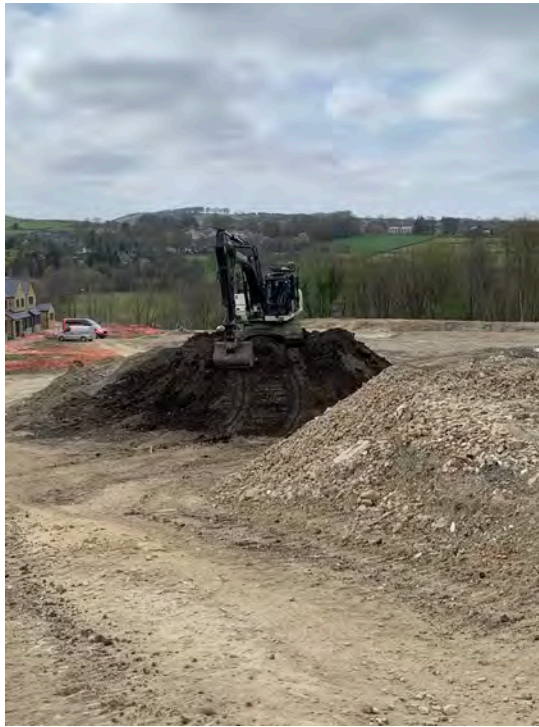
All tests undertaken for heavy metals, pH and sulphate were within guidelines for residential use of the site with plant uptake. No asbestos fibres were detected in the samples.

Figure 6 Topsoil stockpile

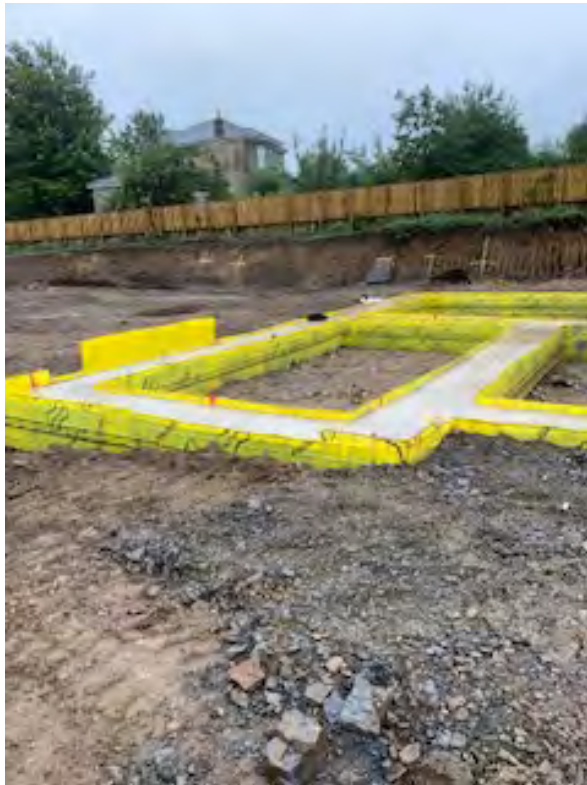
The validation of the installation of the gas membrane, taping and validation of the underfloor venting area was undertaken by GeoShield with all photographs and validation sheets presented in Appendix C.

Figure 7 Underfloor Venting Areas

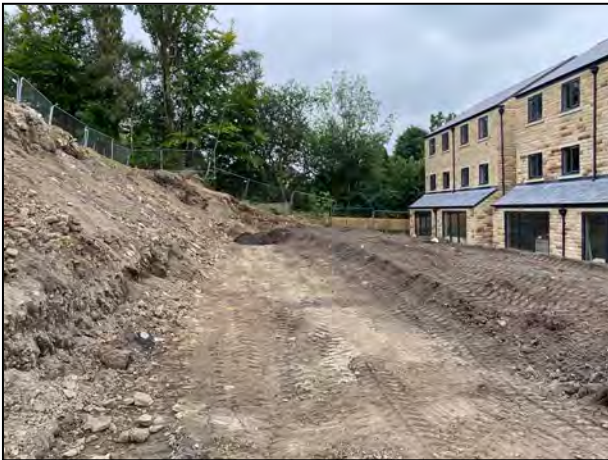
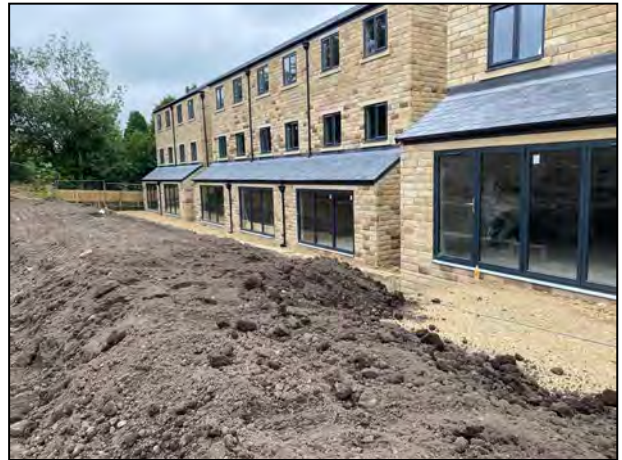
View over the newly laid 600mm thick topsoil in rear gardens of 7 – 13 house plots

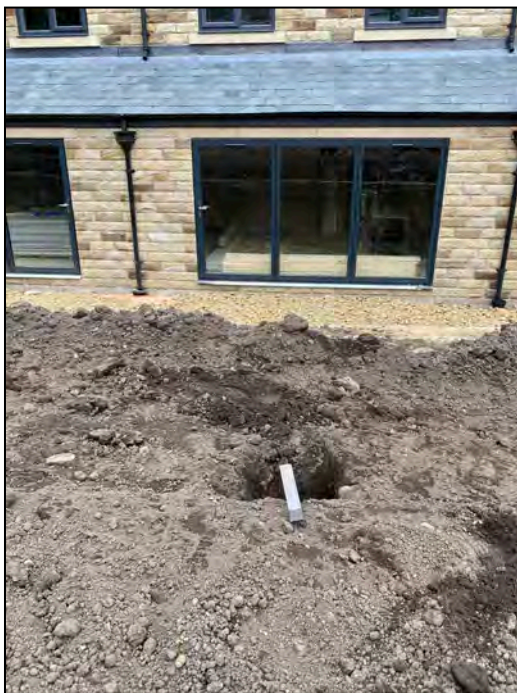
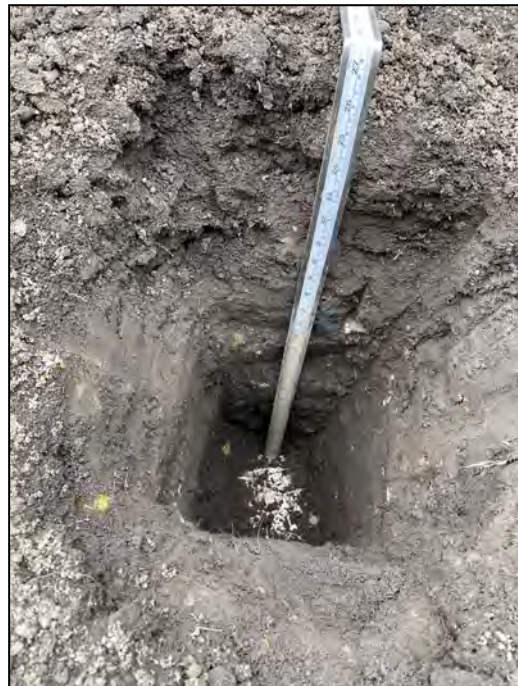
Trial Pits outside House Plot No 9 confirming 600mm of topsoil

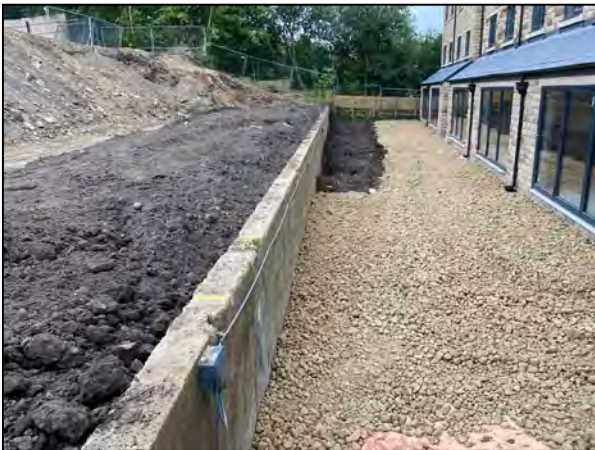
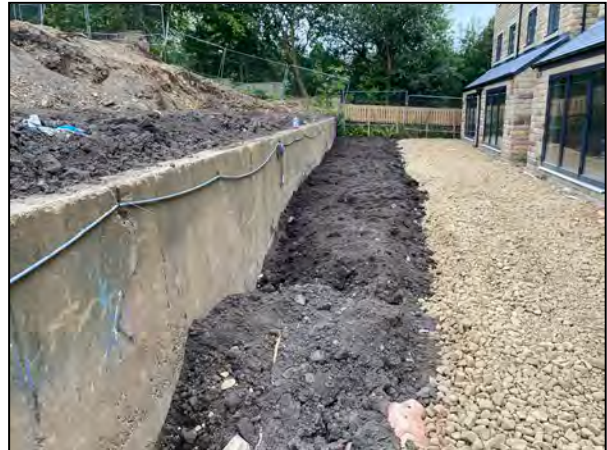
View along retaining wall showing topsoil on upper and lower garden levels where trial pits were excavated. Aggregate laid over geotextile shows areas where hard cover will be laid.

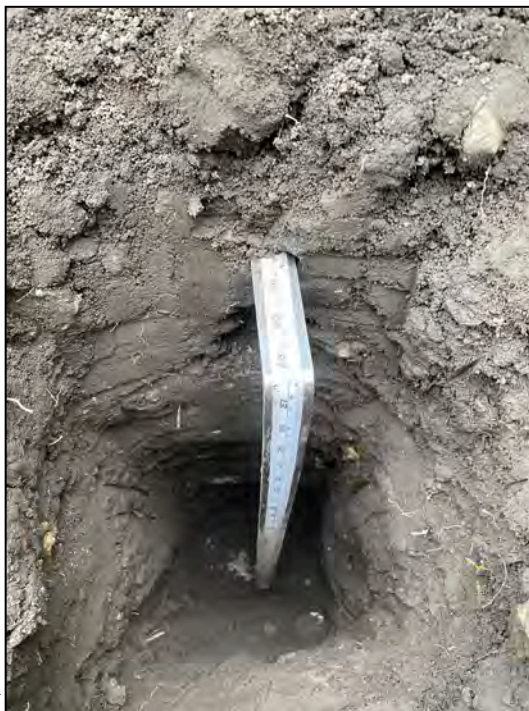
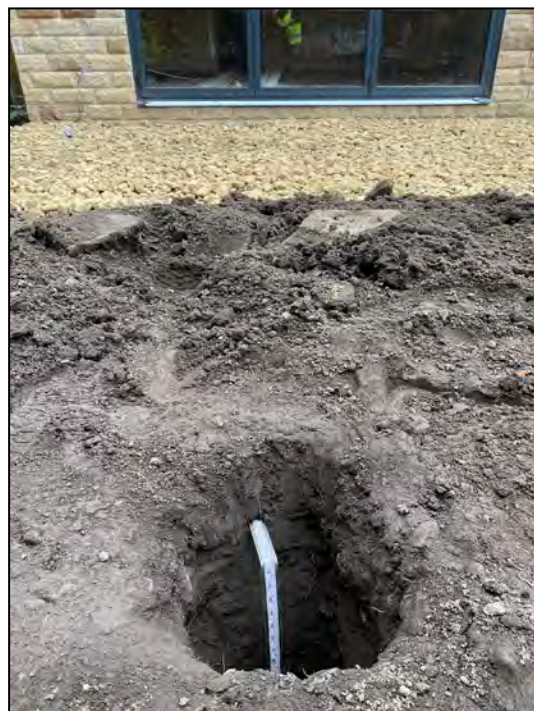
Garden area of house plots 11 and 13 showing the 600mm depth of topsoil in the excavated trial pits.

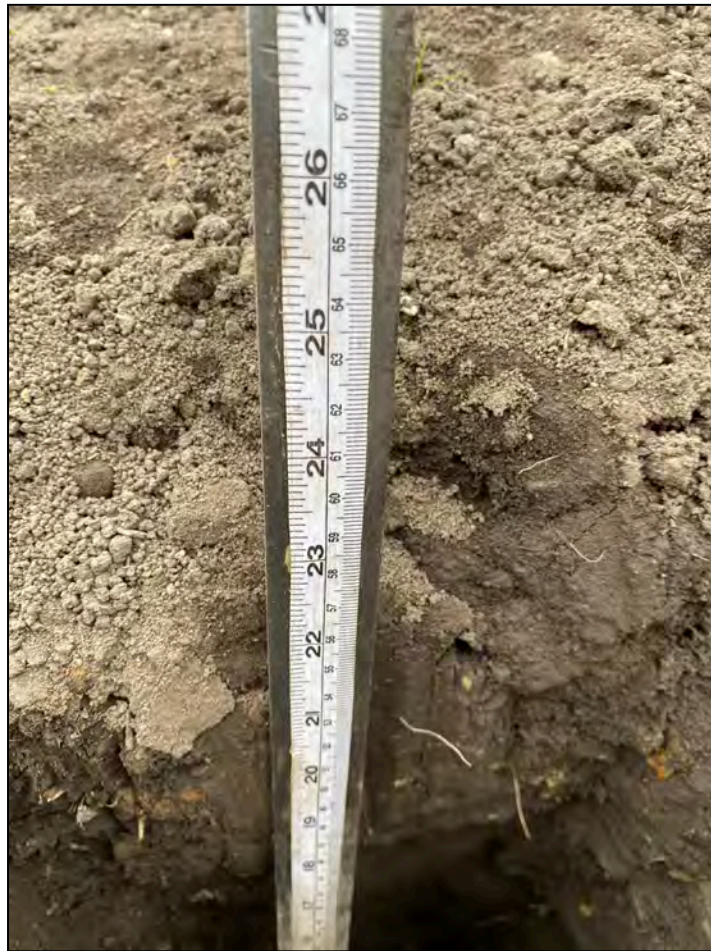
Close up of measuring pole in TP indicating topsoil depth greater than 600mm

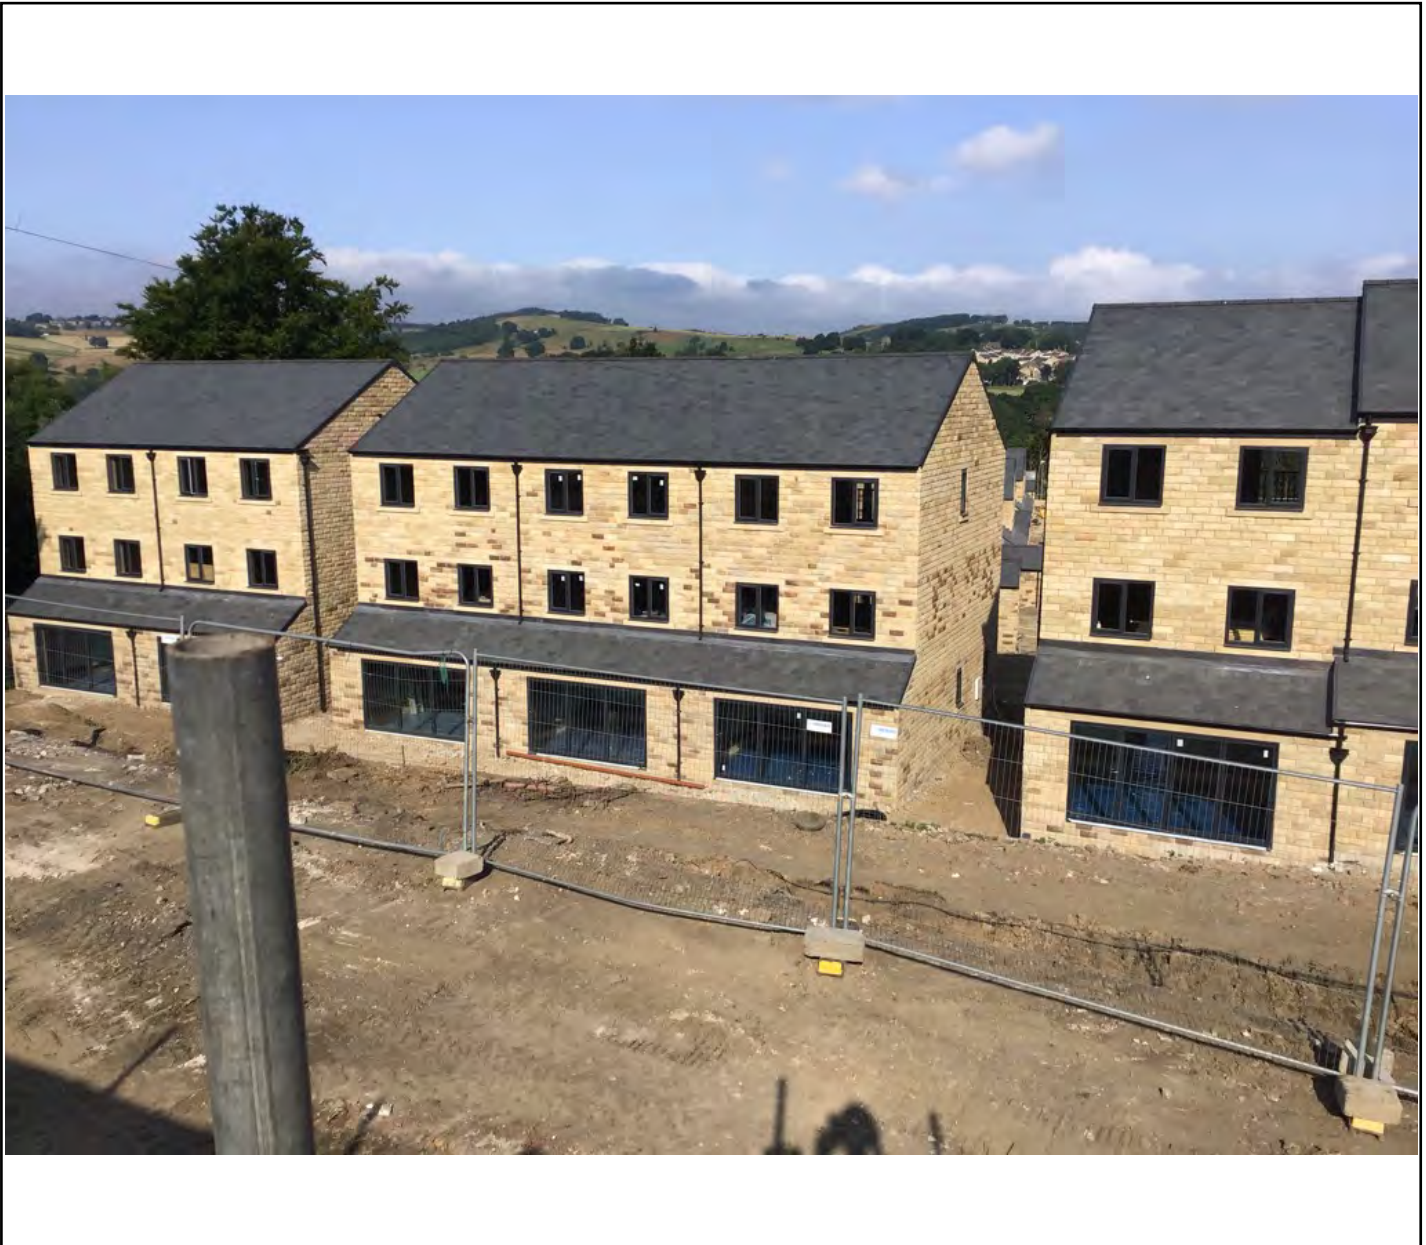
Overview of Plots 7-13

Visqueen Standard Gas Barrier visible through glass doors

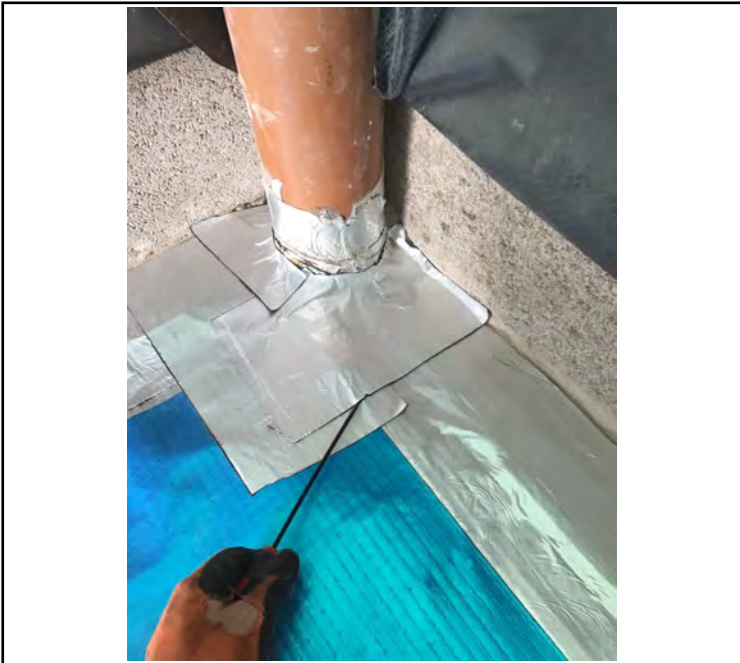
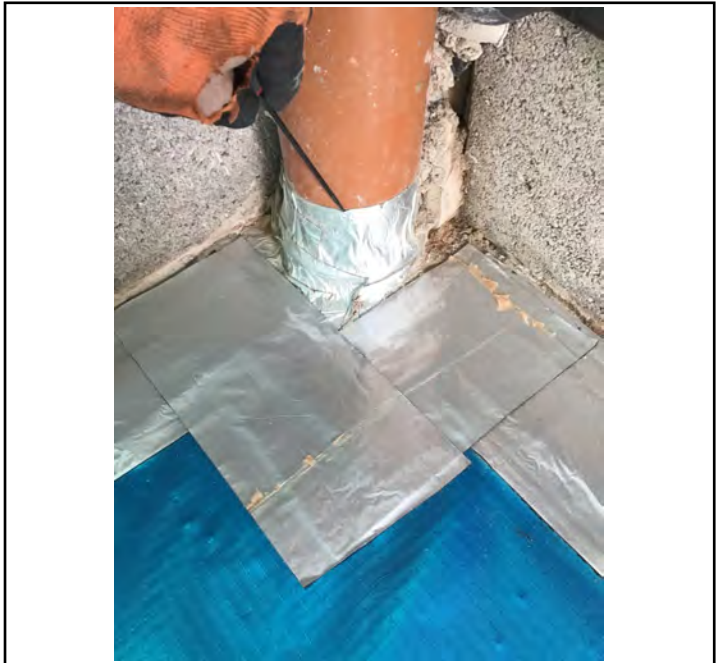
pens details to good standard. All works visually inspected and tested with Mechanical

Point Stress Test (Pick and probe). No faults found.

1. Pick and probe to pipe pen detail

2. Pick and probe to pipe pen detail

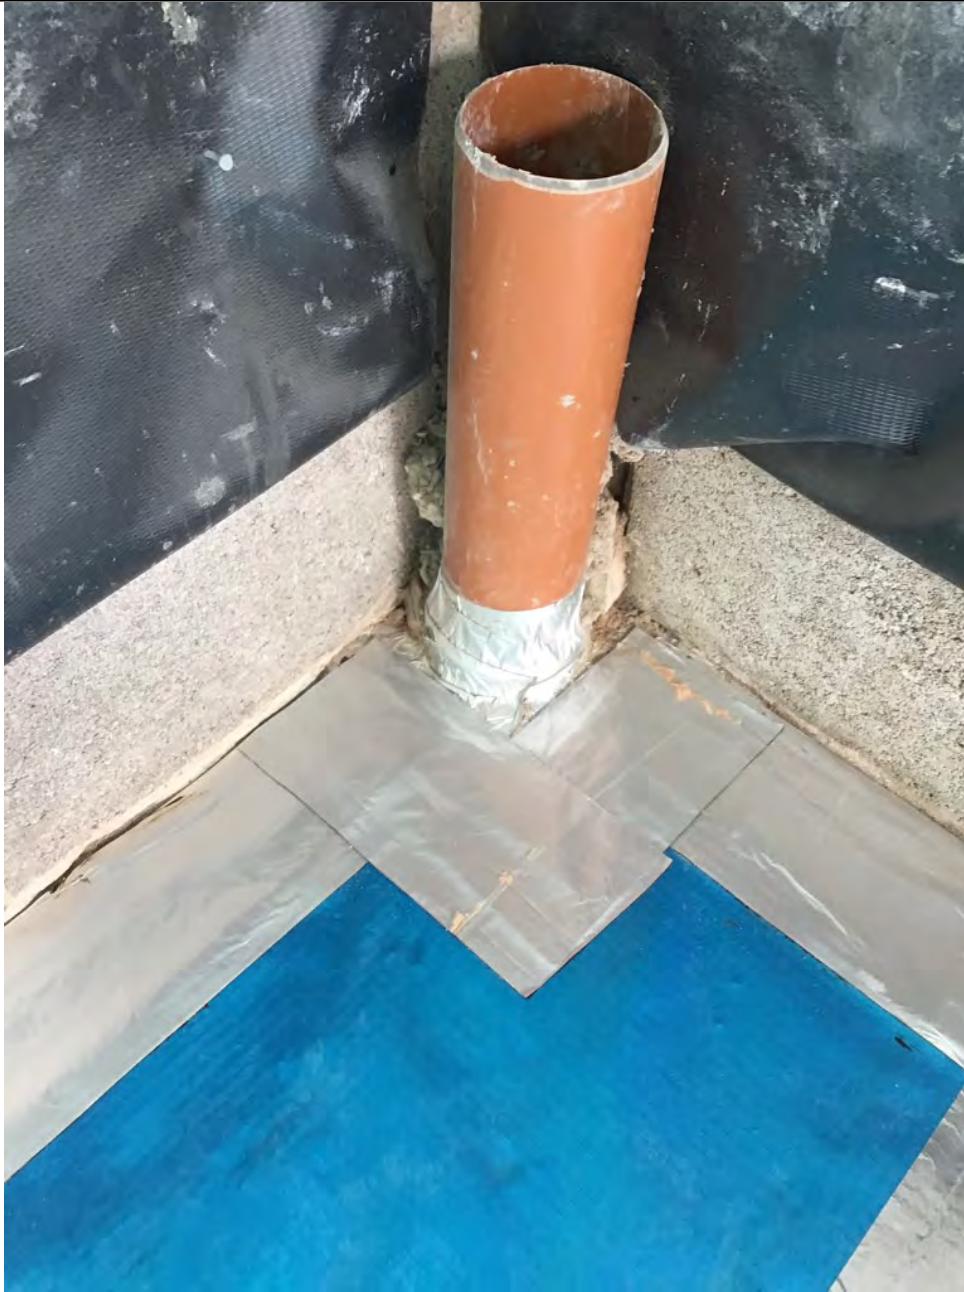
3. Overview of pipe penetration sealed to good standard. Passed and verified.

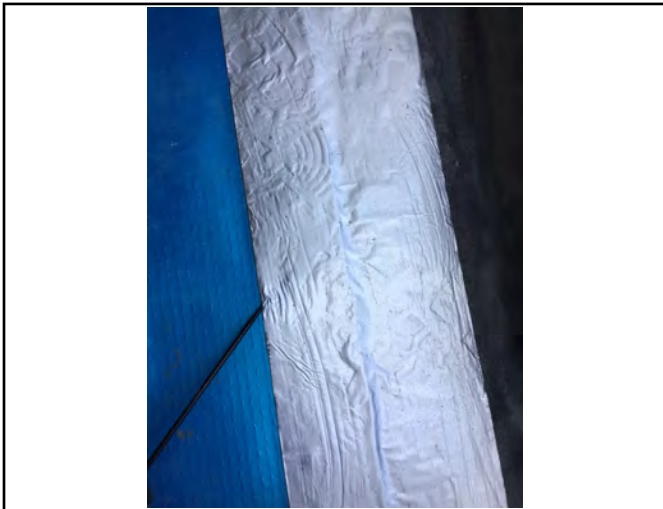
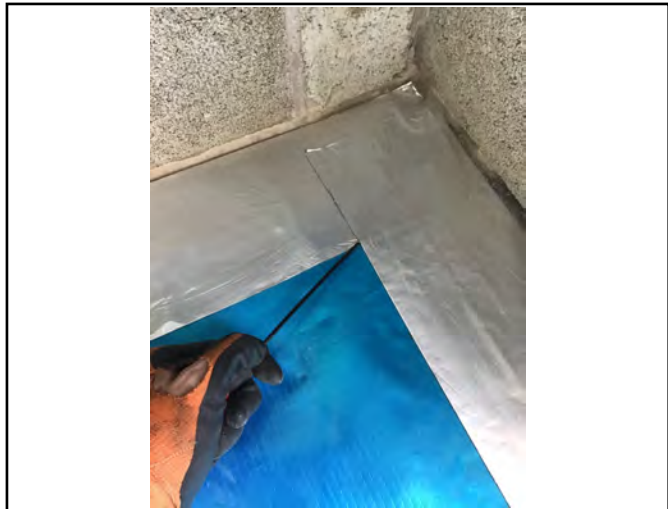
1. Pick and probe carried out to GR Lap Tape

2. Good bond and good overlap, between strips of GR Lap Tape

Passed and verified with no faults found

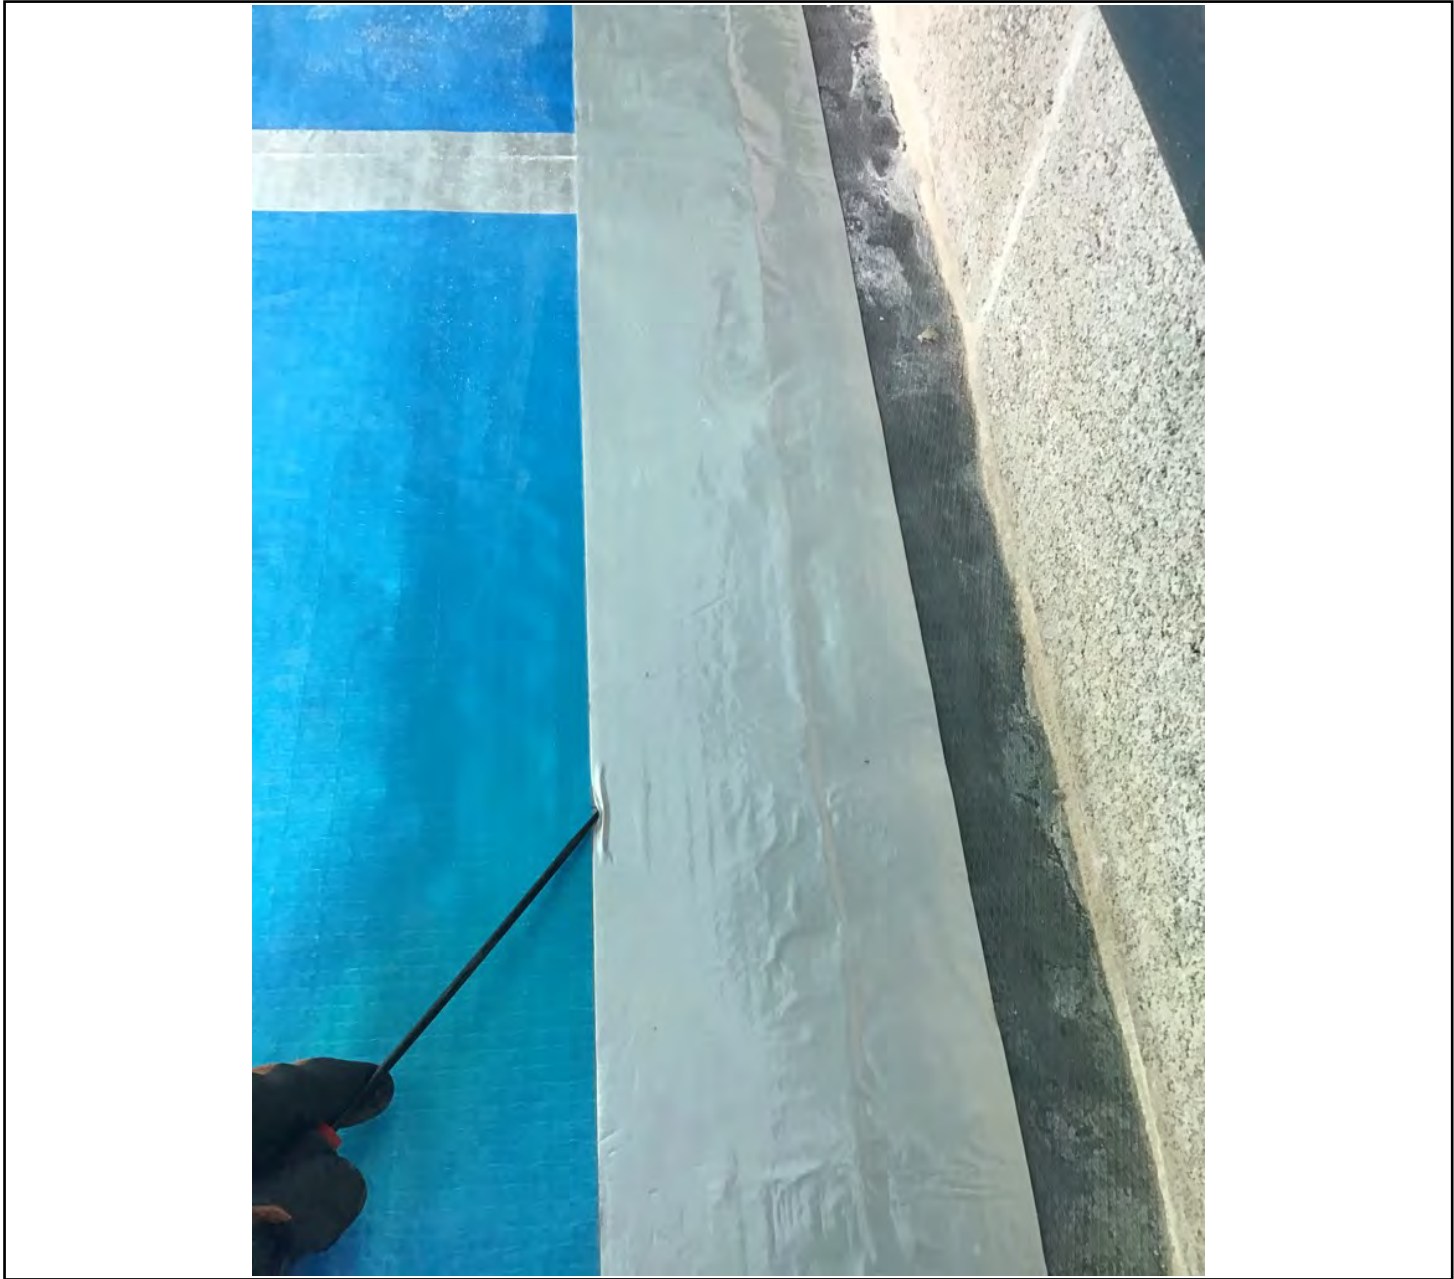
3. Photo evidence of good bond achieved.

This good standard has been maintained throughout all plots.

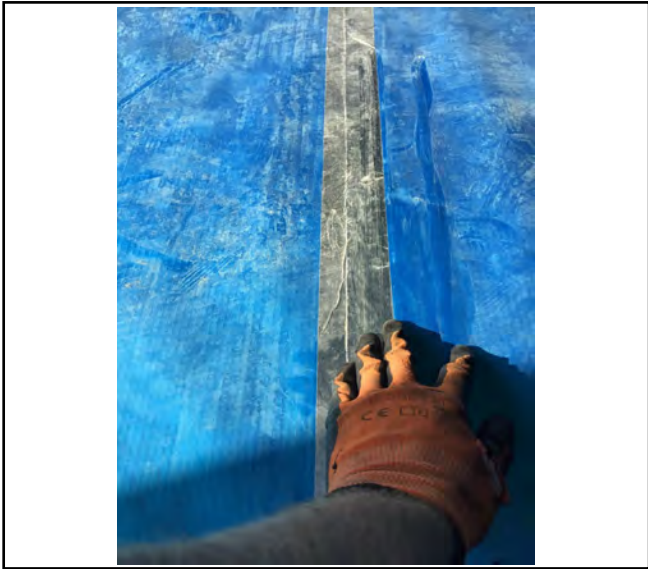
sealed as per manufacturers specification. Visual inspection and pick and probe

carried out. Good install with no faults found.

1. GR Foil Tape applied to overlaps and continuous seal achieved.

2. Double sided butyl tape installed in all joints
