# Invasive Species Survey

North Bierley Phase 2

R-EE-5613-01

July 2021

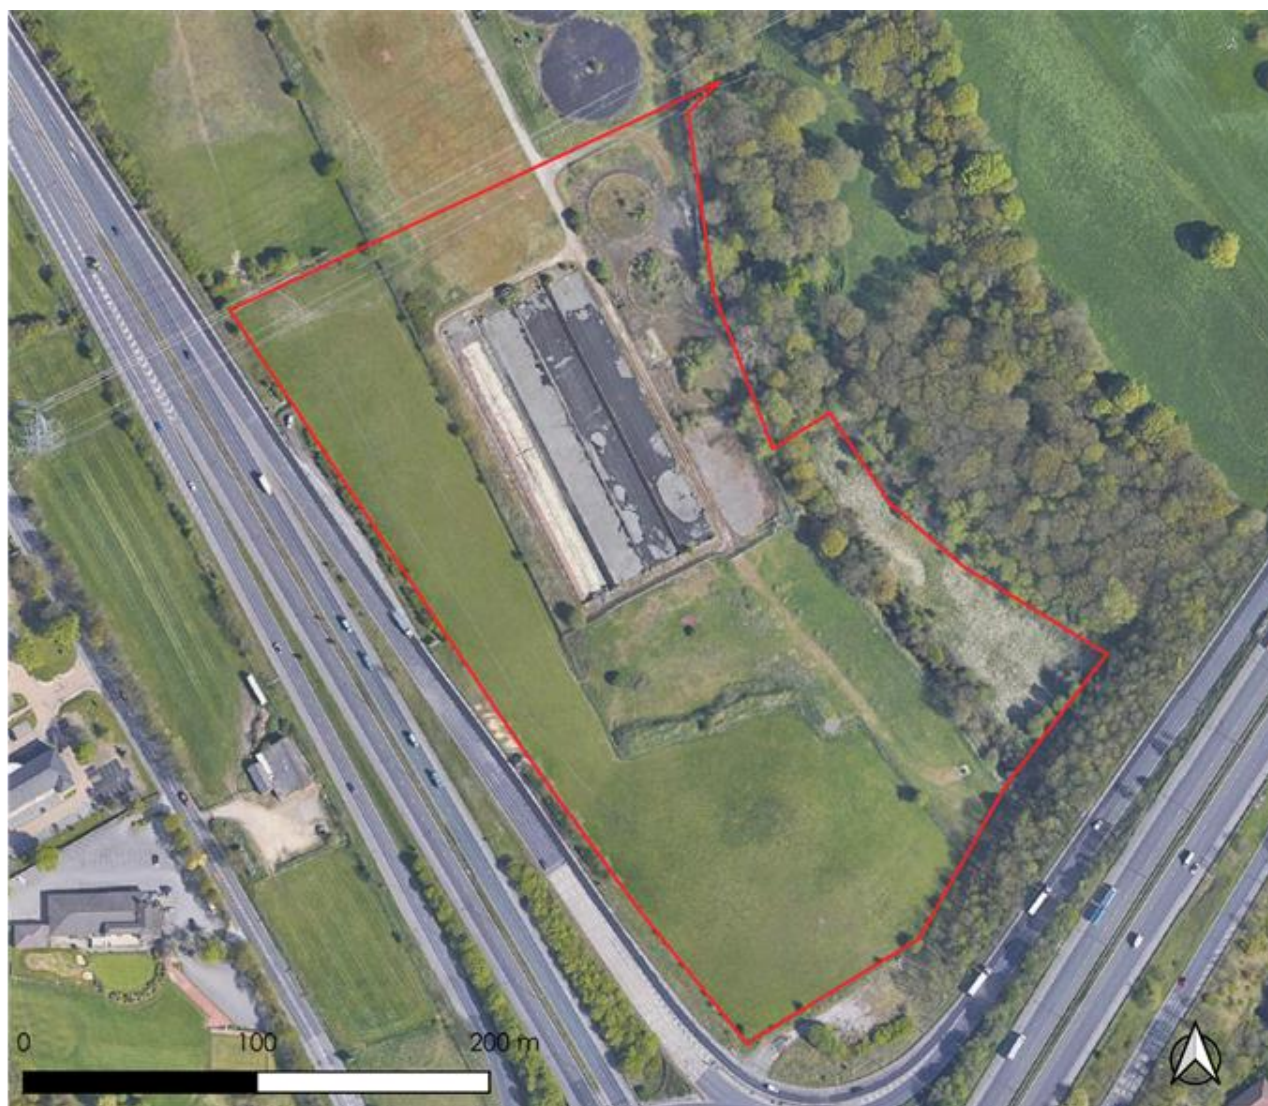
**Figure 1** Survey boundary (red)

The survey boundary is shown in Figure 1 below.

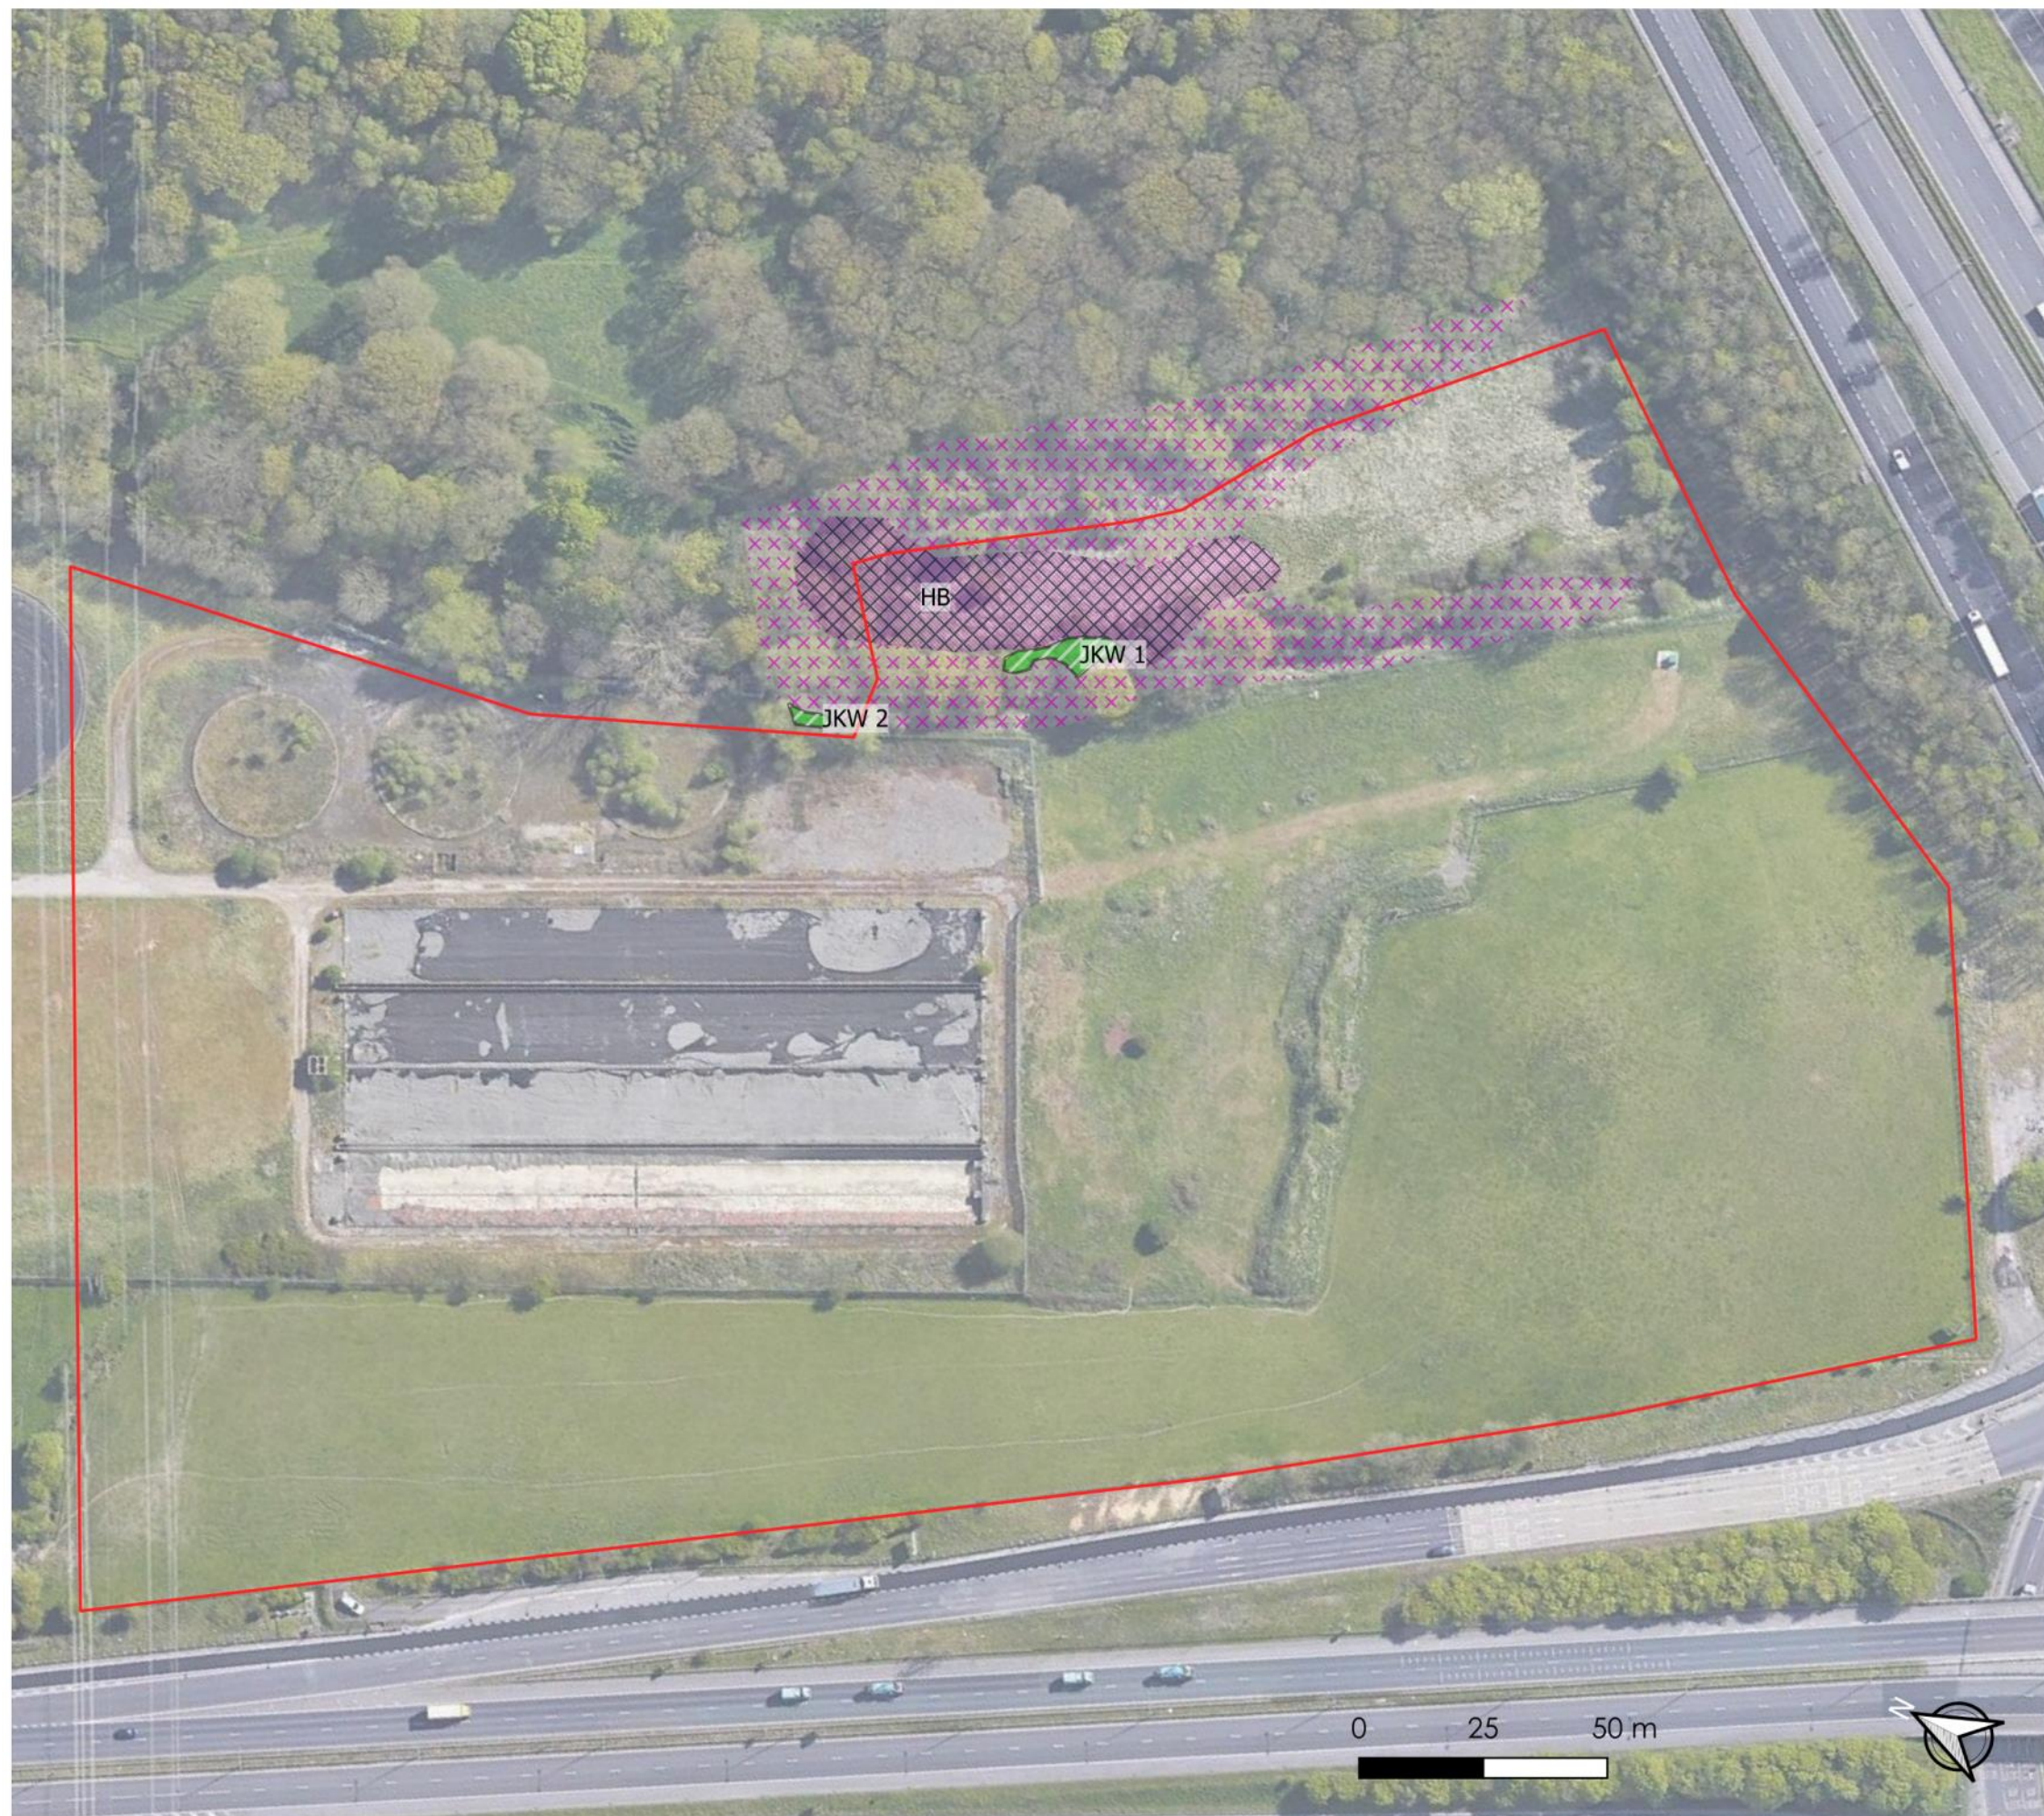
**Figure 2**

INNS stands identified through current survey in July 2021

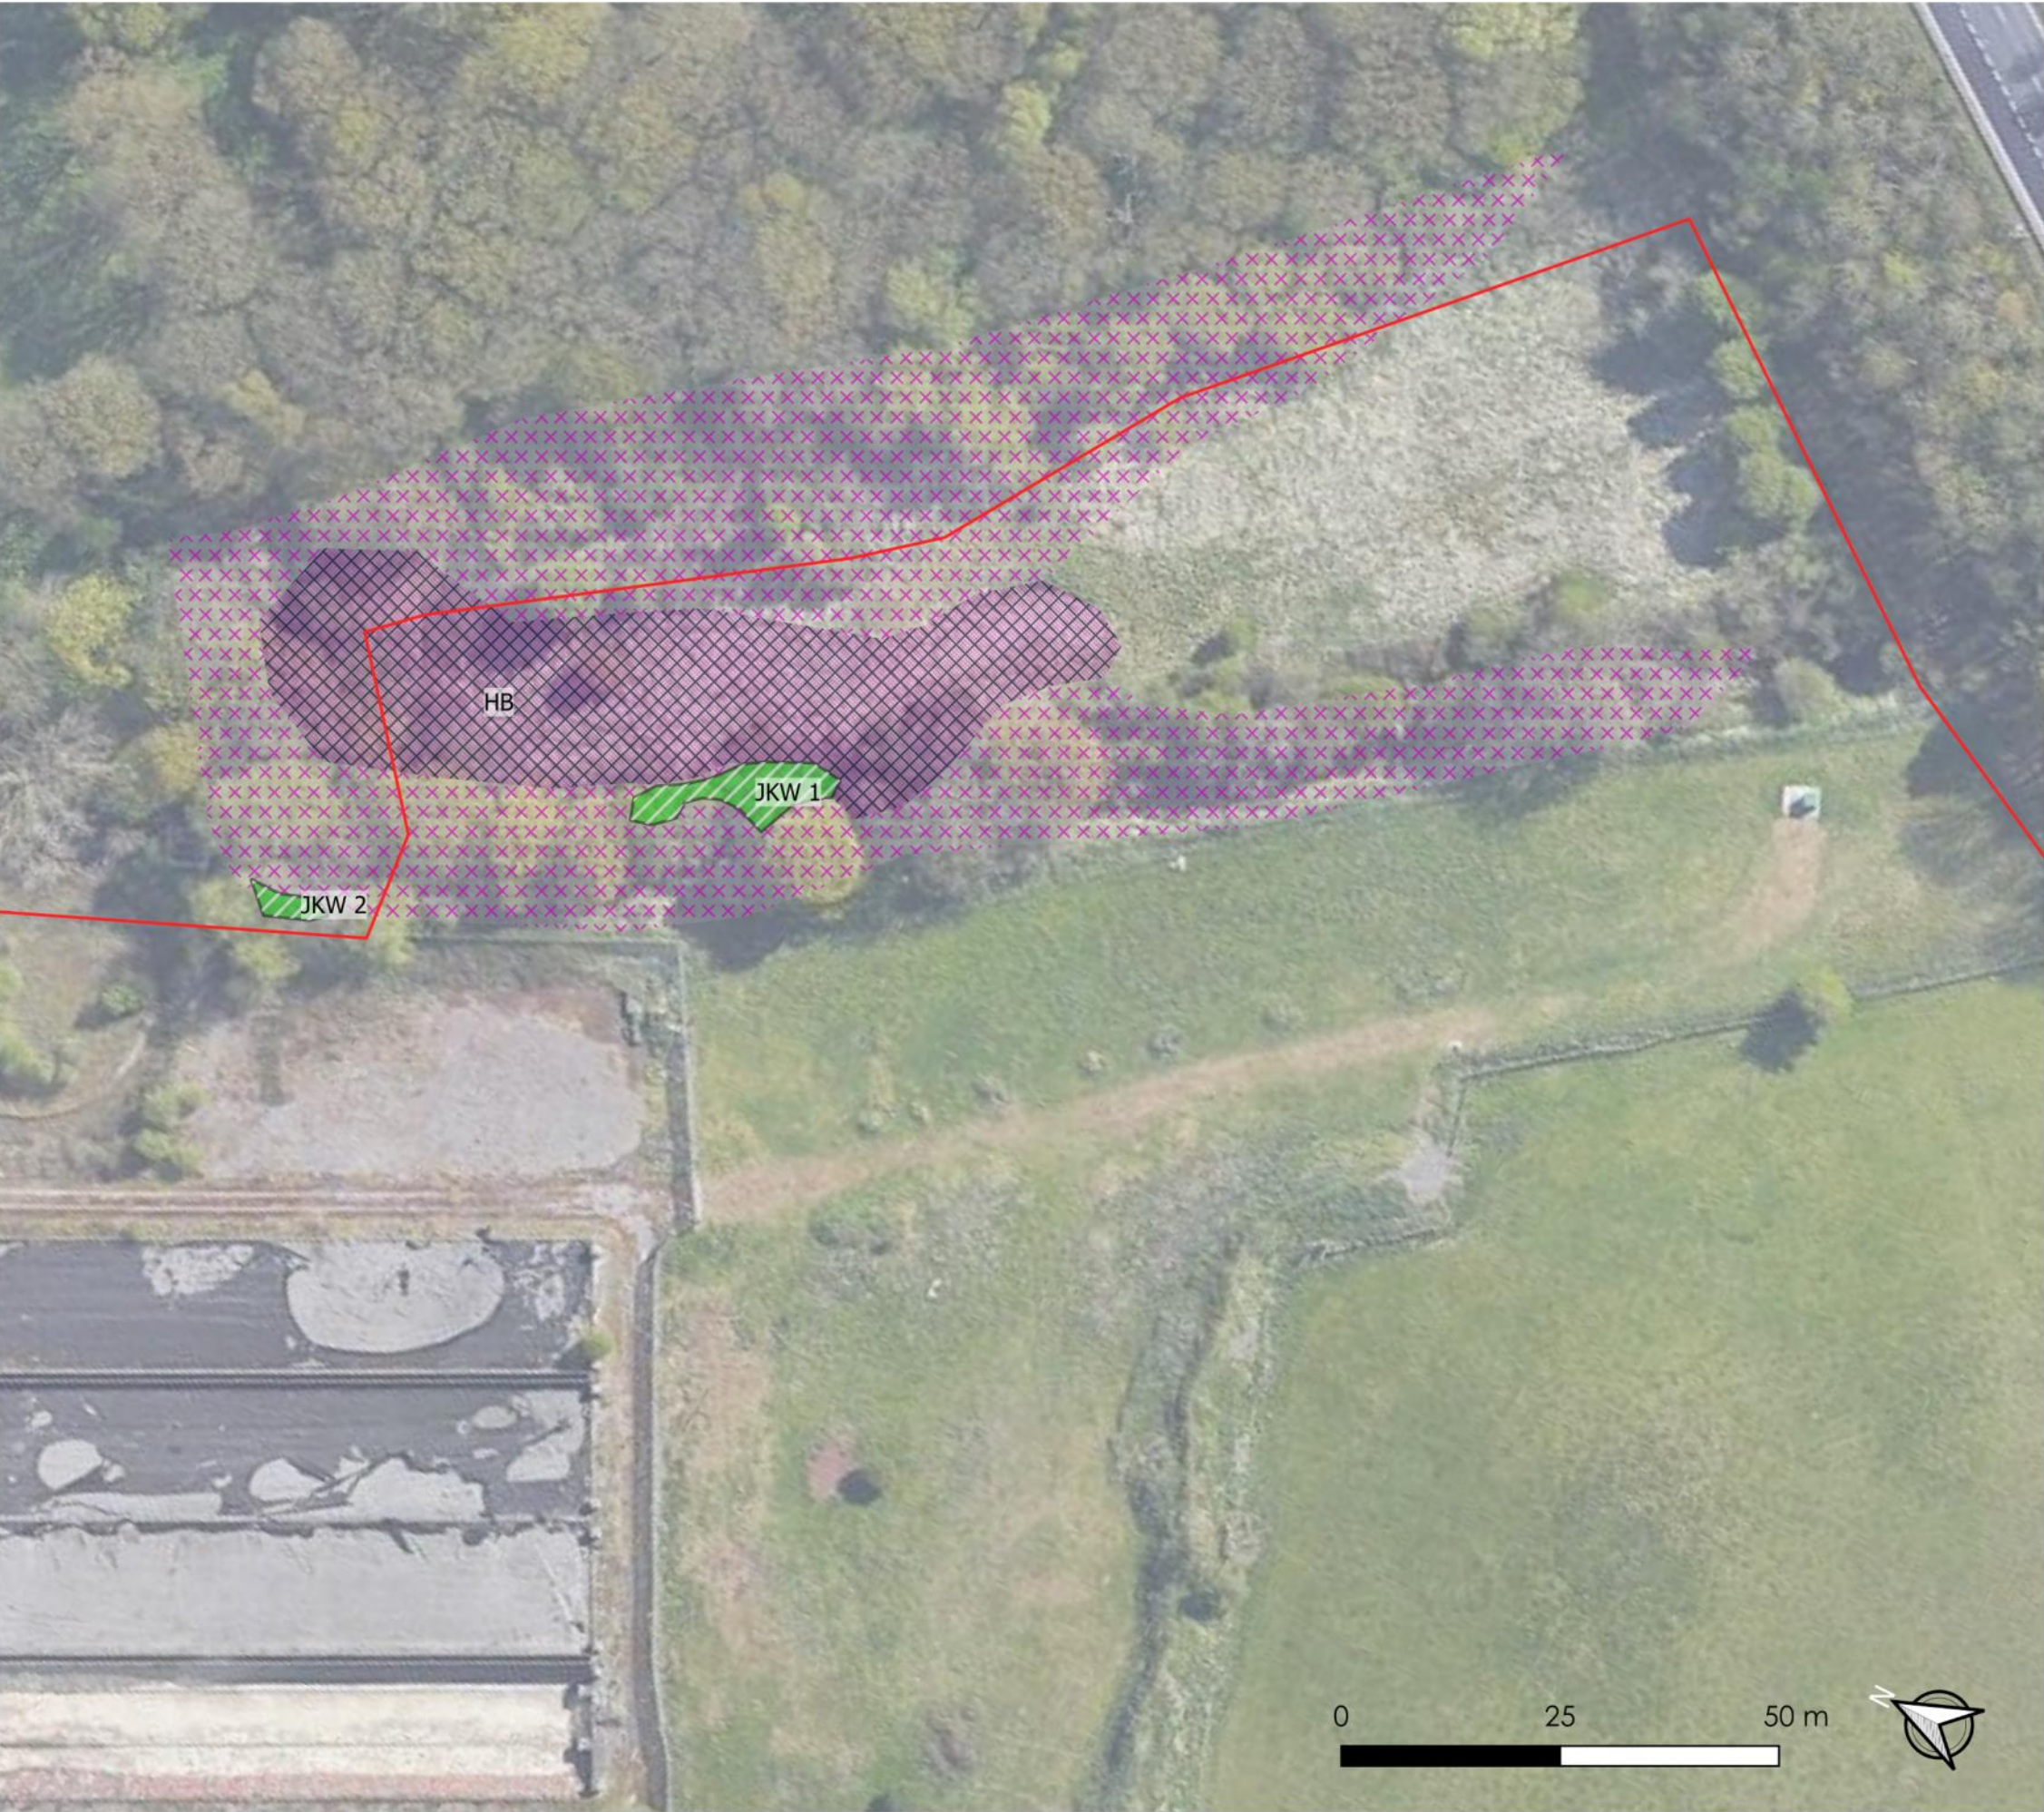
**Figure 4**

INNS stands - focus on areas mapped in relation to aerial photography

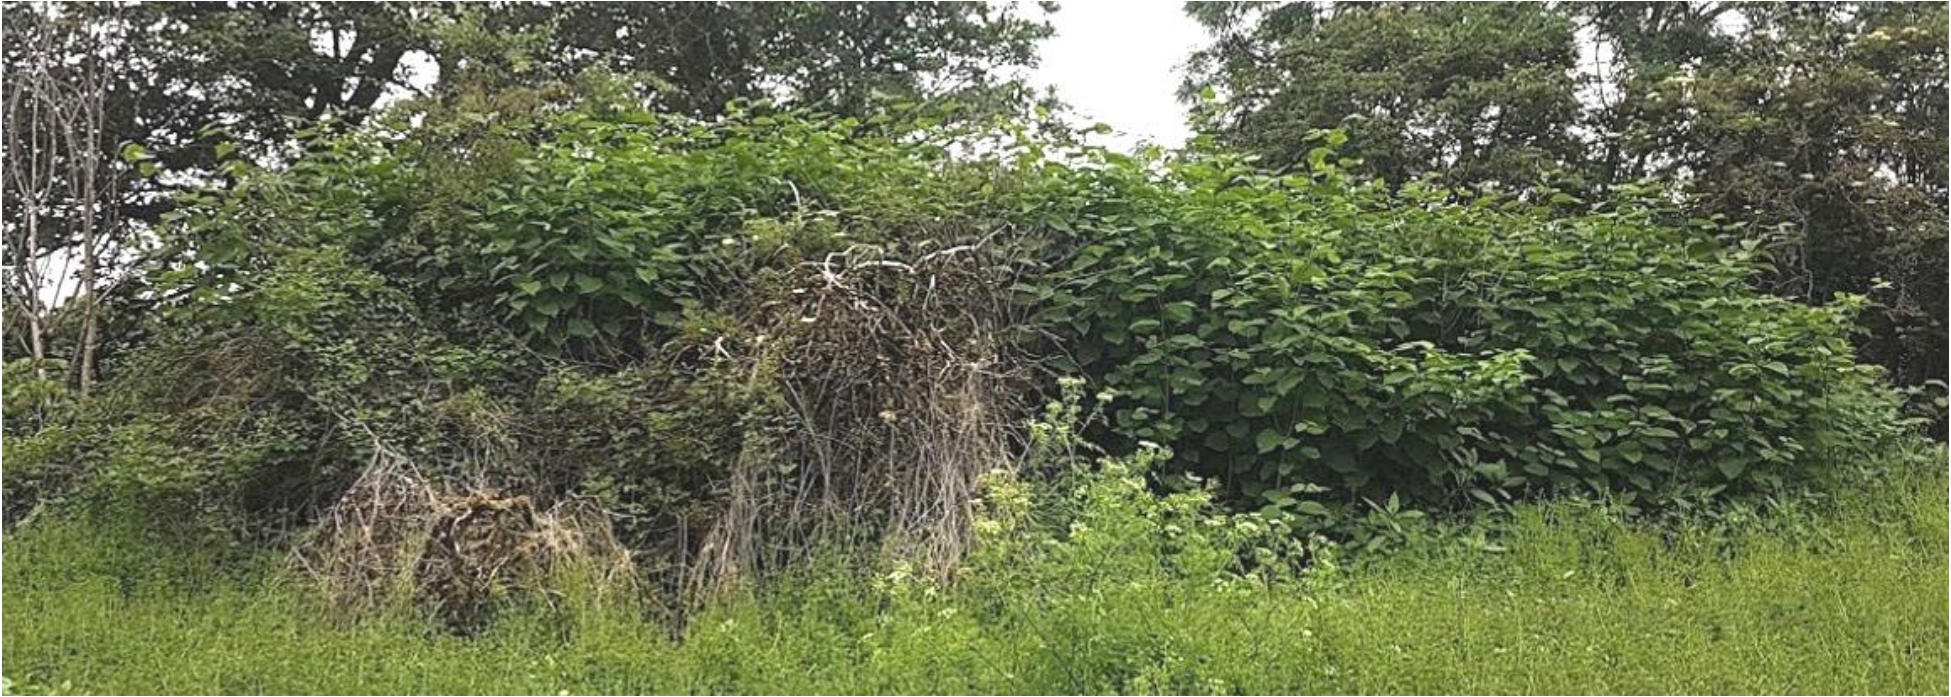
| Patch Ref. | Description and condition | |
|---|---|---|
| JKW 1 | <p>This is a mature dense stand of Japanese knotweed on the north eastern bank of Hunsworth Beck.</p> <p>The stand comprises several crowns of stems which have merged over successive seasons resulting in a continuous dense patch.</p> <p>Current seasonal growth is vigorous and large leaves suggest the species may be a hybrid with the related species of giant knotweed.</p> | |

Patch JKW1 is within the property and constitutes a RICS category 3 risk. No built structures are at risk. The patch will grow in extent as underground rhizome extends into surrounding soils over subsequent seasons. JKW2 is exterior to the red line, though rhizome has potential to extend into the development area (Figure 6 below).

- Development presents an opportunity to enhance the habitat value of retained naturally vegetated areas.
- Reasonable aims would be to completely remove the two JKW stands using herbicide injected into growing stems (foliar spraying within the stream channel would require additional Environment Agency permits).

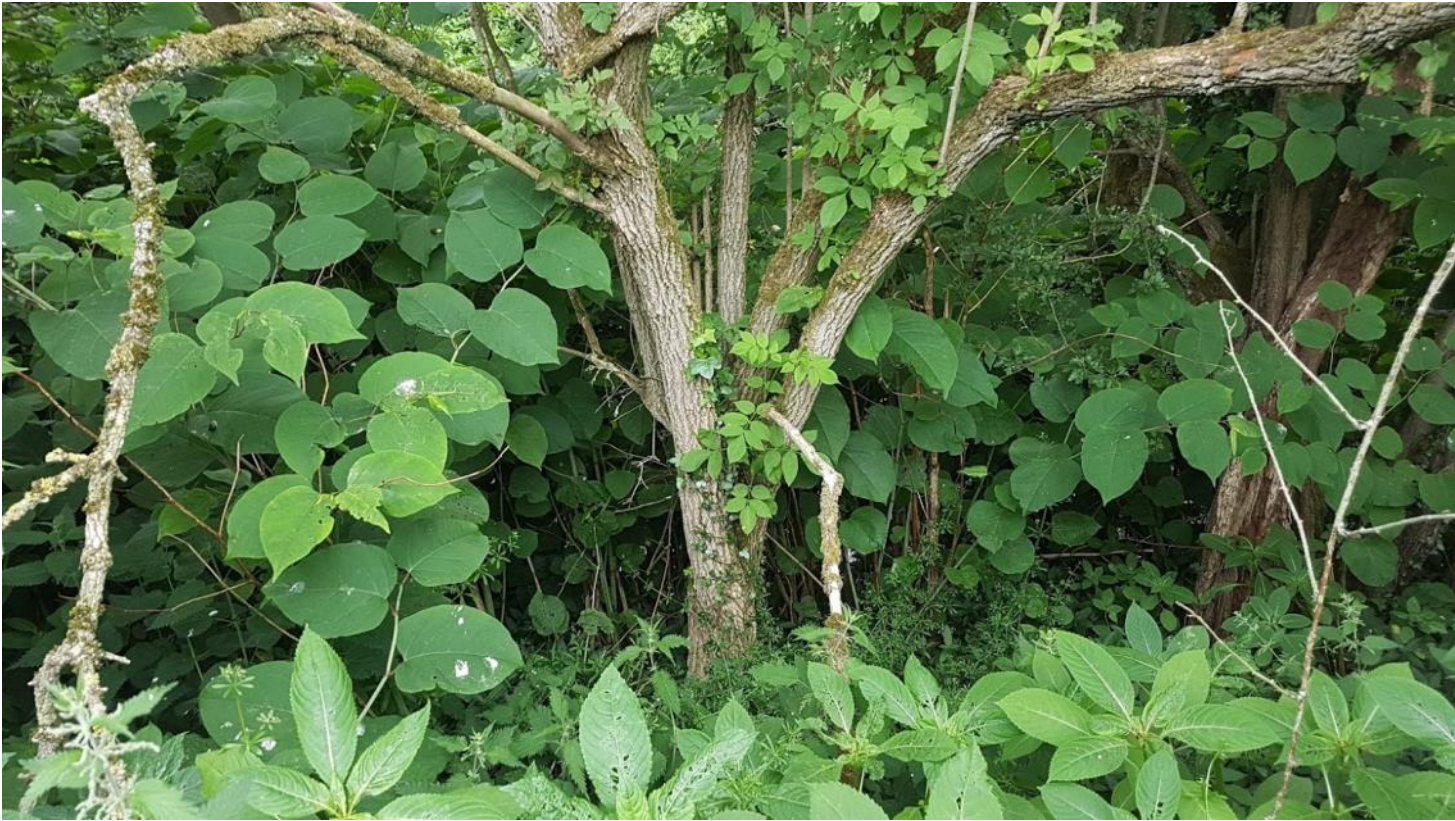
| Patch Ref. | Description and condition | |
|---|---|---|
| | <p>Close view of above towards showing leaf shape.</p> <p>Note adjacent Himalayan balsam growth below in photo.</p> | |

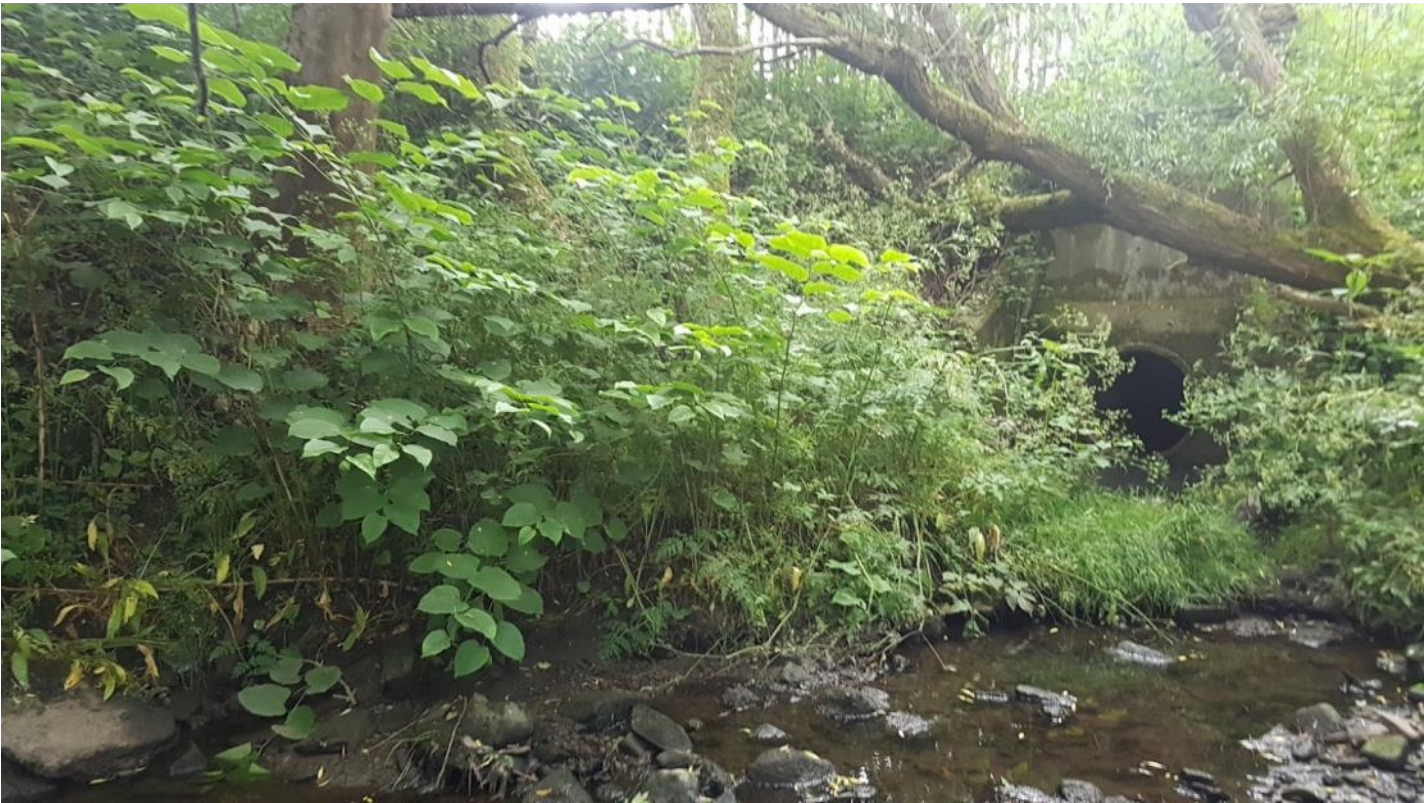
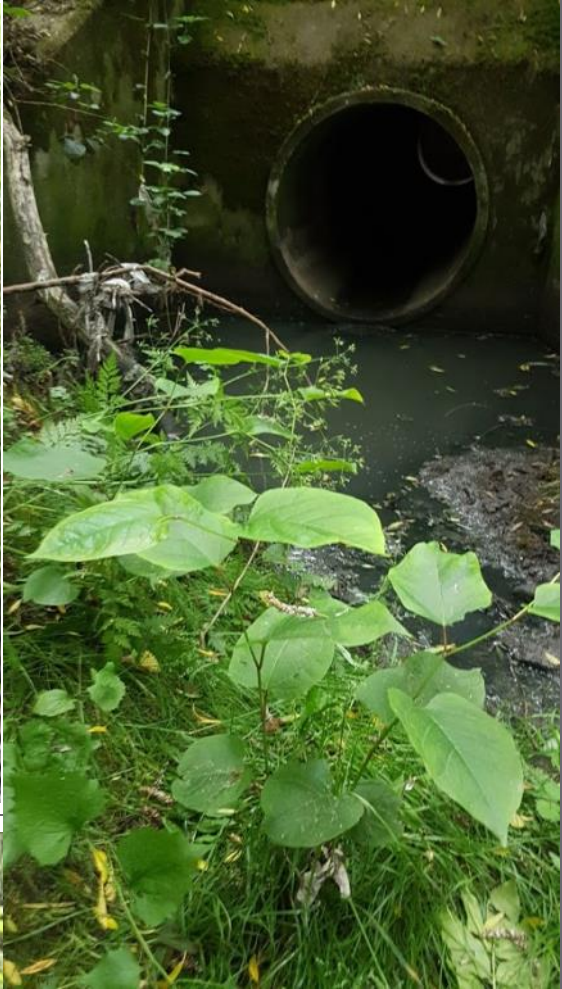
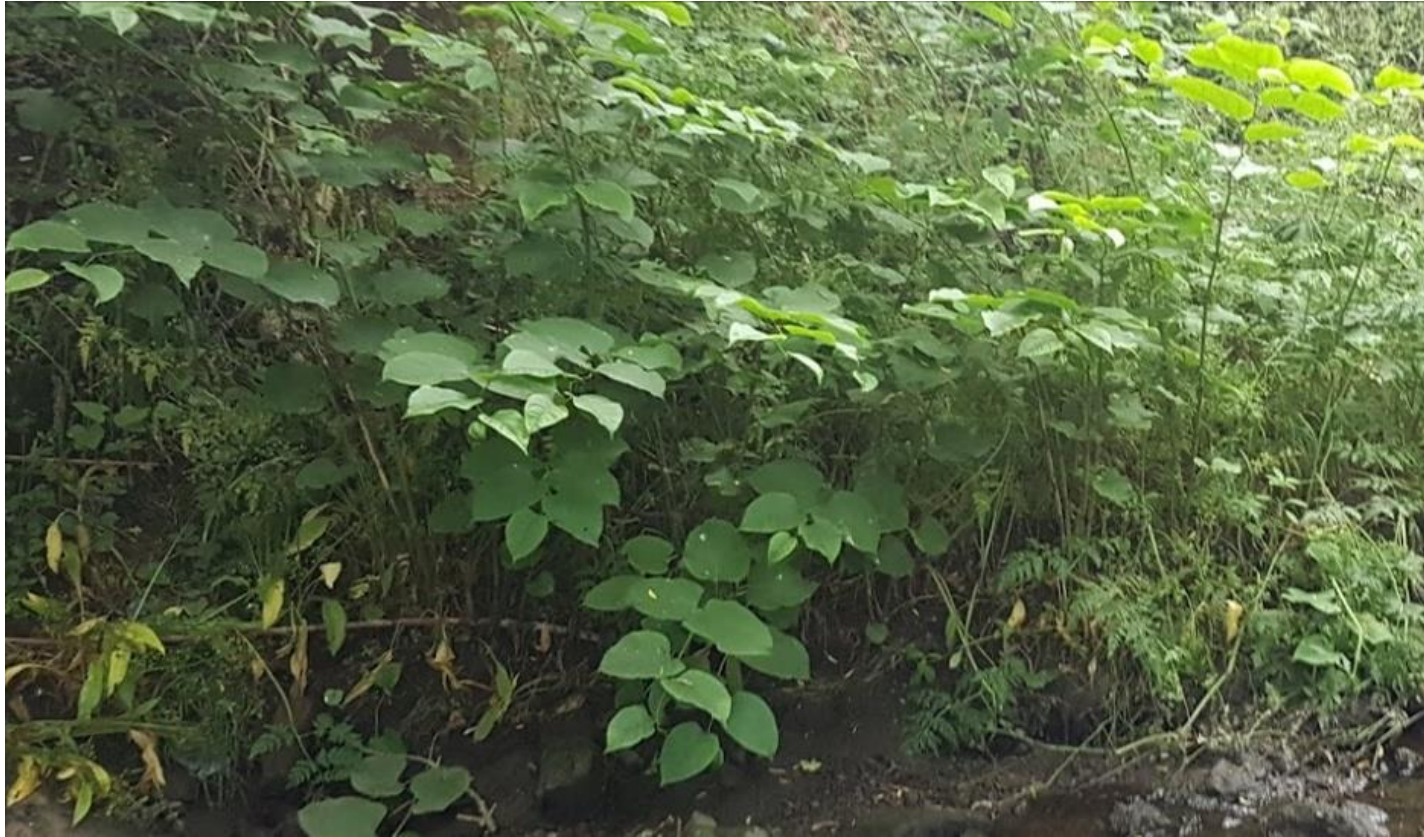
| Patch Ref. | Description and condition | | |
|---|---|---|---|
| JKW 2 | <p>A smaller stand growing adjacent to an outfall pipe that discharges into the stream channel .</p> <p>Comprising around 6 crowns of stems with some juvenile growth as shown right.</p> <p>The stand is positioned exterior to the red line boundary but noted sue to its proximity to development which may need to be accounted for in relation to any planned ground works withing 7 metres of the stand—an area where JWK rhizome may be present.</p> | | |

Neither JKW patch appears to have direct impact on areas which are likely to require ground works to facilitate development, however any engineering works required within the buffer risk zones (Figure 6) should be planned with the assumption that substrates may contain JKW rhizome and a method for compliant containment or disposal of substrates devised by a competent invasive species specialist.

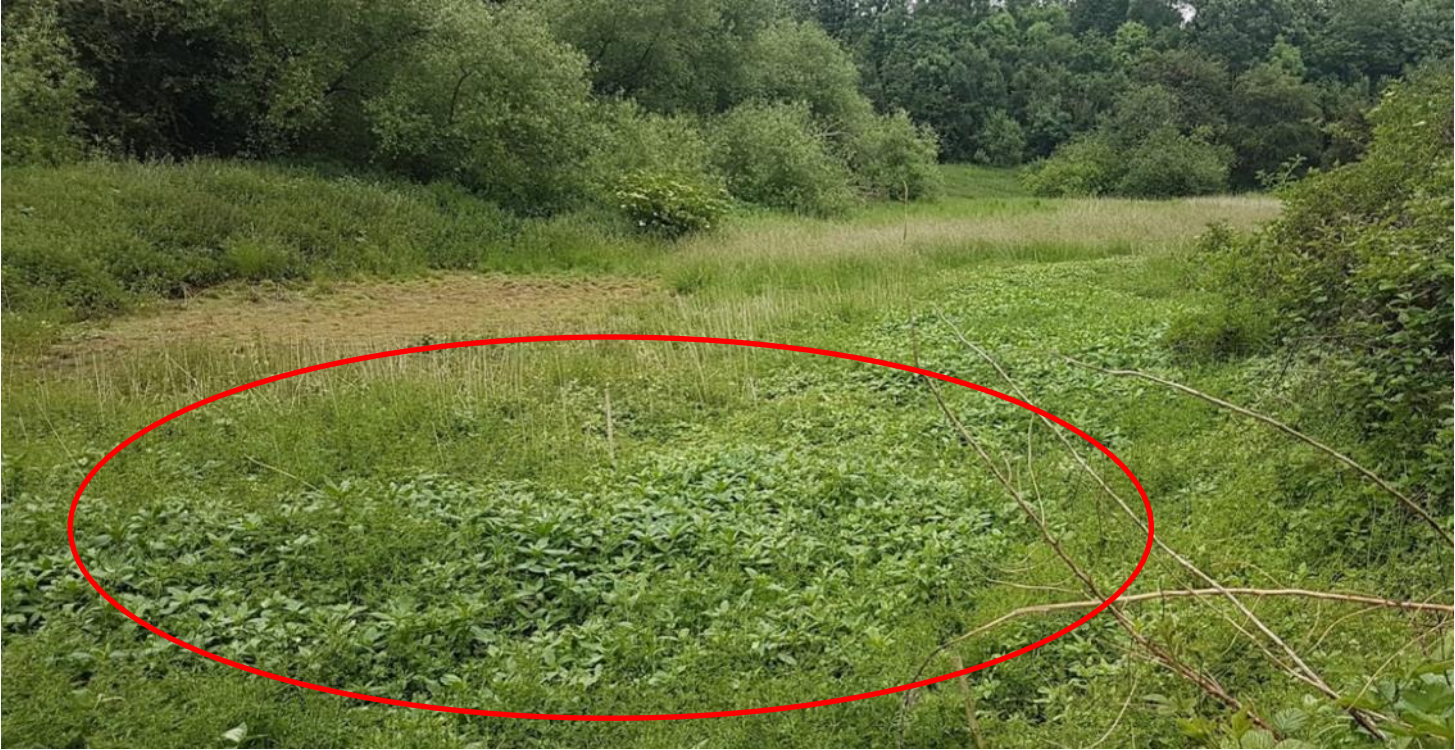
| Patch Ref. | Description and condition | |
|---|---|---|
| HB dense | <p>Himalyan balsam is distributed extensively across the open scrub / grassland to the north east of the stream corridor.</p> <p>It dominates open ground with damp soils though appears to be out-competed by other vigorous herbaceous plants indicative of high nutrient conditions—dense nettle and cleavers in parts.</p> | |

Himalayan balsam is present throughout the more shaded and damp areas of the site, the mature woodland and stream channel areas in particular. The plant spreads by the casting of hundreds of seed from each plant every year. It can proliferate in areas which are favourable enough—generally damp and shaded. It may also be outcompeted by grasses and other plant species where conditions are less favourable such as open dry grassland within the site.

Soils containing HB plants and areas up to 6m surrounding must be considered potentially infected by HB seed to a depth of up to 500mm (typically 100-200mm). Excavation or disturbance of infected soils poses a risk of spread within, and from, the Site and if soils are removed as waste would require treatment/disposal as a controlled waste.

- Complete removal of Himalayan balsam is unlikely to be achievable without a wider landscape strategy in collaboration with neighbouring landowners. Control aims should seek to limit the extent and reproductive capability of existing patches, while enhancing vegetation composition to be less favourable to this species. For instance, seeding with a tussock grass mix may provide beneficial competition to reduce overall cover of HB.

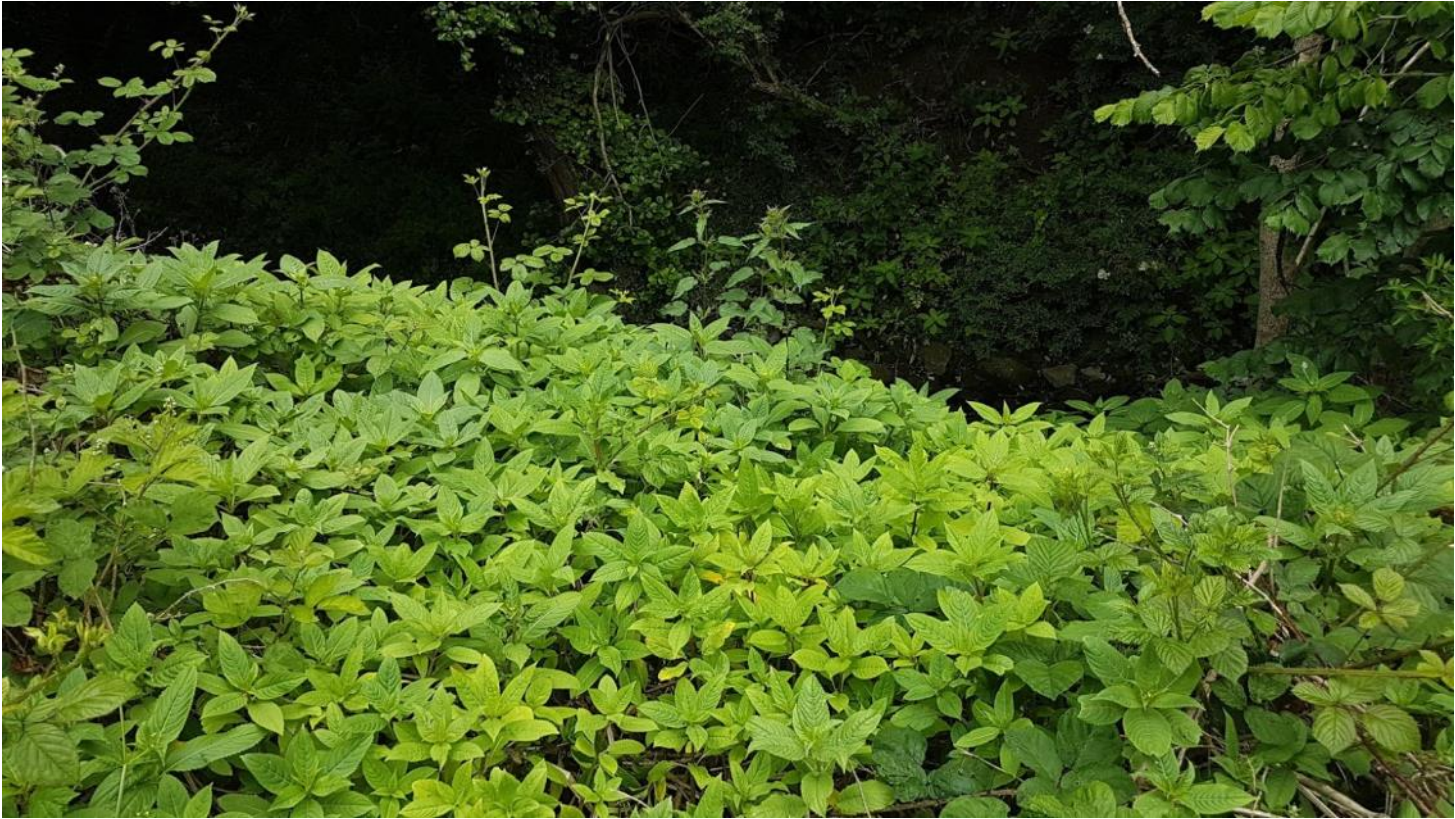
| Patch Ref. | Description and condition | |
|---|---|---|
| | <p>Stands are particularly dense on open shaded stream banks in localised patches.</p> | |

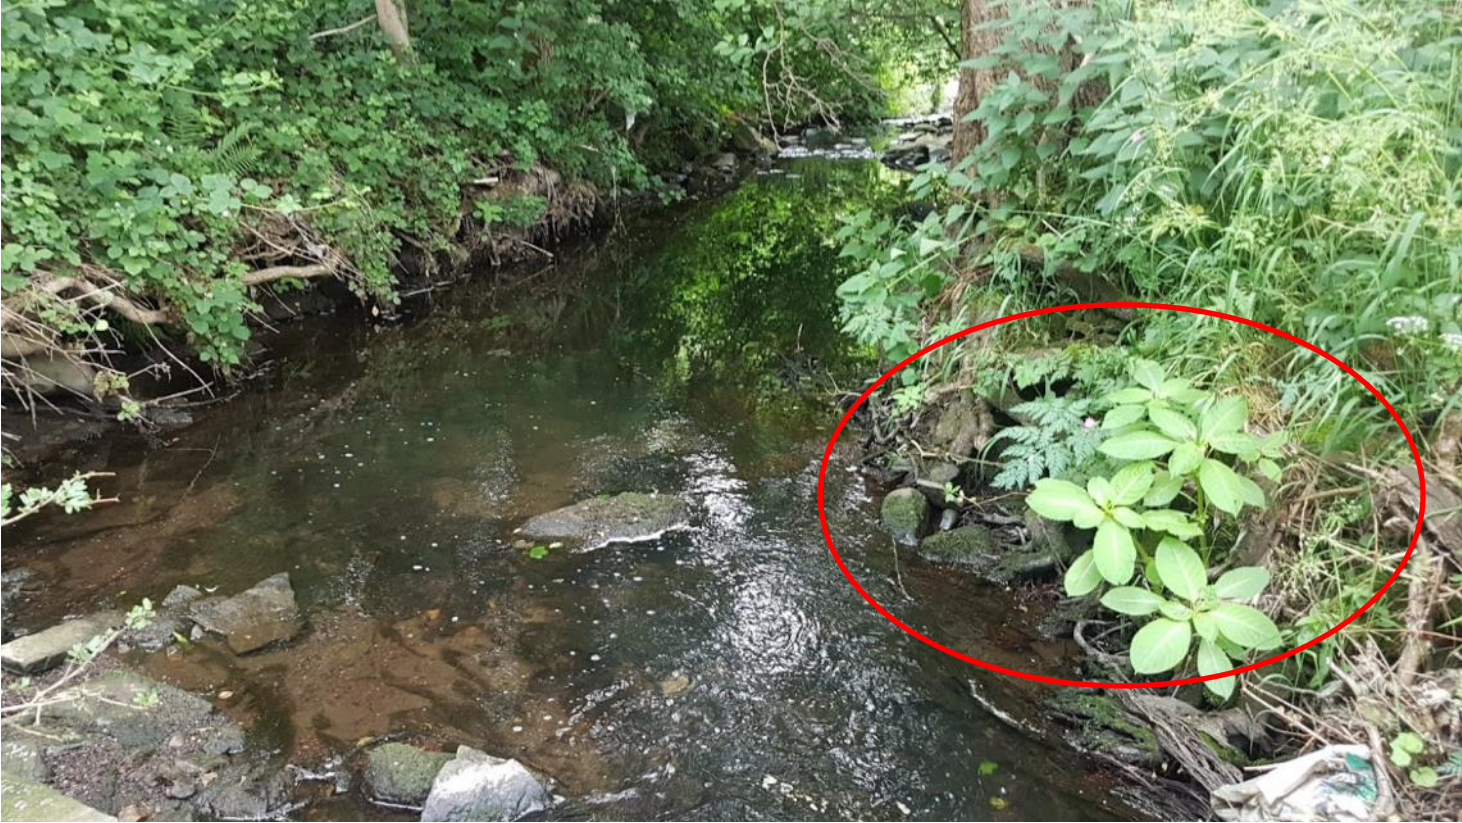
| Patch Ref. | Description and condition | |
|---|---|---|
| HB<br><br>Scatt. | <p>HB is scattered throughout the stream corridor and adjacent unmanaged scrub land as mapped.</p> <p>This is indicative of the presence of this species over many years, which has extensively colonised.</p> | |

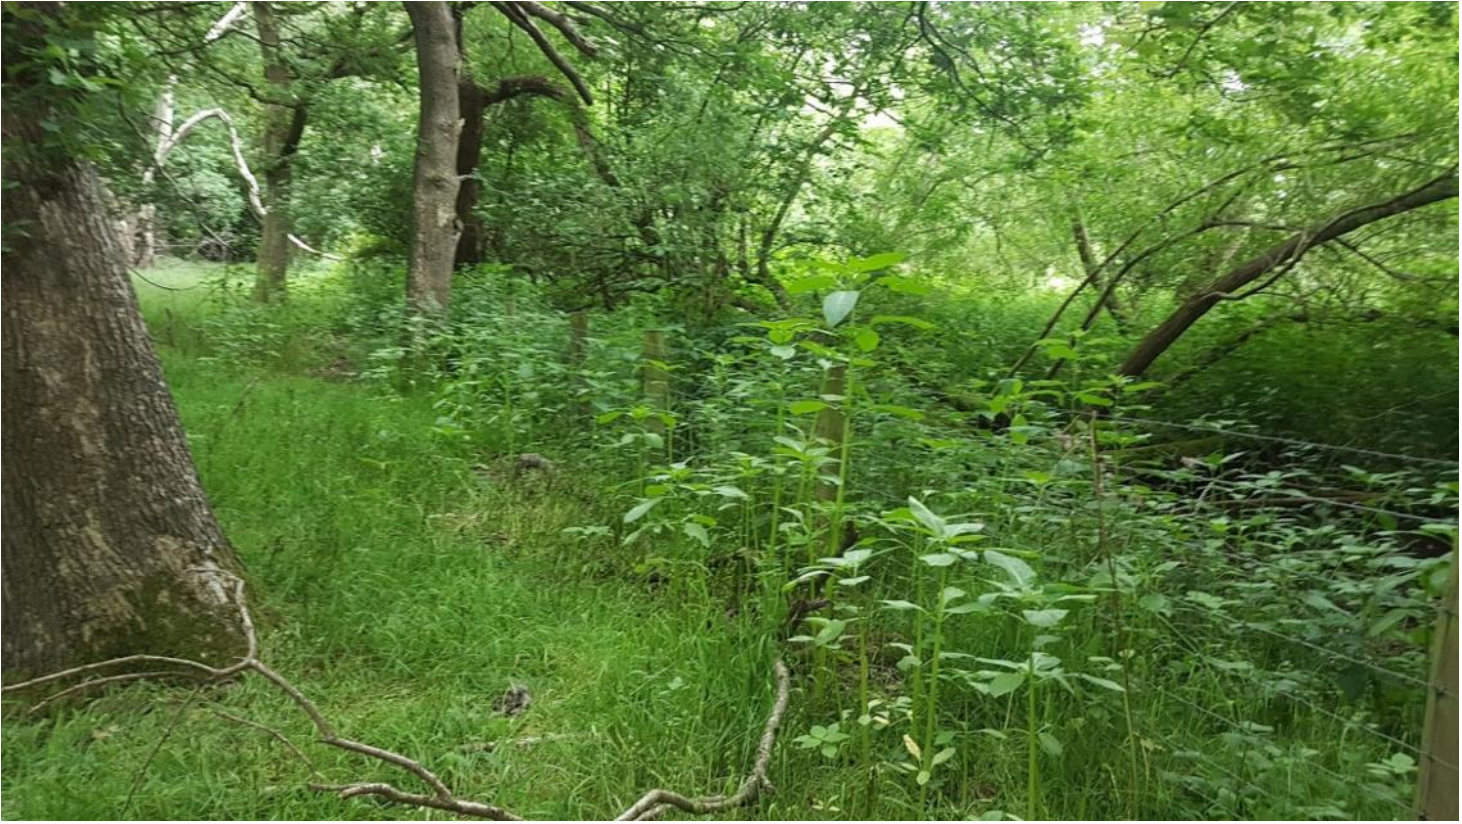
| Patch Ref. | Description and condition | |
|---|---|---|
| | <p>HB scattered along the north eastern boundary of the site adjacent to Hanging Wood. Cattle grazing within the woodland and also into pasture land within the red line boundary, has likely prevented further spread of HB into these areas.</p> | |
