SAFETY AUDIT

STAGE 1/2

Wadsworth Gardens PROWs, Cleckheaton

ON BEHALF OF
BARRATT & DAVID WILSON HOMES

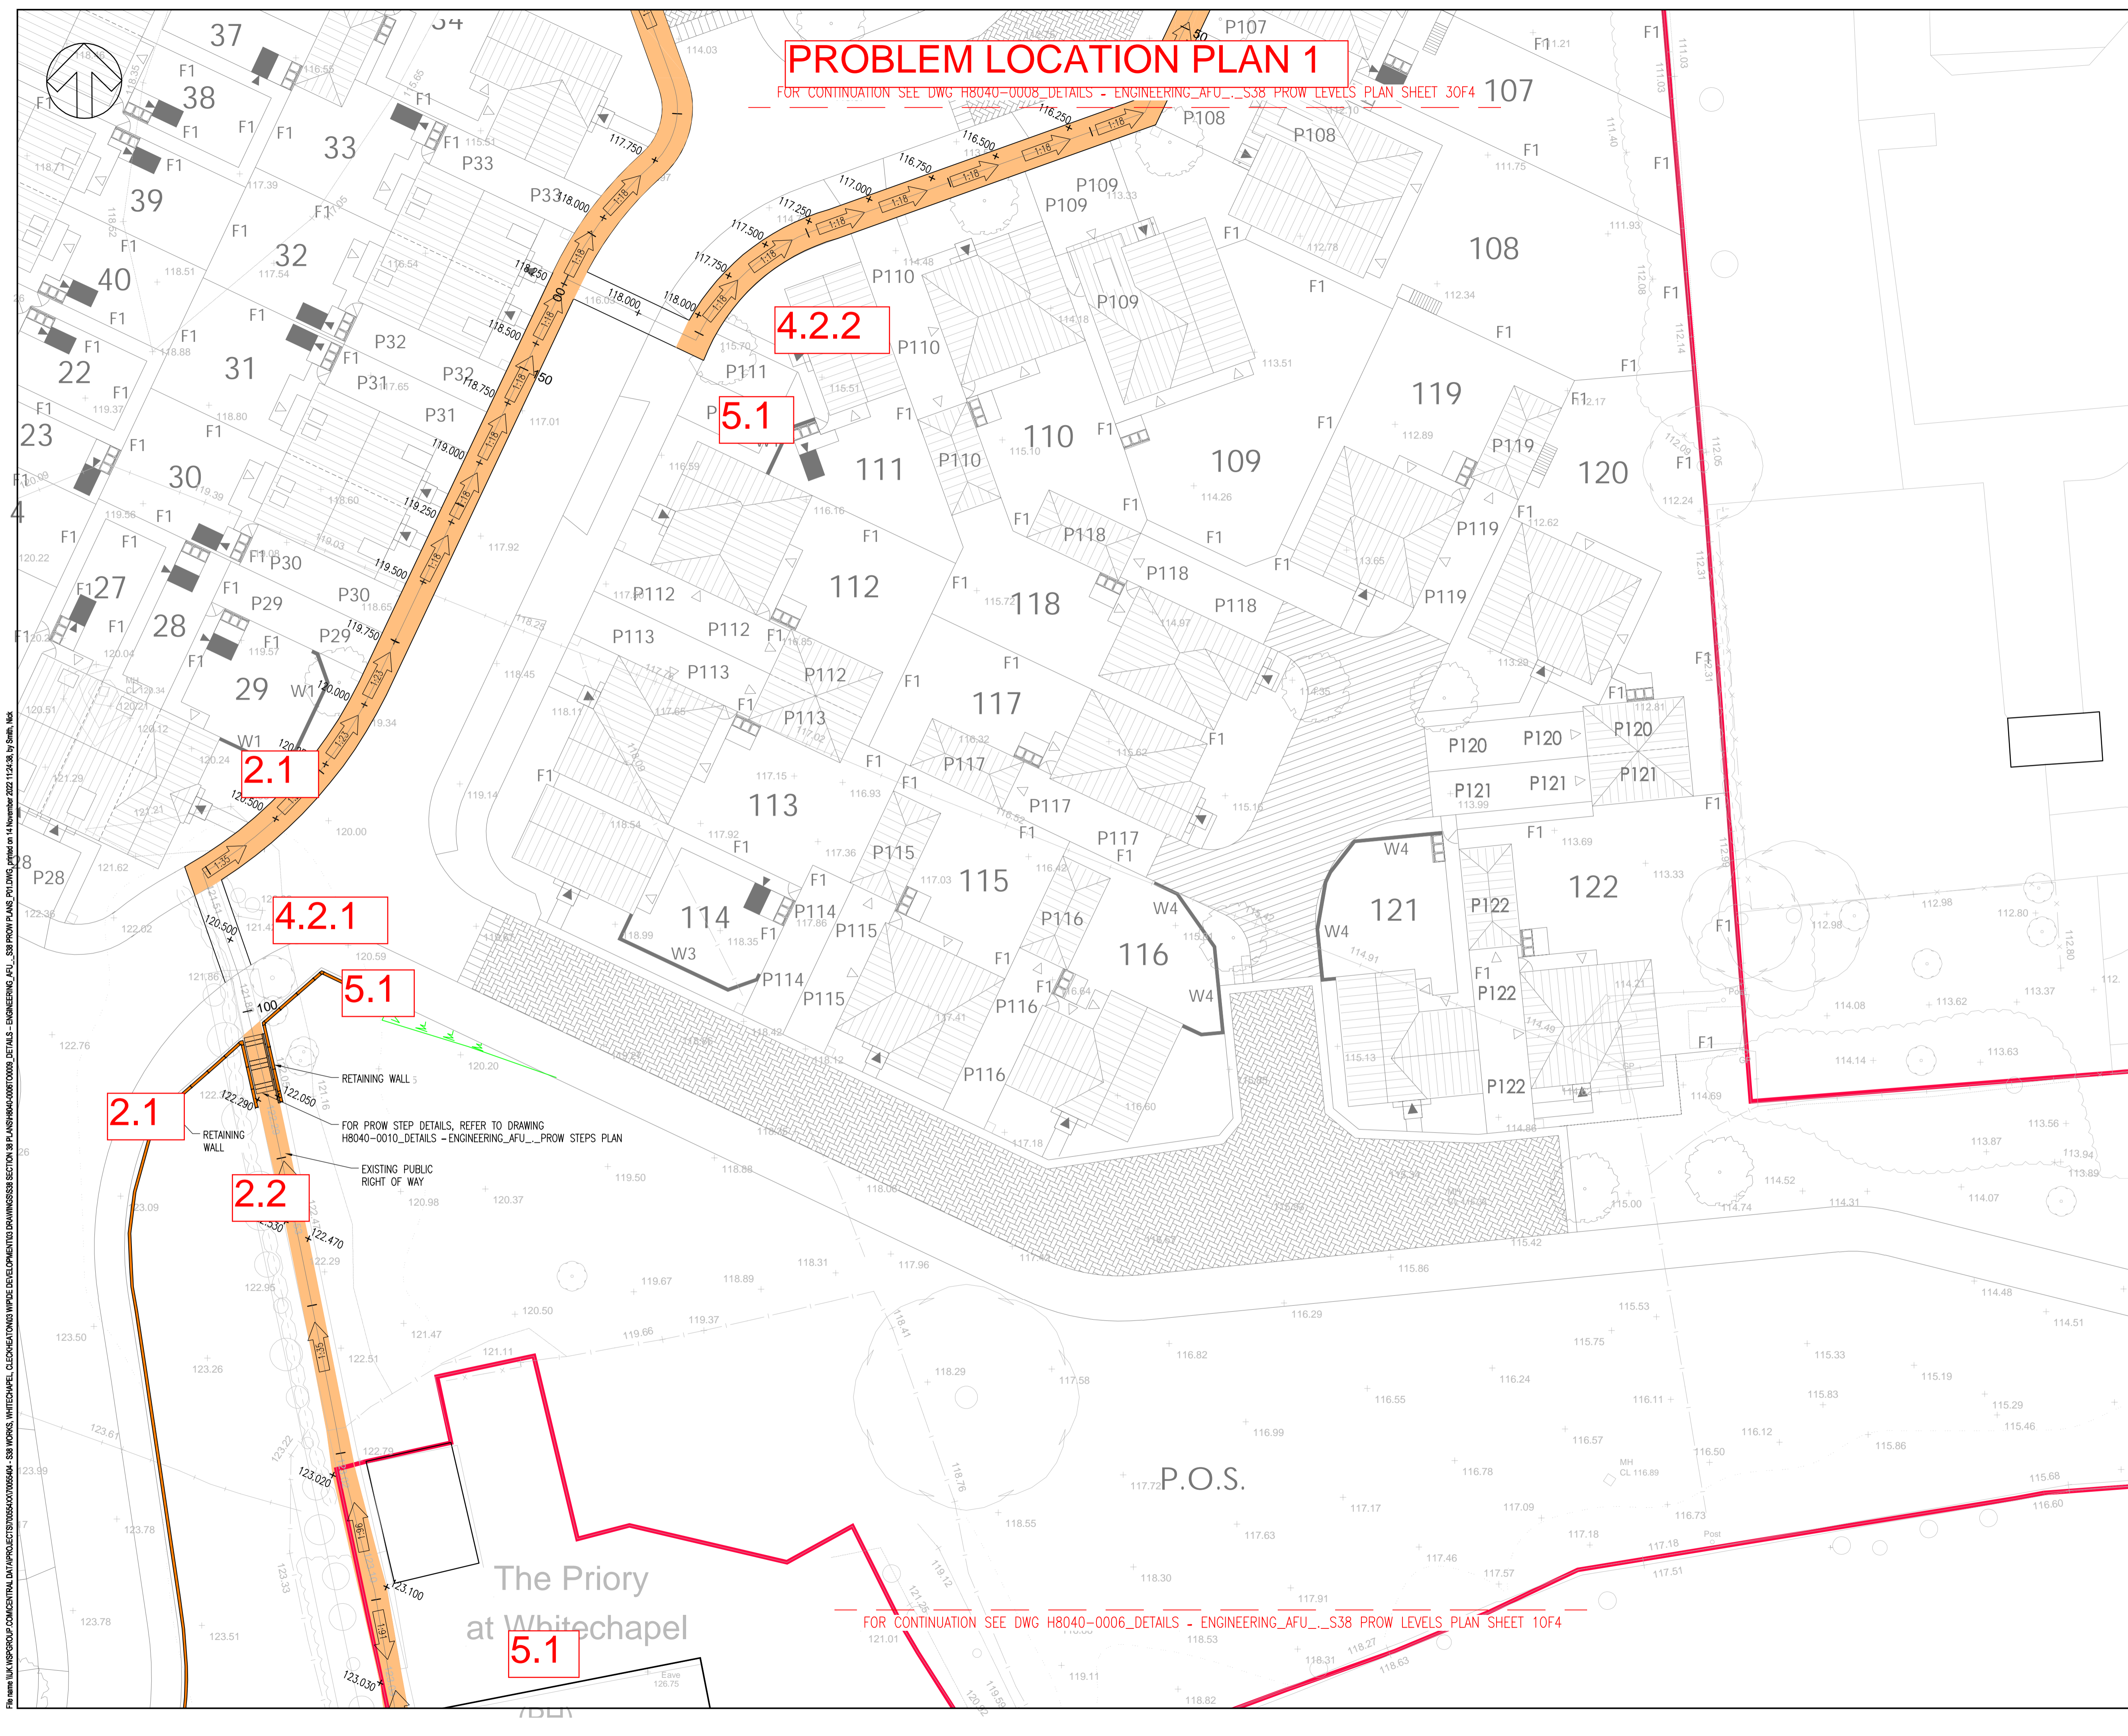
PROBLEM LOCATION PLAN 1

2.1 Problem: Visibility for pedestrians crossing Road 1

Location: Adjacent to top of proposed steps (plots 28 / 29)

Summary: *No visibility splays shown on the drawings for pedestrians crossing Road 1 adjacent to the top of the proposed steps in the new PROW near plots 28 / 29. It is unclear whether adjacent boundary treatments / retaining wall parapet would obstruct splays placing pedestrians in danger.*

No visibility splays are shown on the drawings for pedestrians using the proposed crossing location for the new PROW adjacent to the top of the steps in the latter near plots 28 / 29. Pedestrians crossing from south to north after emerging from the steps would have to look left over the parapet wall to view oncoming traffic. It is not clear whether the height of this wall relative to the vertical alignment of Road 1 would prevent a pedestrian from observing an approaching vehicle and vice versa.

For pedestrians crossing at the same location but from north to south, it is not clear whether there is sufficient visibility afforded to a pedestrian within the proposed highway of vehicles approaching from the north and vice versa without crossing in to private garden areas where planting might obstruct their view.

Failure to provide adequate visibility for pedestrians to judge whether it is safe to cross a carriageway could lead to collisions.

2.3 Problem: Design of Proposed Steps

Location: Off Road 1 opposite plots 28 / 29

Summary: *The design of the proposed steps does not fully address usage by vulnerable users with mobility difficulties. There are no measures proposed for aiding people with vision deficiencies. These issues could result in potential injuries to such users.*

The proposed steps are located just off Road 1 opposite plots 28 / 29. They will link the lower level of the existing PROW up to the new road level. Whilst no ramp is proposed adjacent to the steps, there is a commodious alternative route via the footway along Whitechapel Road and the new footway along the eastern side of Road 1.

The design of the proposed steps has risers of 170mm and tread depth (going) of 300mm with landings of 1000mm. The steps are shown as being 1200mm wide and will have a total rise of 1.53m. There is no tactile paving shown on the drawings at the top or bottom of the proposed steps.

Current guidance in CD 143 indicates that risers should be a maximum of 50mm whilst the treads should be a minimum of 280mm and 350mm with landings of 1800mm. These are guidance figures for such measures on Trunk Roads which none of the roads in the area are classified as such. Other advice that is available on such matters (in relation to accessibility under the Disability Discrimination Act (DDA) and access to commercial buildings and advice of the Sensory Trust) suggests that risers should be provided between 100mm and 150mm whilst the treads should be between 280mm and 350mm with landings of at least 1200mm.

Therefore, the steps as proposed do not completely comply with current guidance for users with mobility difficulties or vision deficiencies which could result in falls and stumbling of users.

4.2.1 Problem: Location of crossing point of Road 1

Summary: *The drawings show that the proposed dropped crossings / tactile paving are offset from the direct line of the route for pedestrians emerging from the top of the steps. The location of this crossing point is not clear to approaching drivers. These factors could result in collisions with pedestrians crossing at less safe locations.*

The drawings provided show that the proposed dropped crossings / tactile paving located adjacent to the top of the steps on the PROW opposite plots 28 / 29 are offset from the direct line of the route for pedestrians emerging from the top of the steps. No explanation for this offset has been provided.

The location of this crossing point on a tight bend is not readily apparent to approaching drivers and the latter might be taken by surprise if say a group of walkers suddenly emerged from the steps and needed to cross the road.

The above deficiencies could result in collisions with pedestrians crossing at less safe locations.

4.2.2 Problem: Location of crossing point of Road 1

Location: Road 1 adjacent to plot 111

Summary: *The proposals indicate that part of the diverted PROW will cross Road 1 in the vicinity of plot 111. This uses the vehicle crossover to the drive to plot 111 and there is no dropped kerb or tactile paving on the opposite footway. Failure to indicate a safe crossing point for pedestrians could lead them to use less safe locations.*

The drawings indicate that part of the diverted PROW will cross Road 1 in the vicinity of plot 111 using the vehicle crossover to its driveway. The Audit Team has noted that there is no dropped kerb or tactile paving on the opposite footway in this location.

Whilst the potential for a crossing pedestrian being in conflict with a vehicle using the driveway to plot 111 is small, the location is not ideal and would make it difficult to provide tactile paving in that location. The lack of a dropped crossing and tactile paving on the opposite footway would result in people in wheelchairs or with perambulators having to bump over full height kerbing.

Failure to indicate a safe crossing point for pedestrians could lead them to use less safe locations.

It is recommended that the drawings be amended to show what visibility can be achieved at this crossing point for pedestrians and boundaries / treatments be designed so as to avoid them being obstructed.

It is recommended that the drawings be amended to provide risers of no more than 150mm, treads of at least 300mm (already shown) and the landings be increased to at least 1200mm. The provision of corduroy paving at the top and bottom of the steps is also recommended.

It is recommended that the drawings be amended to revise the position of the dropped crossings / tactile paving to be in line with the proposed route. The presence of the crossing point is recommended to be highlighted by either the provision of a different colour / texture of road surface and / or placed on a flat top speed hump.

It is recommended that the design team review the location of this crossing point and place it away from driveways so as to allow the provision of dropped crossings and tactile paving.

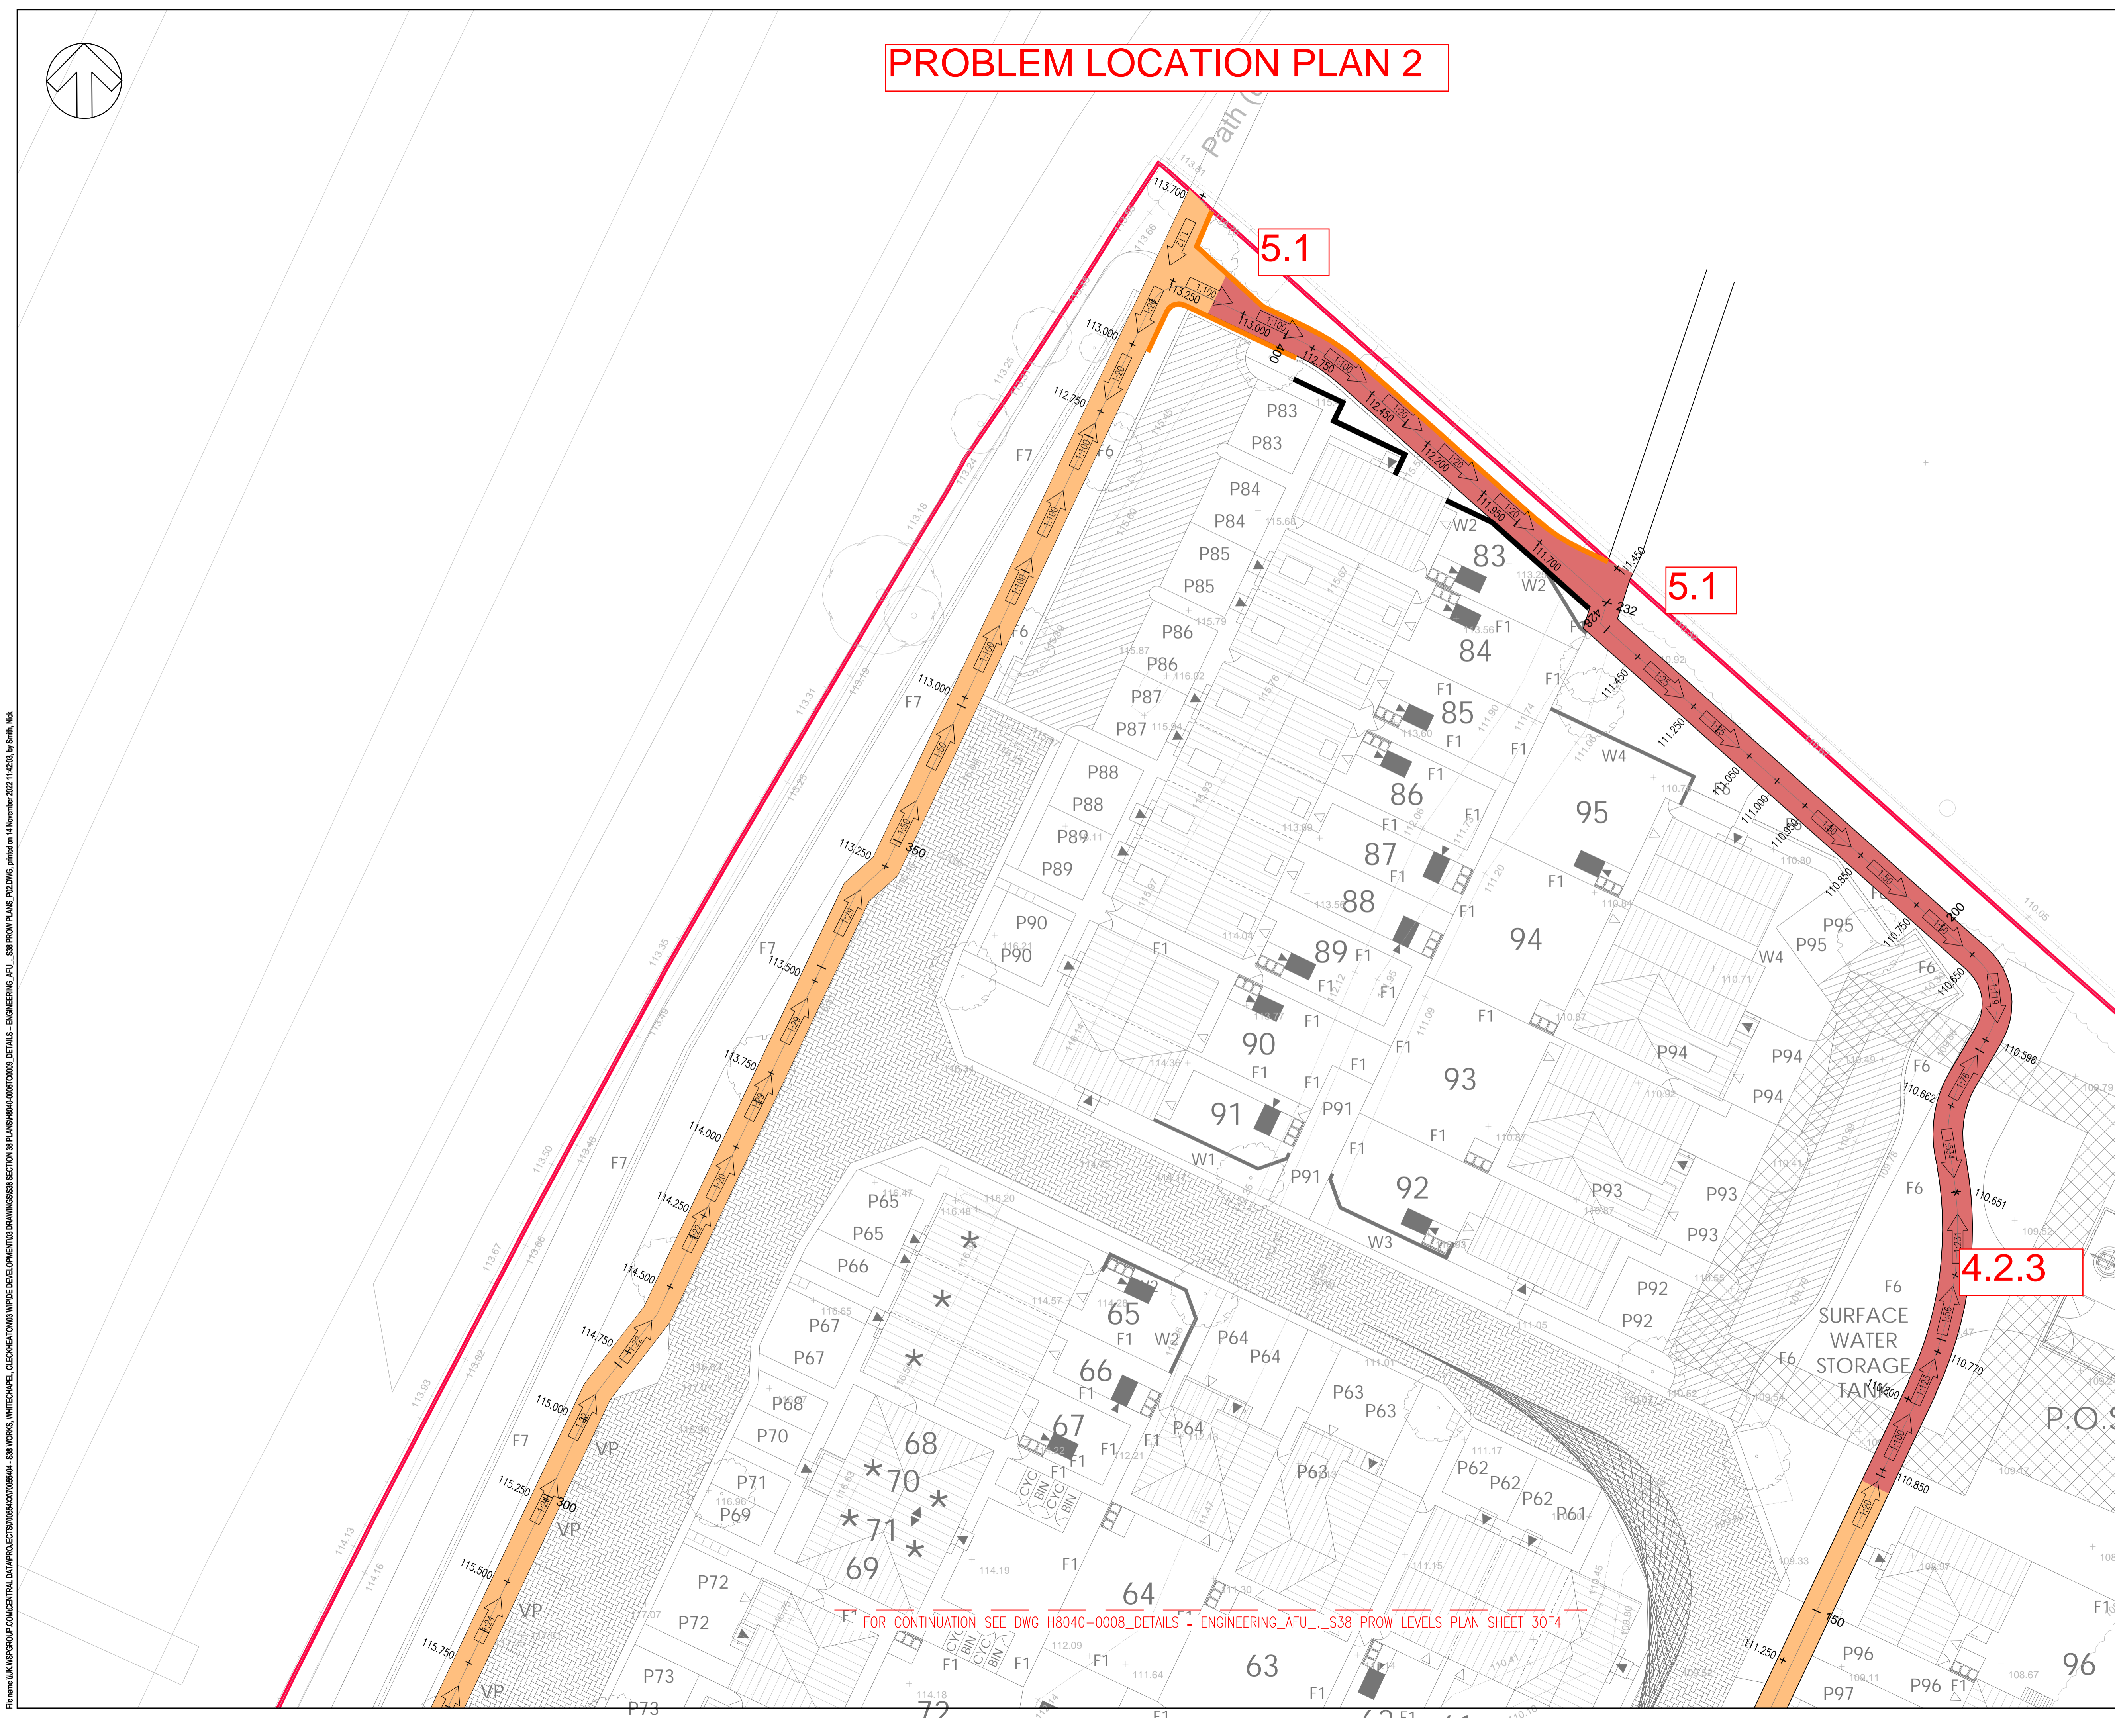
PROBLEM LOCATION PLAN 2

4.2.3 Problem: PROW crosses private access road of unknown construction

Location: Private access road to pumping station

Summary: *The drawings indicate the route of the PROW will cross the private access road serving the pumping station. No details of the construction of this access road are provided and the PROW would be overrun by maintenance vehicles which could result in its failure creating trip hazards.*

The drawings provided to the Audit Team indicate that the route of the PROW at the north east end of Road 1 (near plot 96) will then continue across the private access road serving the pumping station. No details of the construction specification of this access road are provided.

The drawings show that the PROW in the above location would be to a loose stone footpath specification. As this will be overrun by maintenance vehicles, over a period of time this construction might fail and so create trip hazards for users.

5.1 Problem: Lack of signage details provided

Location: Along PROW routes

Summary: *The drawings do not show the provision of PROW signage so the Audit team are unable to review but have made some recommendations.*

The drawings do not show the provision of PROW signage, so the Audit team are unable to review but have made some recommendations.

It is recommended that the specification for the PROW in the above location be upgraded so as to cater for overrun by maintenance vehicles.

In the absence of any signage drawings for the PROW the Audit Team has made the following recommendations:

- 1 A PROW signage scheme shall be prepared and be subject to review by the Audit Team.
- 2 The signage scheme shall include direction signs from Whitechapel Road to the north eastern end of the development site and at any points in between where a route decision has to be made.
- 3 Given the presence of steps proposed on part of the PROW route, the alternative route for people in wheelchairs and with perambulators should be sign posted on / along Whitechapel Road and Road 1.
- 4 The designated crossing points where PROW users cross the new estate roads shall be sign posted / clearly marked and / or warning signage provided as necessary.
