141 Toftshaw Lane, East Bierley

Bat Survey Report

1st October 2021

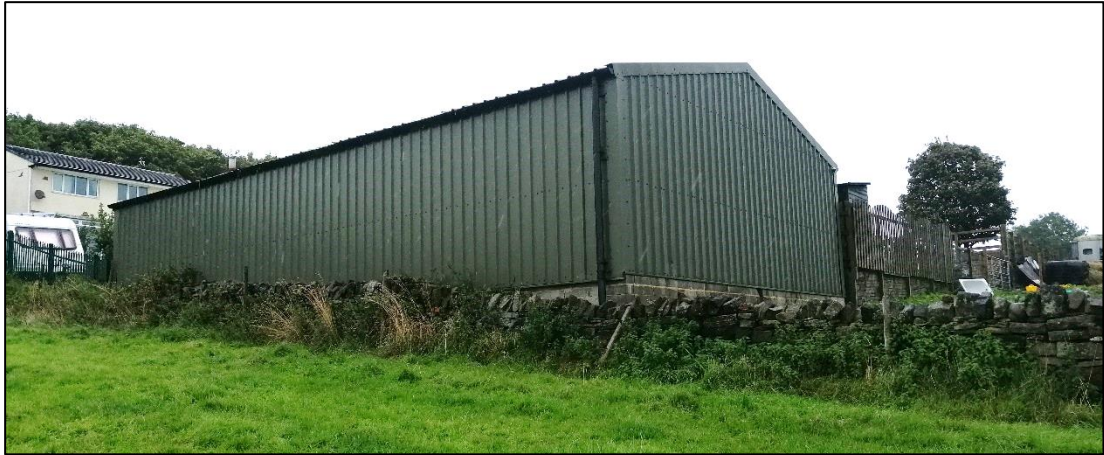
Plate 1. West elevation and south facing gable

5.2.2 The building is steel framed beneath a pitched corrugated sheet-metal roof with single skin 10cm concrete block infill between the vertical sections of steel frame. The exterior in its entirety is clad with corrugated metal sheets and the building is accessed either by two large roller shutter doors (north and east elevations) or a normal doorway with a roller shutter (east elevation). The building has uPVC rainwater goods (Plates 1 - 3).

5.2.3 The entire building is clad with metal sheets and consequently it lacks features with potential to support roosting bats on its exterior. Whilst there is a void between the sheet metal and the concrete blocks, there is no access to this void. Also, it is not

foreseen that bats could cling on to the surface of the metal sheets to access the space between the metal cladding and verge capping.

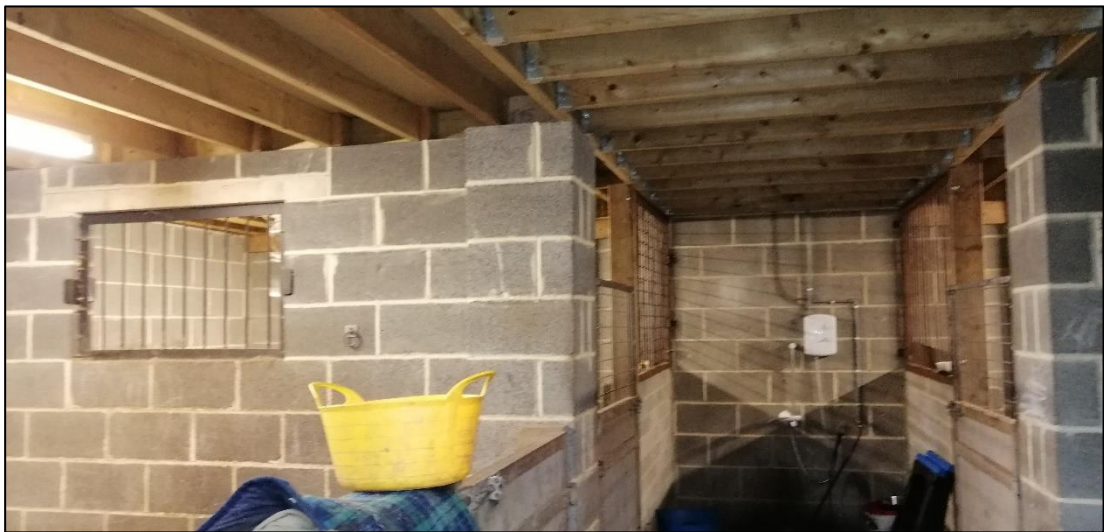
Plate 4. Stables

- 5.2.4 The building is open to the underside of the roof sheets, which are supported by a steel frame and timber joists. There is a mezzanine floor above the four stable compartments, which have concrete block dividing walls. No signs of bats or nesting birds were found.
