**COMBINED STAGE 1/STAGE 2  
GEO-ENVIRONMENTAL REPORT**

**AT  
FORMER HOYLE ING DYE WORKS  
MANCHESTER ROAD  
LINTHWAITE  
ON BEHALF OF  
HIGHSTONE BUILDING SERVICES LTD  
AND  
REDWATERS DEVELOPMENTS**

PROJECT: FORMER HOYLE ING DYE WORKS, MANCHESTER ROAD, LINTHWAITE

REPORT REFERENCE: HIG/01r1

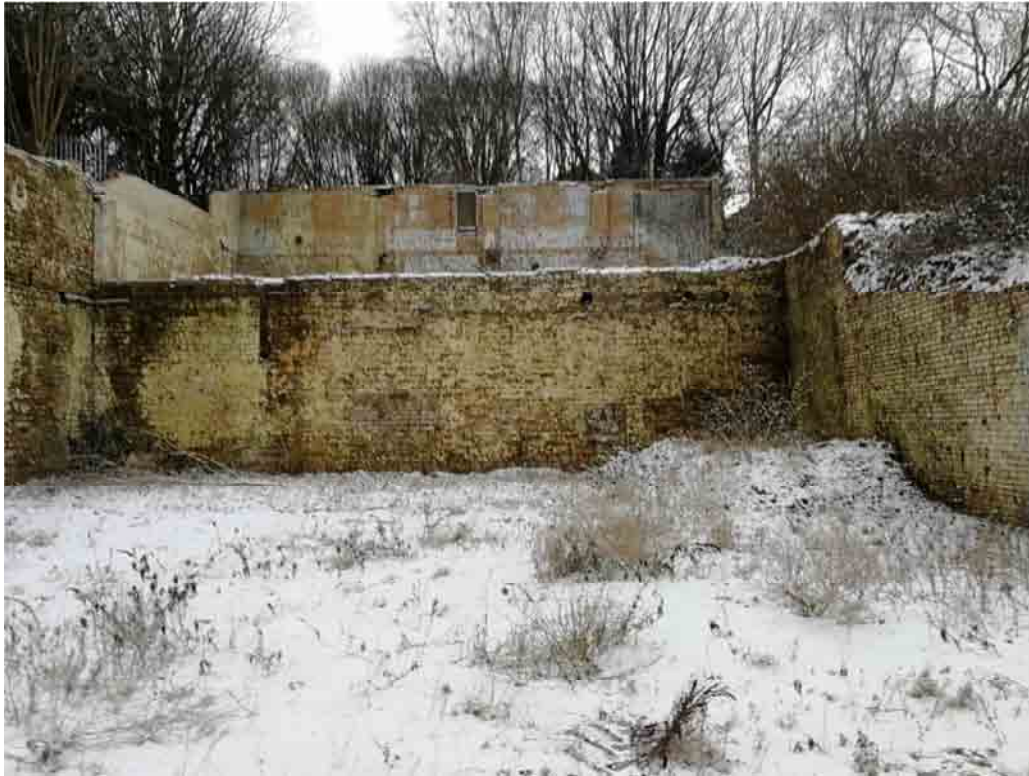
**Photograph 1:** Sandstone retaining wall in background, brick retaining wall to the right. Photograph facing south.

- To assess the structural integrity of the existing sandstone retaining wall that is to remain, it is recommended that a structural survey is undertaken together with associated structural calculations.
- Structural surveys may also be required for the existing chimney and the retaining walls along the site boundary.

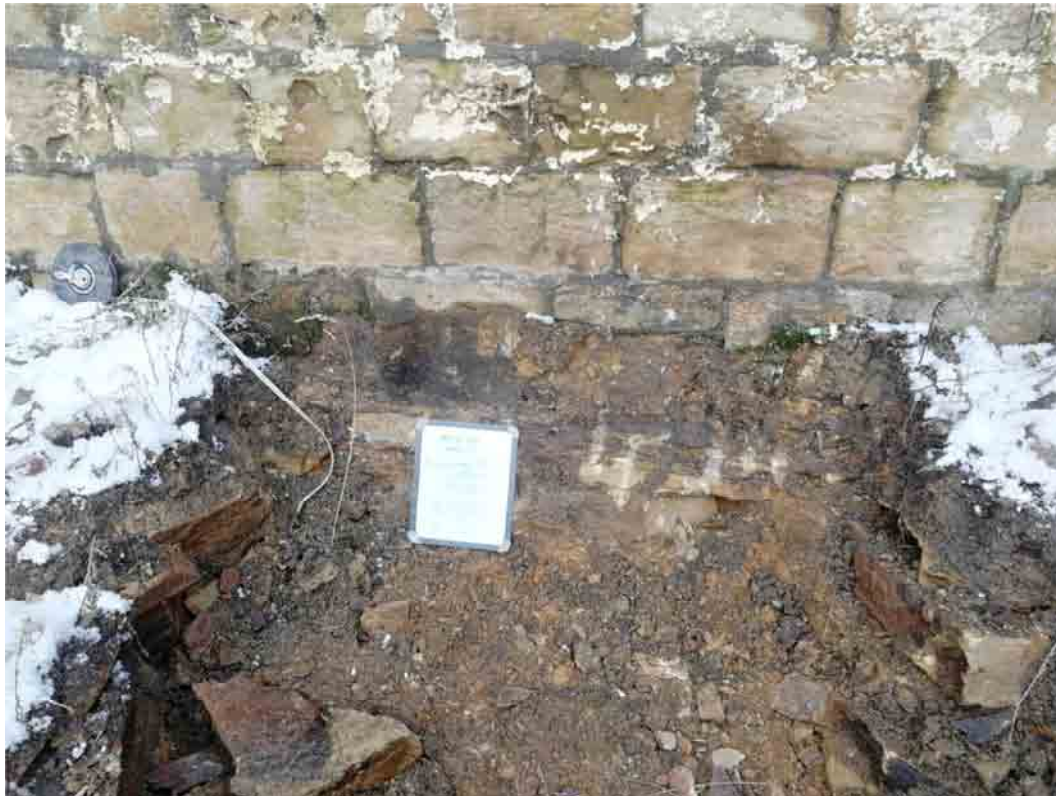
**Photograph 3:** Exposed foundation of the sandstone retaining wall in TP6.

7.5 Excavations were undertaken to expose the foundations of the sandstone block retaining wall at TP6 and the brick retaining wall at TP7. Excavations were also undertaken at the higher level in Area B adjacent to the top of the retaining wall to establish ground conditions. The logs and foundations sketches are presented in Appendix H and the observations are summarised below;

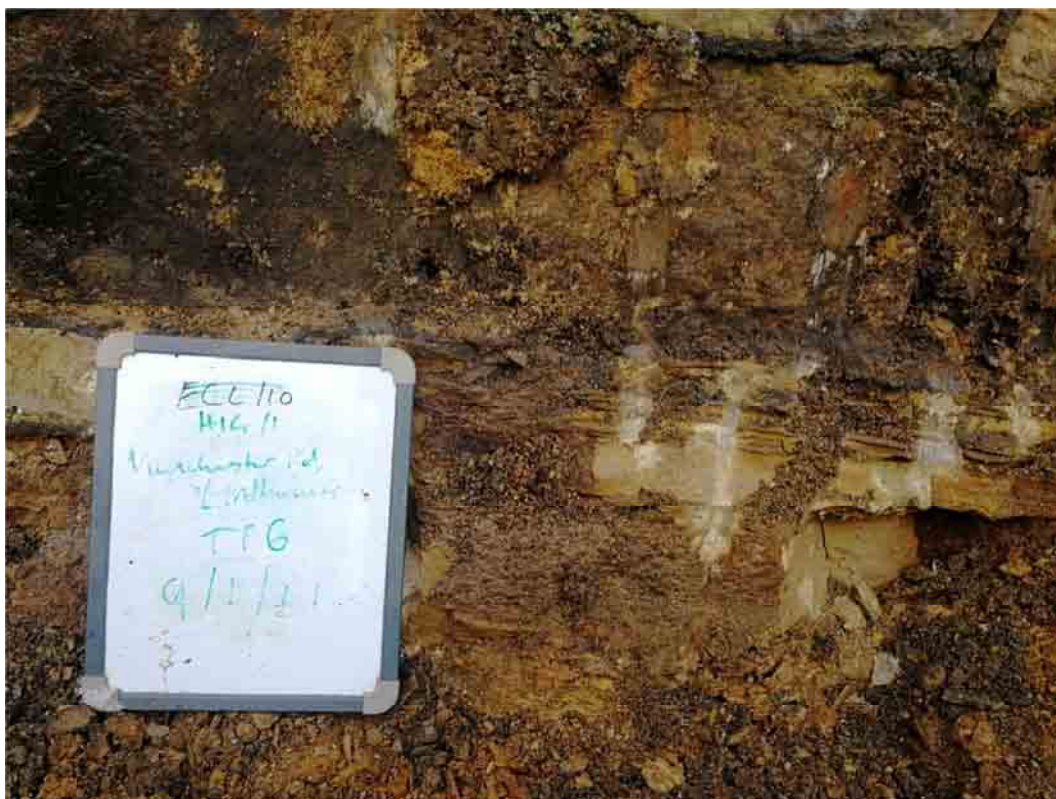
**Photograph 4:** Close-up of exposed foundation in TP6

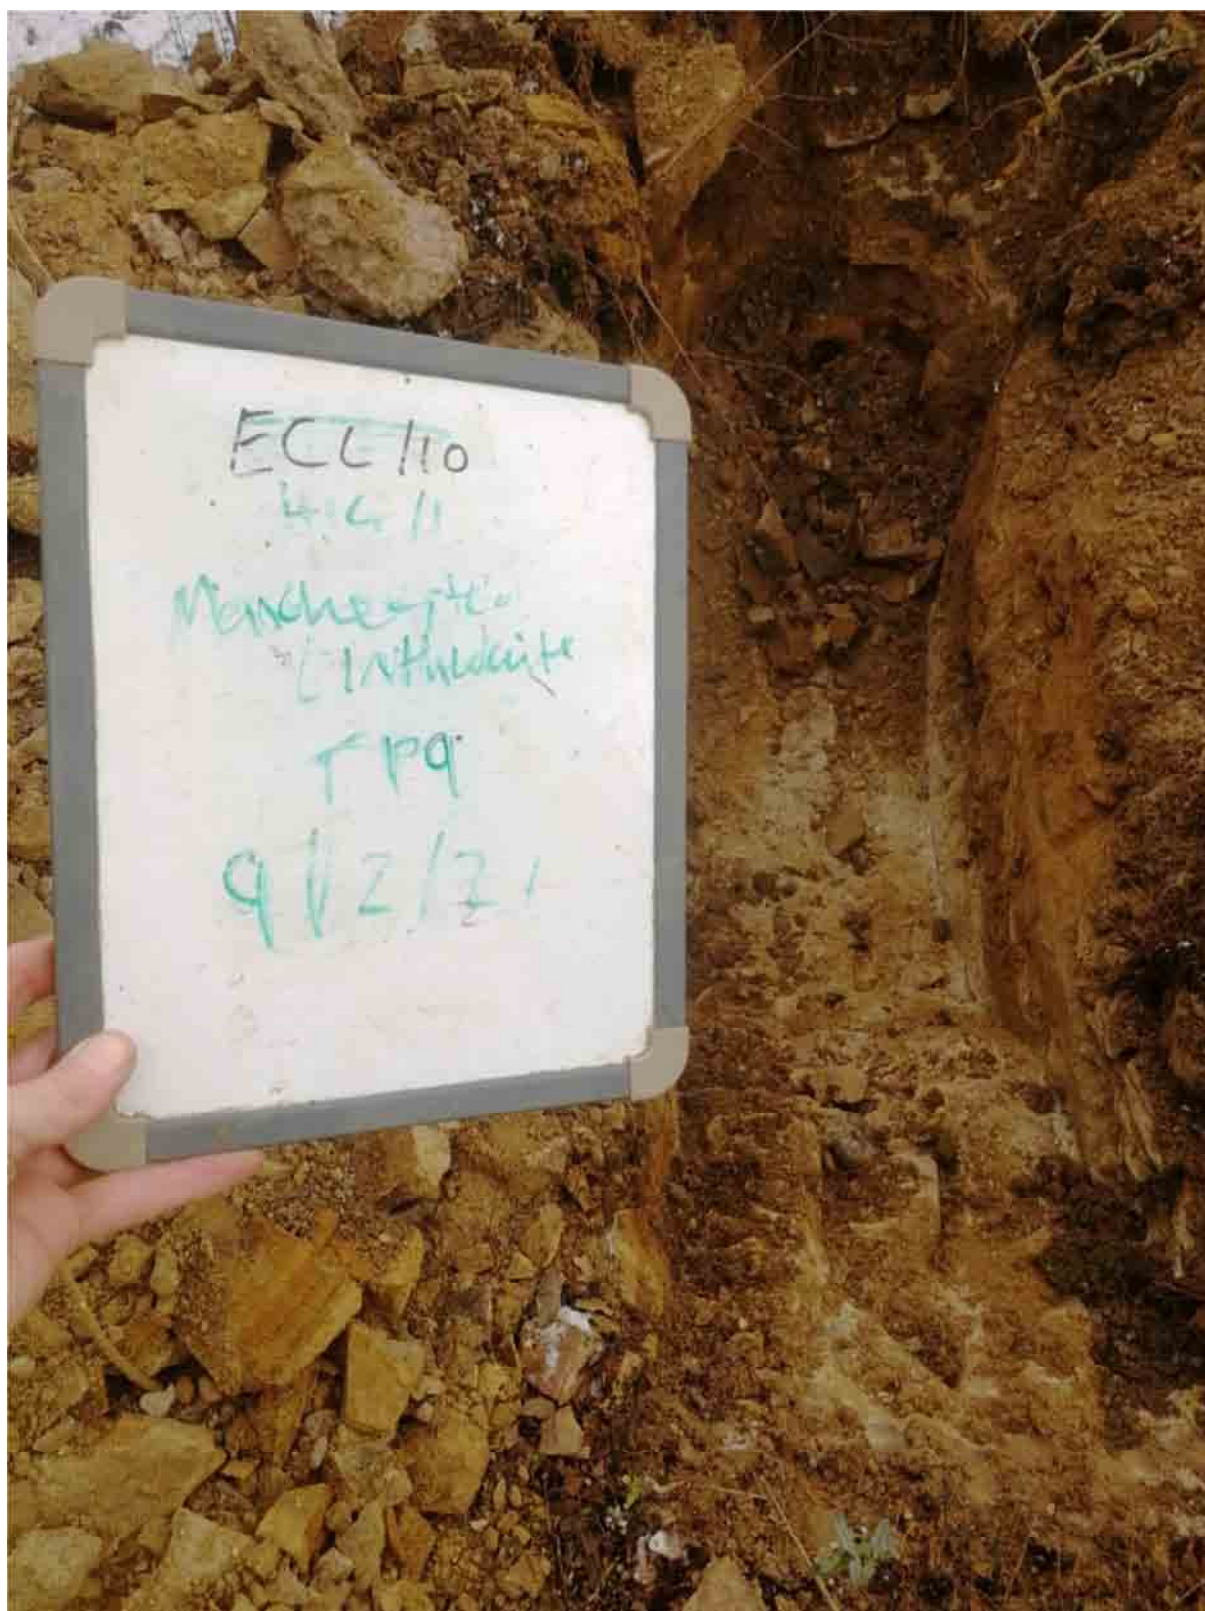
- The foundations for the brick retaining wall near TP7 were found to be less than 250mm deep, and founded on granular residual soils of gravelly sand, with many angular cobbles and boulders. The ground conditions at TP8 at the higher level (not directly above TP7) comprised made ground to 1.8m depth overlying residual soils of soft clay to 2.5m and a mix of cohesive and granular residual soils to 3.9m. The soil was wet from 2.5m to 3.6m.
- The sandstone block retaining wall near TP6 was founded directly on intact sandstone bedrock at approximately 0.2m depth. Trial pit TP9, at the higher elevation above to the retaining wall, identified intact sandstone bedrock at 0.2m depth.

**Photograph 5:** Base of TP9 positioned at the top of the retaining wall in photograph 1.

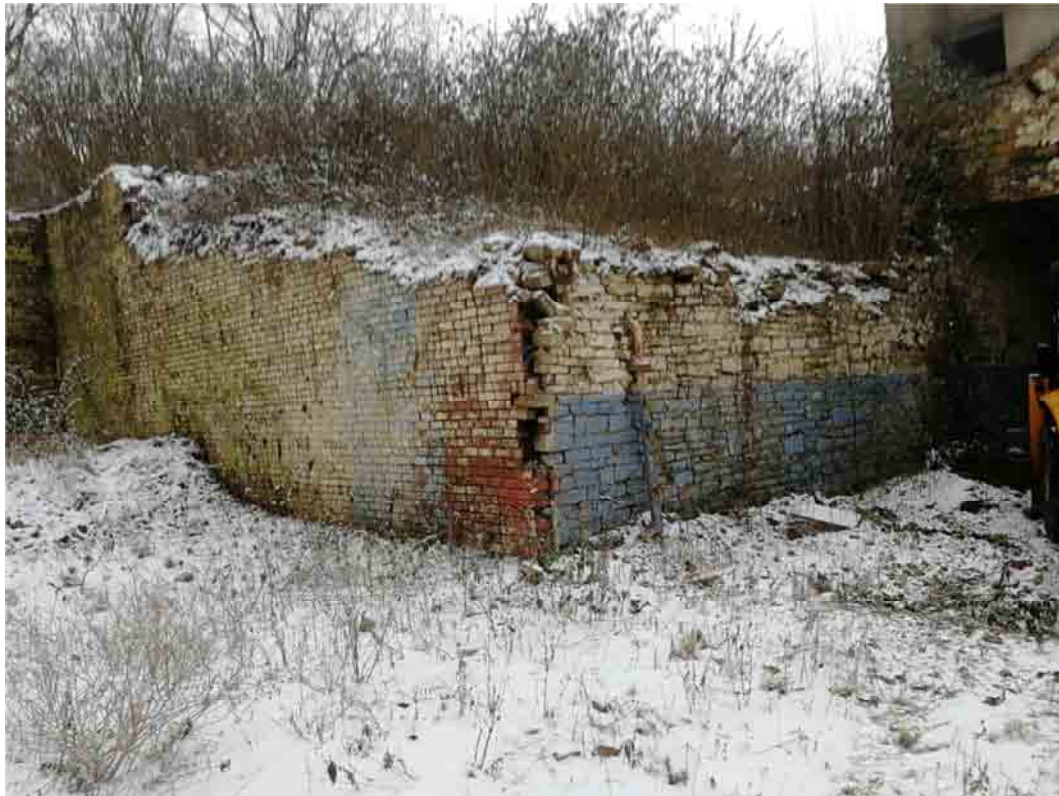
- 3.7 The northwestern face of the brick retaining wall near the middle of the site is visibly damaged, with the wall bowing outwards.

7.6 The northwestern face of the brick retaining wall, near the location of TP7 is visibly damaged, with the wall bowing outwards.

**Photograph 6:** Damage to the brick retaining wall. Photograph taken facing south.

- Foundations to the proposed retaining wall between TP8 and TP10 are likely to require reinforcement due to the presence of a geological fault.
- The brick retaining wall requires structural assessment before removal, for safety reasons.

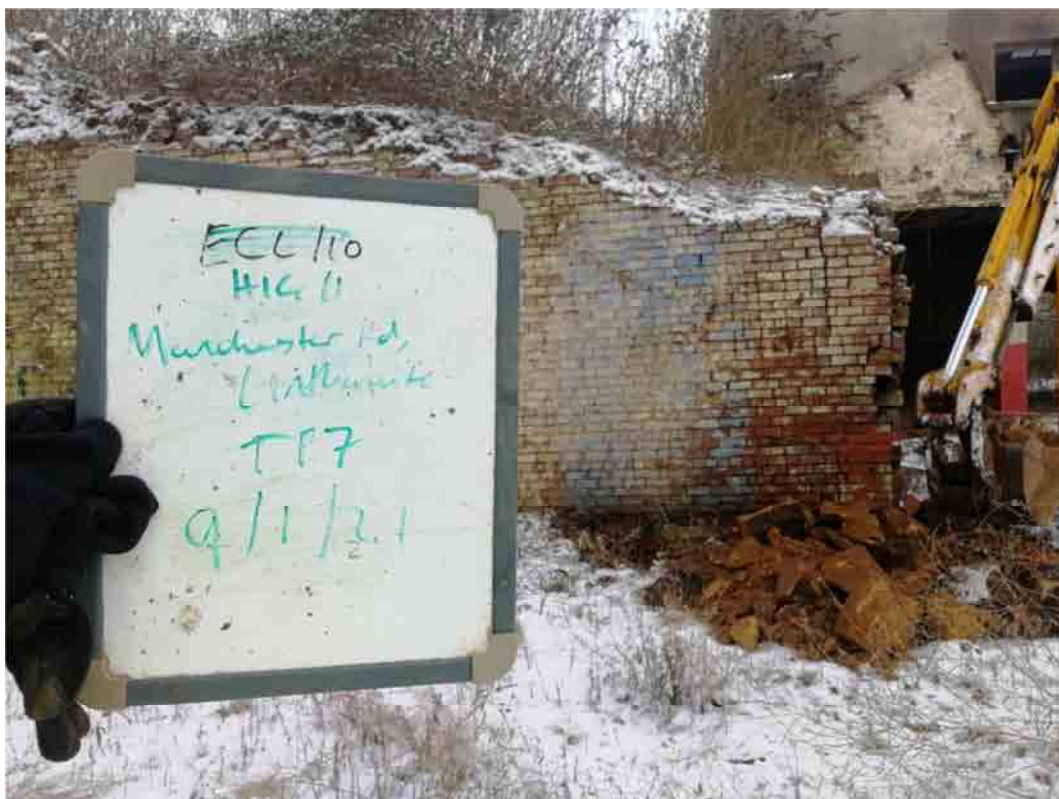
**Photograph 7:** Location of TP7 undertaken to expose foundations of brick retaining wall in photograph 6.

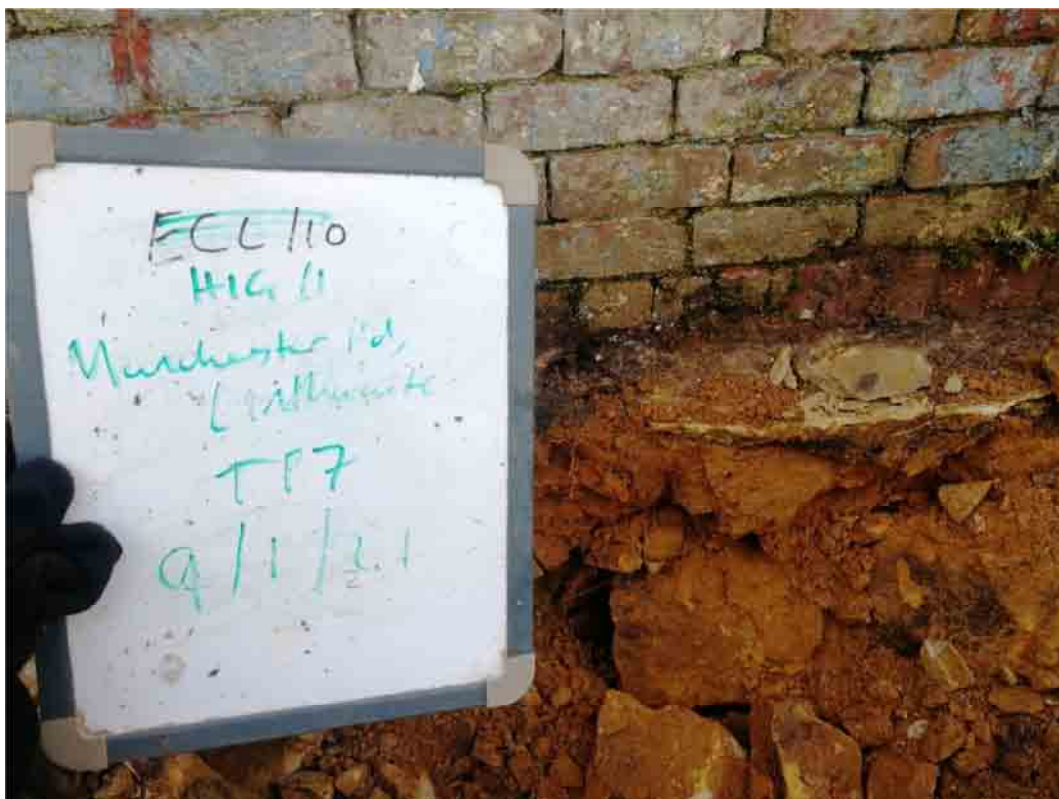
**Photograph 9:** Close-up of exposed foundations in TP7

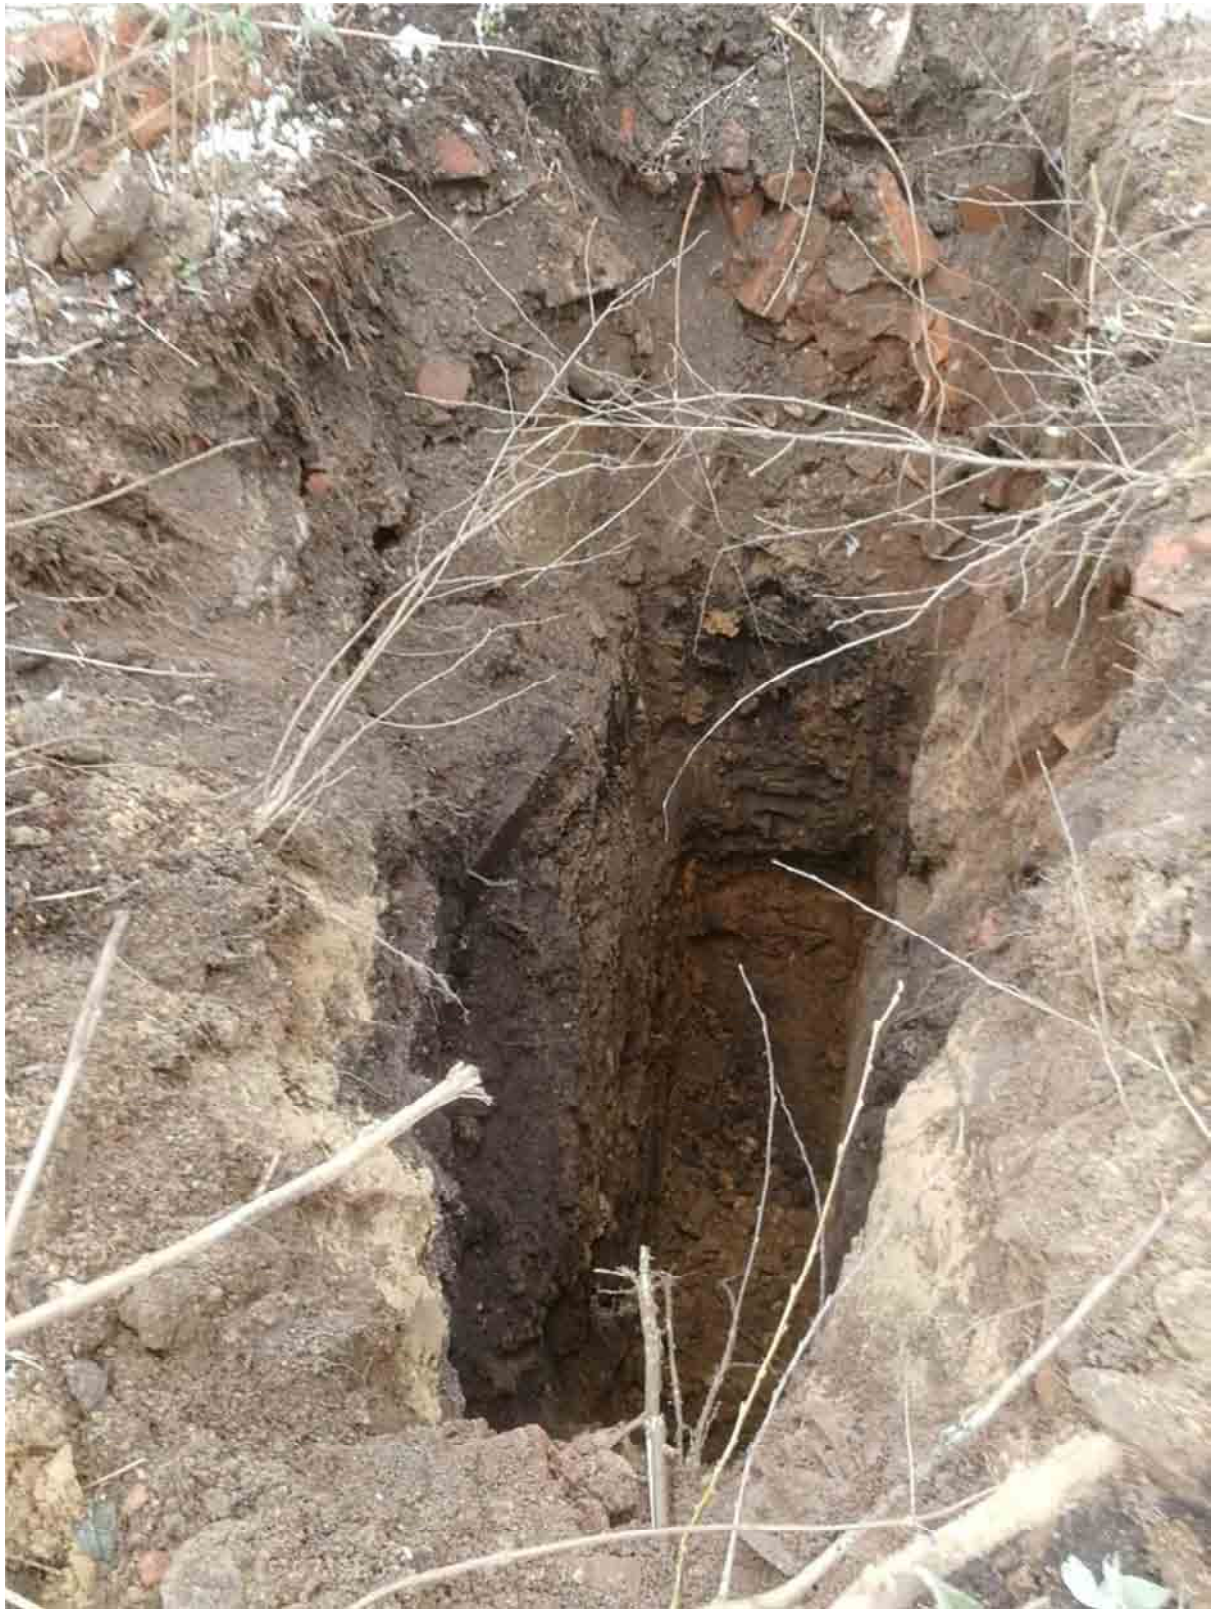
observed during excavations within the made ground in TP3, TP4 and TP8. No noticeable groundwater was identified during the site investigation. However, the soils within TP8 were described as being moist between 2.5m (134.4mAOD) and 3.8m (133.1mAOD) depth.

**Photograph 11:** Base of trial pit TP8.

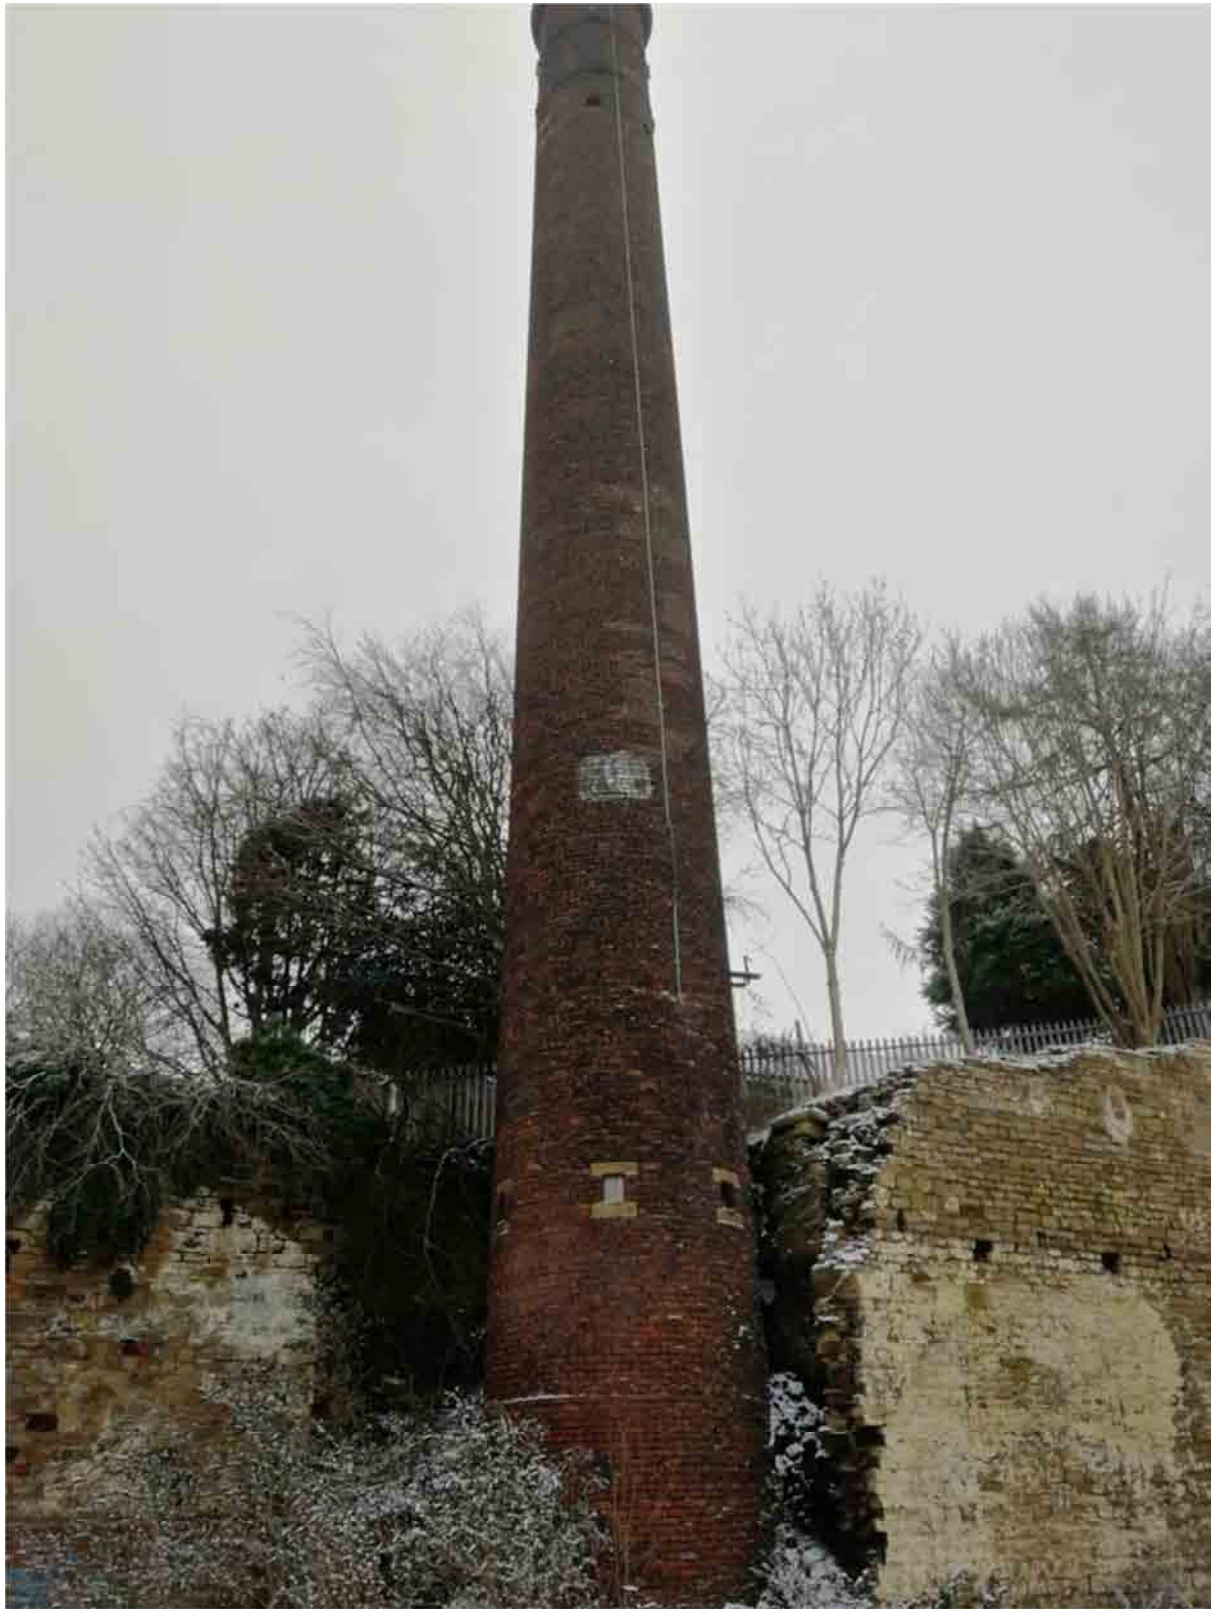
**Photograph 13:** Chimney at northern end of Area A.

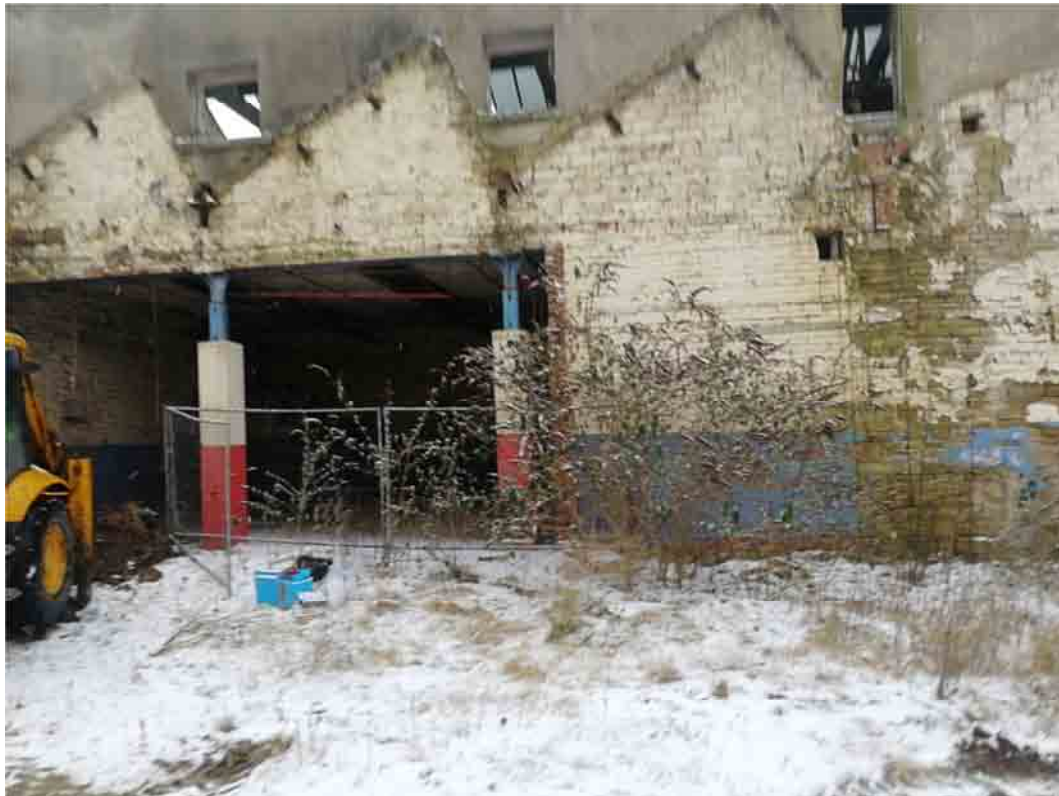
**Photograph 14:** Large dilapidated building in Area A.

- The larger existing building to be demolished forms part of the existing retaining wall. Therefore, temporary retention will be required during the demolition of this building and the retaining wall that is to be replaced (brown dash on the proposed layout plan).

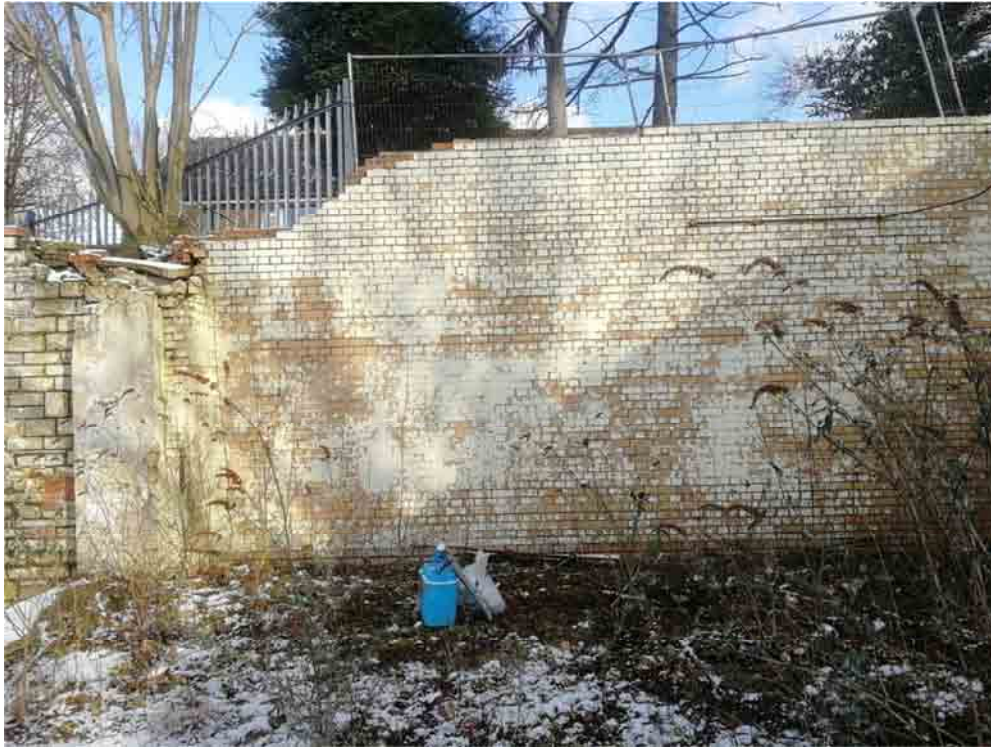
**Photograph 18:** Retaining wall at northern boundary of Area B (above sandstone retaining wall in photograph 1).

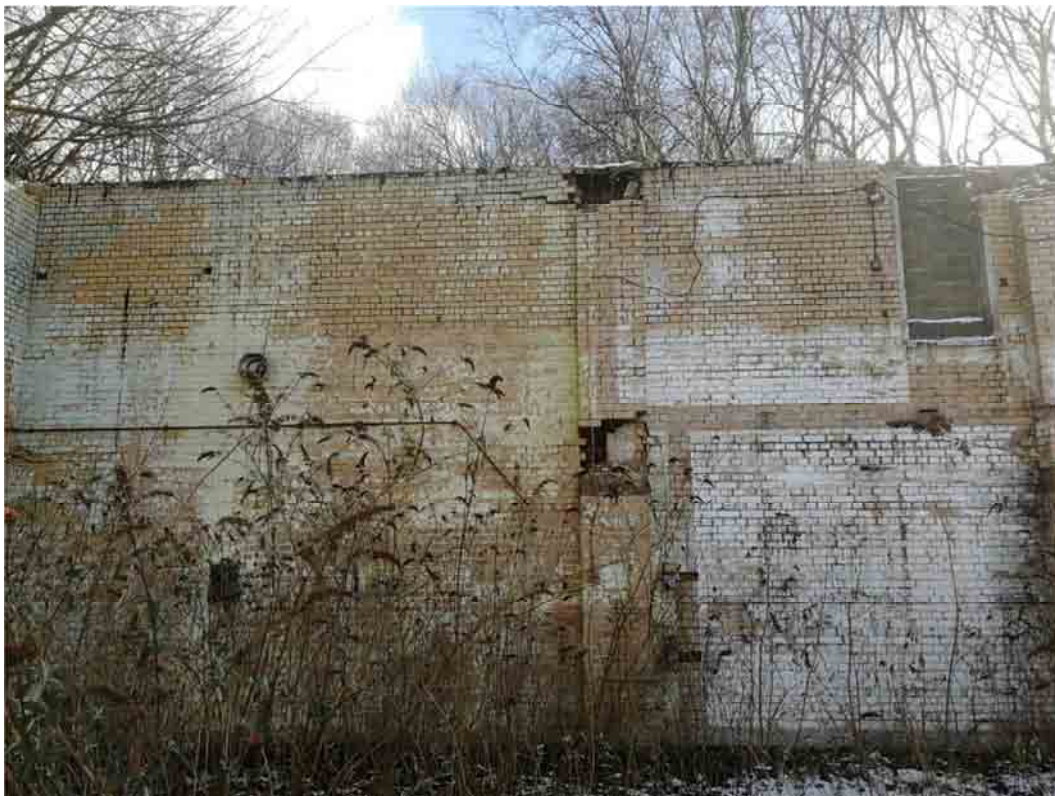
**Photograph 19:** Retaining wall along eastern boundary of Area B.
