**STRUCTURAL INSPECTION REPORT
ON
MILL BUILDING 1, MANCHESTER ROAD, LINTHWAITE, HD7 5QS**

**ON BEHALF OF
REDWATER DEVELOPMENTS LTD & HIGHSTONE HOUSING ASSOCIATION LTD**

AUGUST 2021

Structural Inspection Report on Mill Building 1, Manchester Road, Linthwaite

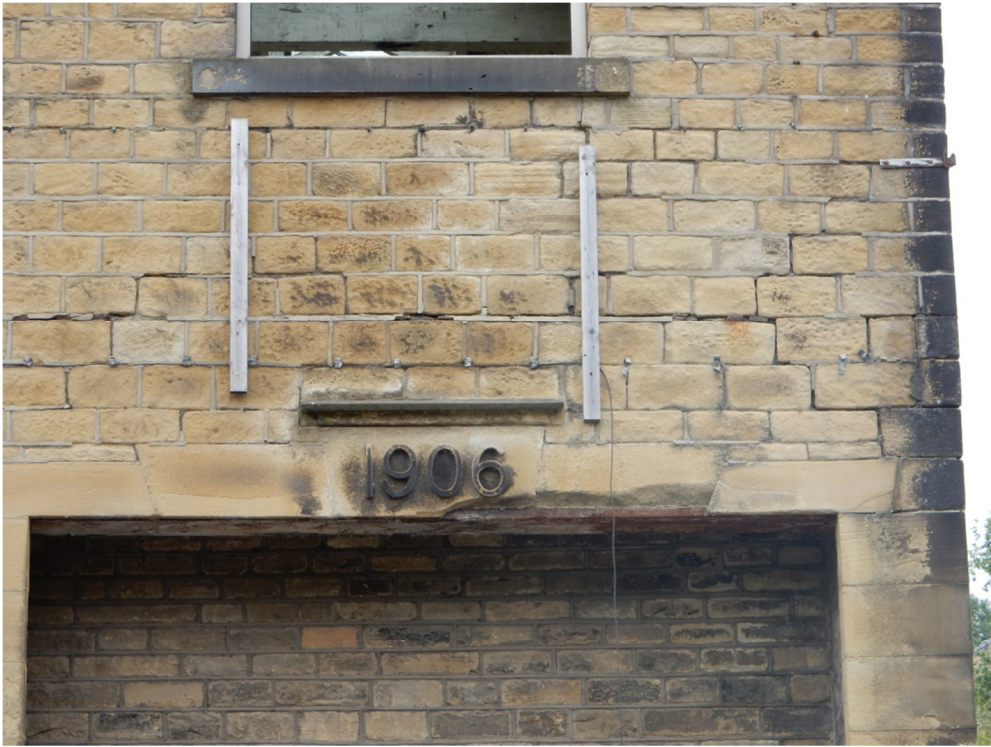
- 3.2 The west elevation gable wall presented a number of masonry crack locations. There were masonry cracks above the right hand side, ground floor opening, together with further masonry cracks above the first floor windows. There were further masonry cracks to the left hand side at high level up to the roof line.

Photograph 1 – West elevation, masonry cracks

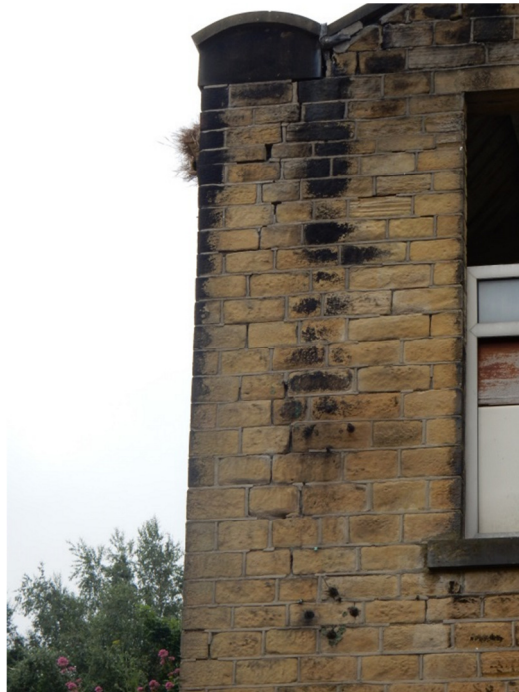
Photograph 2 – West elevation, masonry cracks

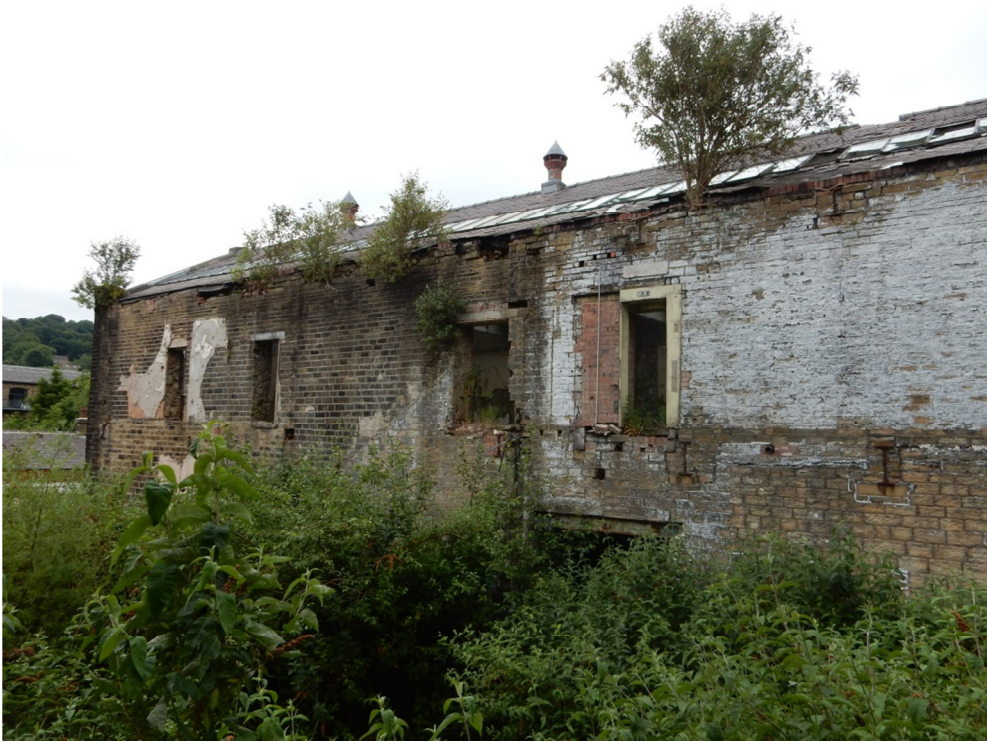
- 3.3 The south elevation presented a number of structural defects. There were masonry cracks evident to the left hand side, running from below first floor level to eaves. There were further masonry cracks on the elevation noted around the retained steel beams (which had been cut back to the wall face) and above the first floor openings. There were also areas of removed/missing masonry particularly apparent at eaves level and around the first floor openings.

Photograph 3 – South elevation

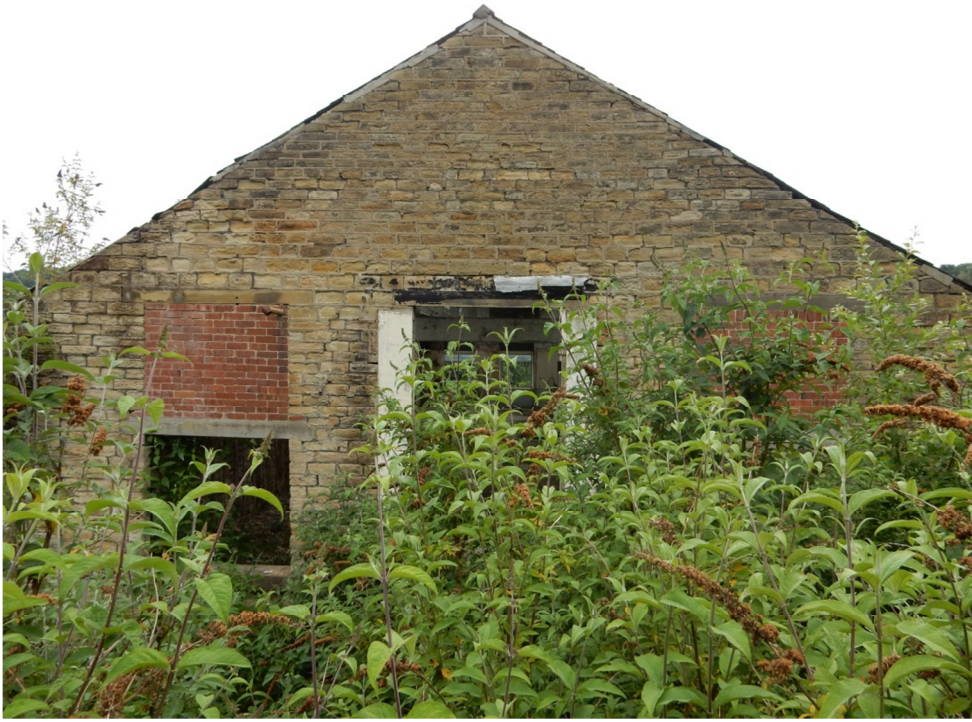
- 3.5 Access to the east elevation was limited due to extensive vegetation growth in this location. There were areas of weathered masonry apparent above the first floor windows together with signs of minor masonry cracks.

Photograph 5 – East elevation

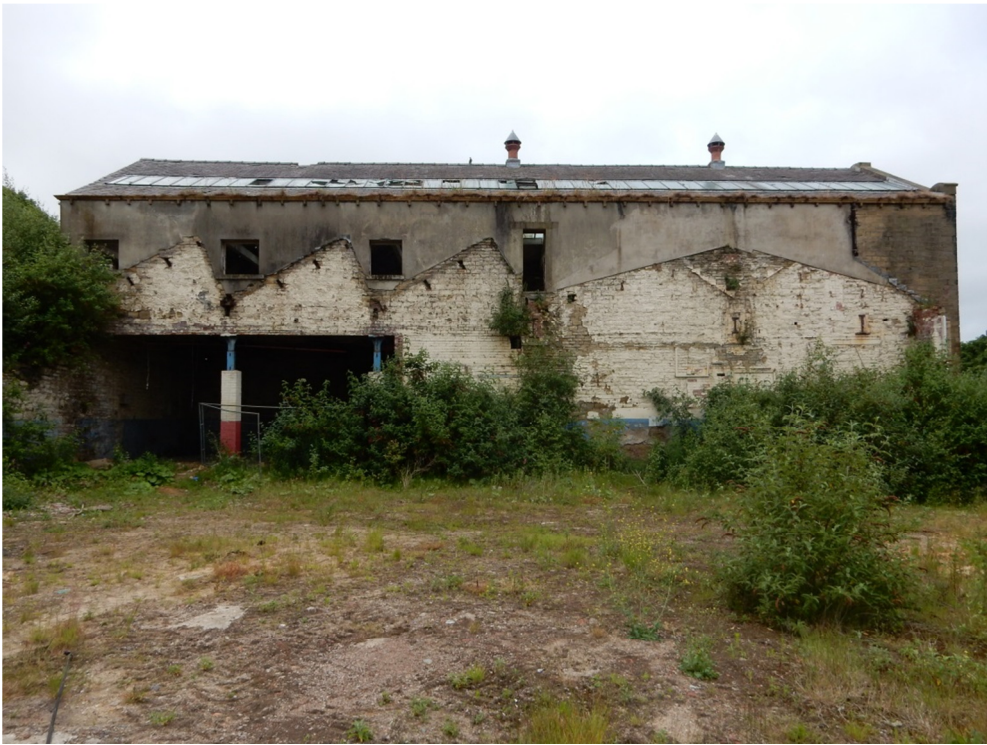
- 3.7 The north elevation was of stone masonry construction with a rendered finish outlining the historic roof lines of the structures that have previously been removed. There were several cracks noted in

the render above the first floor window lintels up to eaves level. The condition of the masonry behind the render was obscured.

Photograph 6 – North elevation

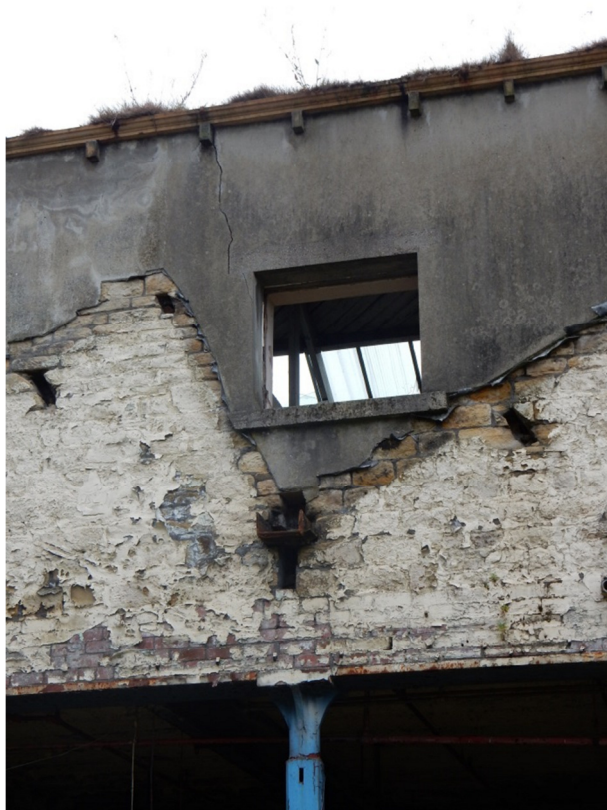
Photograph 7 -North elevation, render cracks

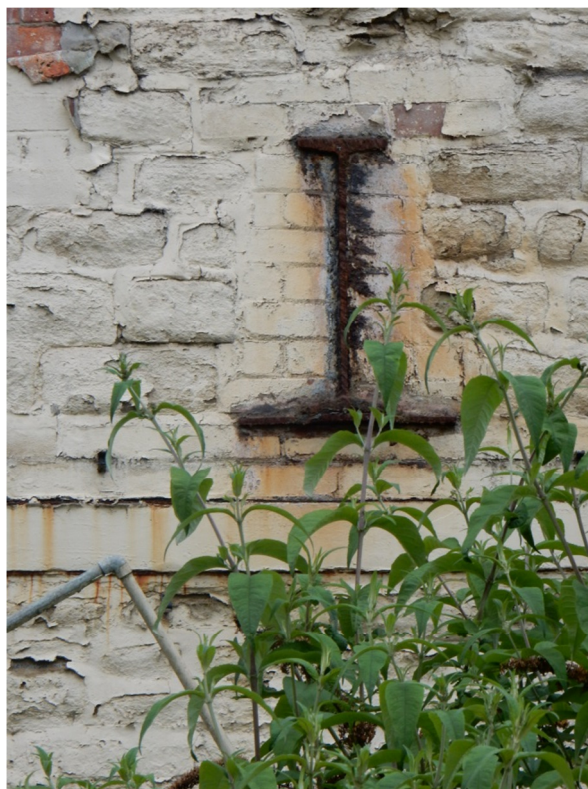
- 3.8 There were pockets of masonry missing on the north elevation assumed to relate to historic roof beams/structures that have been removed. The elevation also had steel beams which had been cut back to the wall face and remained built into the wall.
- 3.9 The north elevation had a large opening at ground floor which was formed by two supporting steel posts. These were encased in brick masonry piers up to approximately 3m above ground level. One of the piers had been damaged at low level exposing the steel post in this location. The beam over this opening was supported on one end by the east elevation wall forming the retaining wall. The condition of the wall adjacent to this location appeared poor.

Photograph 8 -North elevation, built in steel beam

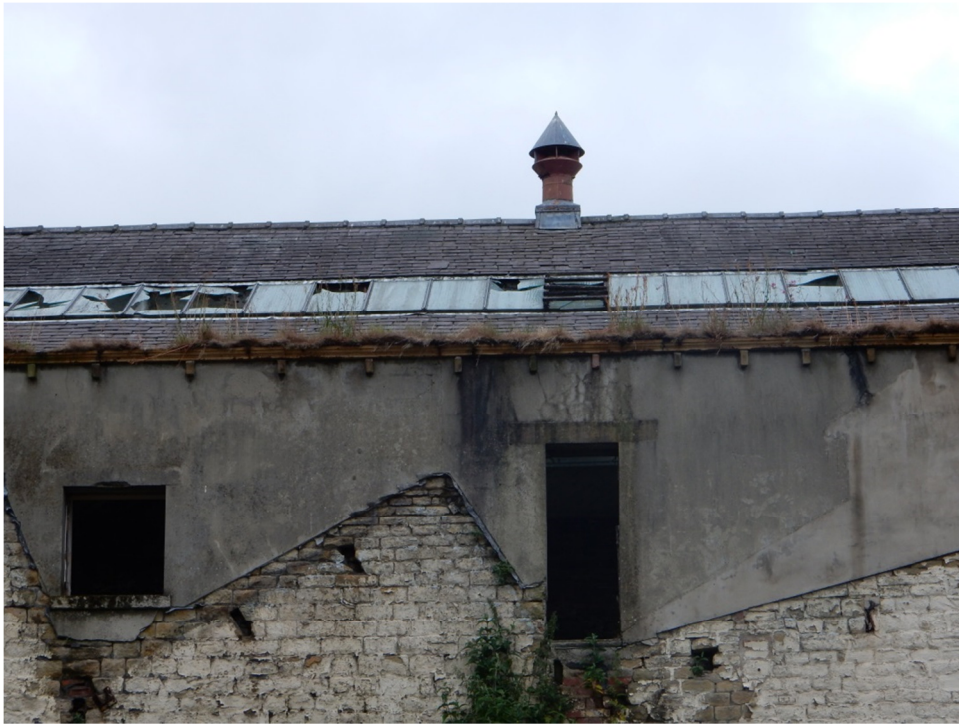
- 3.6 The north elevation roof showed some signs of neglect with missing ridge tiles, small areas of displaced roof slates and areas of damage to the glazed rooflights. There was also low level vegetation growth on the roof at the eaves level.

Photograph 9 -North elevation, roof

- 6.1 The building shows significant signs of neglect and is considered to be in a poor structural condition; The roof requires repairs to make good areas of missing tiles and glazing. The existing timber roof trusses appear to have suffered from water damage and wet rot. The concrete floor secondary steelwork is badly corroded. The external masonry walls would require a significant amount of repair/rebuild. All the doors and windows are missing so the building is fully exposed to the weather which leads to the rapid deterioration of the structure.

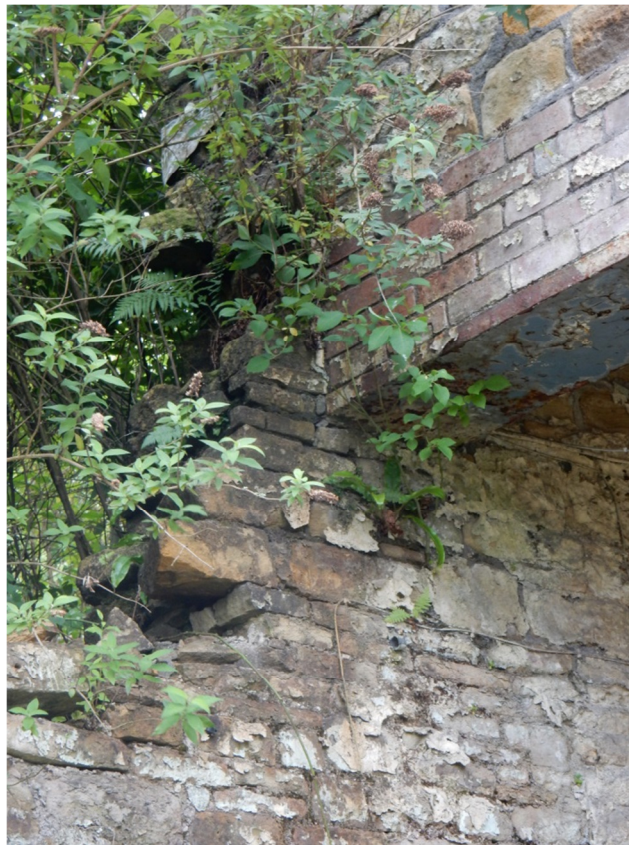
Photograph 10 -North elevation, beam bearing

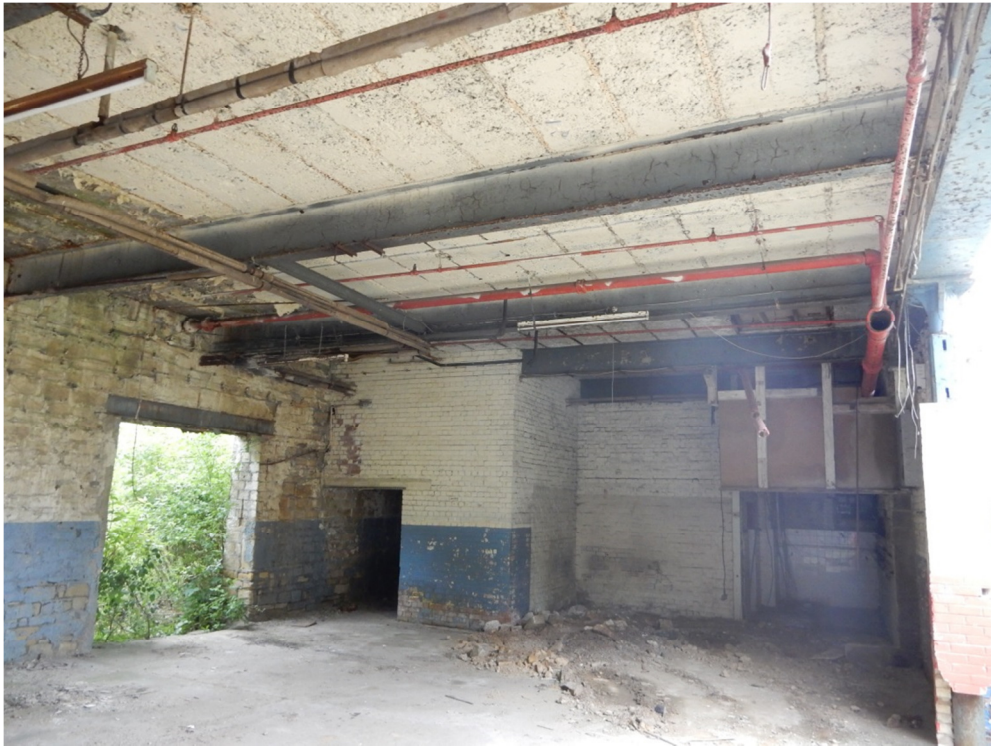
- 4.2 The internal condition of the masonry walls at ground floor appeared to be generally poor.
- 4.3 The ground floor construction was assumed to be a concrete/screed laid on hardcore. This floor appeared to be in reasonable condition with no obvious cracking/movement.

Photograph 11 -Ground floor

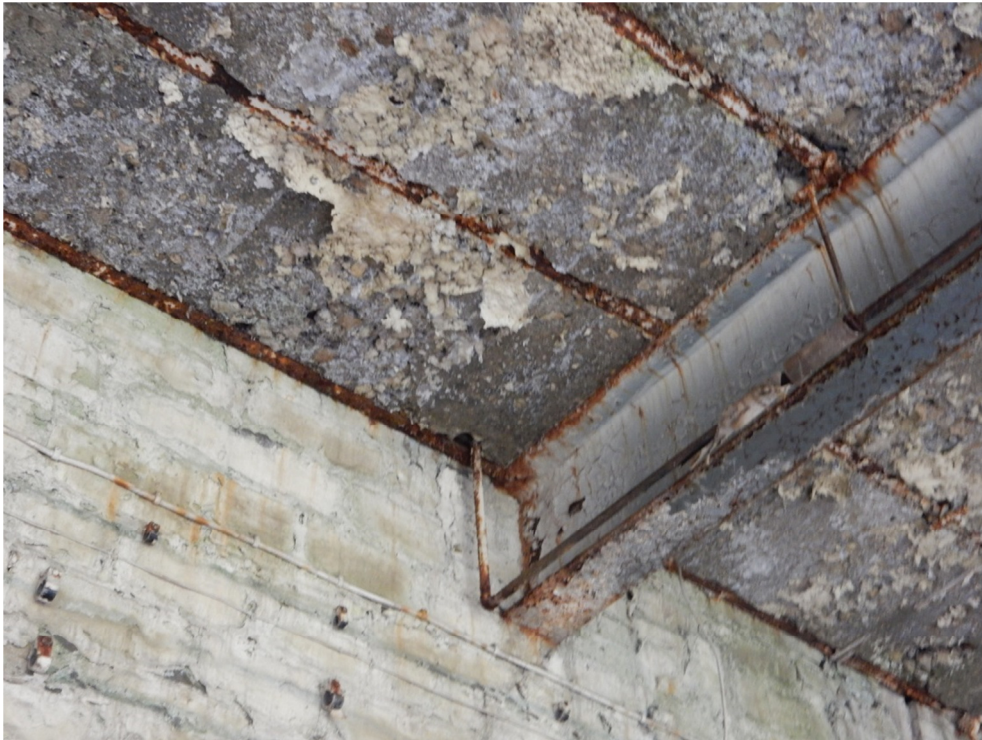
- 4.4 The first floor construction consists of a concrete floor spanning onto secondary steel beams, which are supported by primary steel beams spanning from north to south across the building. There are some localised areas of spalling to the underside of the concrete and the secondary steel beams appear to be badly corroded. Several of the primary steel beams are also showing signs of corrosion.

Photograph 12 -Underside of first floor

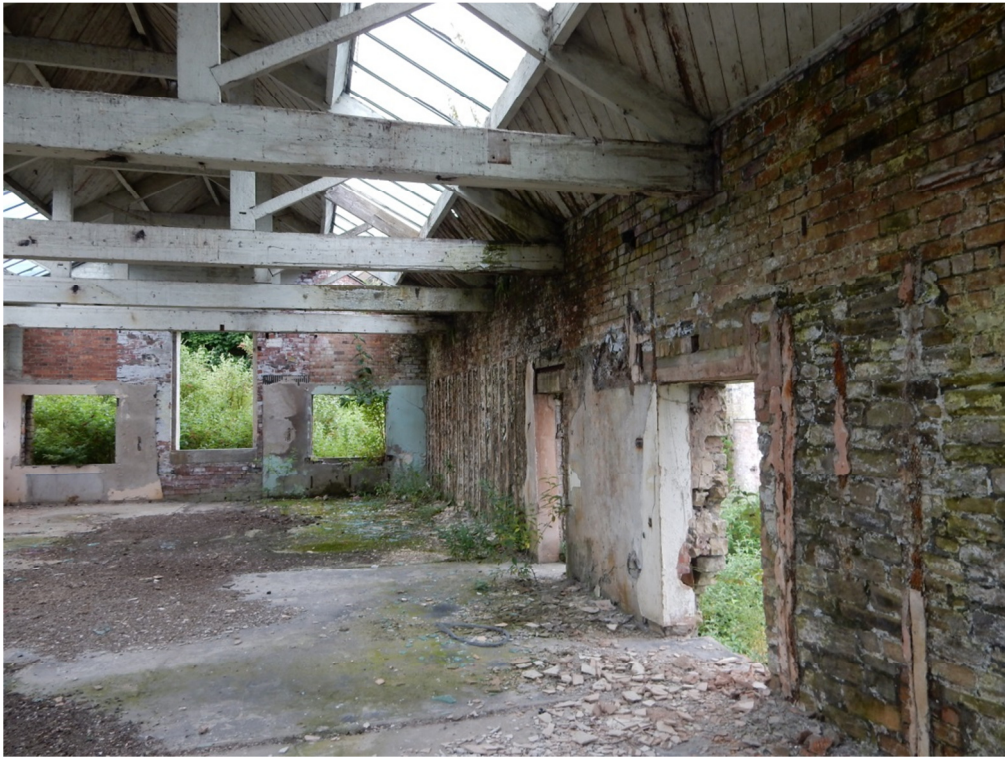
- 4.5 The internal condition of the masonry walls at first floor was poor. There were numerous masonry cracks evident, many of which corresponded to the location of the bearing of the timber trusses, and were observed above the window openings up to the underside of the truss bearings or to the eaves. There were also sections of masonry at high level which showed a degree of movement around the trusses, indicated by a bow in the wall in these locations.

Photograph 13 –First floor

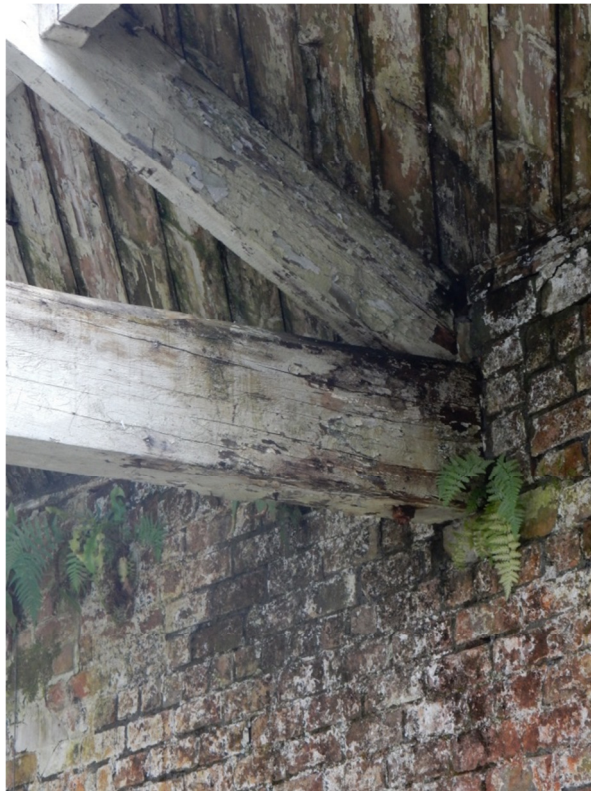
- 4.6 A number of the timber roof trusses were showing signs of water damage and suspected wet rot also. This is likely due to the water ingress from the disrepair of the roof above these locations.

Photograph 14 – Roof truss bearing

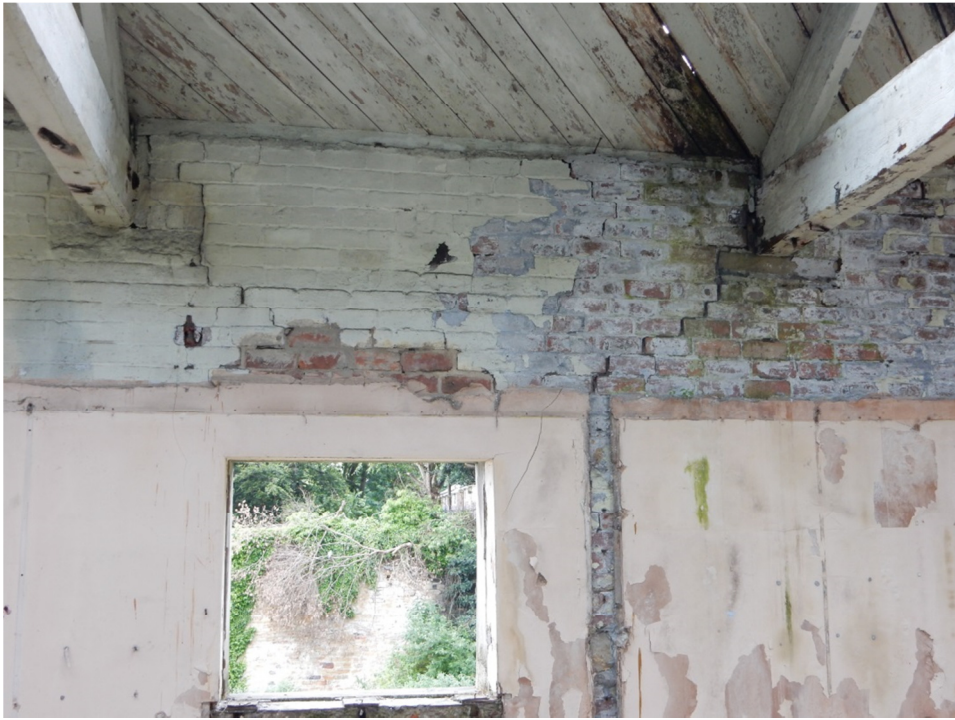
Photograph 15 – First floor masonry cracks

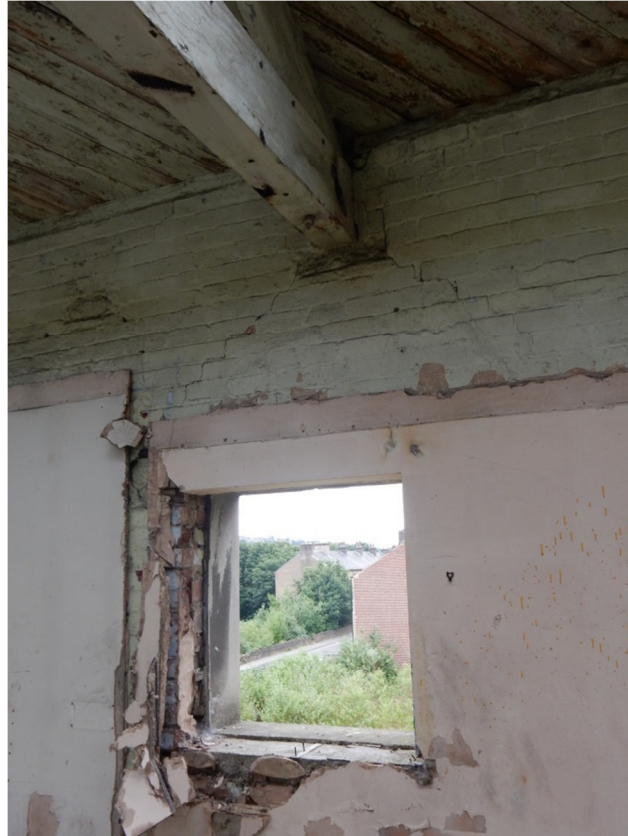
Photograph 16 – First floor masonry cracks

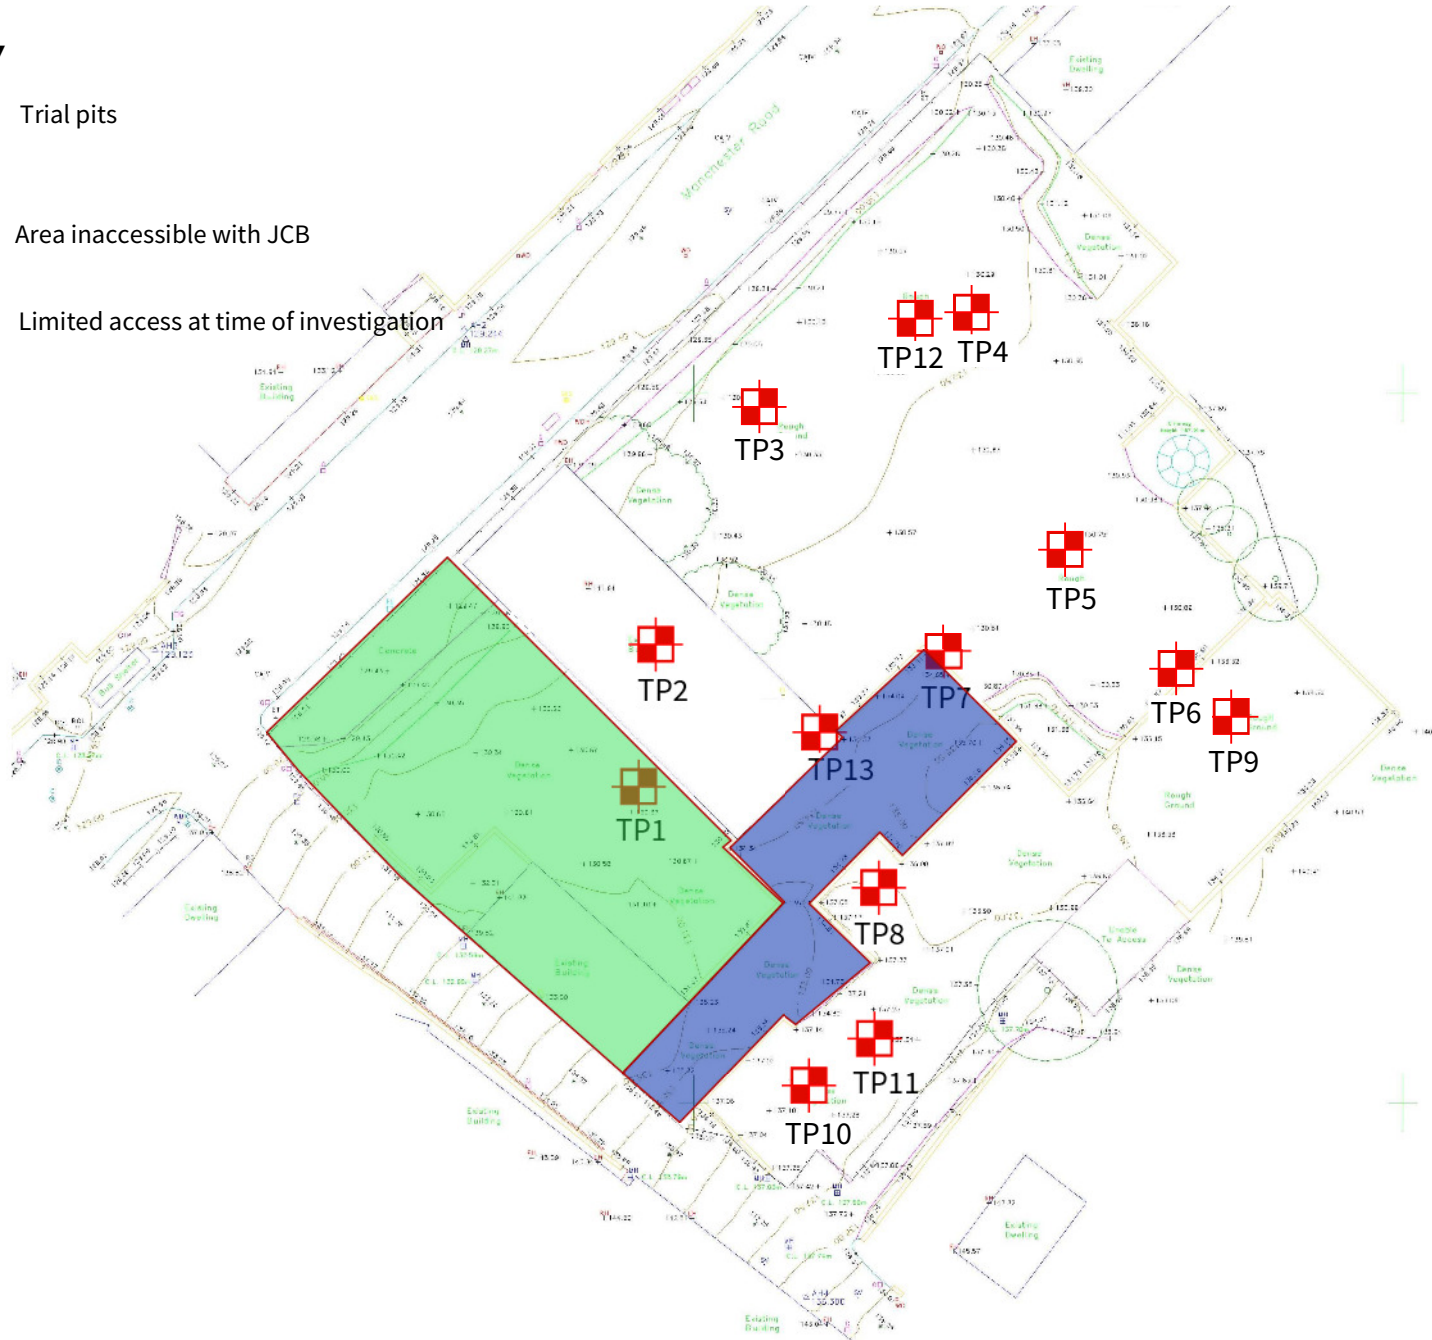
Title
SITE INVESTIGATION PLAN

- 5.2 Part of this investigation included a trial pit inside Mill Building 1 (referred to as TP2 in the site investigation, and the Site Investigation Plan is included in Appendix B for reference). Visual and olfactory signs of contamination were identified in this trial pit, namely a tarry residue with a slight odour, which was detected directly beneath the floor slab.
