**Former Hoyle Ing Dyeworks,
Linthwaite
Nocturnal Bat Survey Report
Highstone Building Services**

Report Title: **Former Hoyle Ing Dyeworks, Linthwaite
Nocturnal Bat Survey Report**

Version: **V1.0**
Issue Date: **October 2021**
Report Ref: **17499**

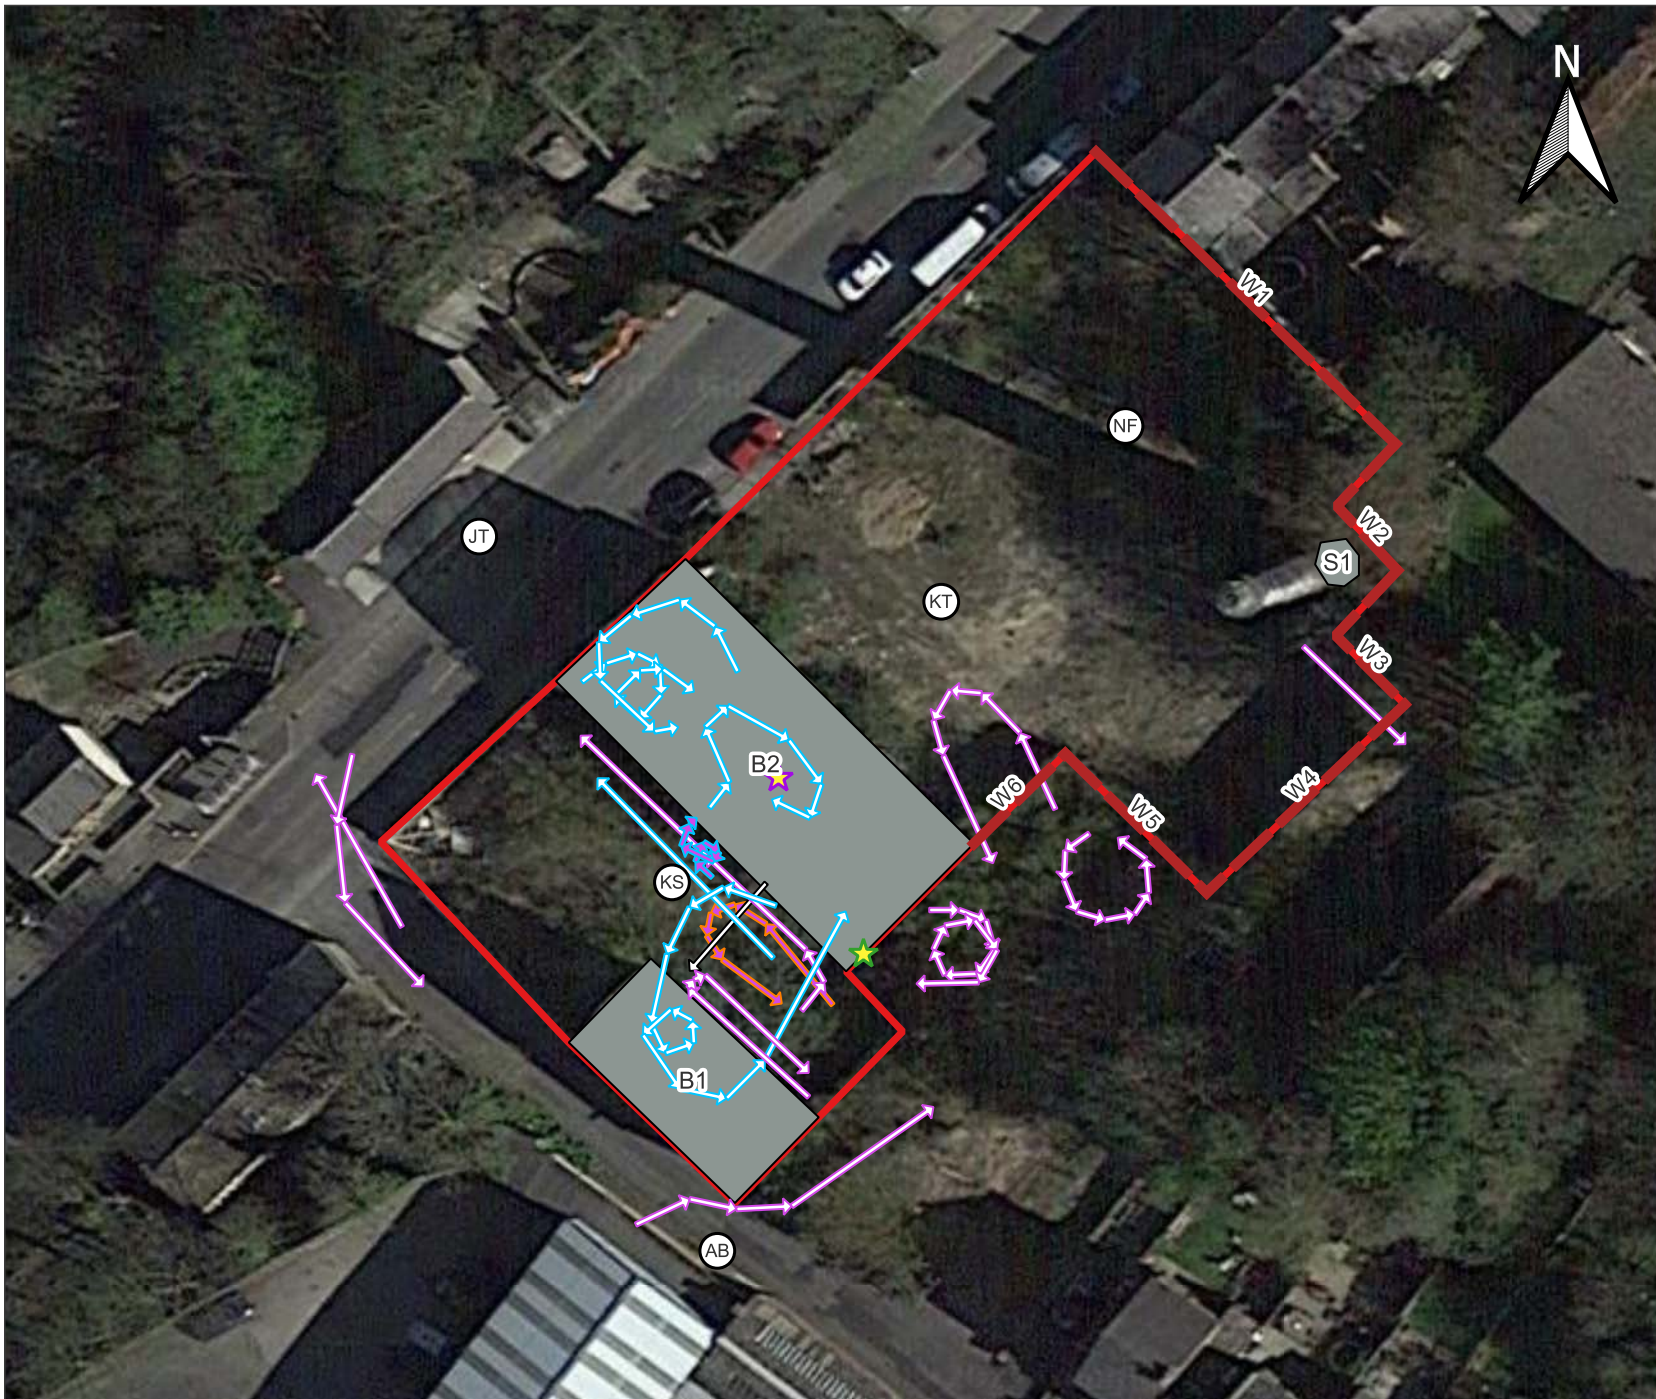
Figure 1a
Bat Survey Findings - Dawn 11.08.2021

- 3.1.5 B2 was subject to a total of three nocturnal surveys. During the dawn re-entry survey on 11th August 2021, a brown long-eared bat was recorded flying around the ground floor of B2 before it was seen flying around the upper floor at 05:10. This bat was not seen to emerge from B2 and so it was considered likely that it was roosting on the upper floor of B2 although the precise roost location could not be confirmed at the time of survey. A common pipistrelle was observed to enter a gap at the roofline on the southern gable of B2 at 05:22. At the end of the survey the upper floor was inspected and scattered brown long-eared bat droppings were recorded, indicative of bats in flight.

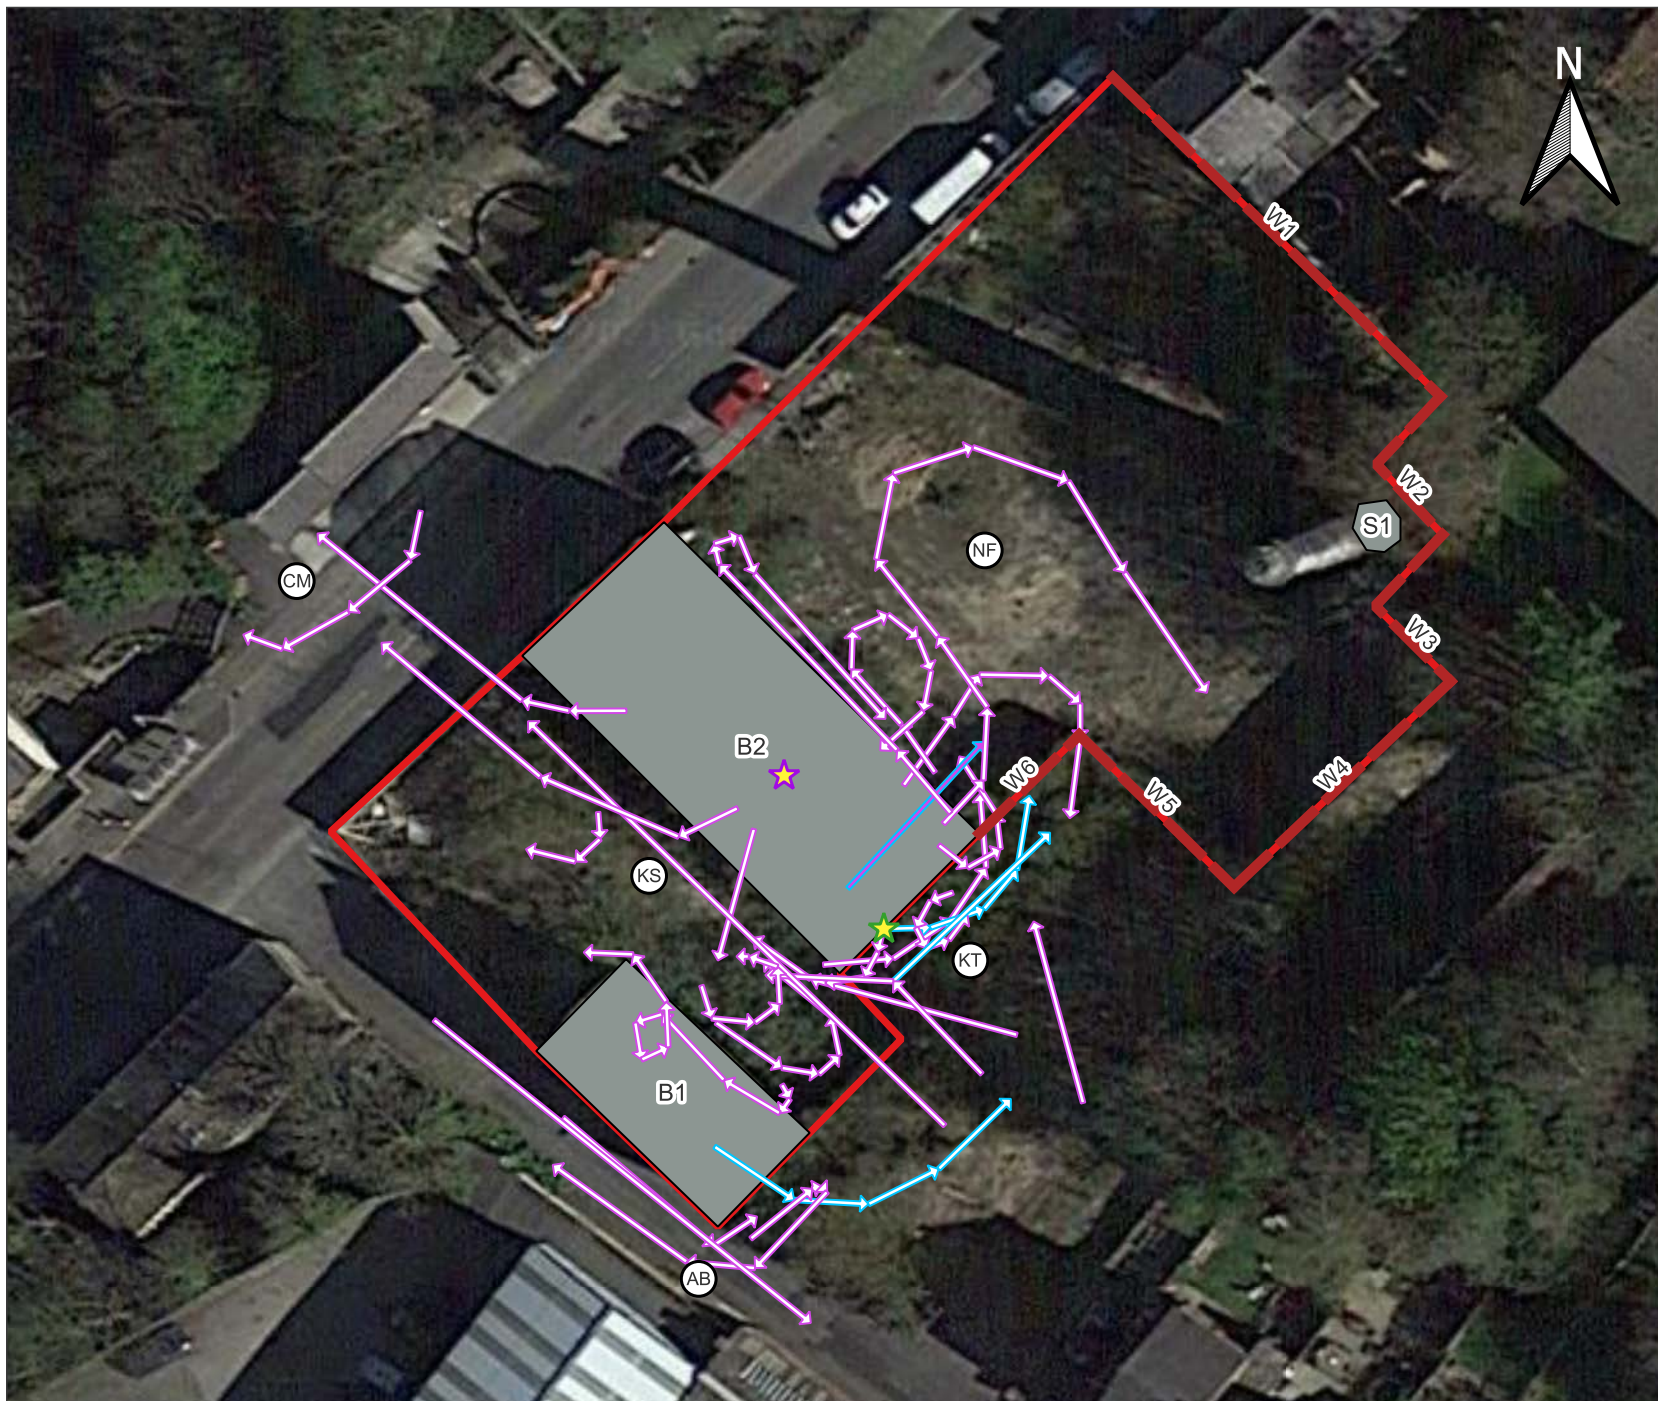
Figure 1b
Bat Survey Findings - Dusk 25.08.2021

- 3.1.6 During the dusk emergence survey on 25th August 2021, a common pipistrelle bat was seen to emerge from the southern gable of B2, from a raised tile at 20:46; this was considered to be the same location as that at which the common pipistrelle was seen to enter during the dawn re-entry survey. Two common pipistrelles were seen to emerge from the ground floor area of B2 at 20:40 through the large opening on the eastern aspect; these were considered to have taken a direct route from the south-western corner of the ground floor although an exact roosting location could not be confirmed. Surveyors observed a number of bats emerging from the upper floor windows however these were considered to have flown into B2 through another window and were not considered to be roosting in the building.

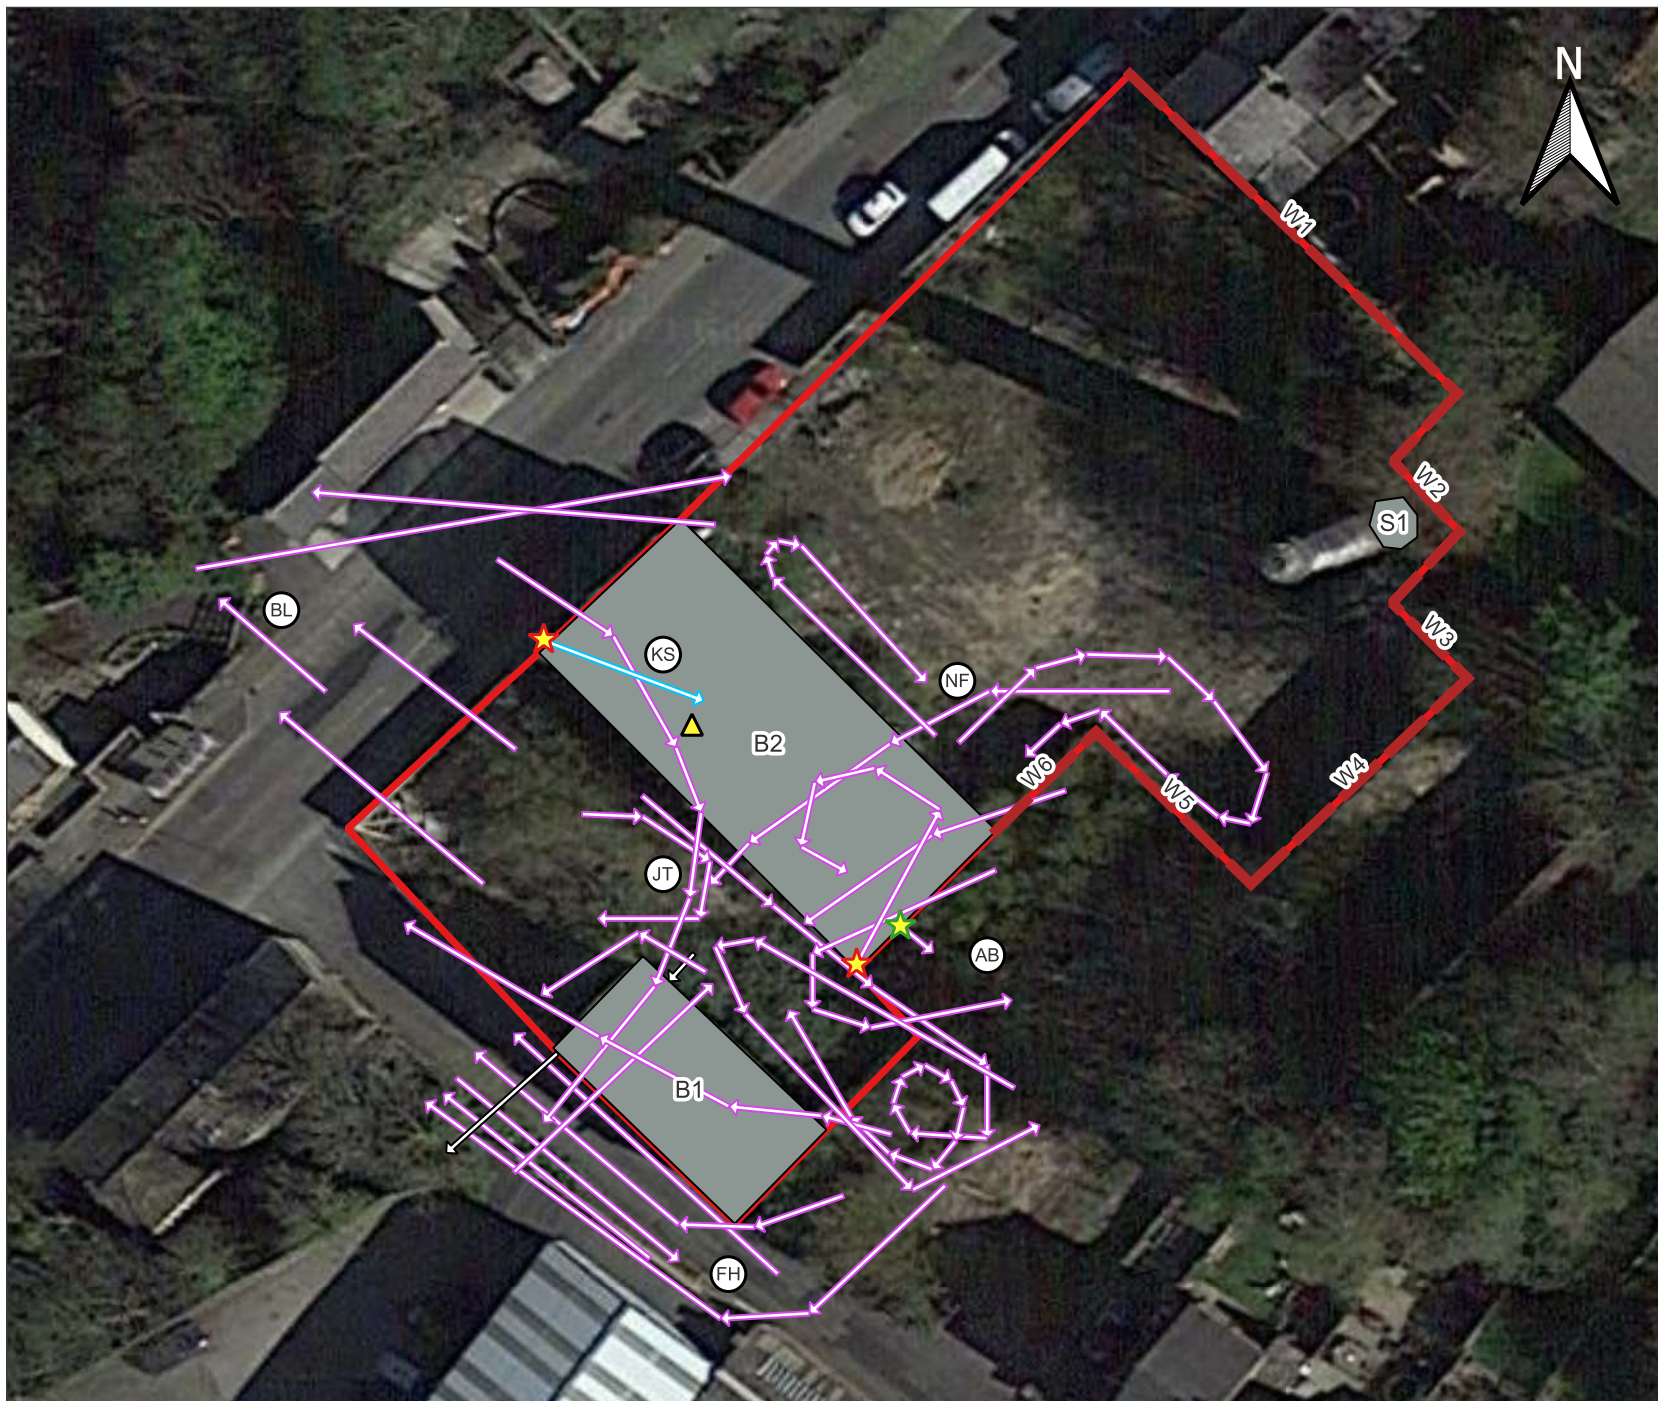
Figure 1c
Bat Survey Findings - Dusk 16.09.2021

- 3.1.7 During the dusk emergence survey undertaken on 16th September 2021, two surveyors were stationed inside B2; one each on the ground floor and upper floor. A single common pipistrelle was recorded to emerge from a gap in the stonework in the south-western corner of the ground floor of B2 at 19:38. It then proceeded to forage around the ground floor before exiting through the opening on the western aspect and continuing to forage within the Site. A common pipistrelle was observed to emerge from beneath the raised tile on the southern gable of B2 at 19:45, in the same location as that recorded during the dawn re-entry and first dusk emergence survey. At 19:48 a brown long-eared bat was observed to emerge from a gap in the stonework in the north-western corner of the upper floor. This bat was seen to drop from above the window before flying down the stairs to the

ground floor area. This bat was not seen by the surveyors on the ground floor and outside B2, and so was considered to have exited the building through a doorway or window.

- 3.1.8 During the second dusk emergence survey, butterfly wings were recorded on the ground floor of B2 in the same location as the brown long-eared bat was seen flying on the dawn re-entry survey. These were considered to be feeding remains and were positioned under metal pipework and an exposed girder which were suitable feeding perches for the species.
- 3.1.9 General foraging activity recorded during the nocturnal surveys was spread across all elevations of B2, with the highest level of activity associated with the area of scrub to the west, and to south and east of B2. Echolocation calls recorded were attributed to common pipistrelle, pipistrelle sp. and brown long-eared bat.

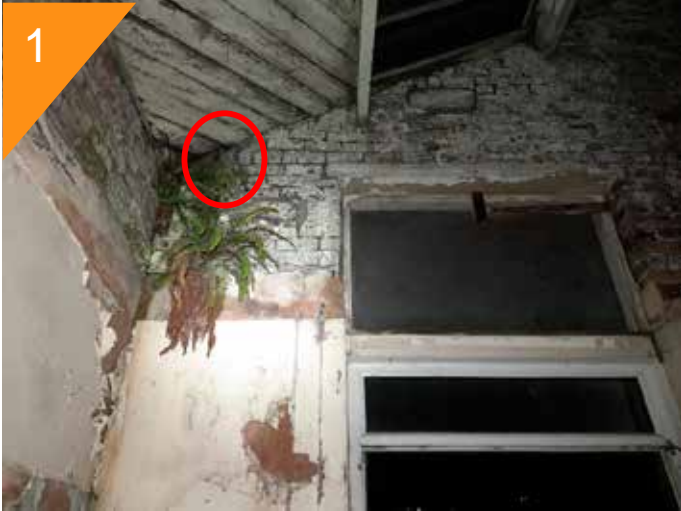
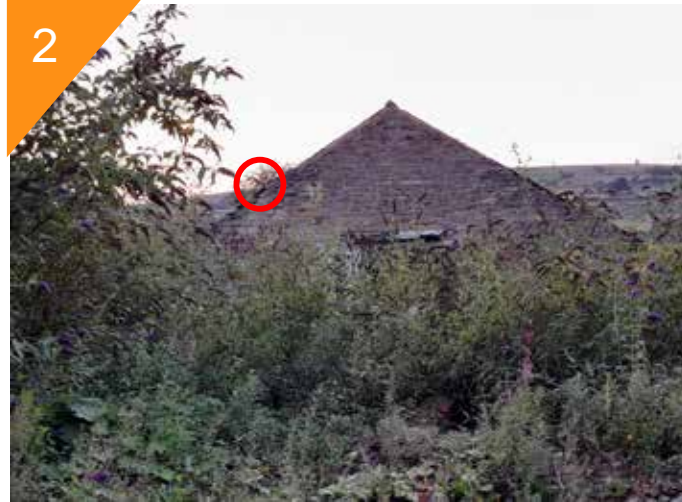
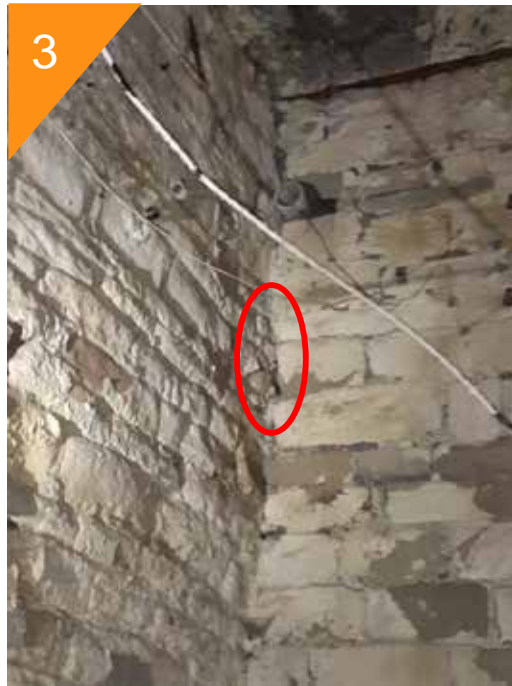
- 4.3.2 Common pipistrelle was recorded to be roosting in two locations in B2, both at the southern extent of this building. A single brown long-eared bat was recorded to be roosting in the stonework at the northern extent of this building. Of the roosts identified, none were observed to support greater than single bats on any given nocturnal survey visit. As such, the roosts recorded on the Site are considered to comprise day roosts used by individual or low numbers of bats. No evidence of any maternity colonies was identified within B2. The ground floor of B2 is also used by brown long-eared bat as a feeding location with feeding perch/es recorded within the darker area in the northern half of the building.

- Plate 1 View of brown long eared bat roost in gap in stonework at north-western extent of the upper floor of B2.
- Plate 2 View of common pipistrelle roost beneath raised tile on southern gable of B2.
- Plate 3 View of common pipistrelle roost location in gap in stonework at the south-western extent of the ground floor of B2.

- 4.3.5 Due to the confirmed presence of roosting bats within B2, demolition will need to proceed under a European Protected Species Mitigation Licence (EPS ML) or through registration on the Bat Mitigation Class Licence (BMCL) of a Registered Consultant, as appropriate. Any bat licence application can only be completed following receipt of the necessary consents (i.e. planning permission) with all conditions relating to wildlife discharged. The BMCL route is suitable for buildings which support a small number of common bat species roosts and has a faster turnaround by Natural England than a full EPSML application: the appropriate licensing route can only be determined when full details of bat roosting activity associated with the buildings have been characterised although current data indicated that BMCL is likely to be appropriate.

- 4.3.6 An EPSML or BMCL would include the production of a bat mitigation strategy for the Site, detailing measures to avoid death or injury to bats during the demolition works. Appropriate working methods will need to be employed under the licence during Site clearance and will likely need to include the following outline measures:

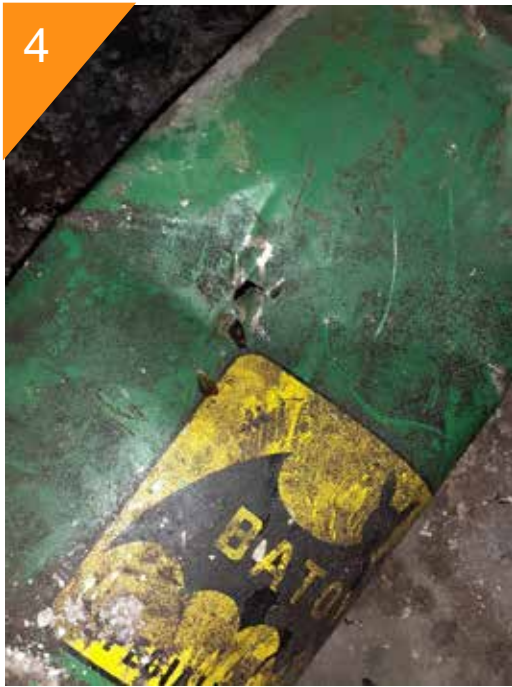
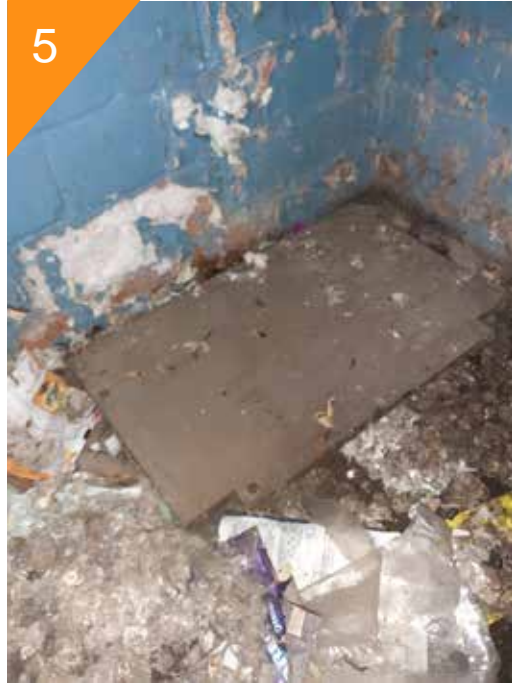
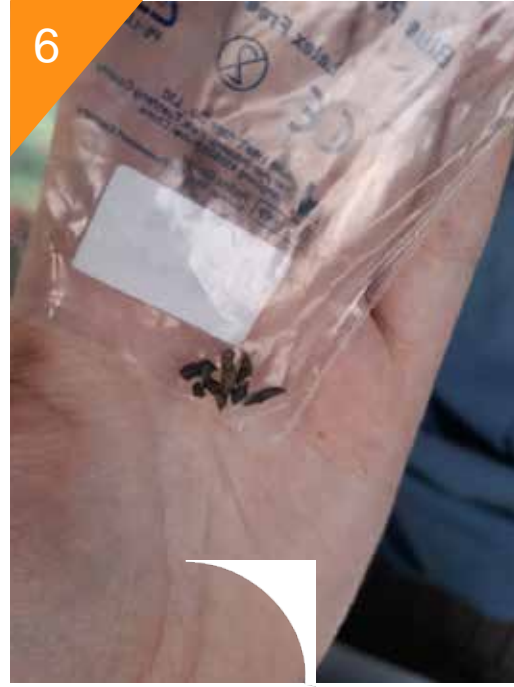
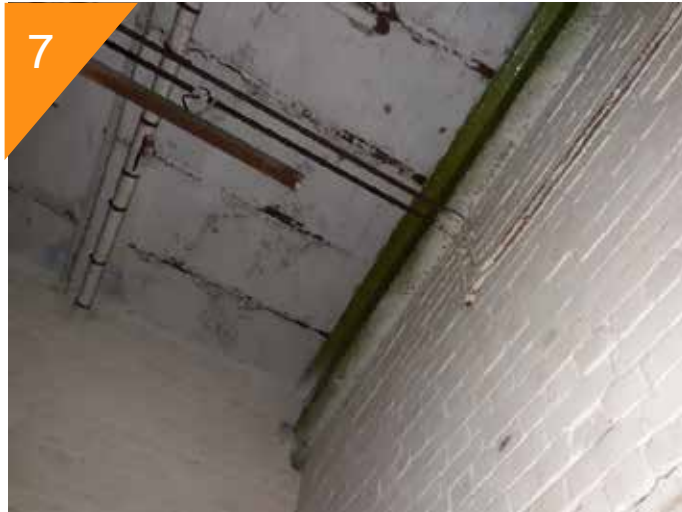
- Plate 4 View of brown long-eared bat feeding remains on ground floor of B2.
- Plate 5 View of brown long-eared bat feeding remains on ground floor of B2.
- Plate 6 View of brown long-eared bat droppings collected from upper floor of B2. These were not sent for DNA analysis as Ecus surveyors were confident of the ID.
- Plate 7 View of piping and girders above feeding remains, which are considered to be brown long-eared bat feeding perches.
