**Bat, and Breeding Bird Scoping Survey**  
**Rose and Crown Inn, Golcar**

February 2023

Rose and Crown Inn,  
132 Knowl Road,  
Golcar,  
Huddersfield,  
HD7 4AN

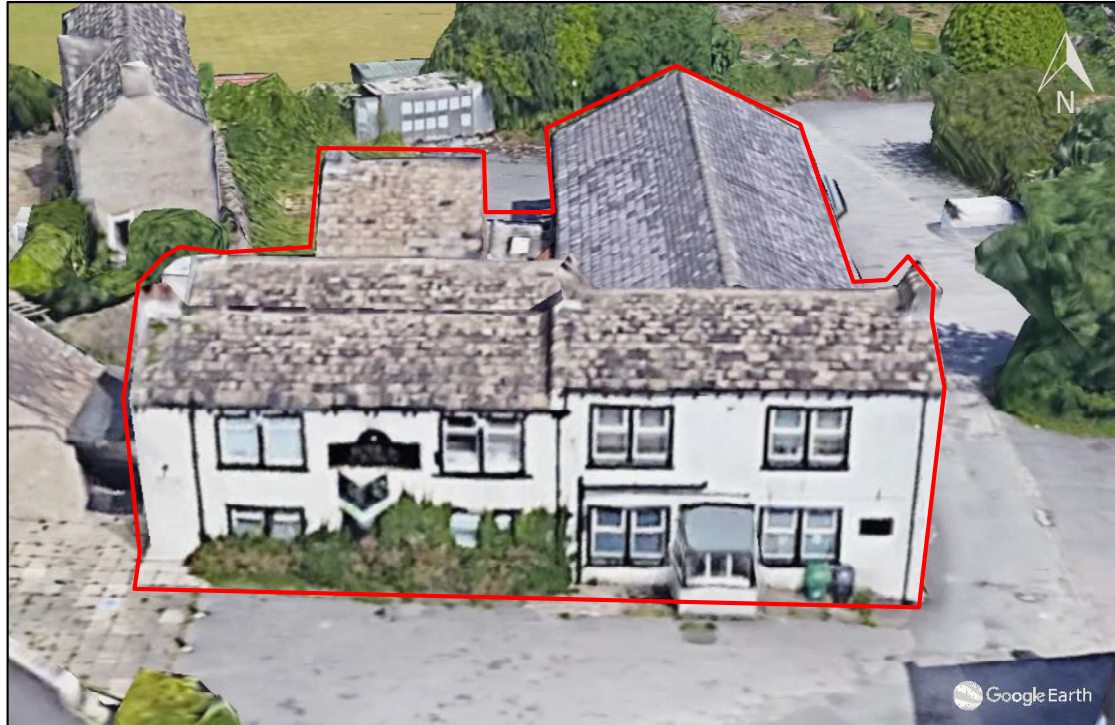
Figure 3: Target buildings outlined in red.

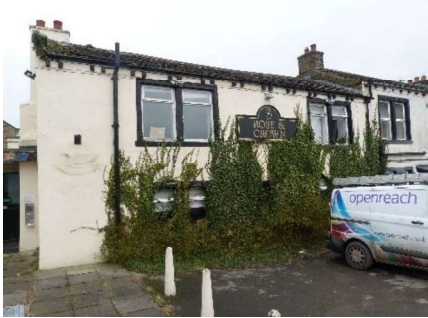
Building ref	Description & photos	PBRH features
<p><b>Building 1:</b>  <b>Low risk of supporting roosting bats</b></p>	<p>Traditional 2-storey pub, with rendered stone walls and a bitumen lined, stone slate roof. Abundance of gaps between stone slate tiles, gaps between tiles and liner. Gaps along wall tops on the south elevation. Loft void is low height with exposed timber trusses, cluttered space which is heavily cobwebbed. No evidence of roosting bats (droppings/feeding remains) identified. No evidence of nesting birds, however, dense vegetation on the south elevation could support nests.</p> <div style="display: flex; flex-wrap: wrap;"> <div style="width: 50%; text-align: center;">

<p>Photo 1: Building 1 - south aspect.</p> </div> <div style="width: 50%; text-align: center;">

No evidence of nesting birds was identified in any of the buildings. However, dense vegetation along the south elevation of B1 could support common passerine species.

We recommend that future works be undertaken outside of the bird nesting season. If this timing is not possible then a check should be made for active bird nests in areas to be worked on, immediately prior to works. If any nests are discovered, work to these areas shall be carried out once any chicks have fledged to avoid disturbance.

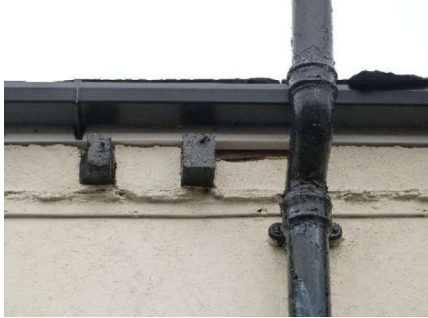
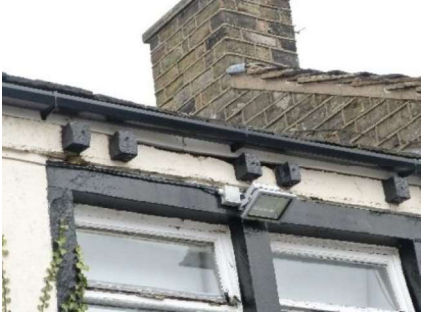
<p>Photo 3: wall top gap.</p> </div> <div style="width: 50%; text-align: center;">

<p>Photo 4: Wall top gaps.</p> </div> <div style="width: 50%; text-align: center;">

<p>Photo 6: Void structure.</p> </div> </div>	<p>Gaps between stone slate tiles and liner</p> <p>Wall top gaps &amp; masonry crevices around timber purlins.</p>

Buildings 1, 1a, 2, 3 and 4 have a low potential risk of supporting roosting bats. Potential roost habitat is generally limited to crevice habitat, including gaps between stone slate tiles and liner, wall top gaps and gaps along eaves. Due to the number and location, bat use of these areas could not be ruled out by visual inspection alone.

Demolition of Buildings 1, 1a, 2, 3 and 4, will result in the loss of PBRH that could not be fully assessed by visual inspection alone. Therefore, to complete the assessment bat activity surveys during the optimal survey season is required.

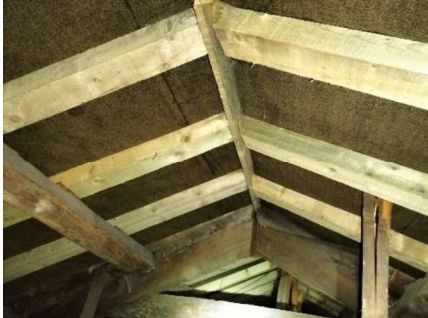
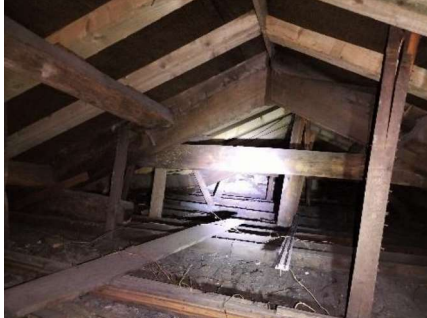
<p>Photo 5: Internal roof structure.</p> </div> <div style="width: 50%; text-align: center;">

No evidence of bat use (feeding remains/droppings) was found in any of the surveyed buildings, and Buildings 5 & 6 have a negligible risk of supporting bats. Additionally, the voids of Buildings 1 and 1a are sub-optimal for supporting void dwelling species, the voids are generally small with cluttered flight spaces; additionally, there were no clearly identifiable access points into the voids. Subsequently, the risk of void-dwelling species utilising these areas in a significant capacity is considered negligible.

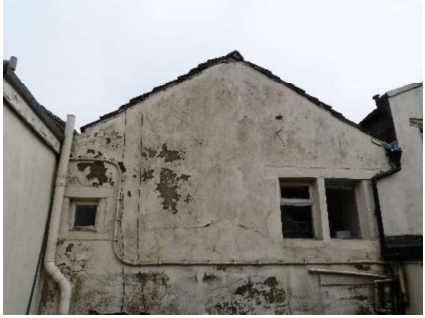
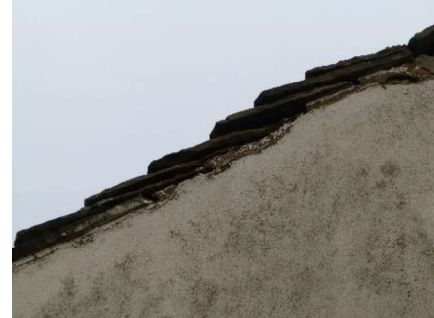
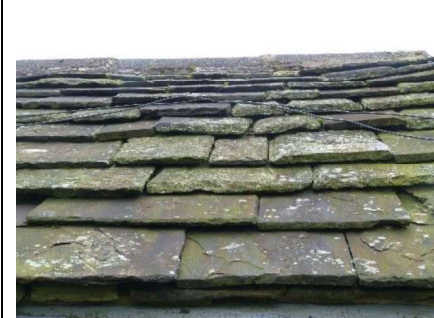
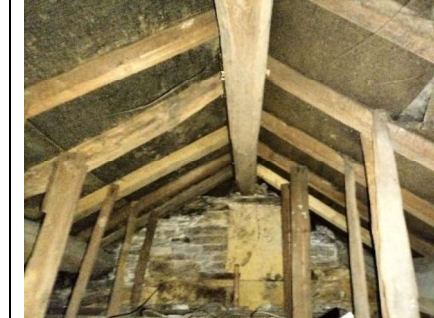
<p><b>Building 1a: Low risk of supporting roosting bats</b></p>	<p>Two-storey building extending from the north aspect of Building 1. Same construction as building 1. PBRH includes gaps between stone tiles and liner, and along wall tops. No evidence of bats found within void – small and low in height &amp; cobwebbed. No clearly identifiable access.</p>	<p>Gaps between tiles and liner and along wall tops.</p>

<p>Photo 7: Building 1a - west elevation.</p>	<p>Photo 8: Wall top gap.</p>	<p>Photo 9: North roof – gaps between tiles.</p>	<p>Photo 10: Building 1a void.</p>
<p><b>Building 3: Low risk of supporting roosting bats</b></p>	<p>Two -storey extension, extending from north elevation of 1a. Stone clad, with bitumen lined, stone slate roof. – gaps between tiles. No evidence of bats in roof void, potential access via gaps between tiles and ripped bitumastic liner. Some internal masonry crevices between brickwork on west gable wall.</p>	<p>Gaps between stone tiles and liner  Potential void habitat and internal crevices.</p>

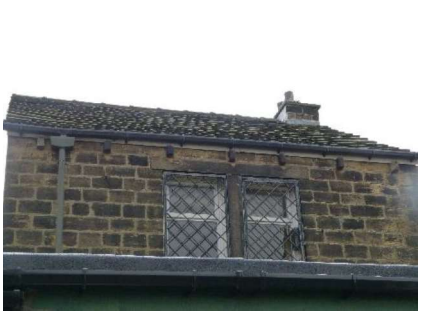
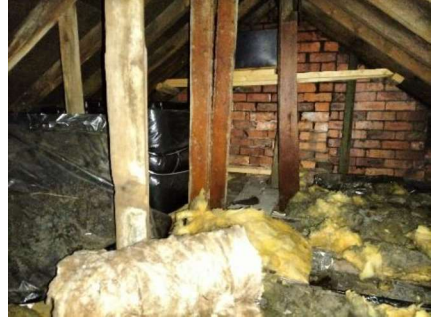
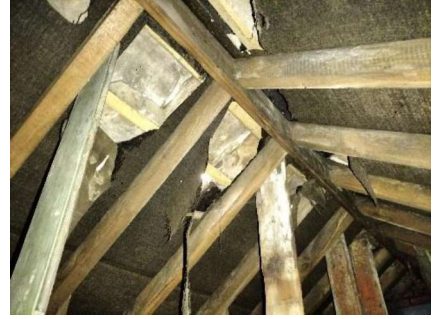
<p>Photo 11: Building 3 – north elevation.</p>	<p>Photo 12: Building 3 void.</p>	<p>Photo 13: Deteriorated roof liner.</p>	
<p><b>Building 2: Low risk of supporting roosting bats.</b></p>	<p>Large single-storey building extending from the north elevation of B1. In generally good condition with well pointed walls and a blue slate tile roof – some gaps between slate tiles, ridge is well sealed. Gaps along eaves of west elevation. False ceiling internally no access to void space.</p>	<p>Gaps between slate tiles and along eaves.</p>

No evidence of bats was identified within B3, therefore current evidence suggests that the void has not been utilised by void-dwelling species. However, the void does offer suitable potential roost habitat. With potential access via gaps between tiles and liner.

Due to a lack of evidence and minimal void habitat, the risk of void-dwelling species using the site in a maternity capacity is considered unlikely. Therefore, mitigation for any roosts identified by the summer surveys should not require a change in plans and can be incorporated within the existing development plan.

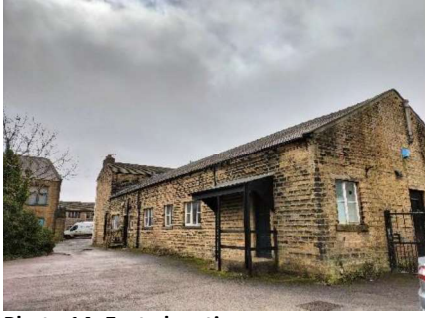
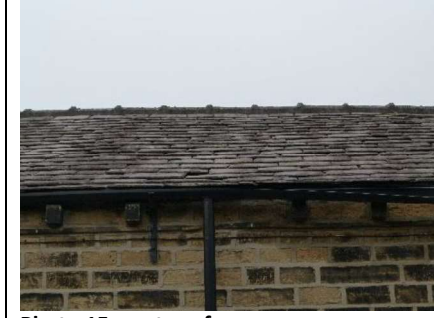
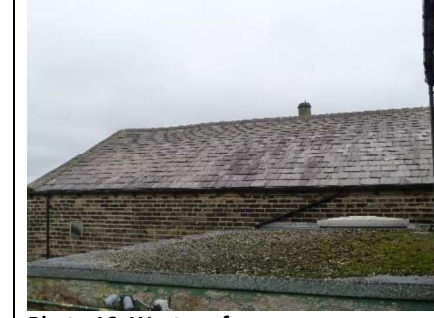
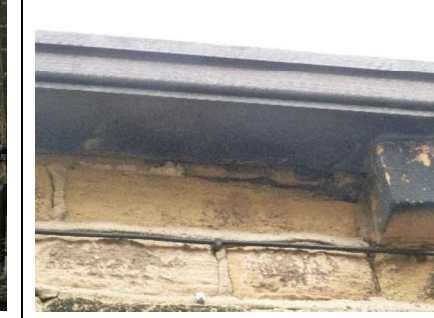
<p>Photo 14: East elevation.</p>	<p>Photo 15: east roof.</p>	<p>Photo 16: West roof.</p>	<p>Photo 17: Eaves gap – west elevation.</p>

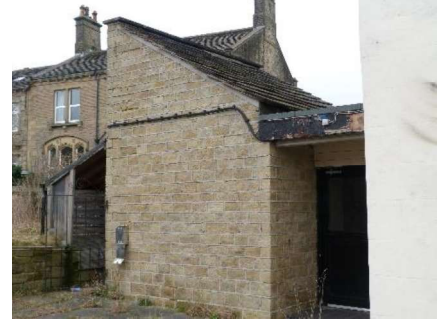
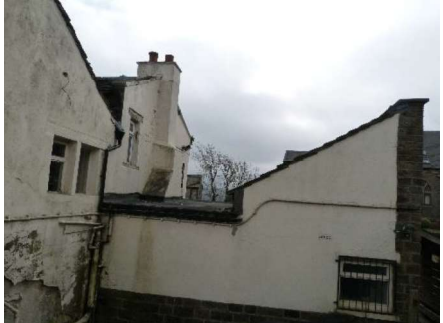
<b>Building 4:</b> Low risk of supporting roosting bats.	Single-storey extension, stone built with partially rendered walls on the north elevation. Roof is a combination of flat and lean to roof. Lean-to roof is tiles with stone slate tiles; low number of gaps between stone tiles.	Gaps between stone slate tiles.

Photo 18: B6 – south elevation.	Photo 19: West elevation.
