# Workshop/Storage Building at Old Stone Yard, Near Bank, Shelley

## Landscape Statement

On behalf of:  
Beneficial Estates Ltd

February 2022

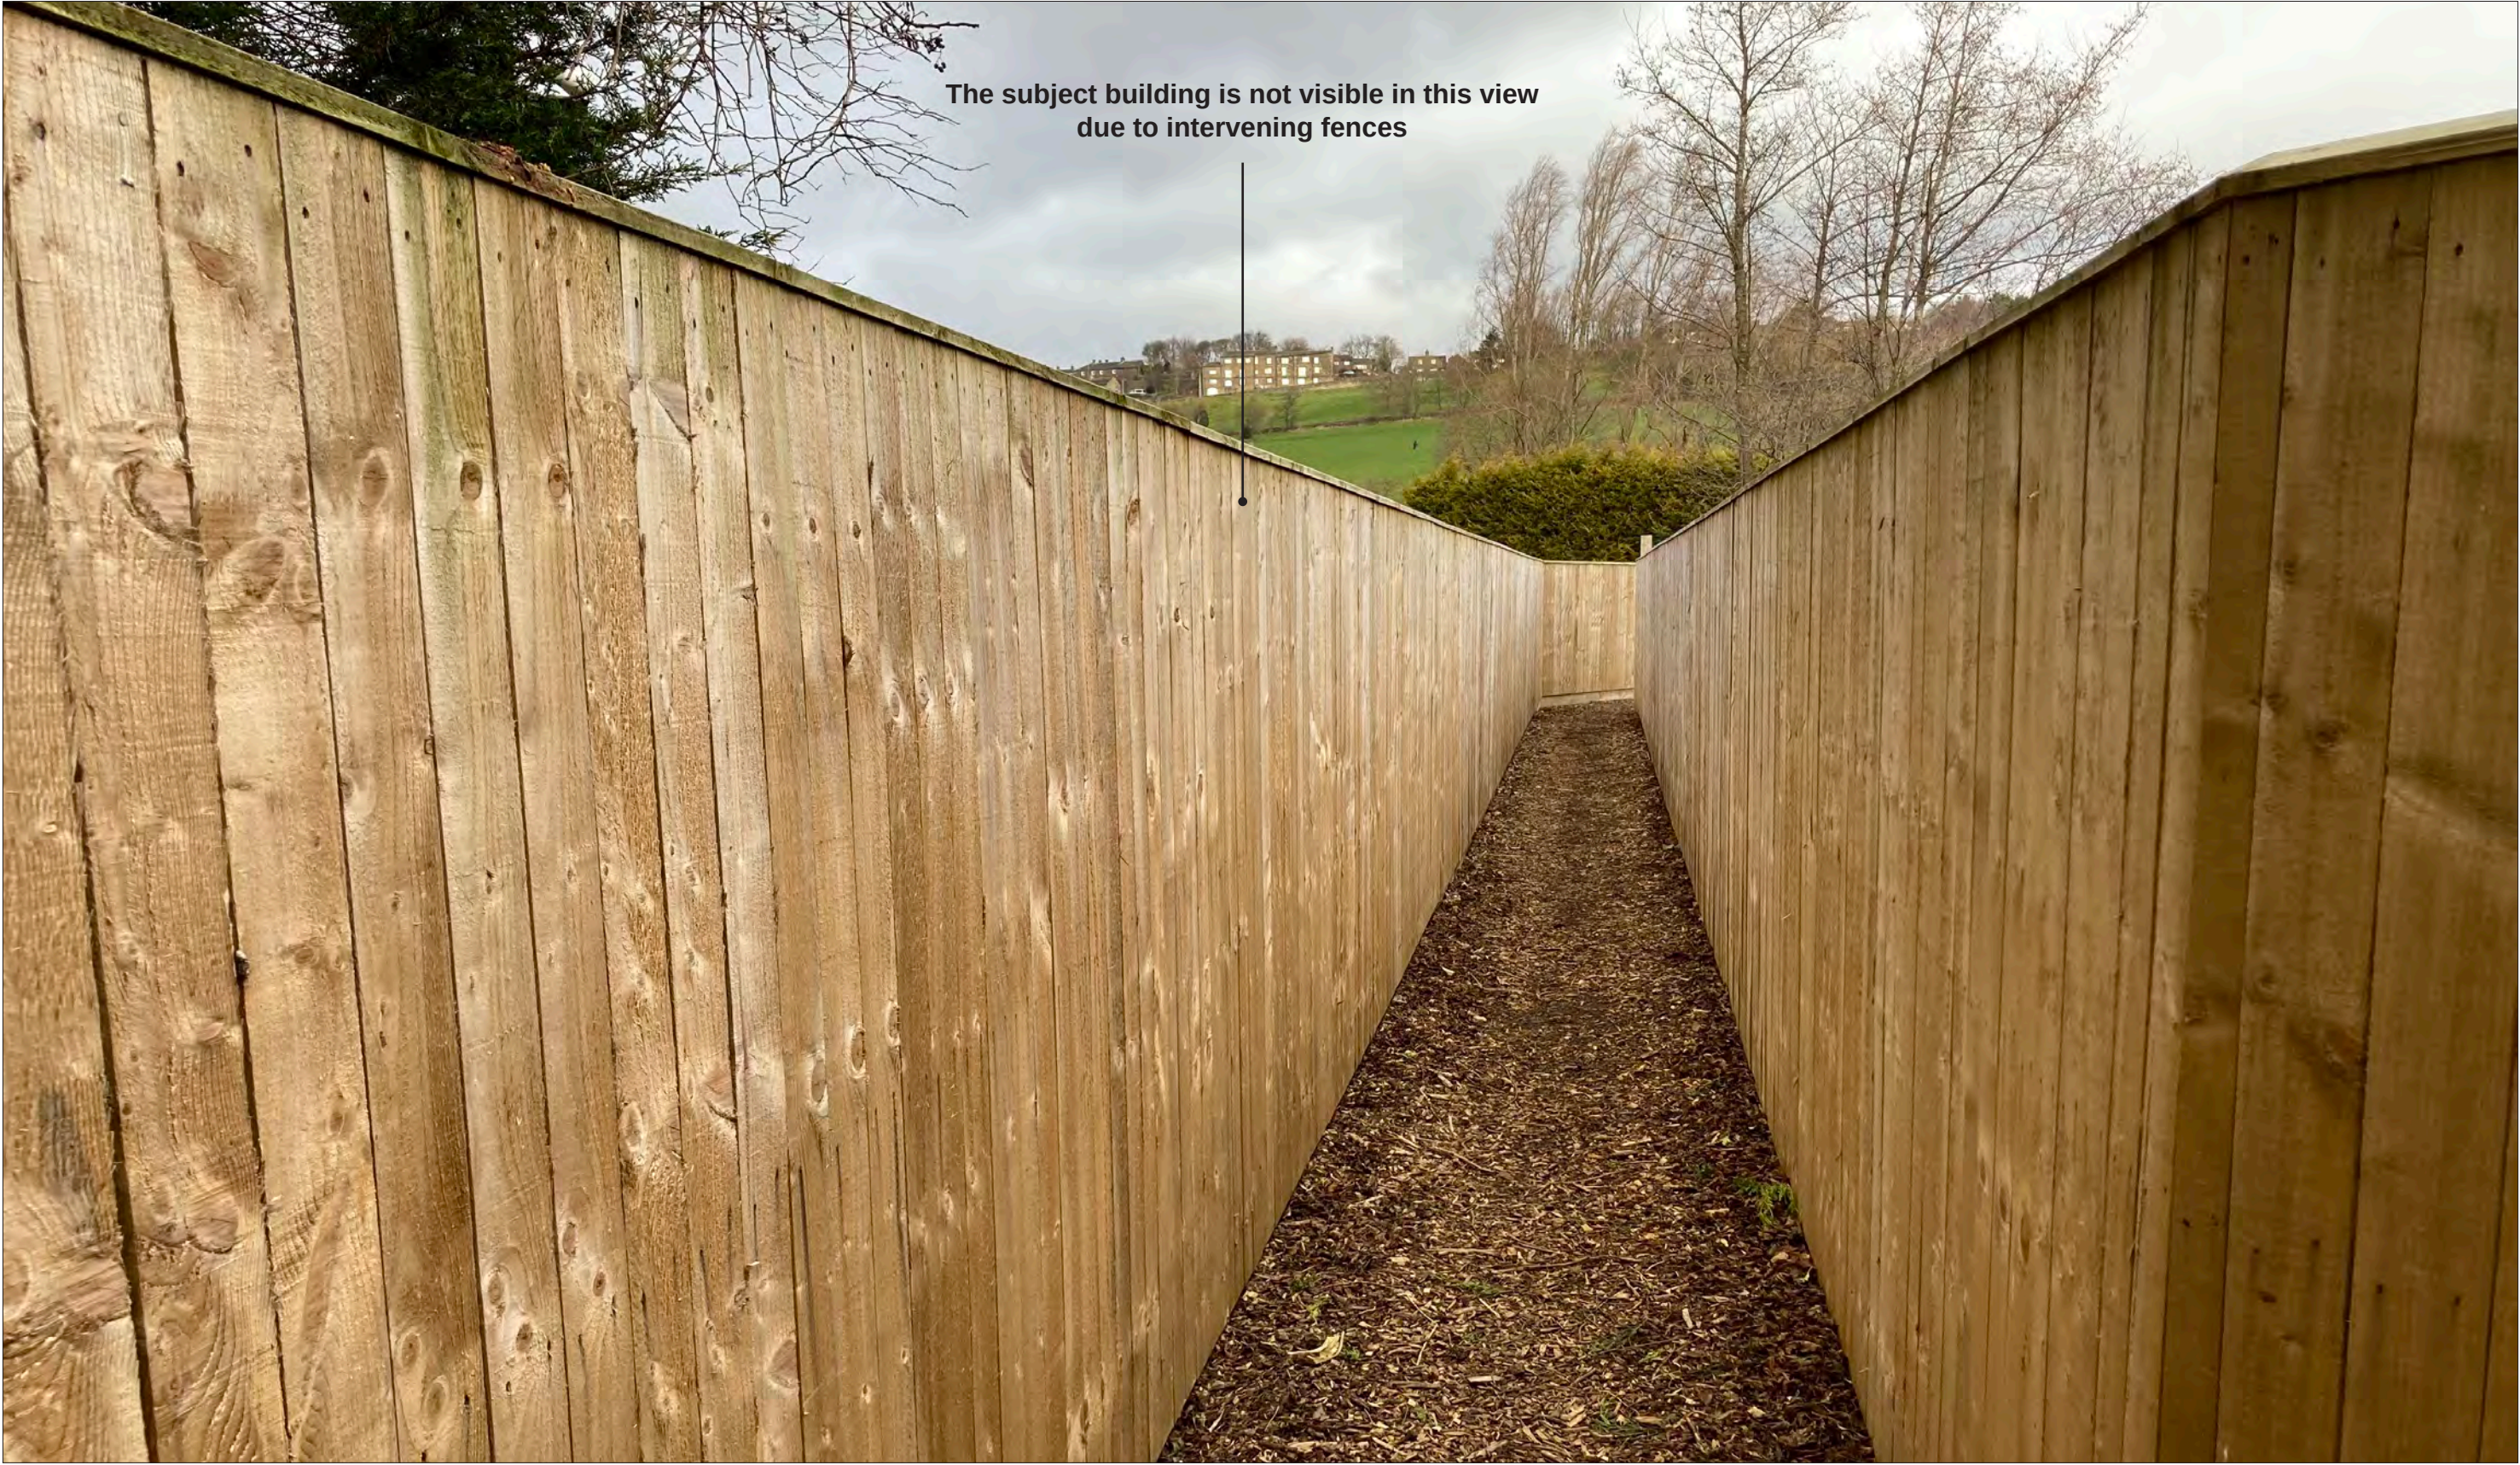
Viewpoint 13: Footpath KIR/147/10

| Date<br>February 2022 | By<br>LN | <b>Viewpoint Information:</b><br><br>Grid Reference: 420940E, 410626N<br>Direction of Centre of View: 39.6° A3<br>Horizontal Field of View: 39.6°<br>Vertical Field of View: 27° | <b>Photography Information:</b><br><br>Camera: Handheld Device<br>Photography Date: 01/02/2022 | |

- 6.2.1 Views of the subject building from publicly accessible locations are extremely limited. The photographic viewpoints illustrated in Appendix 2 and identified on Figure 2 underline the limited extent of visibility. It should be noted that these photographs were taken during the winter when much of the surrounding vegetation was not in leaf. The photographs therefore show a worst case scenario of visibility and when in leaf the vegetation surrounding the site would further restrict visibility of the subject building.
