## **VERIFICATION REPORT**

**FOR  
PLOT 7,  
LAUND ROAD,  
SALENDINE NOOK,  
HUDDERSFIELD,**

**PREPARED FOR  
CREATIVE DEVELOPMENTS  
(HUDDERSFIELD) LIMITED**

**REPORT NO. NE3941F/7  
MARCH 2022**

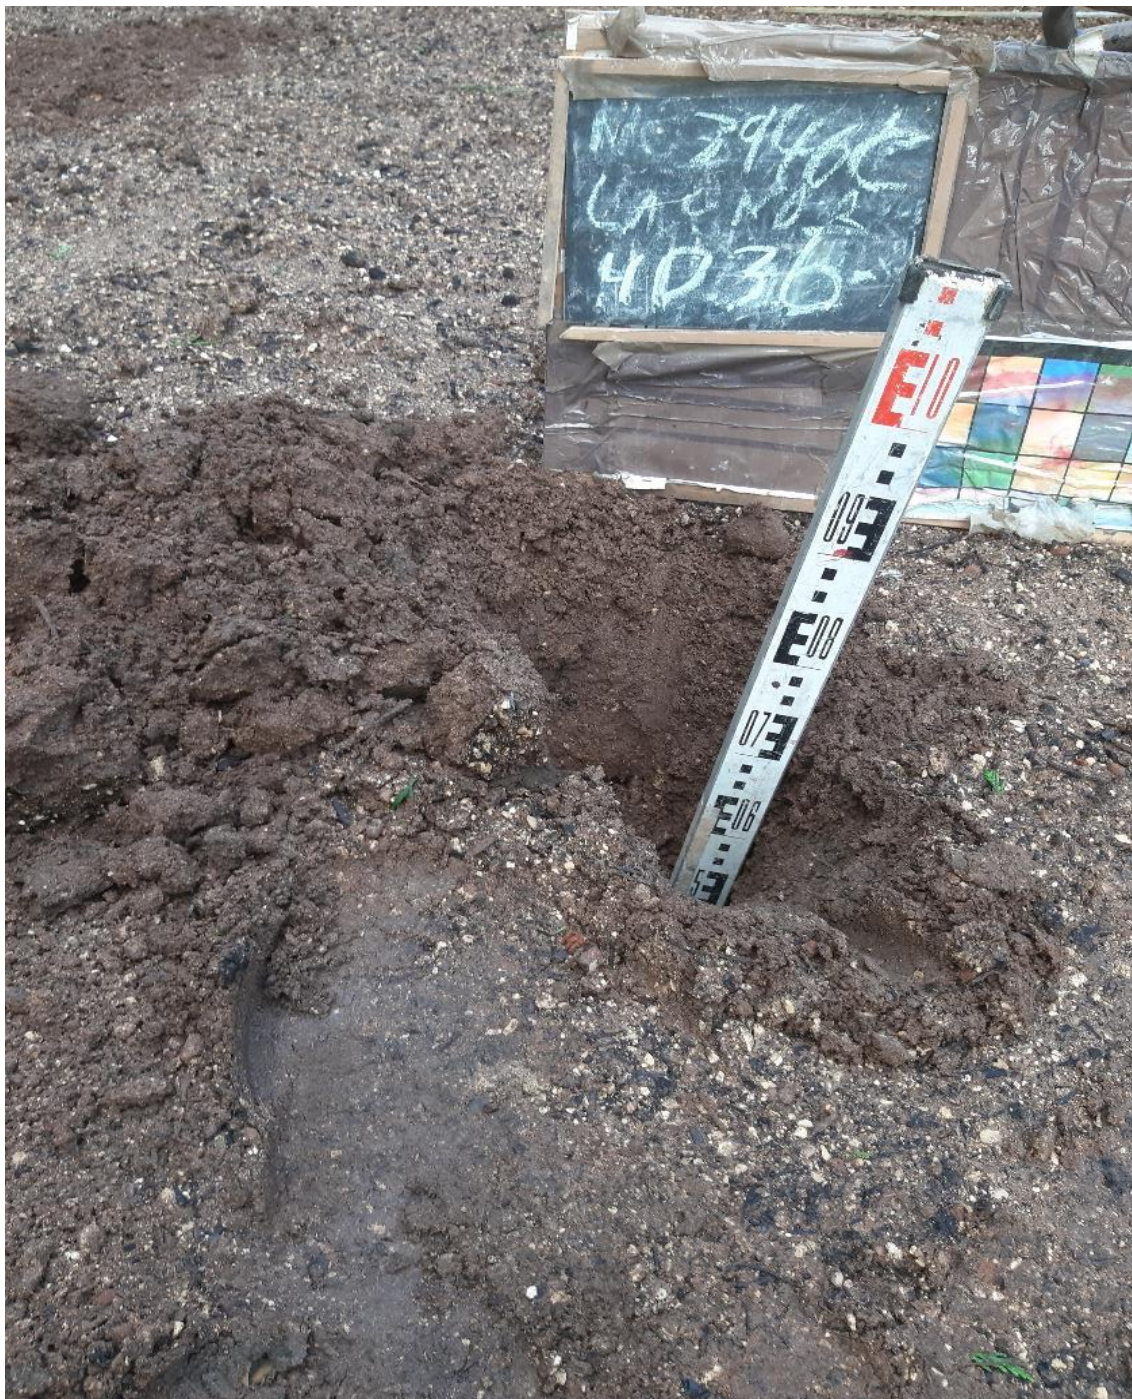
| Pit No. | Location | Depth of Clean Topsoil (mm) | Description |
|---|---|---|---|
| HD36 | Plot 7 Rear | 780 | Brown slightly gravelly sandy topsoil. |

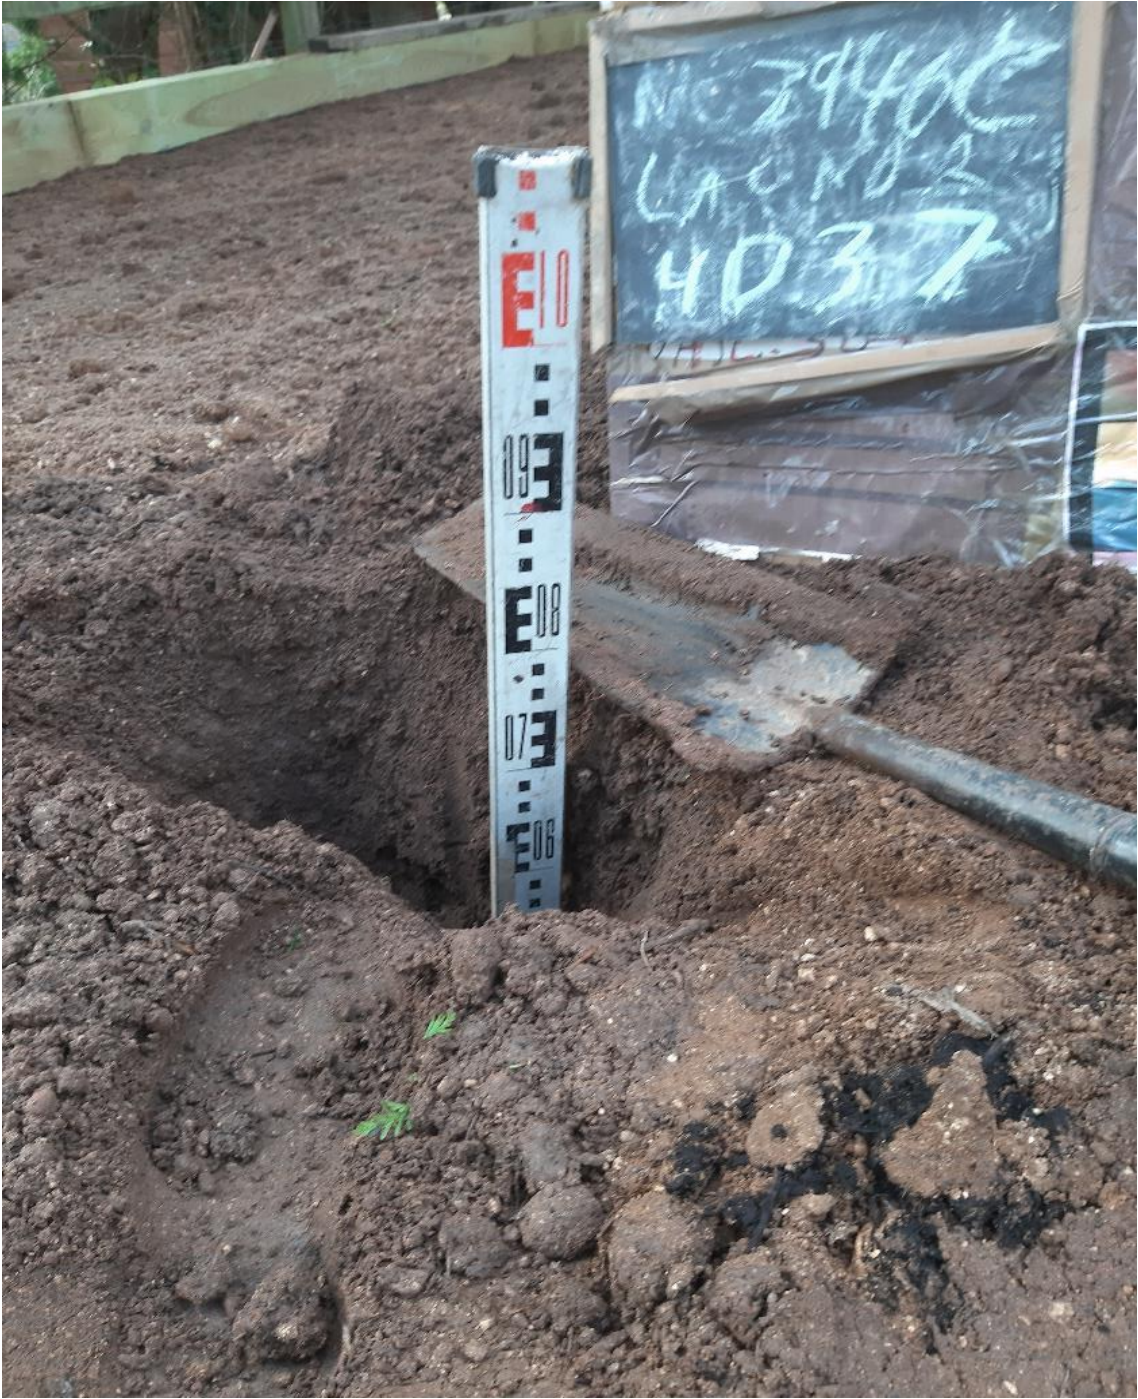
| Pit No. | Location | Depth of Clean Topsoil (mm) | Description |
|---|---|---|---|
| HD37 | Plot 7 Rear | 770 | Brown slightly gravelly sandy topsoil. |

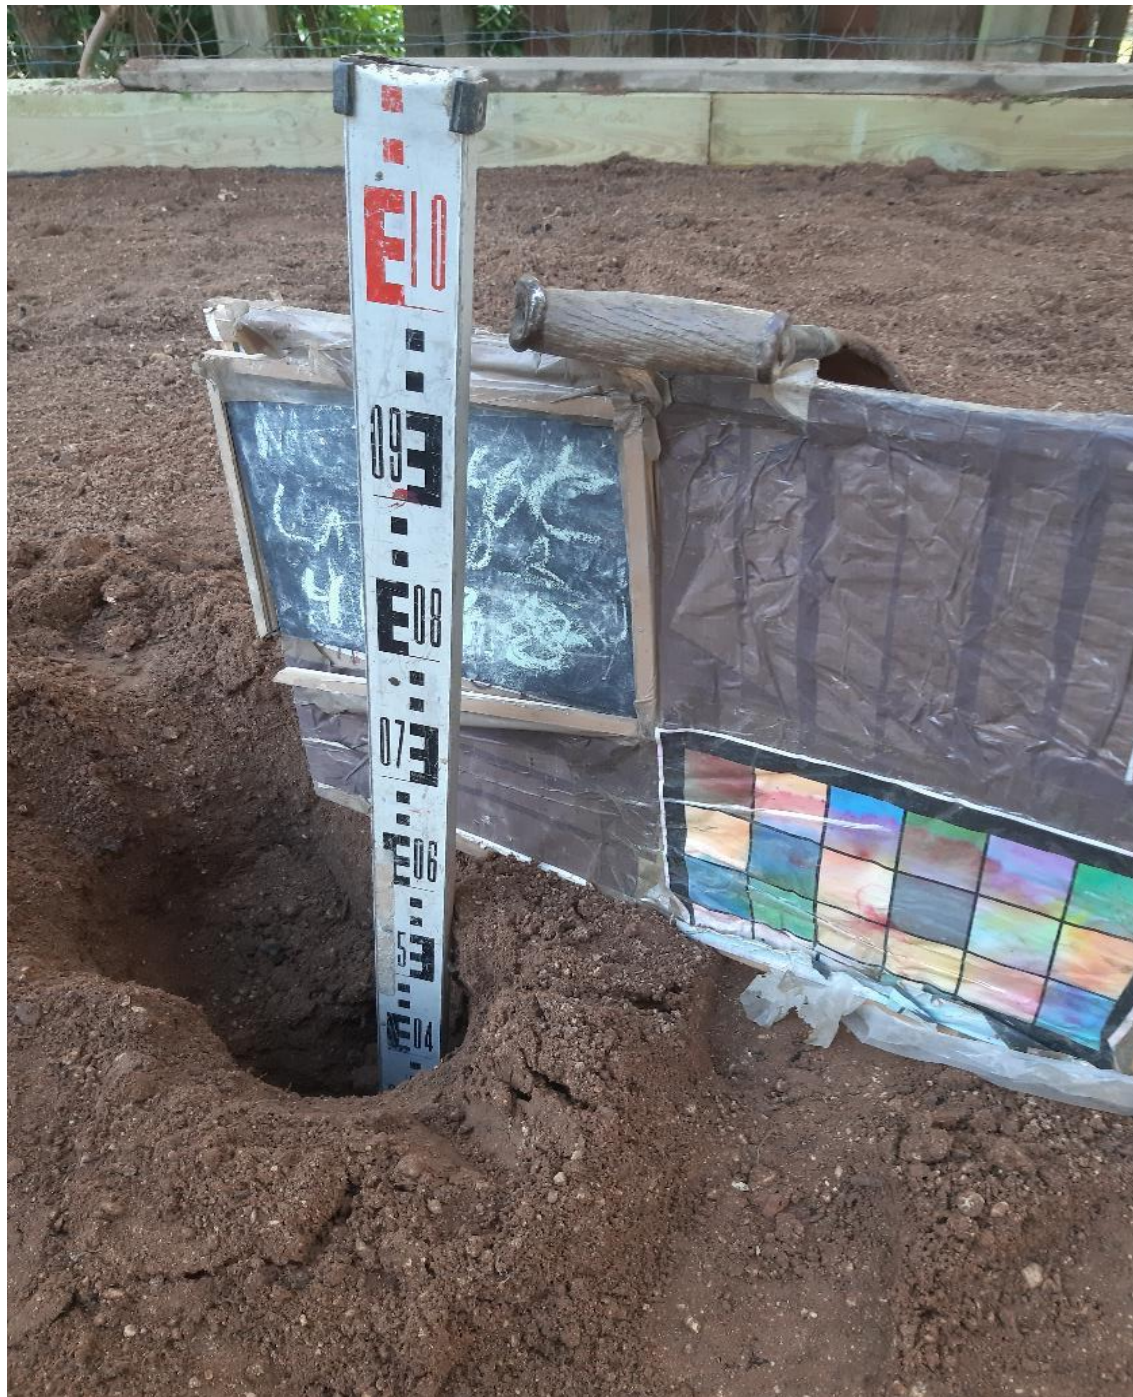
**HD38**

| Pit No. | Location | Depth of Clean Topsoil (mm) | Description |
|---|---|---|---|
| HD38 | Plot 7 Rear/Side | 610 | Brown slightly gravelly sandy topsoil. |

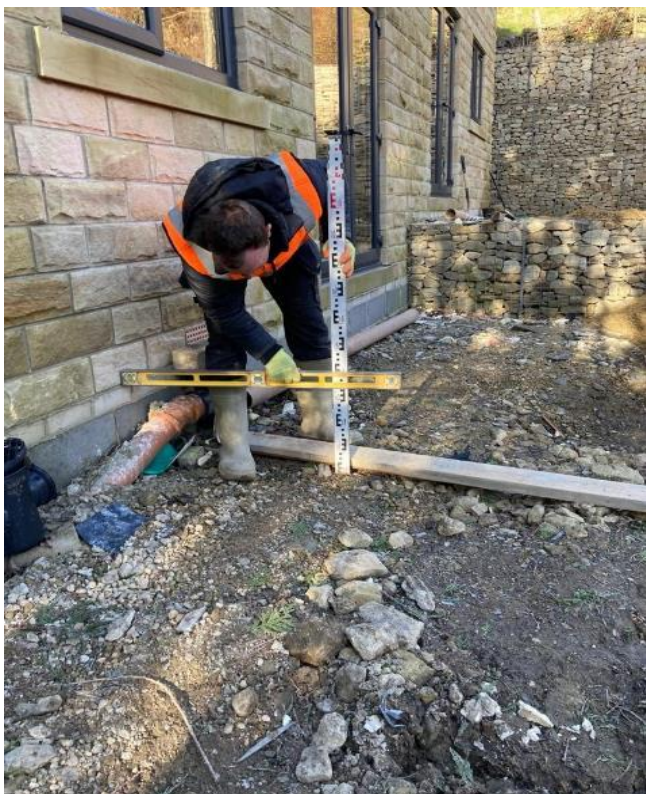
Preparation prior to placing aggregate and hard paving to the rear, with sub base shown to be 300+ mm below finished ground level.

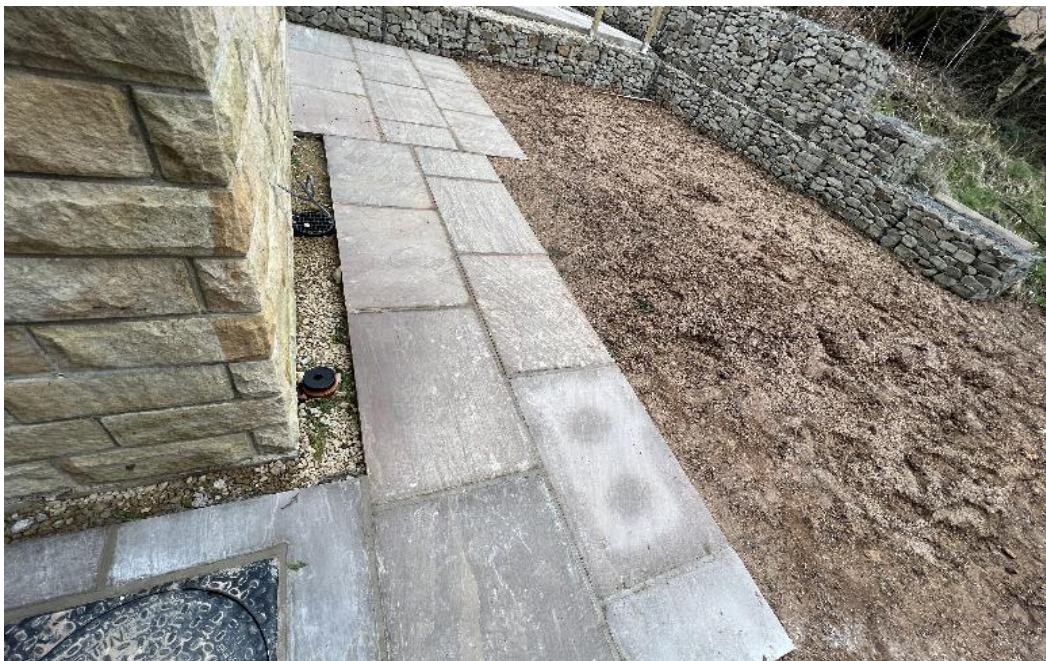
Finished hard paving to the rear.

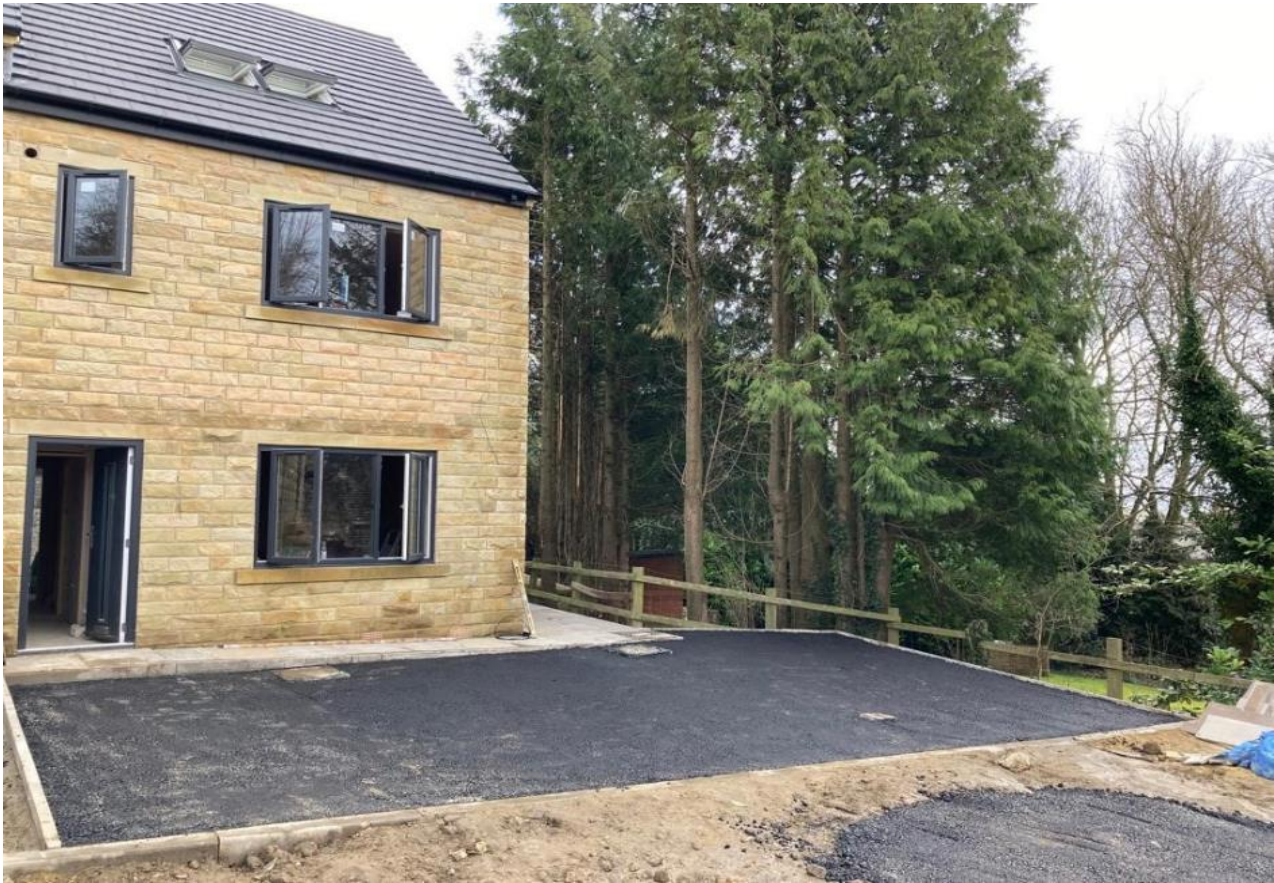
Completed hard paving and macadam driveway to the front.
