# **Geo-environmental Ground Investigation Report**

**PROPOSED RESIDENTIAL DEVELOPMENT**

**CHAIRBARROWS FARM,  
WHITECHAPEL ROAD, CLECKHEATON**

**E21/7893/R001**

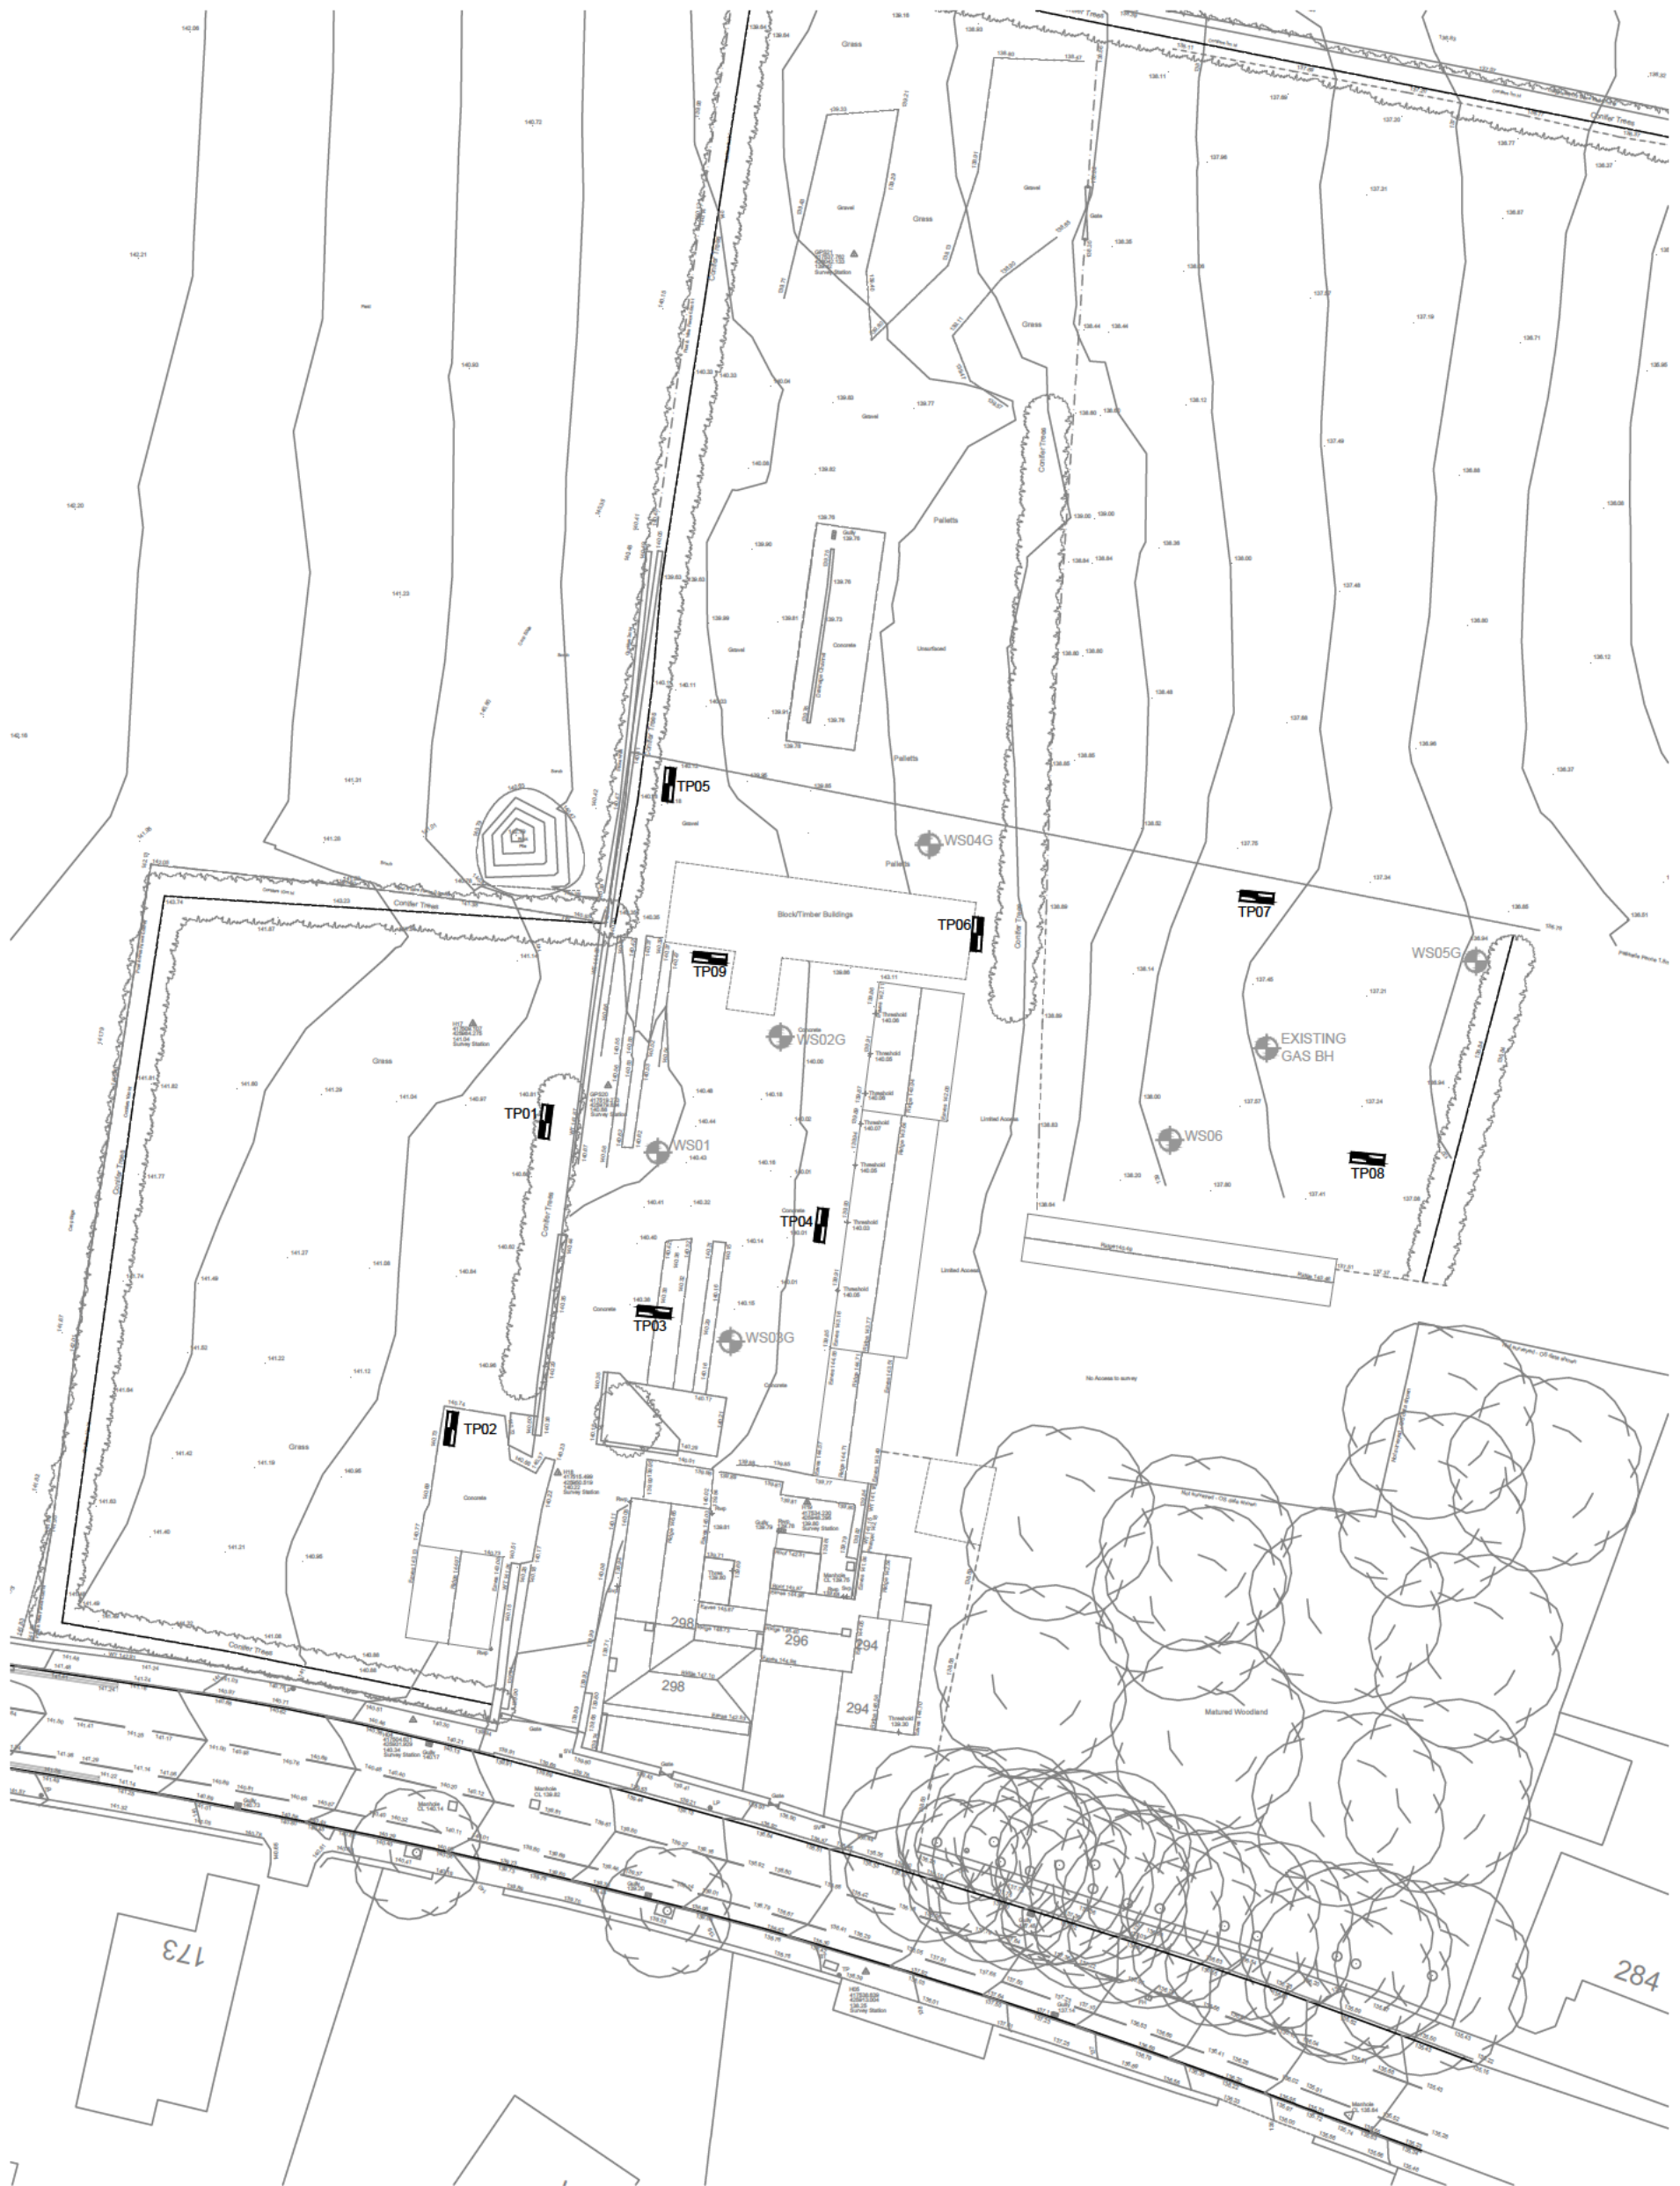
Client				
MICHAEL GRAVES				
Project				
294 - 298 WHITECHAPEL ROAD, CLECKHEATON				
Detail				
TRIAL PIT LOCATION PLAN				
Scale	Dwn	Chkd	Date	Dwg No.
1:500	JF	MH	JAN-22	E21/7893/003_01A

Rev A. Amended to suit Site Investigation Works.

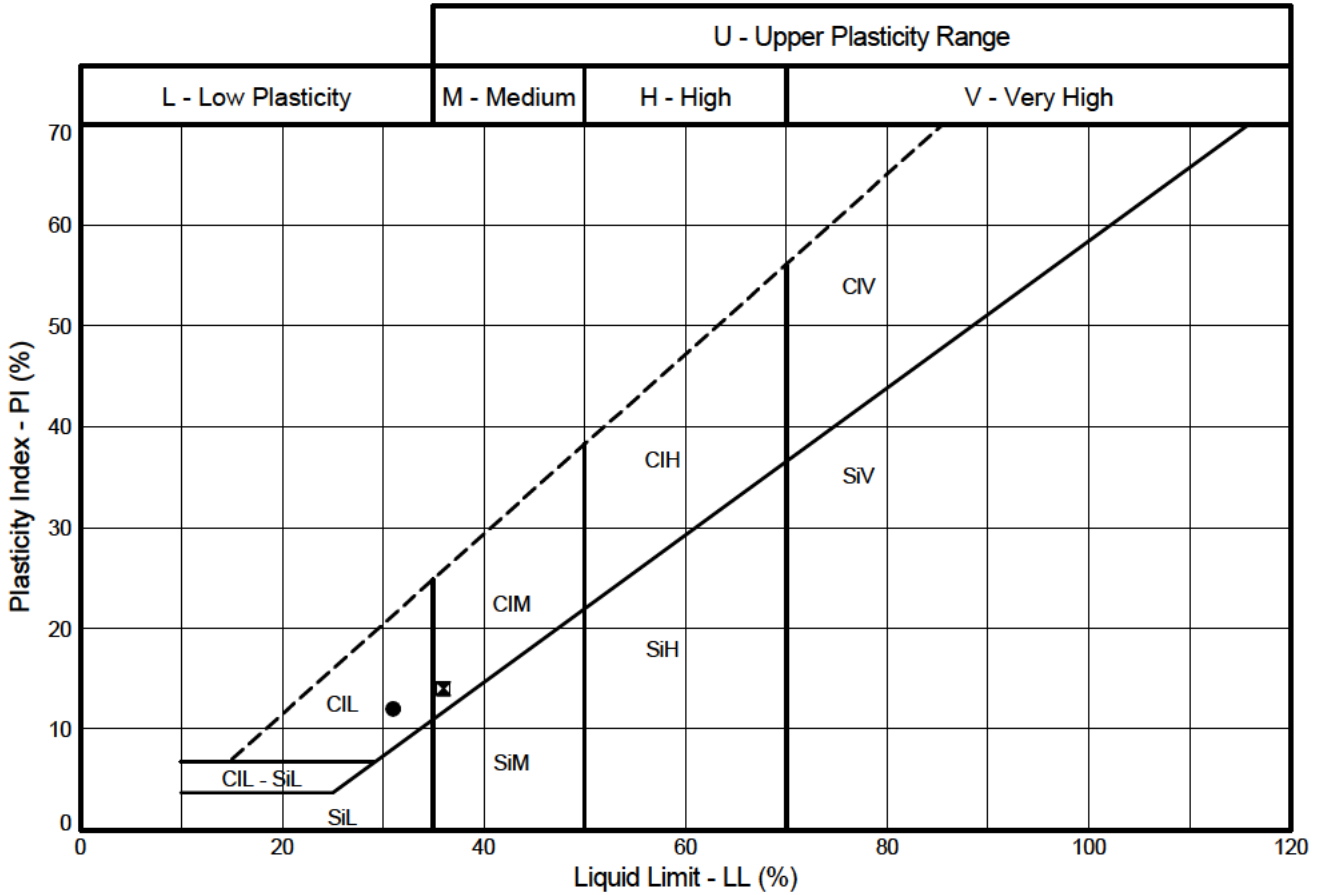
# PI vs LL CHART

According to BS EN 14688-2:2018  
Testing in accordance with BS EN ISO 17892-12:2018+A1:2021

Sample Identification			Test Method #	Preparation Method +	WC %	LL %	PL %	PI %	<425µm %	Lab location	Notes
Exploratory Position ID	Sample	Depth (m)									
●	TP01	D	0.50	5.3/5.5/6.5	5.2.7	17.3	31	19	12	85	C
☒	TP06	D	0.70	5.3/5.5/6.5	5.2.7	19.3	36	22	14	82	C

8.1.15 The result of the geotechnical analysis undertaken on the samples of clayey soil indicates the clay to be of low to medium (Plasticity Index 12-14%). If the modified results are calculated, taking into account the percentage of material retained on a 425micron sieve, the results correspond to a low shrinkage clay. The test certificates are contained in Appendix C.
