# **Phase 2 Geo-environmental Report**

**PROPOSED BUSINESS PARK**

**LINDLEY MOOR ROAD, HUDDERSFIELD**

**E21/7768/R002**

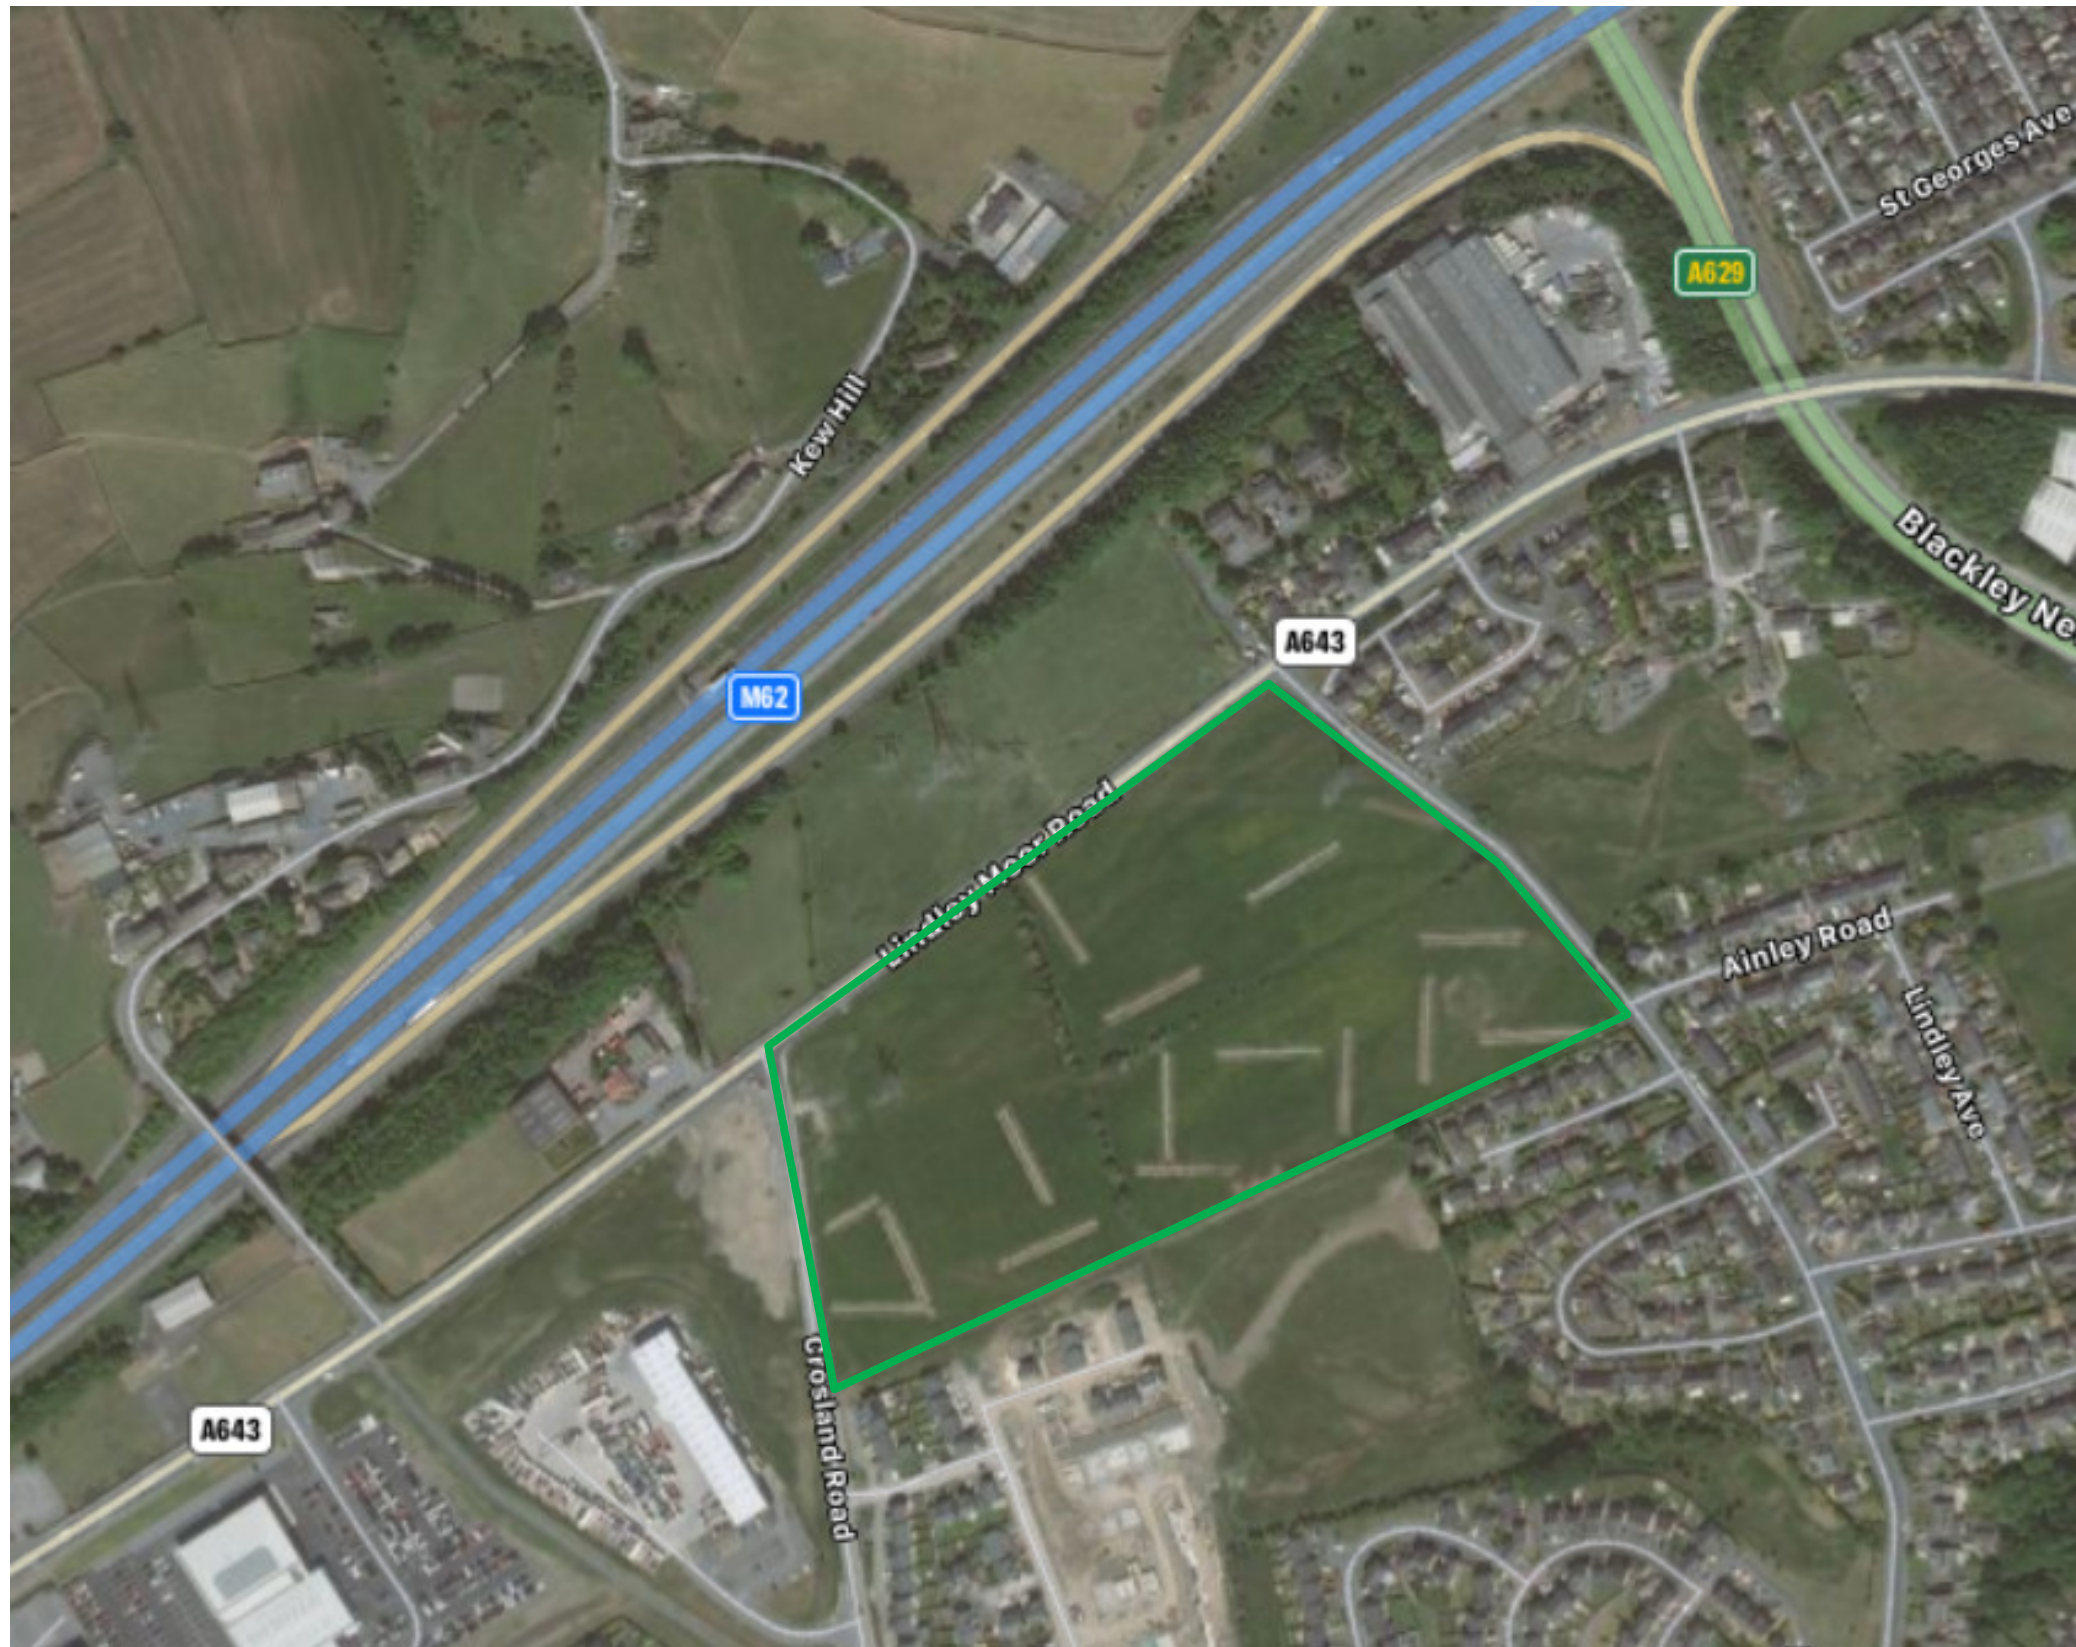
- TRIAL TRENCH LOCATION
- TRIAL PIT LOCATION
- BOREHOLE LOCATION
- WINDOW SAMPLE LOCATION

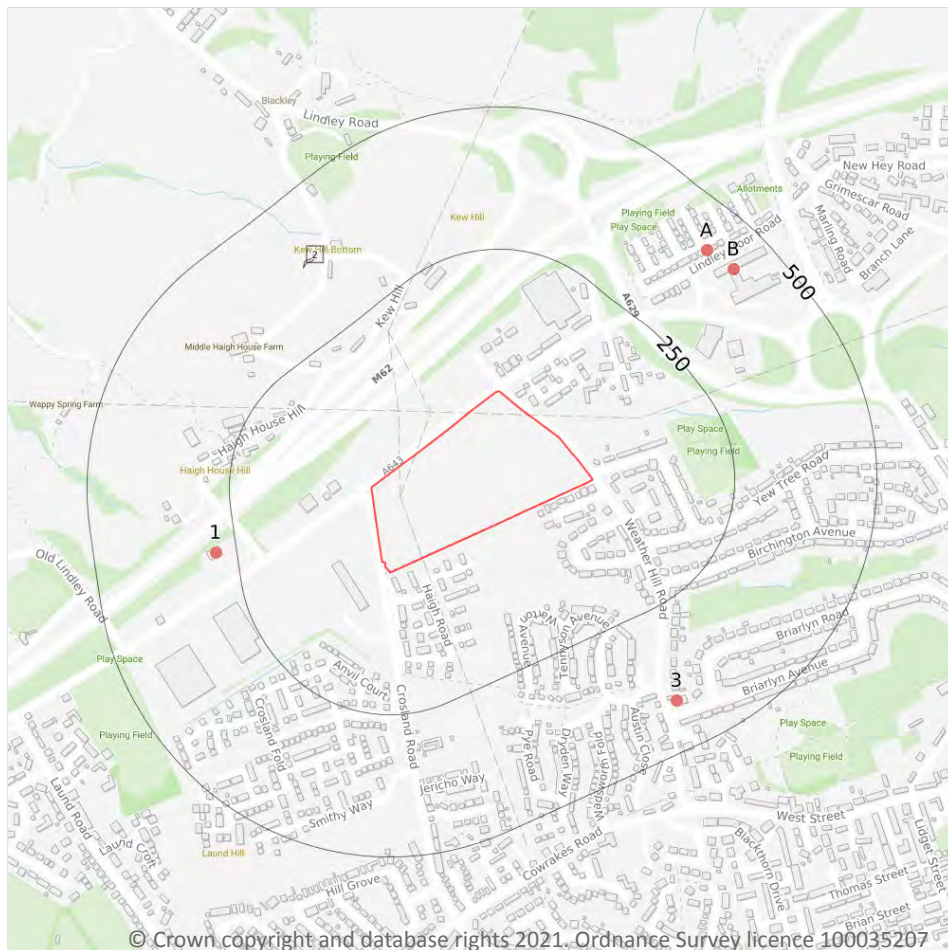
## 3 Waste and landfill

- Site Outline
- Search buffers in metres (m)
- Historical landfill (LA/OS)
- Waste exemptions

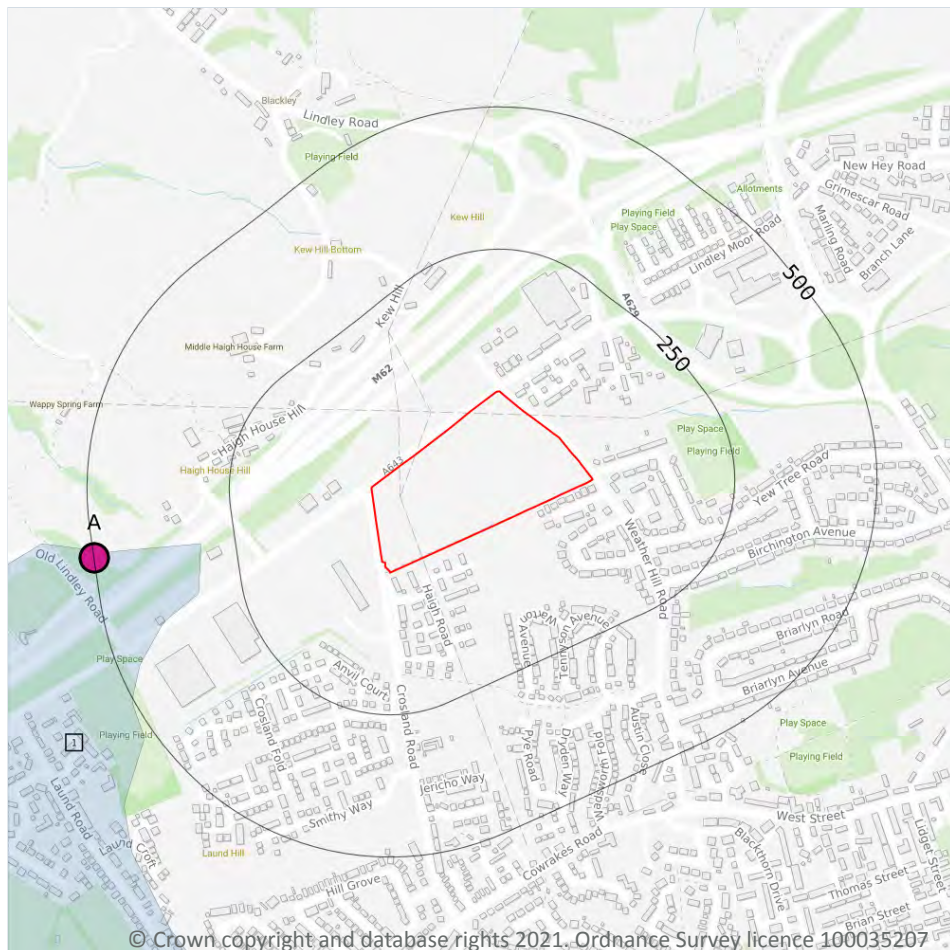
## Abstractions and Source Protection Zones

- Site Outline
- Search buffers in metres (m)
- Source Protection Zone 1  
Inner catchment
- Source Protection Zone 2  
Outer catchment
- Source Protection Zone 3  
Total catchment
- Source Protection Zone 4  
Zone of Special Interest
- Source Protection Zone 1c  
Inner catchment - confined aquifer
- Source Protection Zone 2c  
Outer catchment - confined aquifer
- Source Protection Zone 3c  
Total catchment - confined aquifer
- Drinking water abstraction licences  
Polygon features
- Drinking water abstraction licences  
Linear features
- Groundwater abstraction licence (point)
- Groundwater abstraction licence (area)
- Groundwater abstraction licence (linear)
- Surface Water Abstractions (point)
- Surface Water Abstractions (area)
- Surface Water Abstractions (linear)

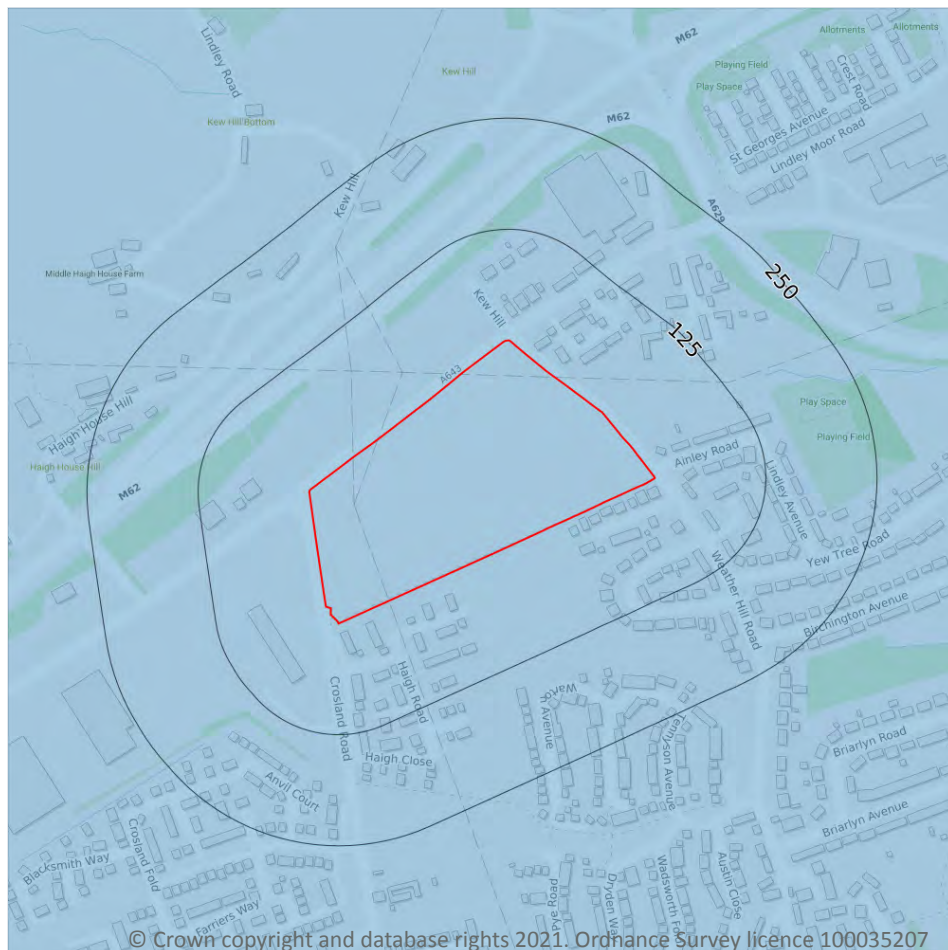
## 9 Groundwater flooding

— Site Outline  
Search buffers in metres (m)

- High
- Moderate - High
- Moderate
- Low
- Negligible
