## Appendix 5

### Foundations and ground work

#### Preliminary works

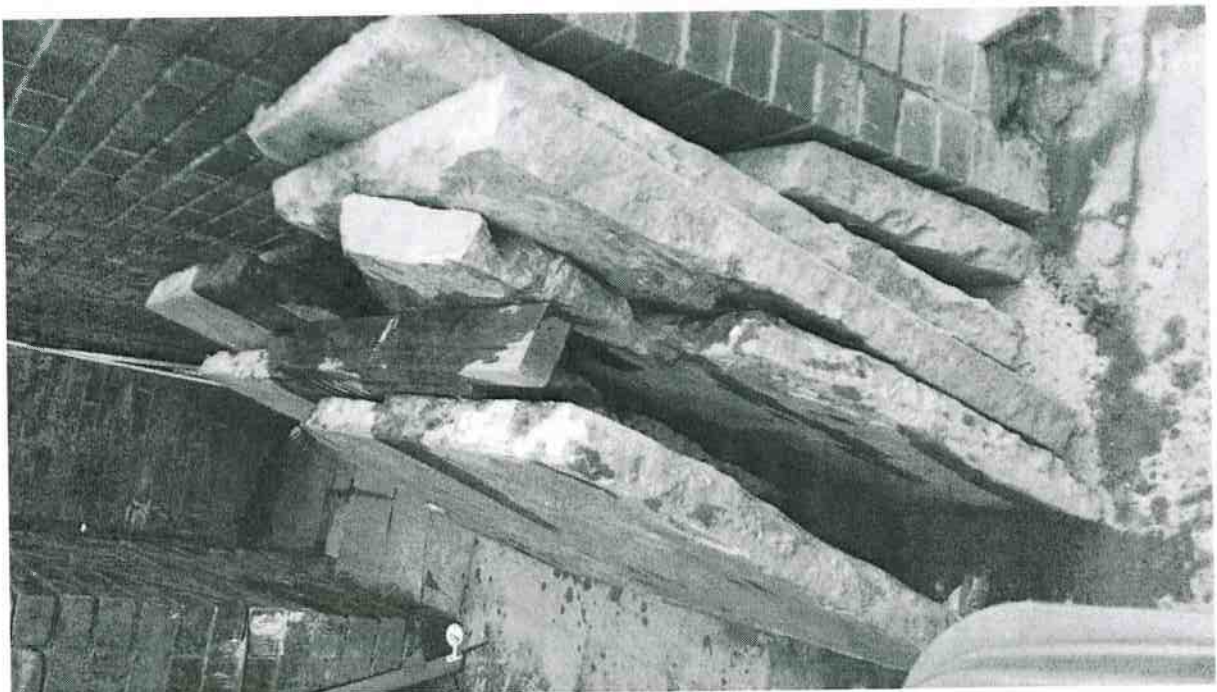
Additional photographs below show the Hard York Stone slabs now removed from the 3.2 x 3.5 metre area. The same York stone design exists and remains in situ across the remainder of the garden area.

The photograph above shows the Hard York Stone removed from where Hot Tub number 1 sits.

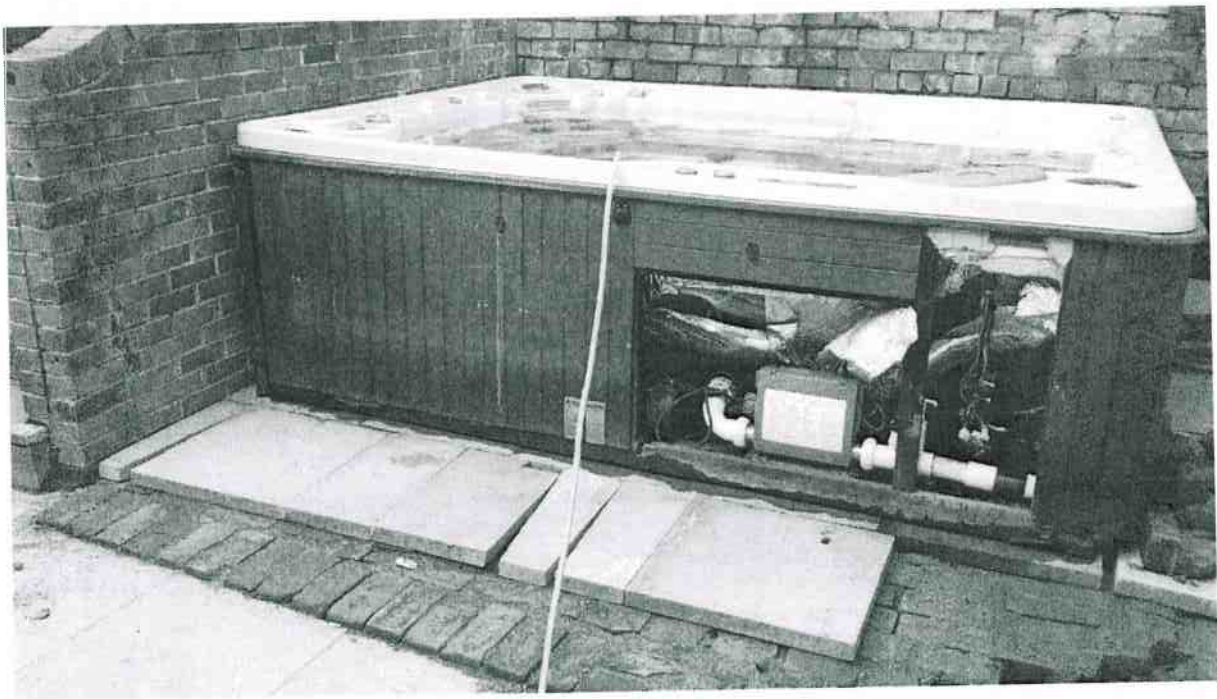
Hot tub number one, shown in the photographs below, now sits on a finely spaced brick base, which in turn sits on a compacted gravel filtration pit, to allow any excess water run through to ground rather than down to the gulley as in the previous design.

The photograph above shows Hot Tub number 1 sat on the excavated 3.2 X 3.5 metres area during testing.
