## Phase 2 Intrusive Site Investigation Report

| <b>LOCATION</b> | Proposed Dwellings, Land off Scott Lane,<br>Cleckheaton BD19 3LX |
| <b>ISSUE DATE</b> | April 2019 |
| <b>OUR REF.</b> | G19086 |

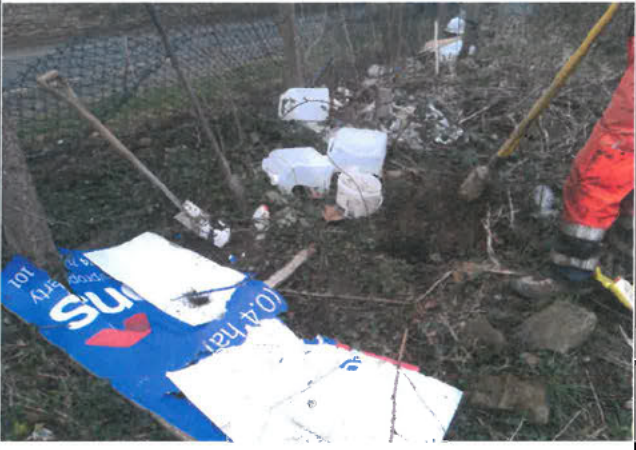
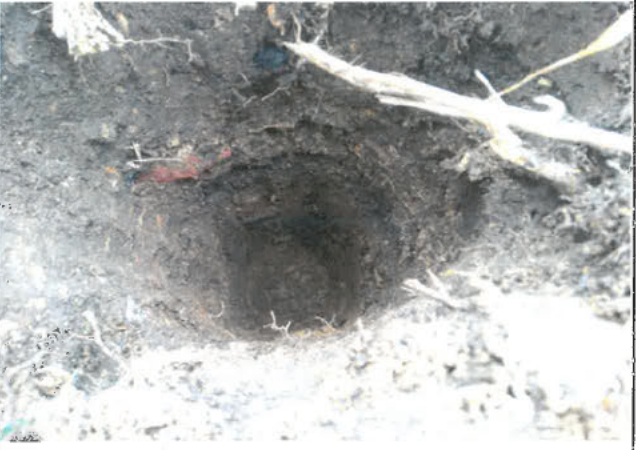
| Depth (m) | Description of Strata | Thick-ness | Legend | Sample | Test Type Result | Root Information | Depth to Water | Depth (m) |
|---|---|---|---|---|---|---|---|---|
| 0.70 | Firm brown very sandy gravelly CLAY. Gravel is fine to coarse and cobbles of sandstone and coal. | 200 | | O | | | | 0.50 |
| | <p>Trial pit Terminated at 0.70m</p> <p>Trial pit Location:</p> <p>Close up of trial pit:</p> | | | | | | | 0.70 |

Remarks: Hand excavated to 0.70m  
Trial pit remained stable and dry on completion

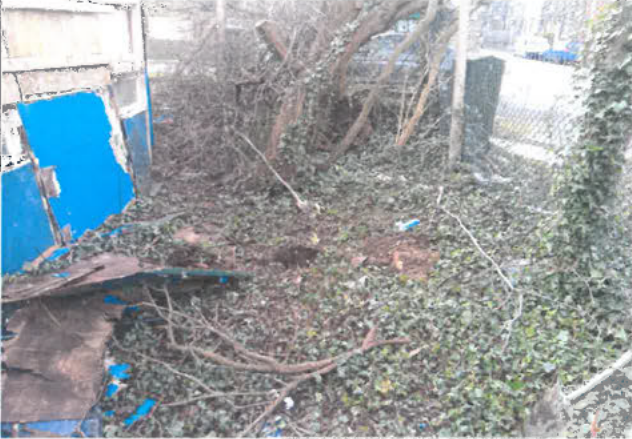
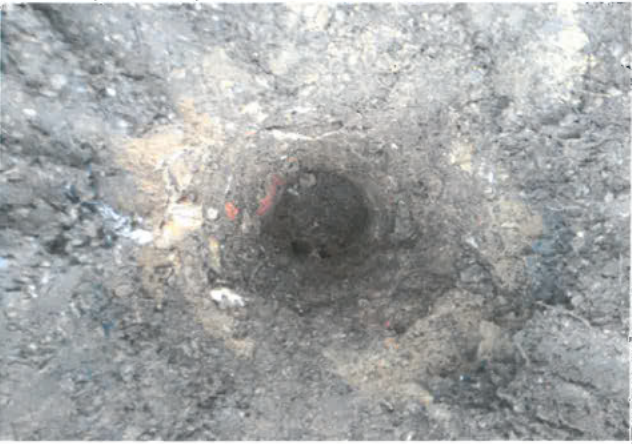
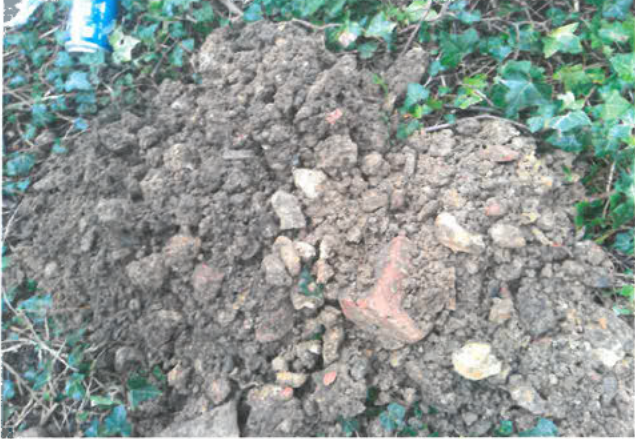
TPC found topsoil comprising loose slightly silty clayey gravelly sand with brick and coal constituents to 0.25m underlain by made ground of loose clayey sandy gravel with sandstone, brick, and occasional coal and ash constituents to the base of the pit at 0.70m.

| Depth (m) | Description of Strata | Thick-ness | Legend | Sample | Test Type Result | Root Information | Depth to Water | Depth (m) |
|---|---|---|---|---|---|---|---|---|
| 0.25 | TOPSOIL. Loose dark brown slightly silty clayey gravelly sand. Gravel is fine to coarse of sandstone and occasional brick and coal. | 250 | | O | Cv kN/m <sup>2</sup> | | | 0.25 |
| 0.70 | MADE GROUND. Loose brown and pale brown clayey sandy gravel. Gravel is fine to coarse and cobbles of sandstone, brick and occasional coal and ash. | 450 | | O | | | | 0.50<br>0.70 |
| <p>Trial pit Terminated at 0.70m due to refusal on large cobble</p> <p>Trial pit Location:</p> <p>Close up of trial pit:</p> | | | | | | | | |
| <p>Soils excavated from trial pit:</p> | | | | | | | | |

Remarks: Hand excavated to 0.70m  
Trial pit remained stable and dry on completion

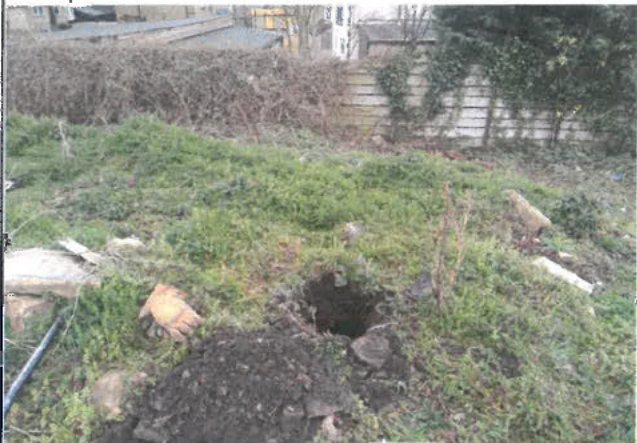
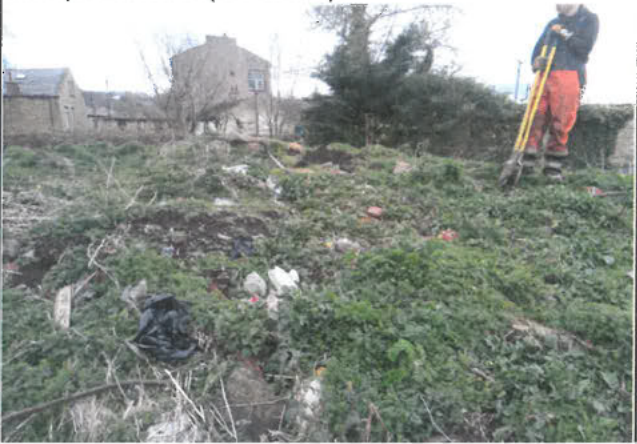
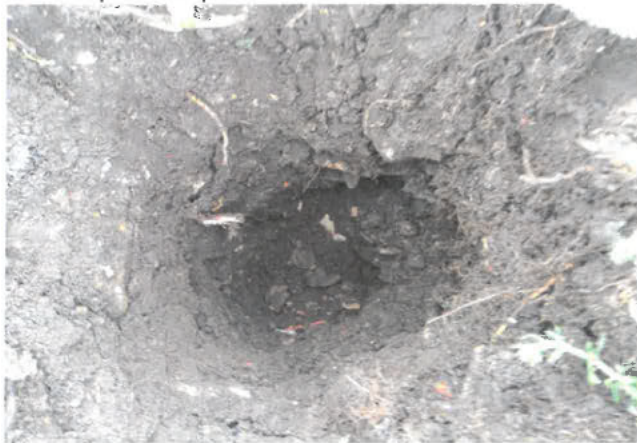
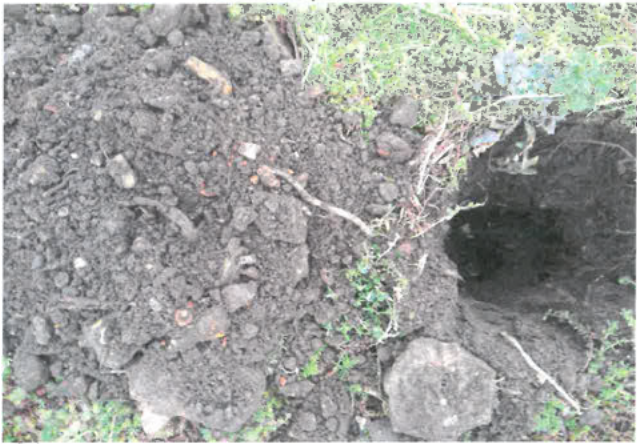
TPD found made ground similar to that encountered in TPC of loose slightly silty gravelly sand / sandy gravel with sandstone brick and occasional coal constituents. A single glass fragment was also noted. The trial pit was terminated at 0.60m on large sandstone cobbles.

| Depth (m) | Description of Strata | Thick-ness | Legend | Sample | Test Type Result | Root Information | Depth to Water | Depth (m) | |
|---|---|---|---|---|---|---|---|---|---|
| 0.60 | MADE GROUND. Loose dark brown slightly silty gravelly sand / sandy gravel. Gravel is fine to coarse and cobbles of sandstone, brick and occasional coal. Single fragment of glass also noted. | 600 | | O | Cv kN/m <sup>2</sup> | | | 0.25<br>0.50<br>0.60 | |
| <p>Trial pit Terminated at 0.60m due to refusal on large cobbles.</p> <p>Trial pit excavated from top of soil heap as shown:</p> <p>Trial pit Location:</p> <p>Trial pit Location (additional):</p> | | | | | | | | | <p>Close up of trial pit:</p> <p>Soils excavated from trial pit:</p> |

Remarks: Hand excavated to 0.60m
