**18 Springwood Road, Thongsbridge**

**Bat Survey Report**

**31 July 2022**

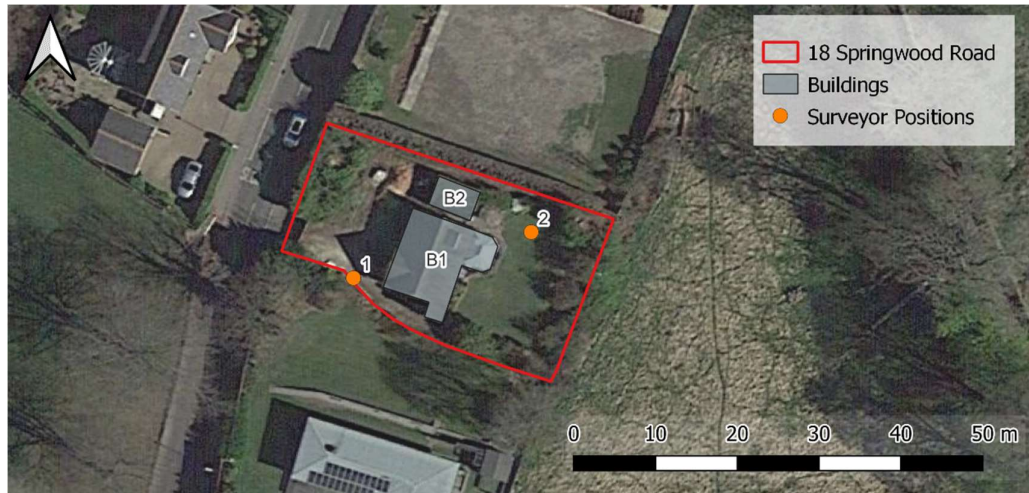
**Figure 2 – Nocturnal survey surveyor positions**

4.2.5 The nocturnal surveys required two surveyor positions. The surveyor positions were covered either by a surveyor using an EM Touch bat detector supported by an infrared (IR) camera and IR lighting system<sup>1</sup> or, an unsupervised infrared (IR) camera and IR lighting system with an EM Touch bat detector. The surveyor positions are shown in Figure 2 and coverage during each survey is shown in Table 2.

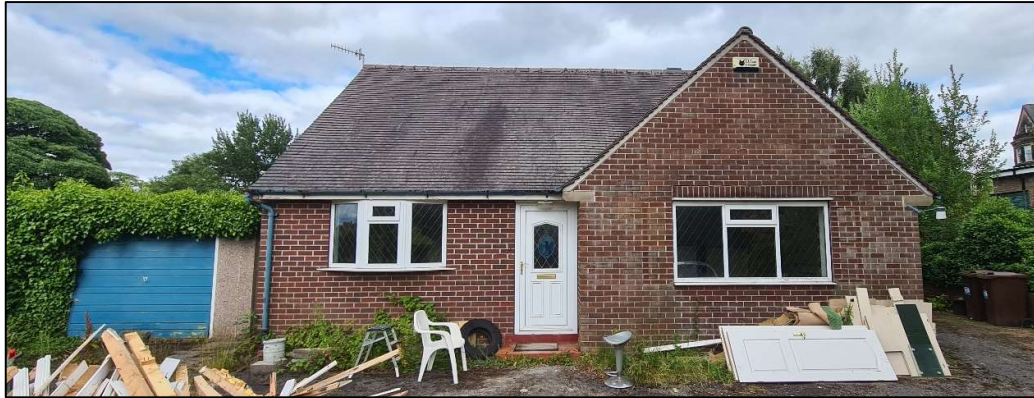
**Plate 1. Front of the building (west elevation)**

- 5.2.2 The site comprised a single storey brick built detached bungalow with additional rooms in the attic (Plate 1). The building was thought to date from the 1950s or 60s. The building had a soffit box present at the eaves with a mortared verge present on the gable ends. The window frames were uPVC and a small amount of uPVC cladding was present on a porch on the southern gable end.
- 5.2.3 A glazed conservatory was present on the eastern elevation of the property (Plate 2).

- 5.2.5 All features with potential to accommodate roosting bats were associated with the rosemary tile roof. There were missing and raised tiles across the roof and mortar gaps beneath vent tiles on the ridge. There were also gaps present between tiles at the roof verges above the gable ends.
- 5.2.6 The lead flashing that was present was generally fairly tight fitting and offered little in the way of bat roosting potential.

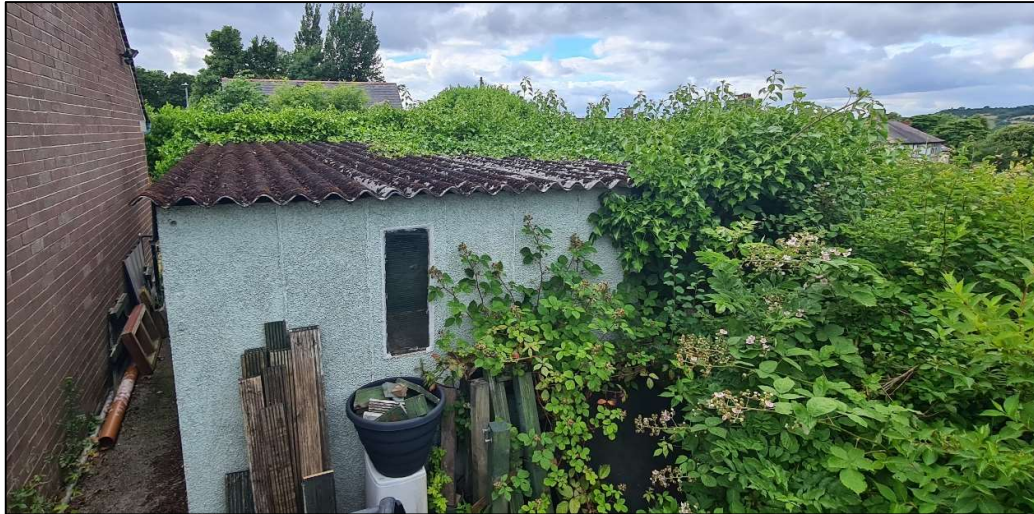
**Plate 3. Rear of the garage including the roof**

- 5.2.4 A detached garage was present to the north of the bungalow (Plate 3). The garage was constructed from pre-fabricated concrete panels with a corrugated asbestos cement sheet roof.

- 5.2.7 The garage adjacent to the building was not considered to have any features likely to be used by roosting bats.

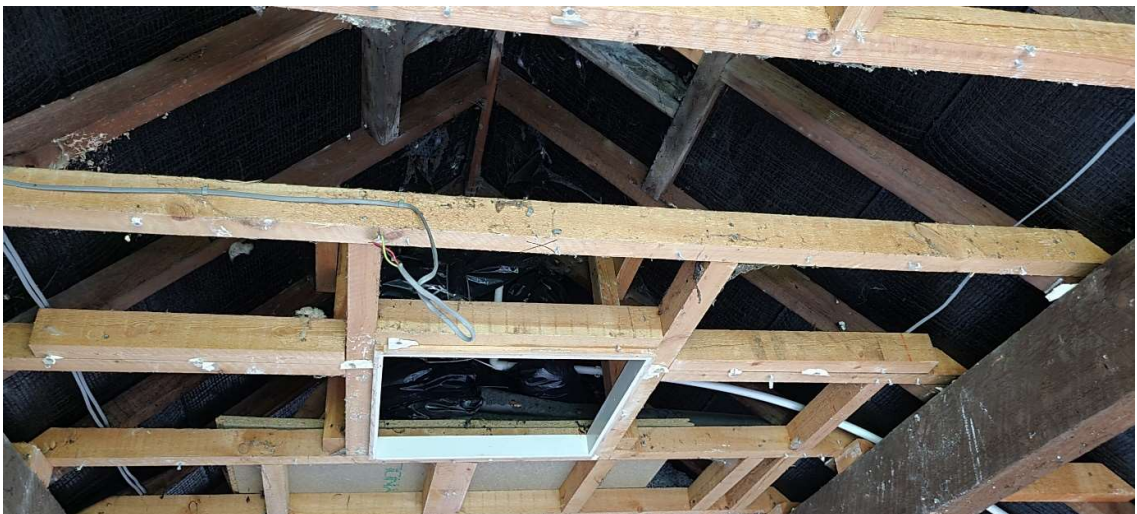
**Plate 4. Inside of roof-space**

- 5.2.8 The roof contained two bedrooms which had been taken out by the time of the survey. No ceiling was present so the Type 1F bituminous felt was visible along the pitch of the roof (Plate 4). No features likely to be used by bats were recorded within the inside of the building and no signs of bats were found.

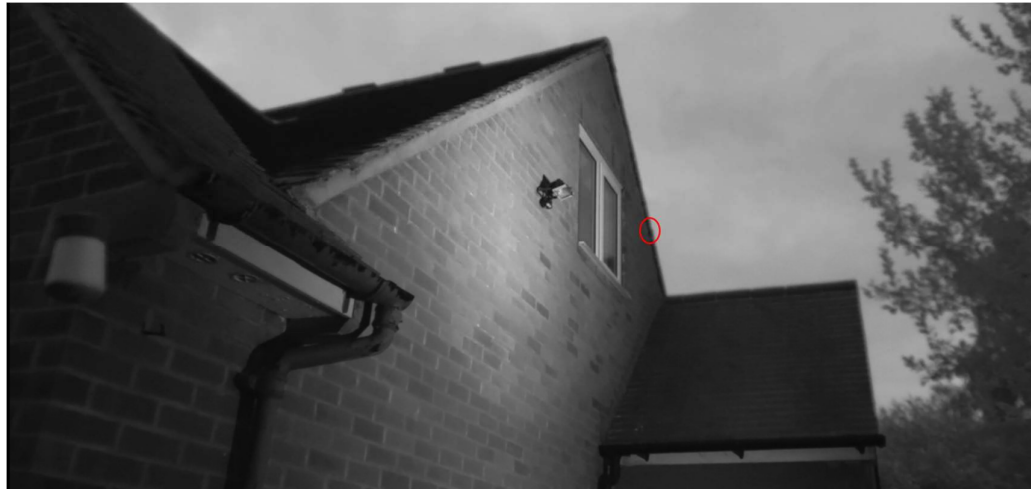
**Plate 5. common pipistrelle roost emergence location**

- 5.2.10 One common pipistrelle was recorded emerging from the verge of the southern gable end of the roof above the porch at 22:04 (location shown in Plate 5). The first bat recorded was a common pipistrelle recorded a minute before the emerging bat at 22:03 (25 minutes after sunset). That bat was recorded foraging in the garden of the property to the south. Occasional common pipistrelle activity was recorded throughout the survey together with a noctule recorded at 22:49 and 23:00.

- 6.1.1 Building 1 was identified as a summer day roost used by a single common pipistrelle. The roost will be lost during the proposed demolition of the building.

- 6.2.3 It is recommended that the following mitigation measures are implemented in order to prevent harm to any bats that may be present during the demolition:
- The demolition (specifically the work impacting the roost) should be completed either during spring (mid-March to May) or autumn (September to early November).
  - The roof tiles must be removed by hand following a toolbox talk by the ecologist.

- The removal of tiles along the ridge, eaves, and gable ends should be completed under direct supervision of the ecologist. The other roof tiles can then be removed providing the ecologist is available to capture and move any bats found.
