Masjid Usman, Huddersfield

Bat Roost Suitability Assessment

02/02/2023

Report reference	ER-6394-01 BRSA
Author	Charlie Foreman BSc (Hons) Assistant Ecologist
Technical Review	Rob Weston BSc (Hons) MSc MCIEEM Technical Director
QA	Jon Roberts MSci (Hons) Biodiversity Technician
Authorised	Rob Weston BSc (Hons) MSc MCIEEM Technical Director
Date	02/02/2023
Report duration	In accordance with CIEEM (2019), unless otherwise stated the findings of this report remain valid for a period of 18 months. After this period advice should be sought on the scope of any updating work required.

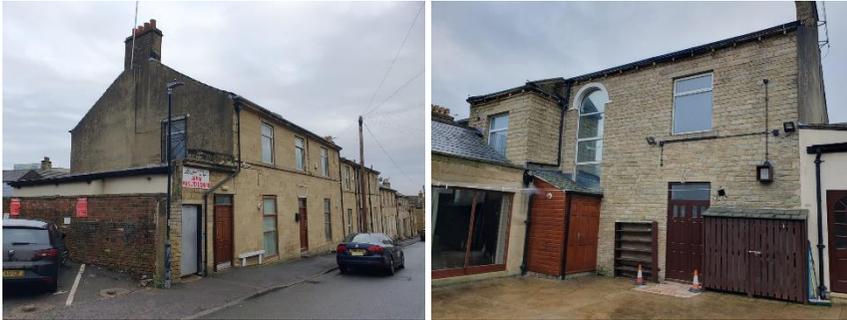
Figure 3 Showing typical view of building – south (left) and north (right).

13. The Site consists of a two-storey end terrace property with a single storey lean-to extension to the west, located on Upper George Street.

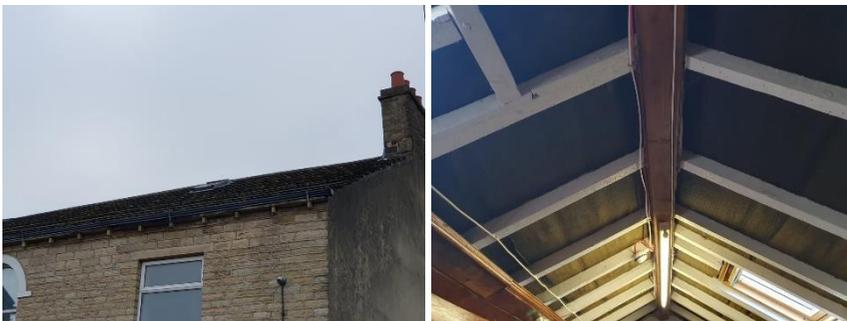
Figure 4 Showing exterior (left) and interior (right) views of roof.

14. The property has a double-pitched concrete tile roof with exposed gable to the west. The roof is in generally good condition with no slipped or damaged tiles noted. The exposed verge is sealed with mortar. uPVC skylights rest flush with fixtures with no points of ingress.
15. Internal inspection found the attic space to be regularly used for storage. The roof is lined with bitumen which appears in good condition and well-sealed. No evidence of roosting was found across the attic.

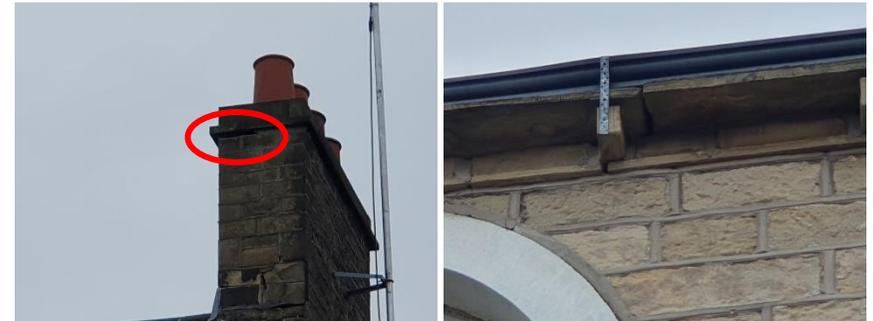
Figure 5 Showing chimney crown gap (left) and stone supports (right).

16. A stone chimney juts from the western elevation. Mortar is largely in fine condition, though a single exception is noted beneath the crown, presenting a gap suitable for roosting by a small number of crevice-dwelling bats. The lead flashing is well-sealed.
17. Plastic guttering is supported by masonry running beneath the eaves. A single gap is noted where masonry surrounding a stone support has shifted, offering a potential roost feature (PRF).

21. Based on the features present, Majid Usman has been assessed as having low suitability for supporting roosts. The features are summarised below:
- Gaps in masonry
 - Damaged/missing mortar
 - Gap to wooden soffit
22. In line with best practice guidelines (Bat Conservation Trust, 2016), further survey should be carried out to establish if potential roost features are being used by bats.
23. This should take the form of a single nocturnal survey (dusk emergence or dawn re-entry). Surveys should be undertaken during the active bat survey season, which runs from May to August inclusive, with September providing sub-optimal conditions.

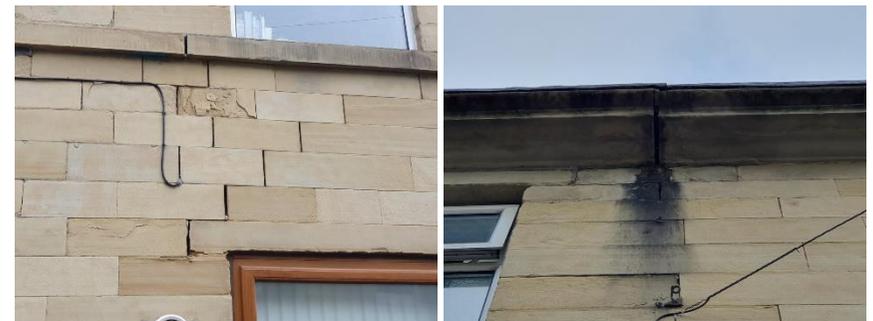
Figure 6 Showing gaps in wall across northern elevation.

18. Across the northern elevation, sandstone walls are in good condition. To the south, fronting onto Upper George Street, several cracks are noted where mortar is missing. Some of the resultant gaps are considered suitable for roosting.
19. uPVC windows and doors all sit flush within surrounding sandstone masonry, with no PRFs noted.

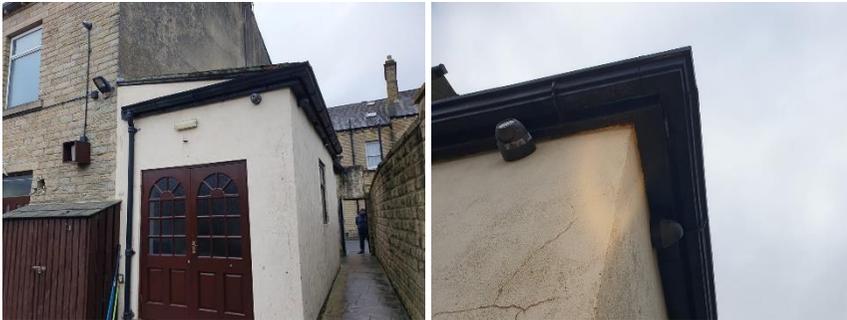
Figure 7 Showing view of extension (left) and gap to soffit (right).

20. At the base of the western gable is a single-storey lean-to extension. Walls are rendered and sealed throughout. Plastic guttering rests adjacent to a wooden soffit. The soffit shows signs of extensive water damage, with rot evident. A single dry gap is noted at the northern corner, though the suitability of this feature to support roosting bats may be limited by the damp conditions present.
