## **VERIFICATION REPORT**

**FOR  
PLOT 6,  
LAUND ROAD,  
SALENDINE NOOK,  
HUDDERSFIELD,**

**PREPARED FOR  
CREATIVE DEVELOPMENTS  
(HUDDERSFIELD) LIMITED**

**REPORT NO. NE3941F/6  
JULY 2022**

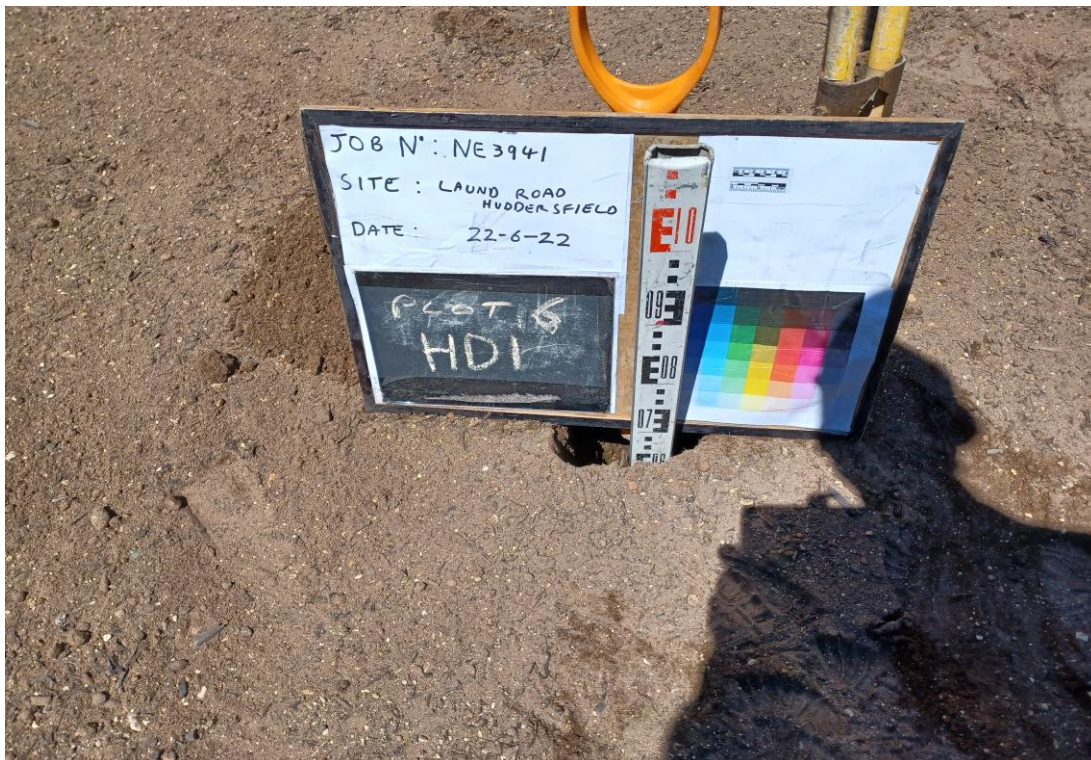
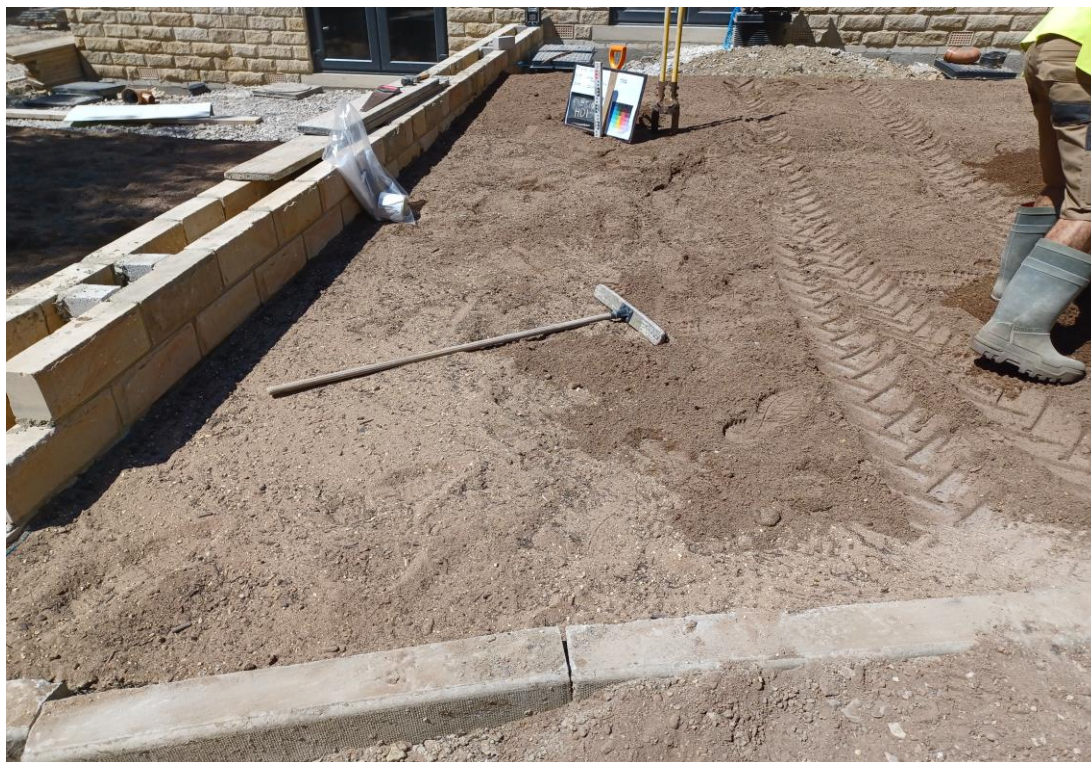
A hand dug pit (HD1) was taken out at the position determined and set out by Sub Surface North East Limited, as shown on Figure 3. The hand dug trial pit was excavated to the base of the cover system at a depth of 0.68m. Samples were taken for logging, in accordance with BS EN ISO 14688-1: 2018 and BS EN ISO 14689-1: 2018, and the resulting Hand Dug Trial Pit Records are appended. The findings are summarised in the following table:

| Pit No. | Location | Depth of Clean Topsoil (mm) | Description |
|---|---|---|---|
| HD1 | Plot 6 Rear | 680 | Brown slightly gravelly sandy topsoil. |

Photographs were taken on completion of the hand dug pits and photographs detailing the prepared aggregate to the front of Plot 6 are appended.

In our opinion, the implementation of the cover system has been successful with a depth of clean cover of 680mm being achieved in the rear garden of Plot 6. This depth of cover exceeds the recommendations given in BRE BR465 and should provide adequate protection to the end users of the site.

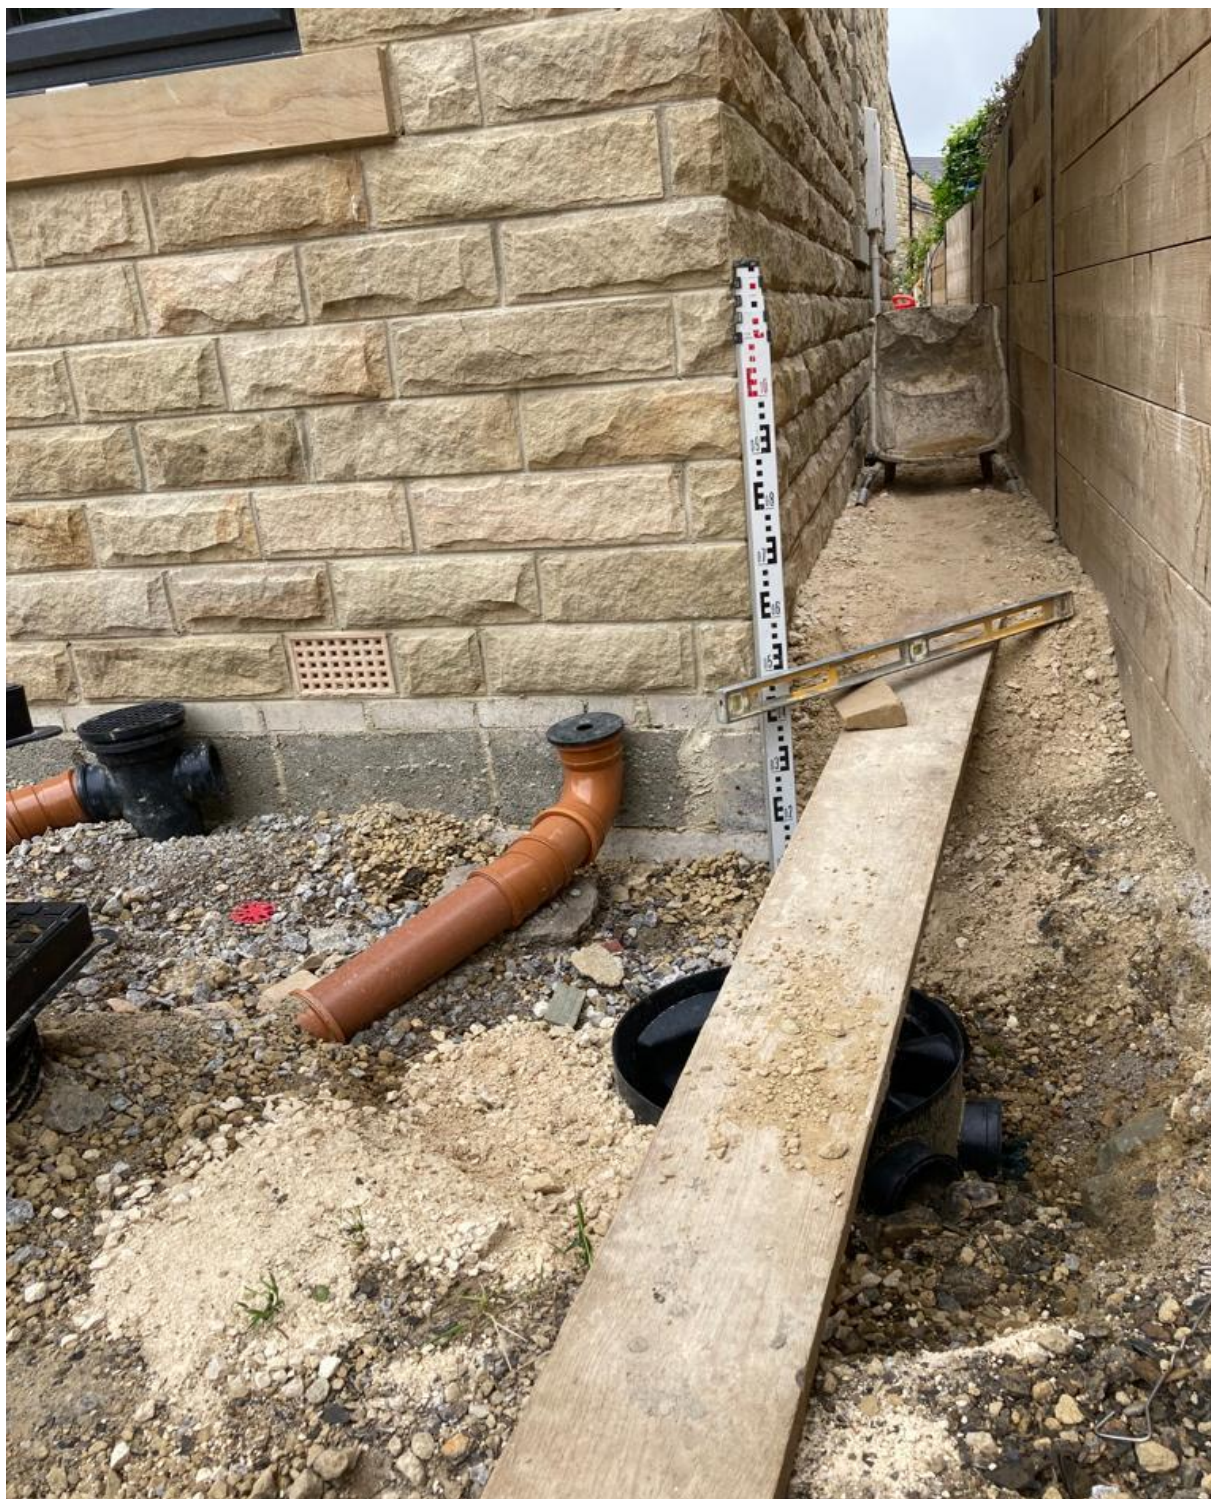
#### FRONT & SIDE HARD PAVING PREPARATION

- A 600mm blanket of clean topsoil was placed in the back garden of Plot 6.
- Hard paving was installed on a minimum 150mm bed of aggregate adjacent to the side, front and rear patio of the building.

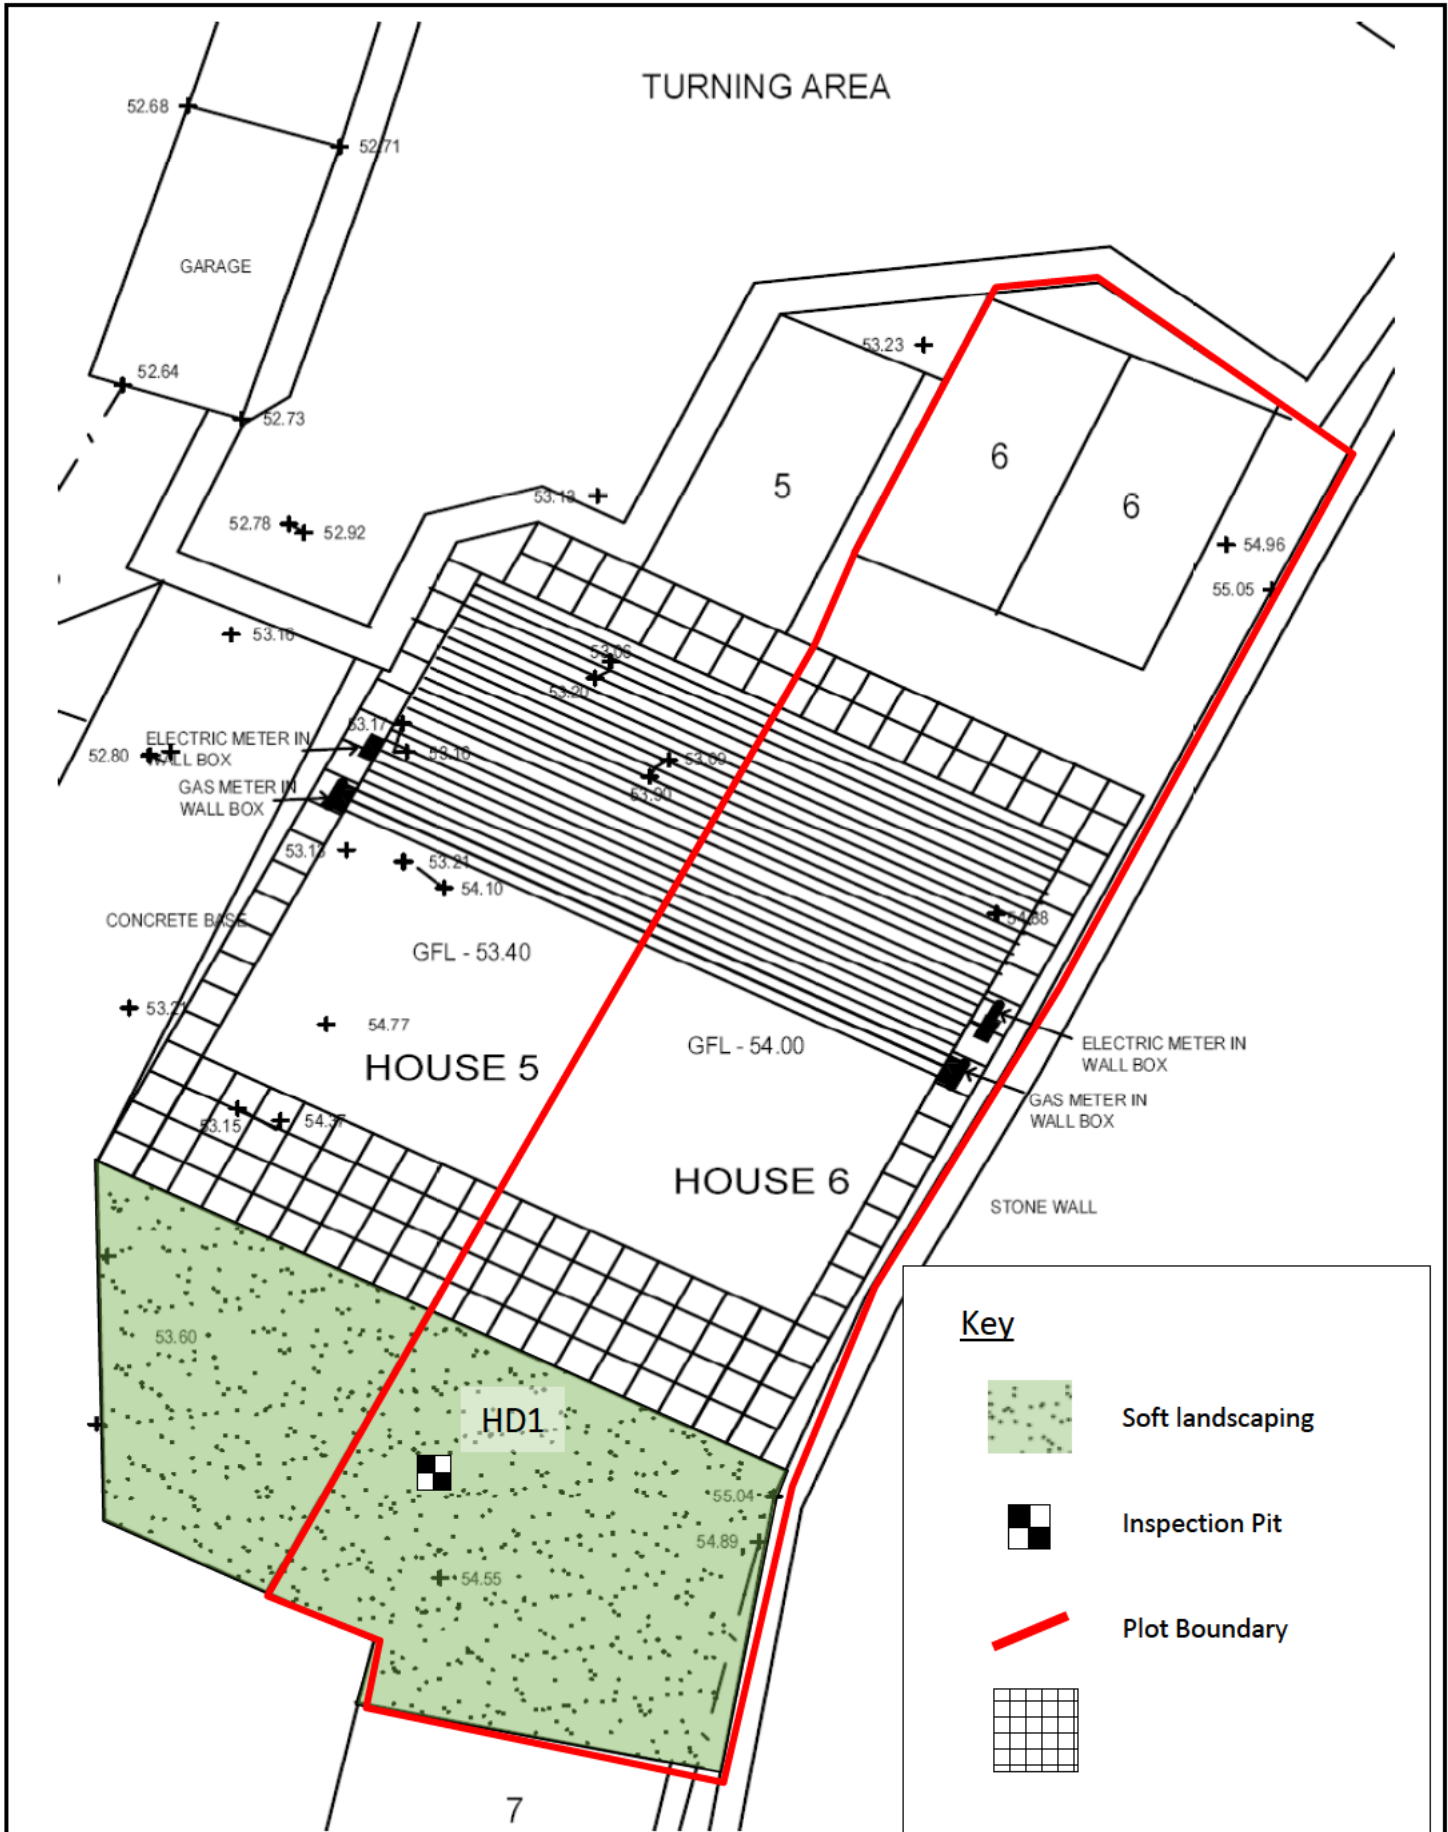
The site is currently being developed as residential housing as depicted on Figure 3.
