Kirklees Council

HECKMONDWIKE BUS STATION

Arboricultural Impact Assessment Report

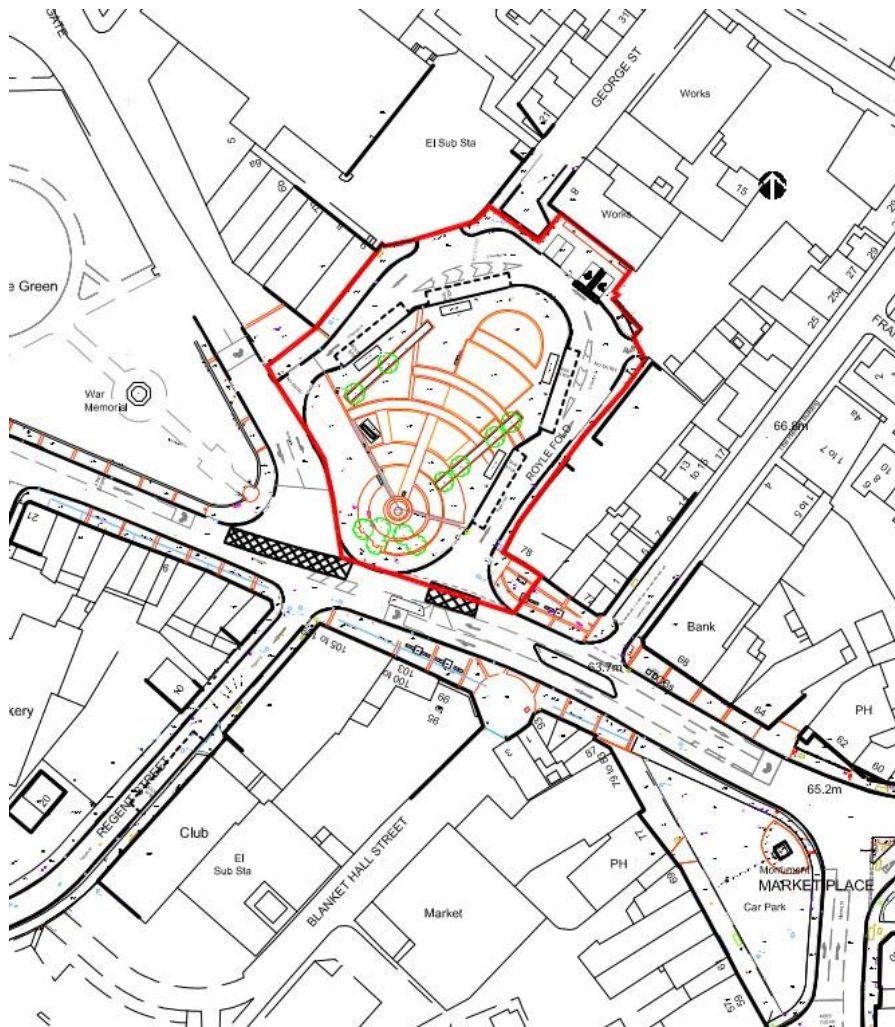
Figure 2-1 - Planning application boundary (red line) as taken from the location plan Drawing no. 20-233-SGP-XX-00-DR-A-010001

2.1.1. The arboricultural study area includes trees up to 15m from the planning application boundary shown in Figure 2-1. The purpose of a 15m buffer is to ensure compliance with BS 5837 which recommends that all arboricultural features whose Root Protection Areas (RPAs) may be impacted are identified, surveyed and included within the assessment. The British Standard caps RPAs to a maximum radius of 15m, hence the extent of the buffer.

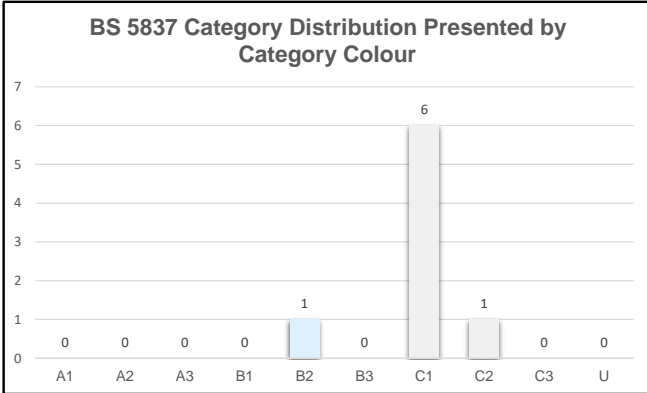
Chart 1

BS 5837 Category Distribution displays the proportion of trees assessed in each category type to enable a better understanding of the category distribution across the population. Trees have been divided into one of four categories based on Table 1 of BS5837 Cascade chart for tree quality assessment.

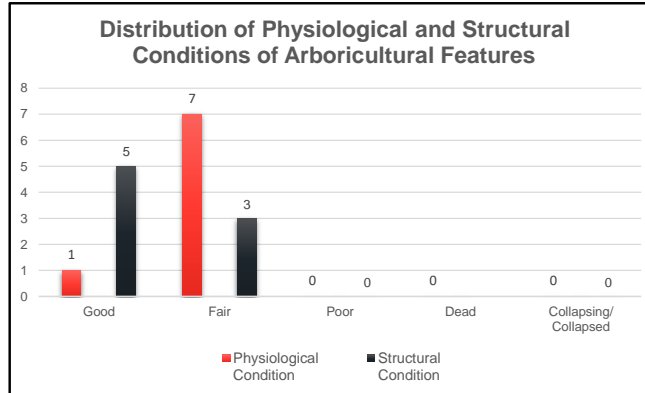
Chart 2

One of the key factors in assessing the long-term value and vulnerability of the resilience of the tree population to pests and diseases is the overall condition of that population. Physiological condition provides an indication of the physiological vitality of the tree whilst tree structural condition is related to the presence of defects (e.g. large cavity or codominant branches with included bark) that can lead to tree failure. An assessment of the condition allows for an assessment of the overall health of the tree population

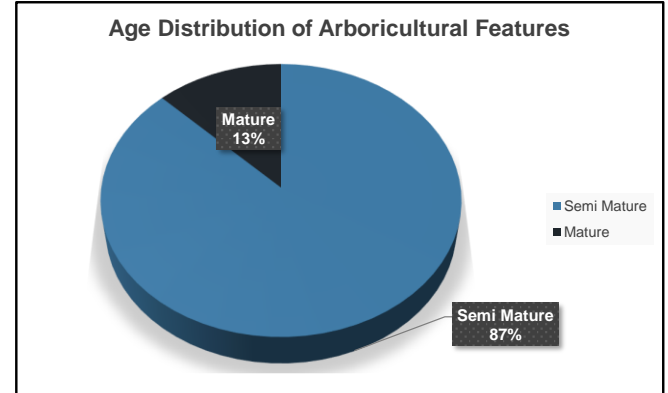
Chart 3

Age Distribution of Arboricultural features shows the percentage of the tree population in each age category. The distribution of age category across the population is useful for understanding the expected longevity of the existing tree cover which can be used for determining mitigation, management and replacement. A population requires sufficient large, mature trees to deliver the widest range of environmental benefits in urban areas and enough trees of a younger age classes to replace these mature trees as they eventually die.

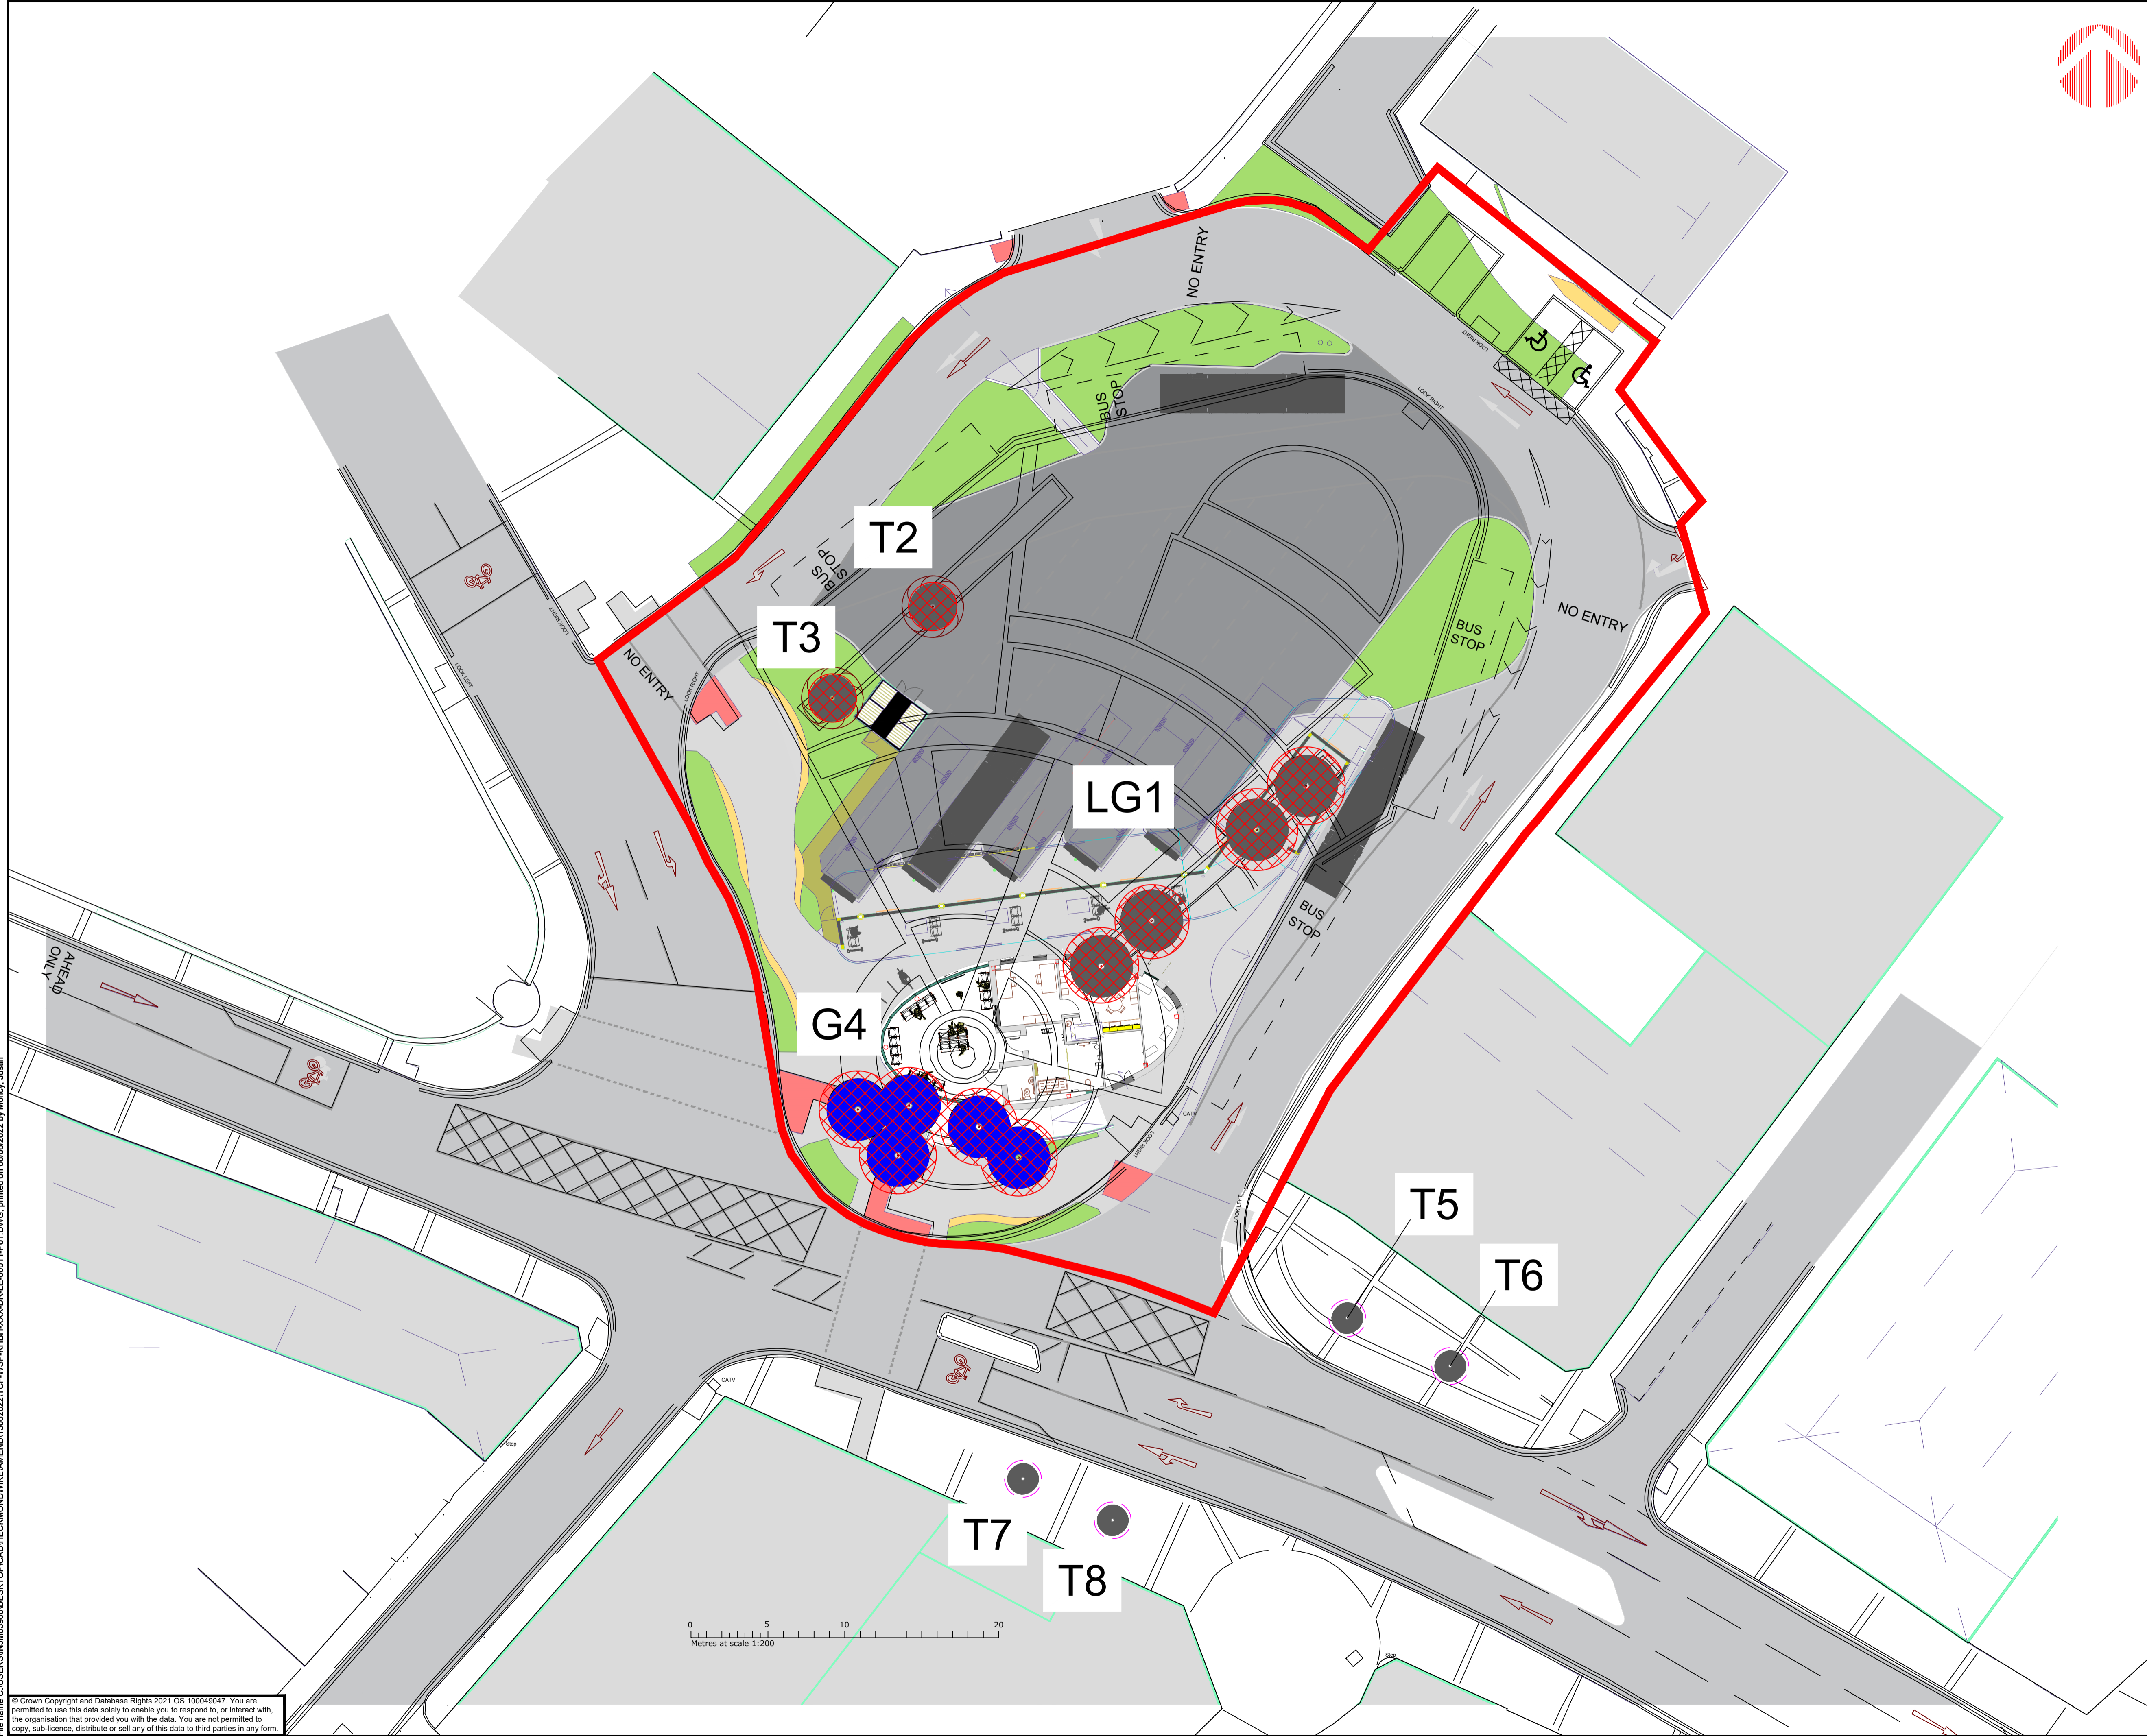
TITLE: Tree Retention and Removal Plan
Sheet 01 of 01

- 4.3.1. The proposed development in relation to arboricultural features is shown in the TRPP of Appendix C. The Proposed Development will result the removal of LG1, T2, T3 and G4.
- 4.3.2. LG1 and G4 are to be removed to enable the construction of the covered concourse and the enclosed waiting area with welfare and office space. T2 and T3 are to be removed to enable the reconfigured layout of the site. While there is potential to retain T3 in a new landscaped area the tree has suffered damage to the upper crown and the tree is of a size that can be replaced with relative ease securing a better quality tree in a location more suited the Proposed Development layout.

- Planning Application Boundary
- Indicative root protection area (RPA)

Development approaches these trees, physical measures should be put in place to protect these trees, details of which are provided in the AMS at Appendix D.
