**PHASE II / GROUND INVESTIGATION  
AND UPDATED RISK ASSESSMENT  
REPORT**

**LAND ADJACENT TO NO. 7, TOWN  
GATE, SCHOLLS**

**MR D. BLACKBURN**

Report Reference: GES 2371-22 PII

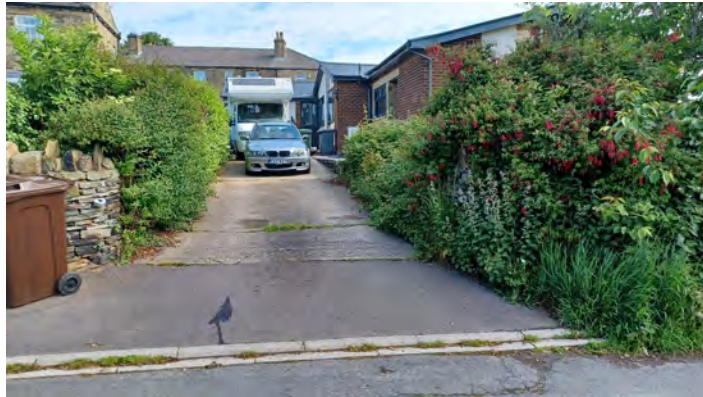
- A. Facing north, view of site access.
- B. Facing northeast, view of central site area.
- C. Facing south, view of eastern site boundary.
- D. Facing north, view of southern site boundary from Town Gate.
