# **The George Hotel, St George's Square Huddersfield**

## **Paint analysis results**

**From samples taken from the exterior of windows  
on the first three floors of the South Elevation**

**September 2022**

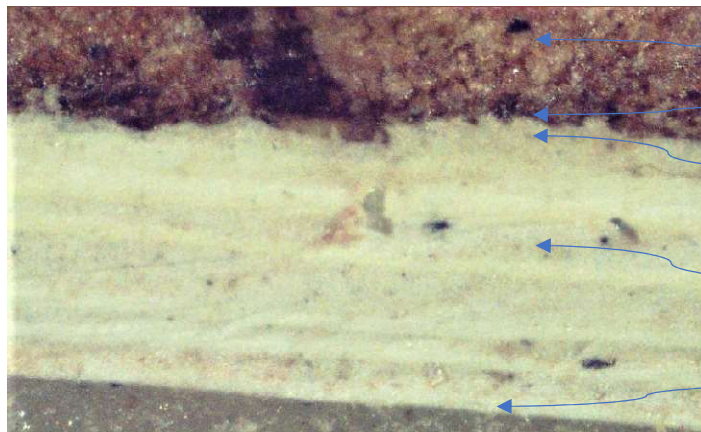
**3. Lower sash sill, 1<sup>st</sup> floor window, 2<sup>nd</sup> from left, when viewed from the front.**

- Wood
- Red lead primer
- Undercoat
- Zinc and lead white primers and cream stone coloured oil paints. (6 alternative layers)
- Modern gloss layers

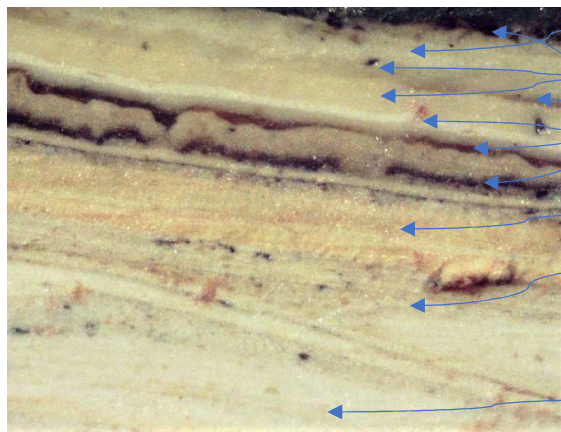
**4. Outer frame sill, ground floor window right of door, when viewed from the front.**

- Undercoat
- 2 layers of Stone coloured oil paint
- Red and white lead primers
- 2 layers of cream oil paint
- Zinc, lead white and red lead primers and stone coloured oil paints. (4 alternative layers)
- Modern gloss layers

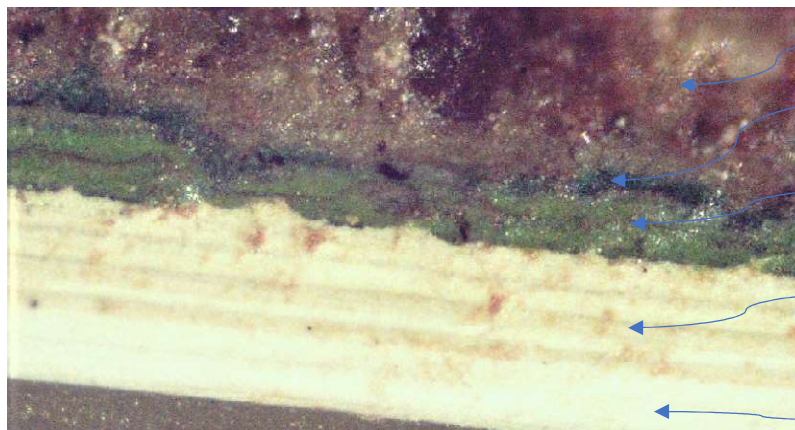
**5. 1<sup>st</sup> floor 1930's metal window, on western elevation**

- Rust
- Bituminous Priming coat
- Two layers of bright dark green
- Zinc and lead white primers and cream stone coloured oil paints. (6 alternative layers)
- Modern gloss layers
