**KIRKLEES CULTURAL HEART**  
**HERITAGE STATEMENT: VOLUME 4**  
**LIBRARY AND ART GALLERY: ASSESSMENT OF SIGNIFICANCE**

CDT430201-FCB-XX-XX-RP-A-000004  
VERSION: V2 | MARCH 2022

FEILDEN CLEGG BRADLEY STUDIOS

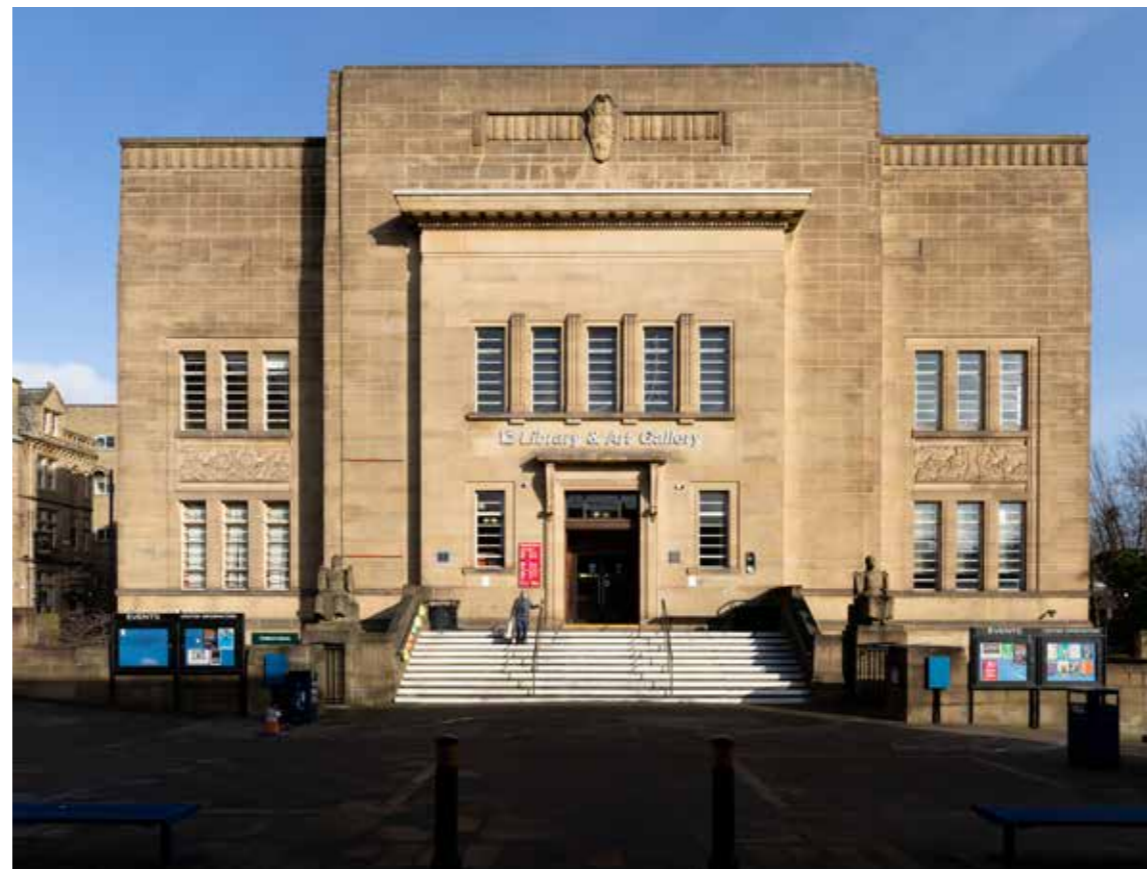
4.4.1 - South elevation onto Princess Alexandra Walk

This south-facing elevation is in a reductive Art Deco style with clear Egyptian and Greek stylistic influences. The entrance is somewhat pinched, set at the centre of the elevation below a series of five tall windows that describe the first-floor landing above the entrance hall. The public entrance seems too understated a gesture for the boldness of the elevation but is likely the consequence of achieving a practical threshold between inside and out. The two enthroned sculptures of 'Spirit of Literature' and 'Spirit of Art', by James Woodford RA and situated to the west and east of the entrance respectively, are of very high aesthetic and artistic value. These are carved from local stone and are highly significant assets in their own right, but also as components in the composition and stylistic execution of the primary elevation. Their inclusion emphasises the main entrance approach. Woodford also created the decoratively carved relief panels set in the spandrel between the ground and first floor windows, which comprise grouped figures symbolising arts and cultural activities. Bronze grilles that originally marked the entrance door head and windows flanking the entrance have since been lost. The central handrails on the approach stair are later 1980s additions.

As an aesthetic and architectural composition, the south elevation is carefully controlled and has an austere elegance. The detailing shows a strong transition between the Art Deco influences of the 1930s and the Modern Movement that was set to dominate.

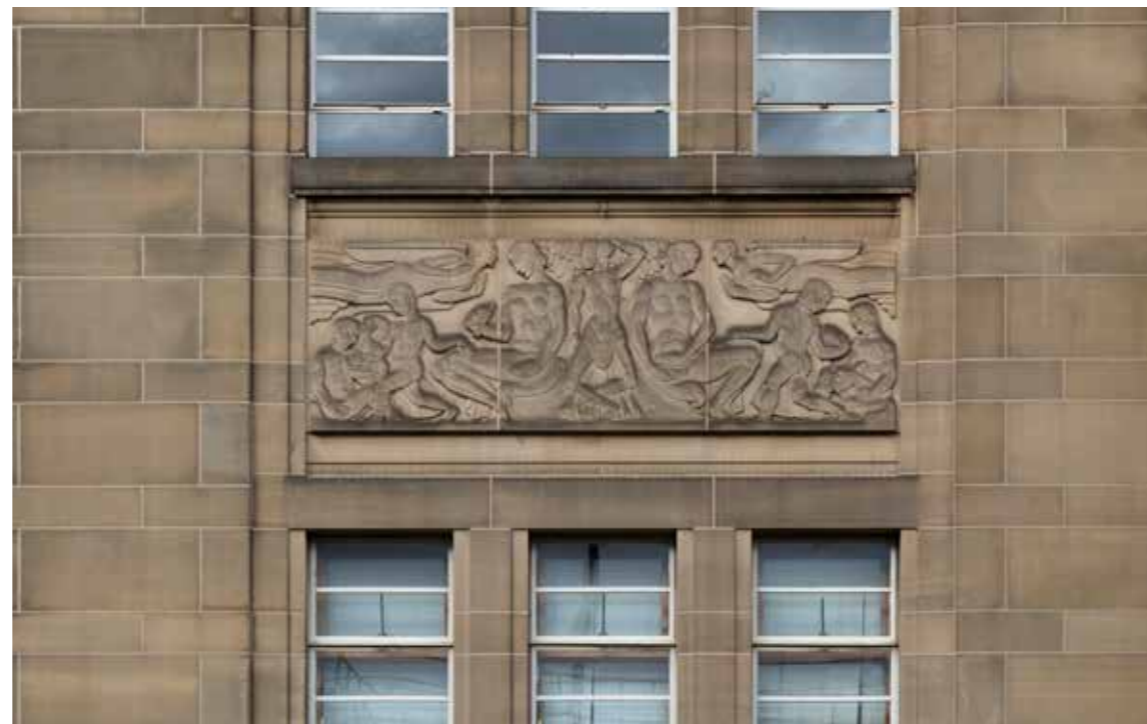
4.4.3 - Decorative panel on south elevation, James Woodford, 1939

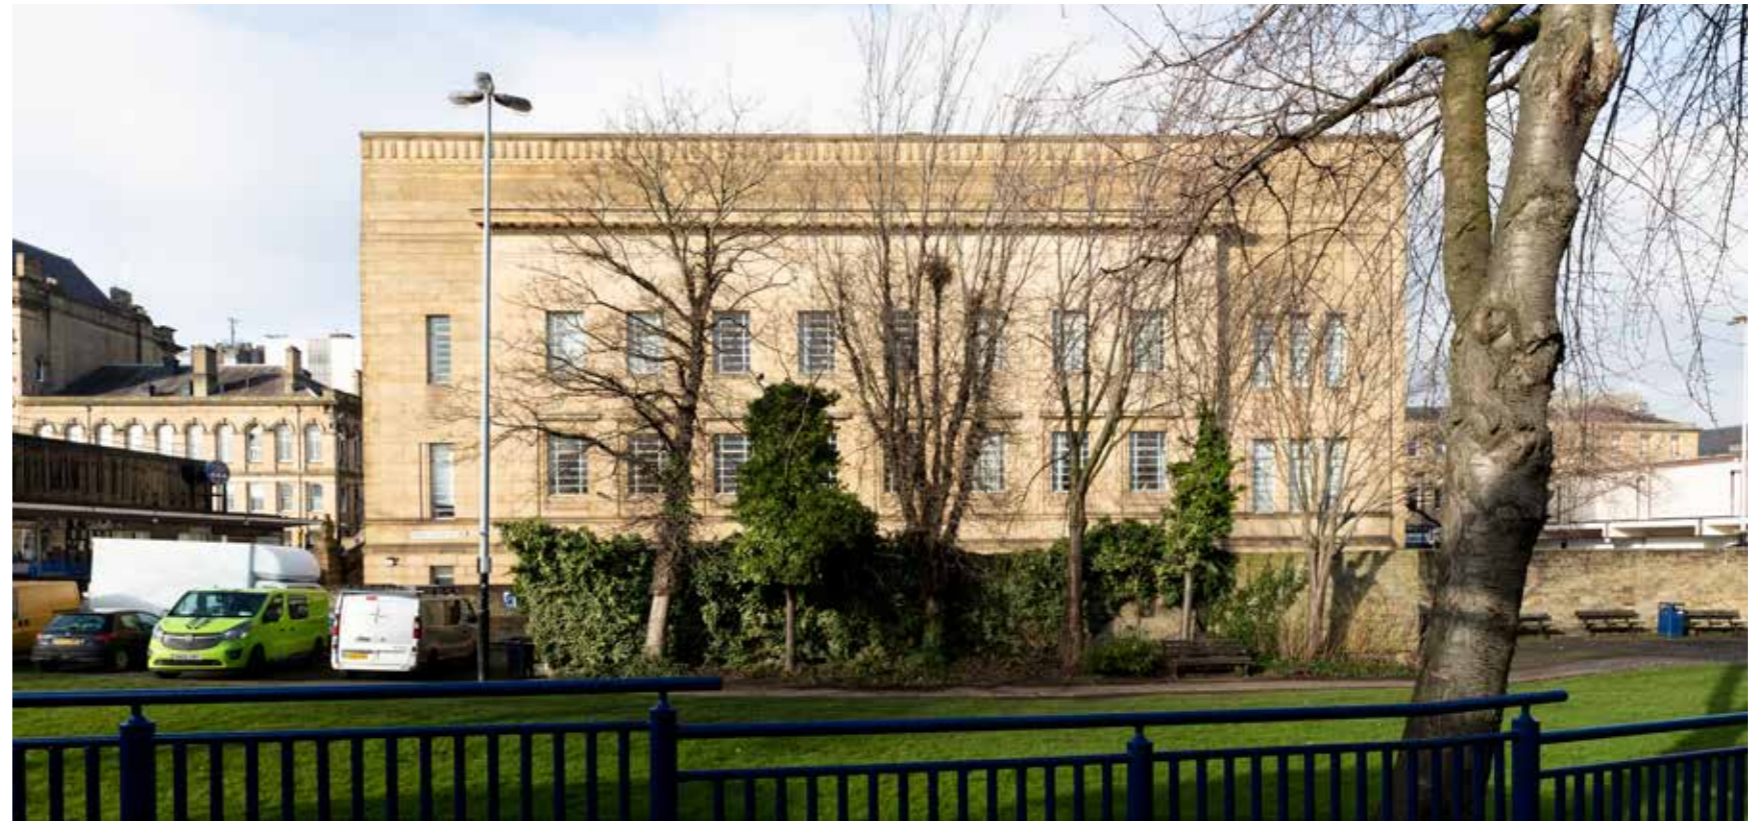
4.4.5 - East elevation facing the Piazza Shopping Centre

The façade of the Library was to be seen in the context of the primary elevation and as a continuation is of the same architectural aesthetic, but on a simplified canvas with reduced artistic adornment. The changes made to the surrounding townscape as a result of the 1969-1974 Murrayfield development left this elevation far more visible than Ashburner would have envisaged. Furthermore, the removal of Bull and Mouth Street and the subsequent formation of a steeply sloping route into subterranean tunnels has served to isolate this elevation from the public realm. This space was initially excavated to form a car park and adjacent delivery zone. The continuation of this as an access route from the tunnels to the upper street level was made some time after 1990.

The east elevation holds value for its architectural detailing, however the erosion of it imposes a negative impact on this aspect of the building.

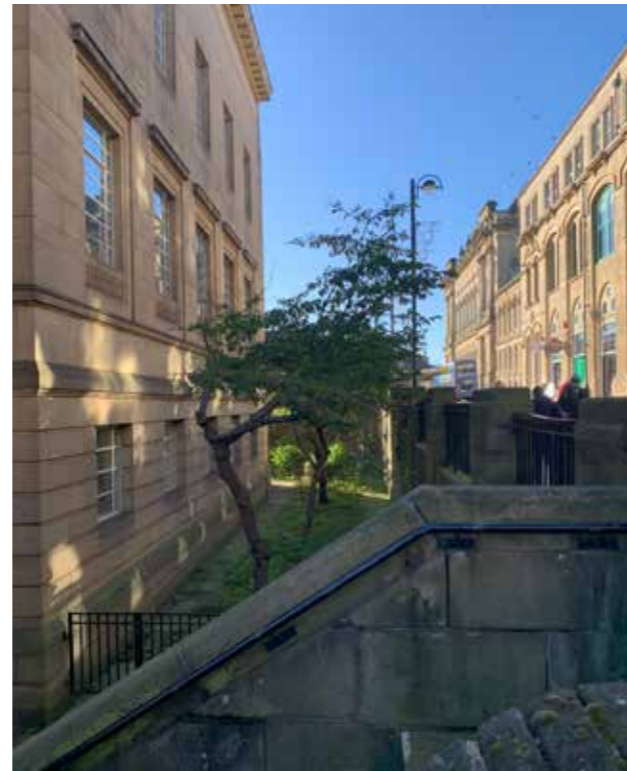
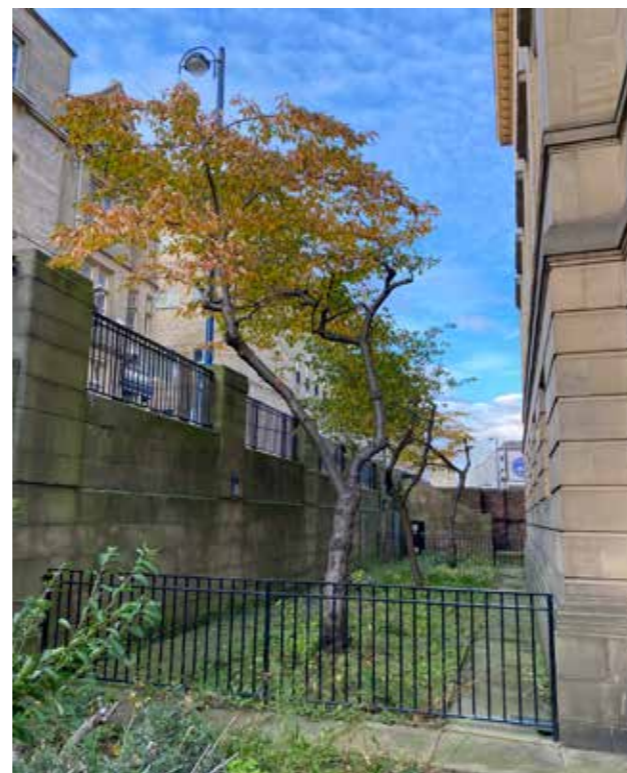
4.4.8 - West elevation and sunken garden

4.4.9 - West elevation and sunken garden

The composition of this elevation is broadly identical to that of the east, with some minor adjustments to suit the shorter plan on this side of the building. This elevation has medium significance.

The northern projection of the elevation beyond the formal piece serves as the façade of the service block. At the time of the building's completion in 1940, the floor at this location would have been disguised by surrounding existing buildings, however later clearance works have left this area empty (see description of the north / tertiary elevation). The west-facing elevation of the service block has low significance.

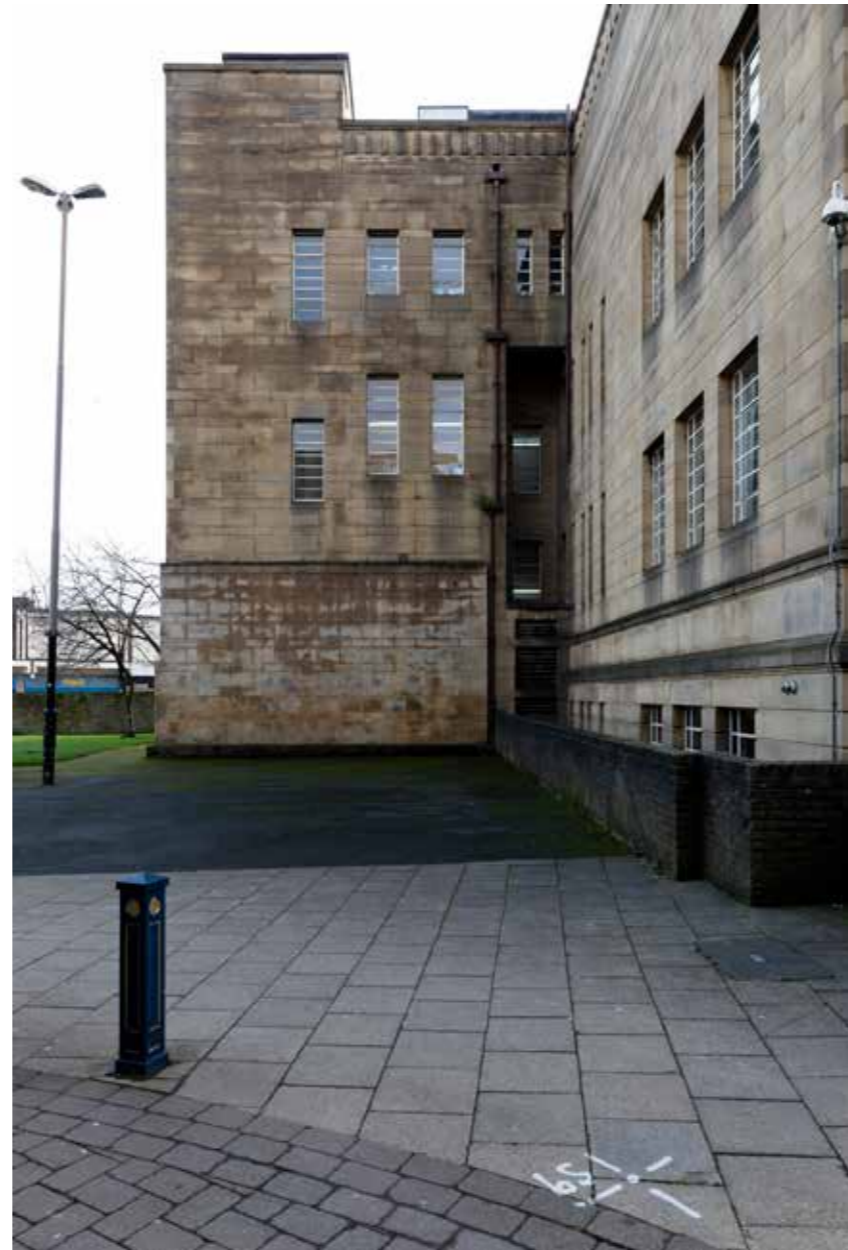
4.4.11 - North elevation

In summary, the north elevation in isolation comprises little in the way of aesthetic value and is of low significance when compared to the building's other elevations. Furthermore, it could be argued to embody negative significance when weighed in the round with its immediate setting, which is considered to impart a negative impact on the building as a whole and its wider context.

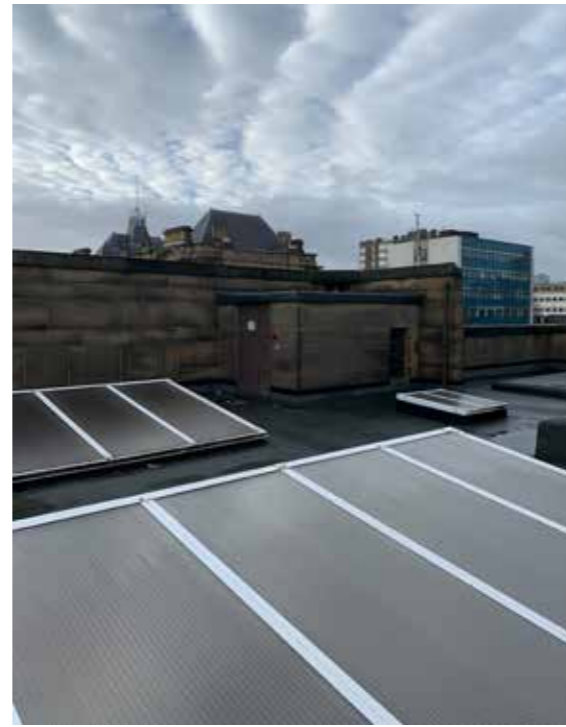
4.4.13 - Modern lanterns to roof

The lanterns are a combination of triangular pitched profiles orientated to match the rooms below with more simplistic upstands. The pitched elements are typically glazed along one face and in-situ concrete to the other. The roof was originally covered in asphalt. All roof forms still exist but in varying degrees of completeness, with some capped and felted over. Where lanterns remain functional, the glazing is of a modern replacement. The arrangement of pitched roofs, gutters and flat roofs across the roofscape have all been relined in mineral felt or other flat roofing material. The original roofing coverings have been either removed or covered over.

The presence of roof lanterns illuminating the gallery holds some significance tied to the functional operation of these spaces, however the absence of original material and the architectural form of the lanterns themselves offer little historic value.

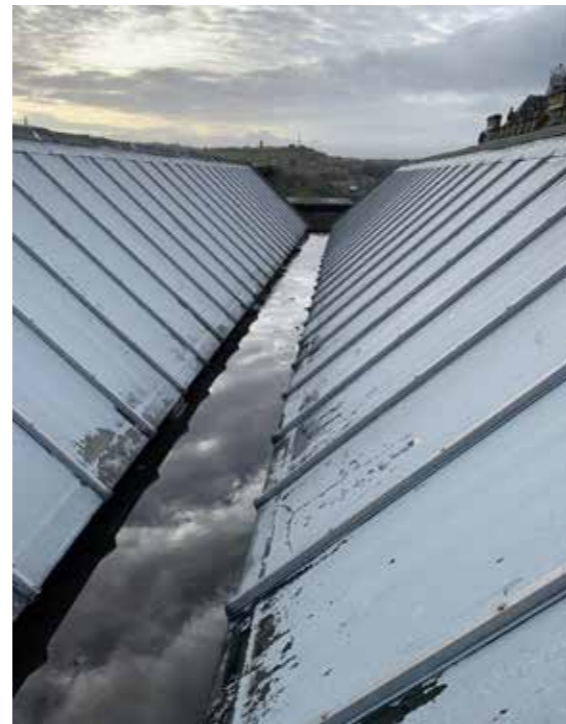
4.4.16 - Original lanterns to roof

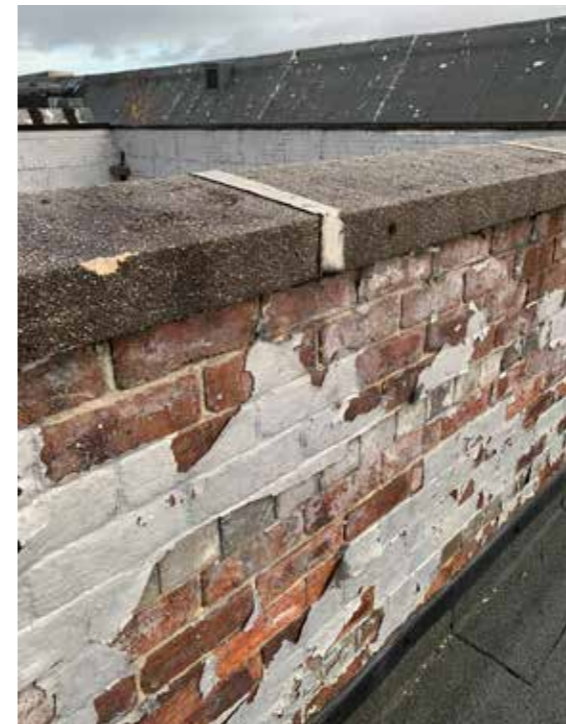
4.4.17 - Deteriorating roof parapet

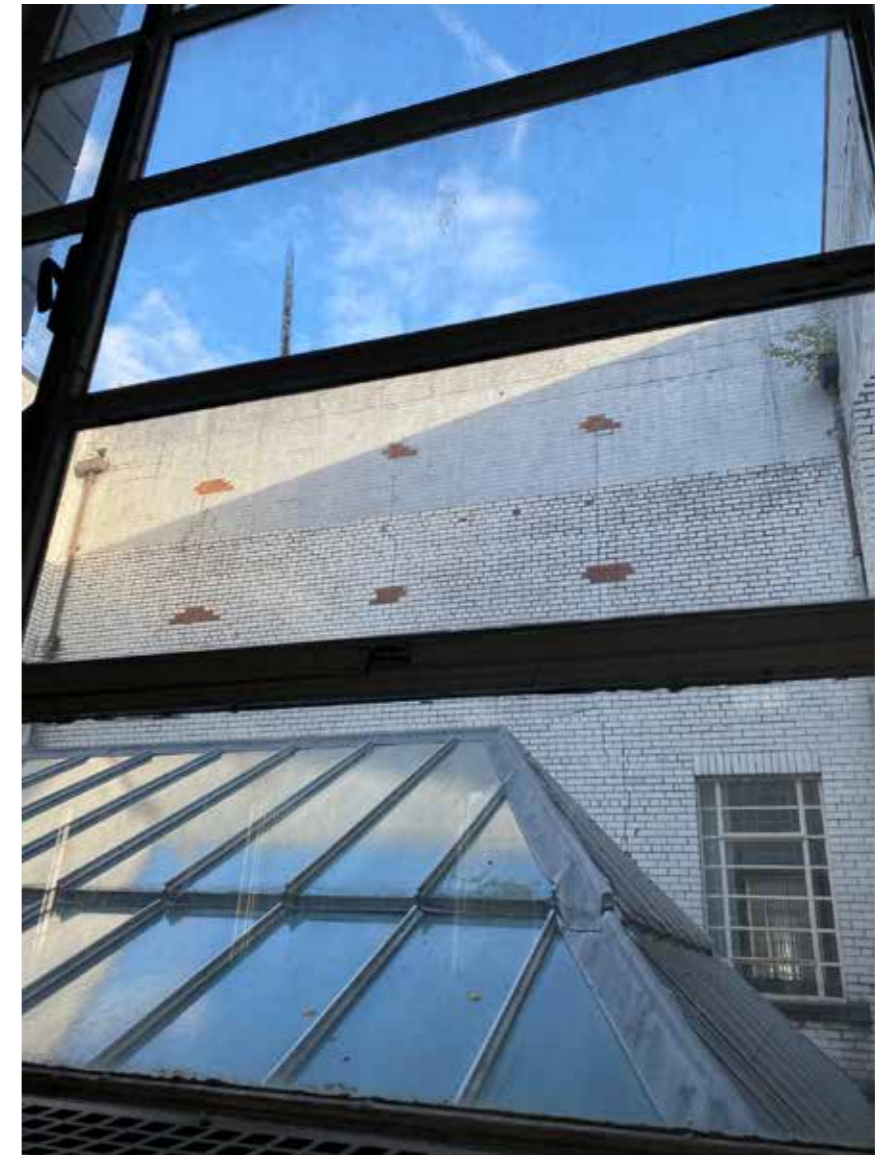
4.4.19 - Lightwell above atrium

The upper roof discharges rainwater into the lightwell, which is reported to regularly flood and requires weekly maintenance to avoid excessive damage.

The lightwell's form and application of materials are not unique or remarkable features, however its inclusion is a key articulating device that drives the building's typology and floor plan arrangement. The importance of natural light penetrating deep into the building characterises these spaces afforded by the lightwell serves to heighten the building's role as a hub for civic and cultural life. As such, the lightwell has historic value for its form and purpose within the wider arrangement of spaces but is low in aesthetic value in relation to its design and use of materials.

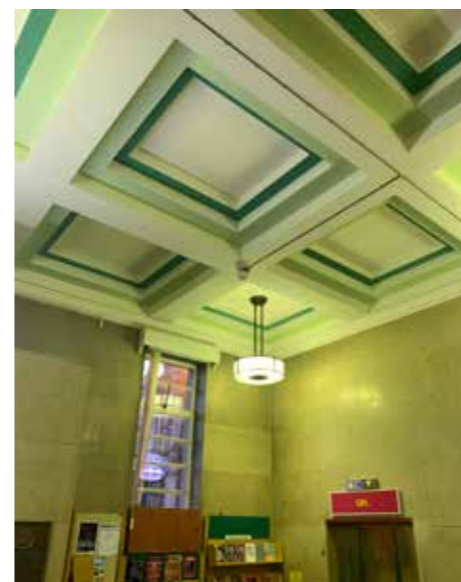
4.5.3 - Ceiling to Entrance Lobby / Reception (Rm.52)

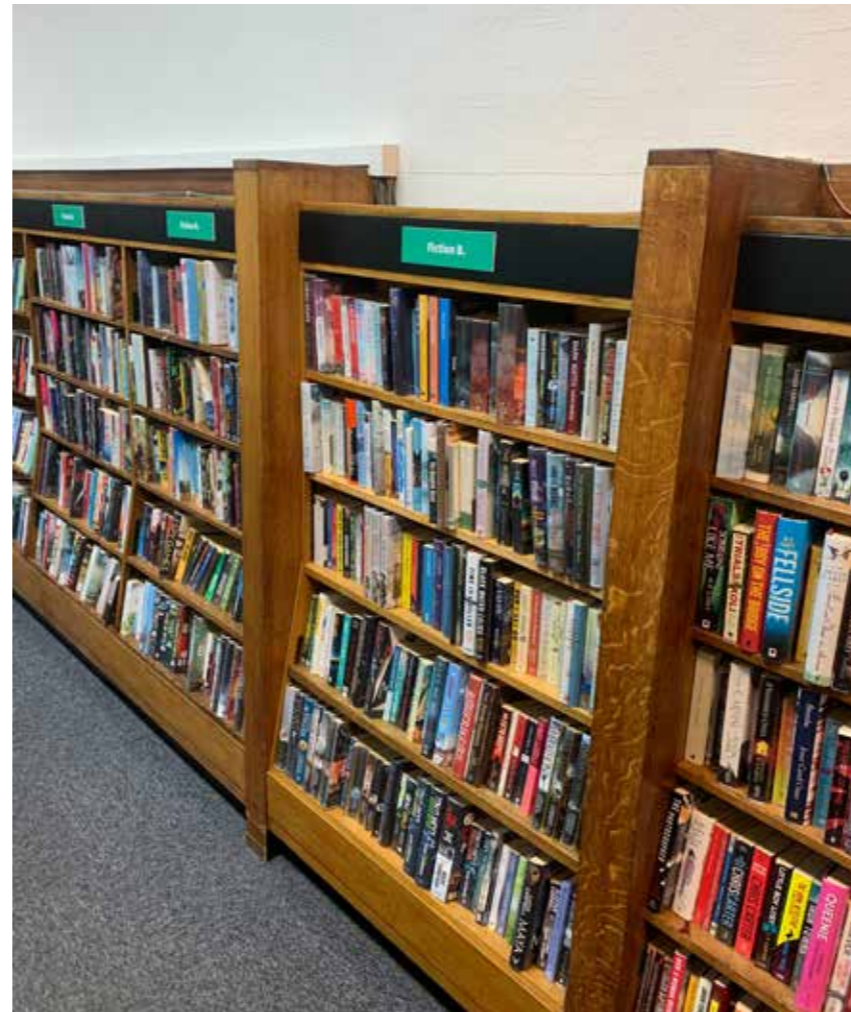
The fittings are a combination of original shelving to the perimeter with modern movable shelving within the floor plate and a modern serving counter. A number of original fittings and fixtures have been lost, including the original serving counter, turnstiles, shelving from the body of the floor area and electric lighting. It is also noted that the current room layout has been flipped from that of the original design, with the modern serving counter currently located at the north end of the plan.

4.5.7 - Shelving in Main Lending Library (Rm.47)

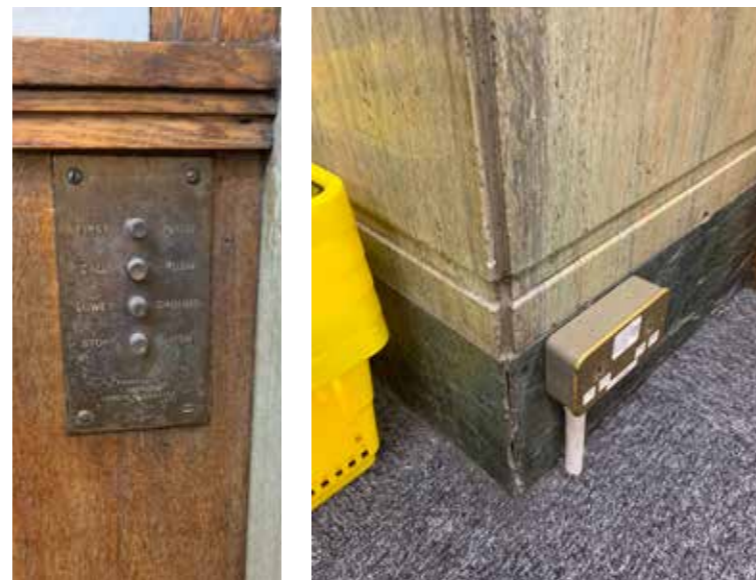
4.5.10 / 4.5.11 / 4.5.12 - Services to Main Lending Library (Rm.47)

The building was designed with a whole-building centralised mechanical ventilation system, with services discreetly hidden within the building fabric (namely the external walls) and selected fixtures. Inlet and extract ducts serving each main room of the library and art gallery spaces were designed to terminate at fitted furniture in the form of bookshelves, archive shelving or dado panelling. These vents are typically described by flat bronze grilles set into and over the joinery. Larger extract vents are found in the walls at higher level and are typically of timber that has been painted to match the wall. The lower ground plant spaces included the main fan room, which is still present and appears to still contain the original or early equipment. This connects to the main shaft that rises and connects to the ventilation distribution that runs through the building. The original plans including a central vacuum cleaning system. This was similarly concealed within the building fabric and is typically located in the corner of the library rooms.

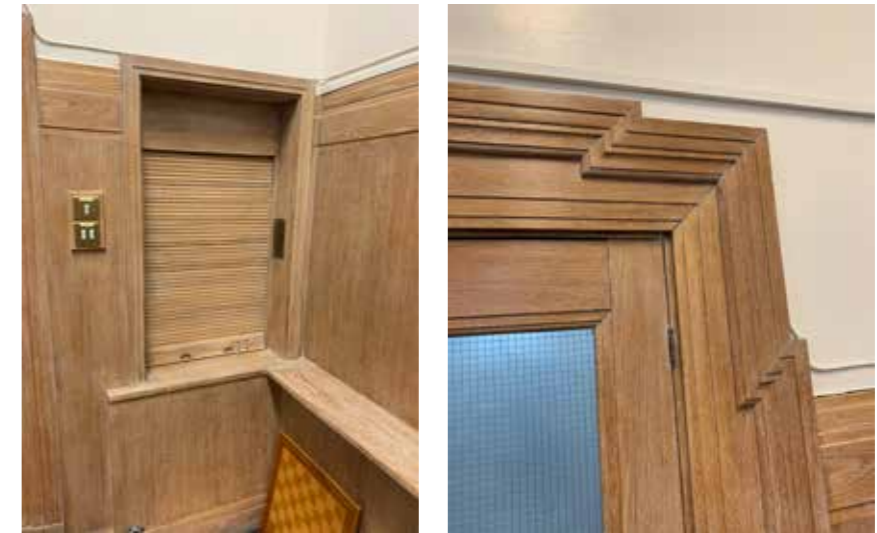
4.5.14 / 4.5.15 - Timber detailing to Special Library / Graphic Novels (Rm.98)

The room finishes are similar to those found in the main Lending Library. Original shelving is evident along the room perimeter only. Other joinery elements including the shelving, doors, architraves, wall panelling, and book lift have been stripped and treated to give the appearance of a limed oak finish. This is at odds with the aesthetic of the wider building and an inappropriate treatment for high quality joinery in this context.

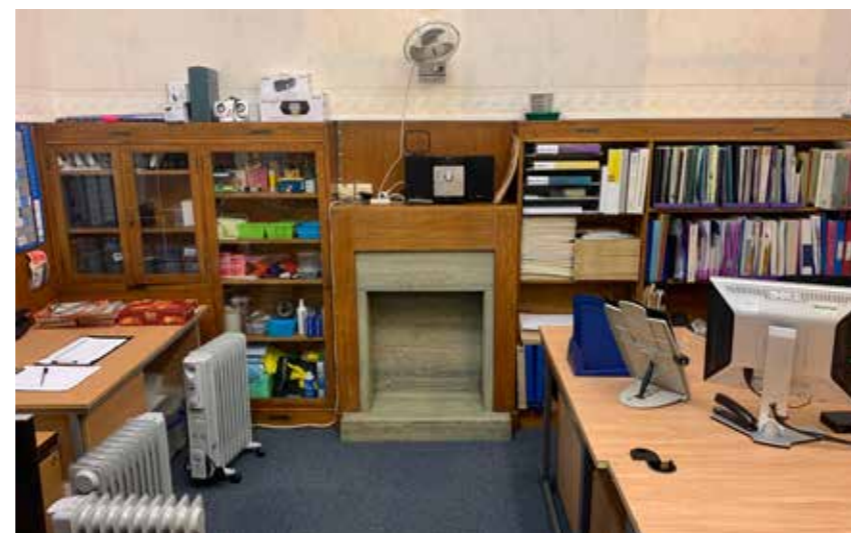
4.5.18 - Marble-lined fireplace in the Office (Rm.48)

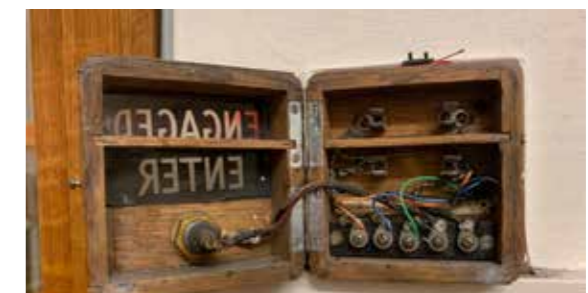
4.5.21 - 'Engaged / enter' sign in the Transcription Service (Rm.49)

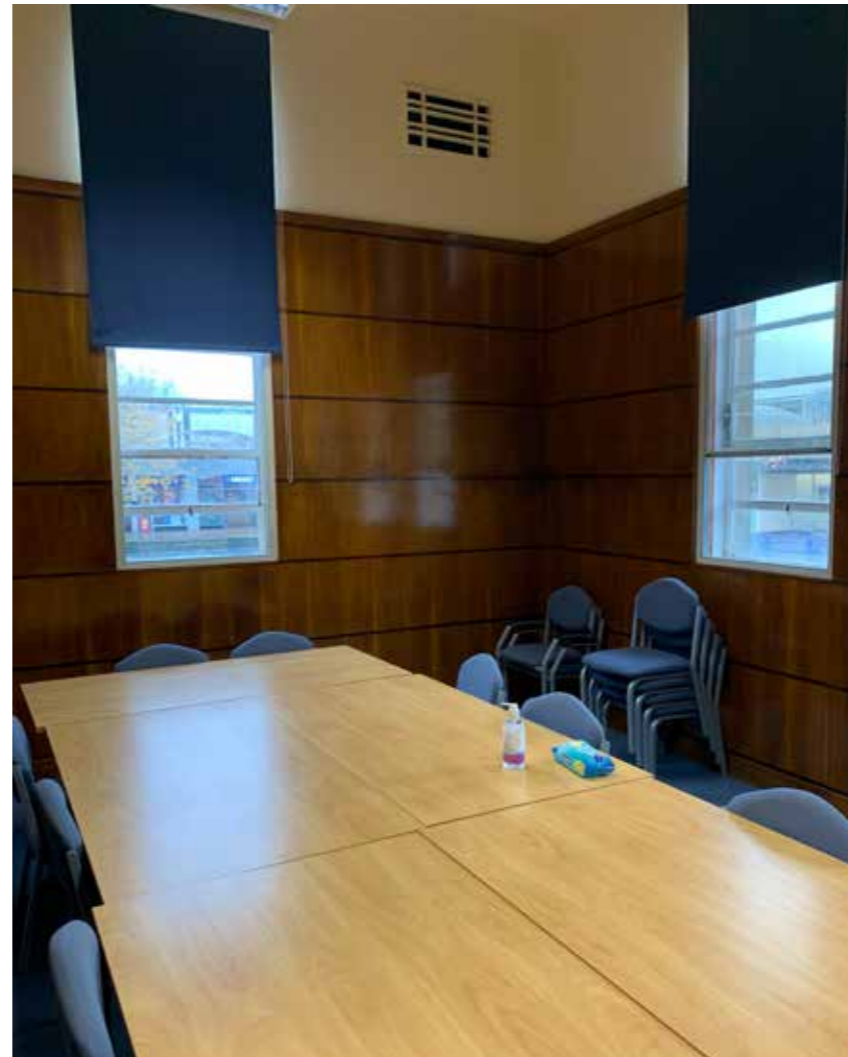
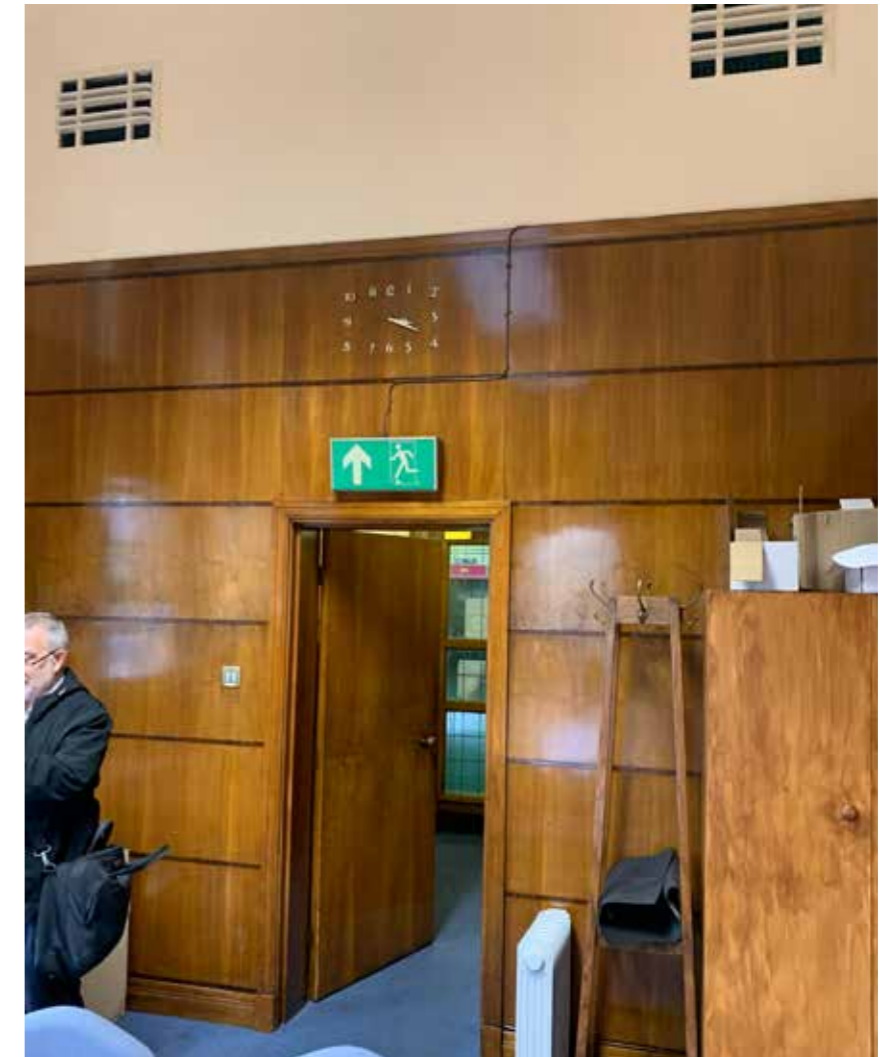
4.5.22 - Committee Room (Rm.57)

This room is finished to a high standard and shares the detailing of the front of house spaces. The room is accessed via a single flush door which appears plain but is likely solid in order to offer better separation from the adjacent space. The door is veneered in teak, laid in a butterfly pattern to match the wall panelling. The walls are lined with the same teak and walnut veneered panelling as the second floor Stair Lobby and rises to picture rail level. Above the panelling, the wall is painted plaster. There are two large white painted timber ventilation louvres as found in other rooms.

The windows have been fitted with modern aluminium secondary glazing. Since installation, these have lost their glazed panels, although the fixed frame remains in place. Above the door is an original rectangular clock with the numbers fitted directly over the panelling offering a clean and elegant Art Deco aesthetic. The original furniture is missing save for the coat and hat stand. This is of oak, well made and detailed to match the wider Library furniture. The original Committee Room table and chairs are understood to have been removed from the building with the table dismantled.

Negative Significance: Modern lighting, carpet tiles, modern surface mounted services, secondary glazing

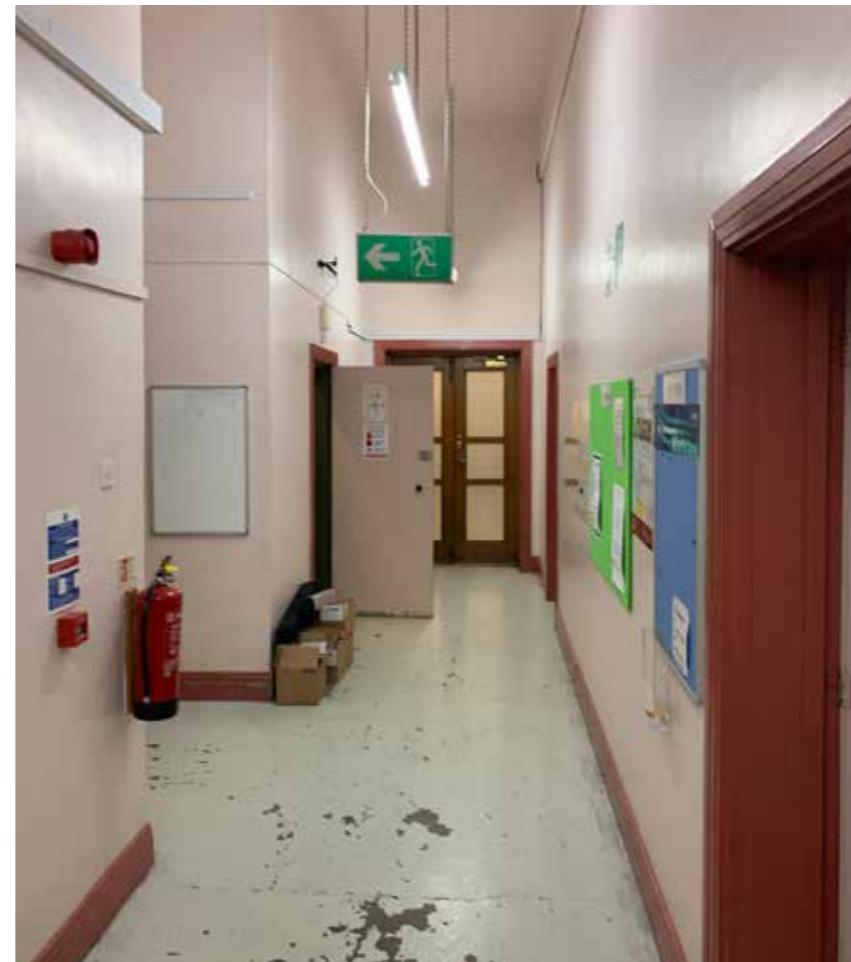
4.5.31 - Corridor (Rm.43)

The service corridor is plain, with the walls and ceiling plastered but without decorative features. The floor appears to be painted concrete. Doors opening into the corridor are typically flush, with those opening into formal library spaces constructed in oak and usually glazed. Skirtings and door architraves are in a stepped profile and painted. Generally, the building's circulation spaces hold no aesthetic value, and only very limited historic value for their part in the overall layout of the library floor plan where their original form remains unchanged.

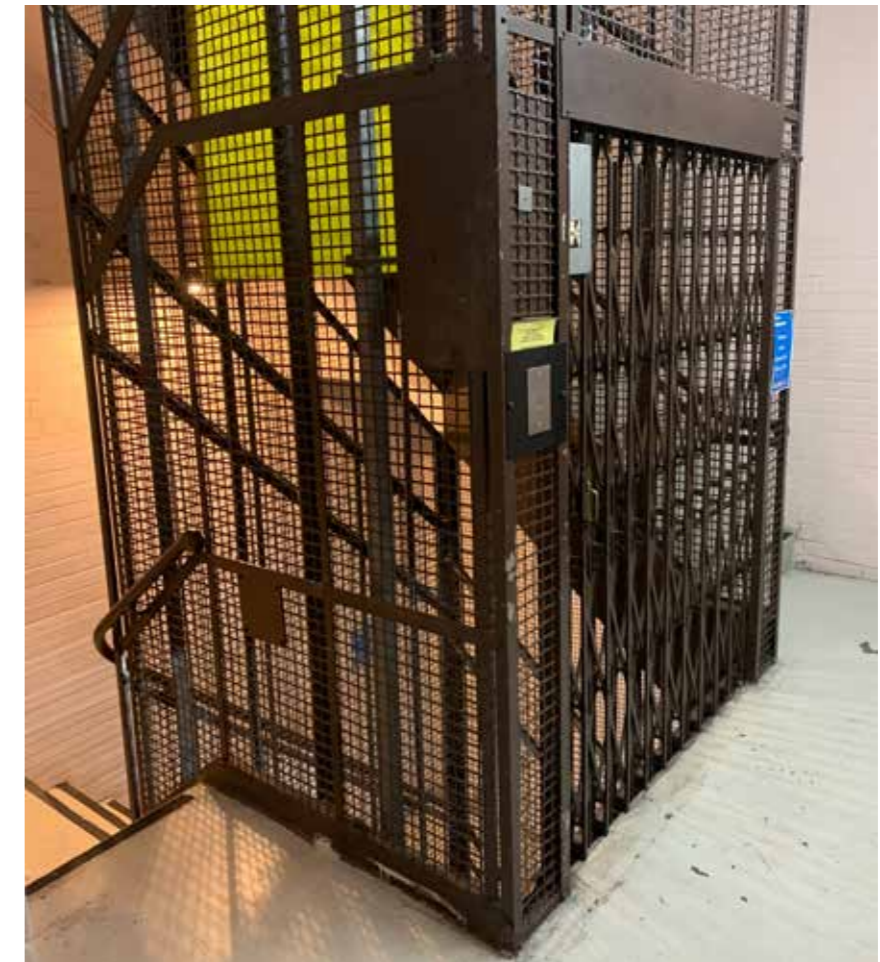
4.5.32 - Stair and Lift (Rm.40 & 41)

The service stair, landing and lift core are common between the floors. The walls of the stair are painted common brickwork in Flemish bond and the stair and floor are painted concrete. Tall Crittall windows occur at each level, with the lower panes in obscure cast glass. The service lift is original, comprising a caged car set within a steel mesh shaft with manual-folding guarding at each entry point. The space is appropriately utilitarian in nature. The lift has historic value as a component of the original design but has no broader significance.

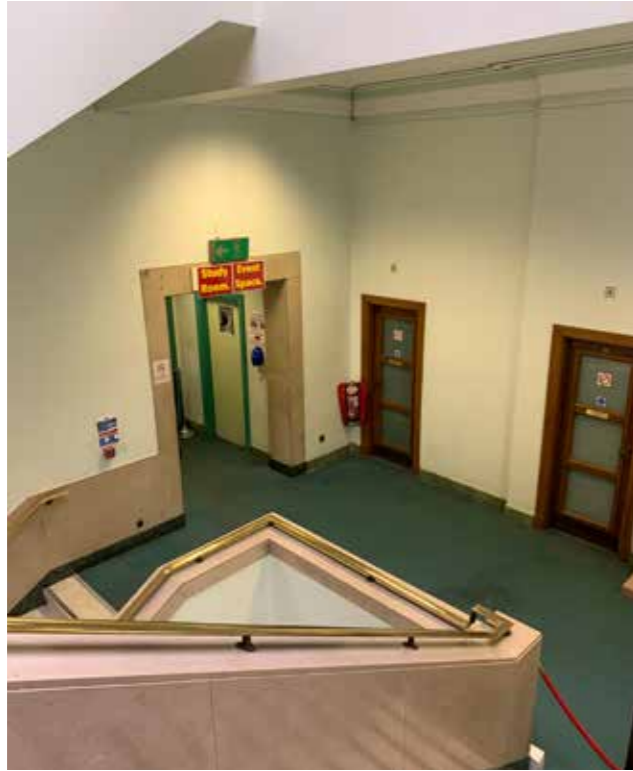
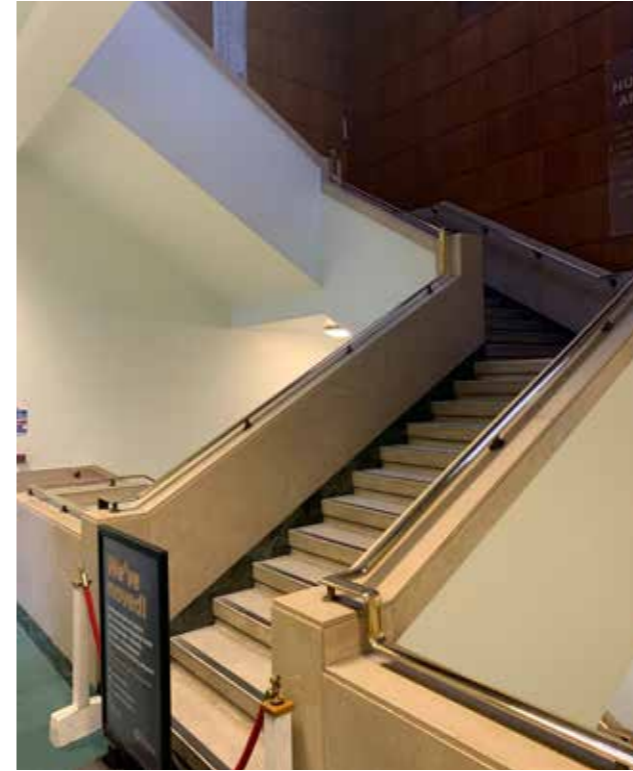
Similar to the ground floor, the walls of the first floor Lobby are lined with large slabs of polished light marble set over Swedish Green marble skirting. The study rooms have a green glazed skirting tile like that found at lower ground. The Lobby ceiling is largely flush with a cornice to the perimeter. A beam downstand occurs on the line of the study rooms and continues to the west wall. This describes the position of the lift shaft. Here the ceiling matches the adjacent ceiling with a decorative cornice. The floor of the Lobby is covered in green carpet tiles but is likely to have the original terrazzo finish below.

4.6.1 - First Floor Stair Lobby (Rm.71)

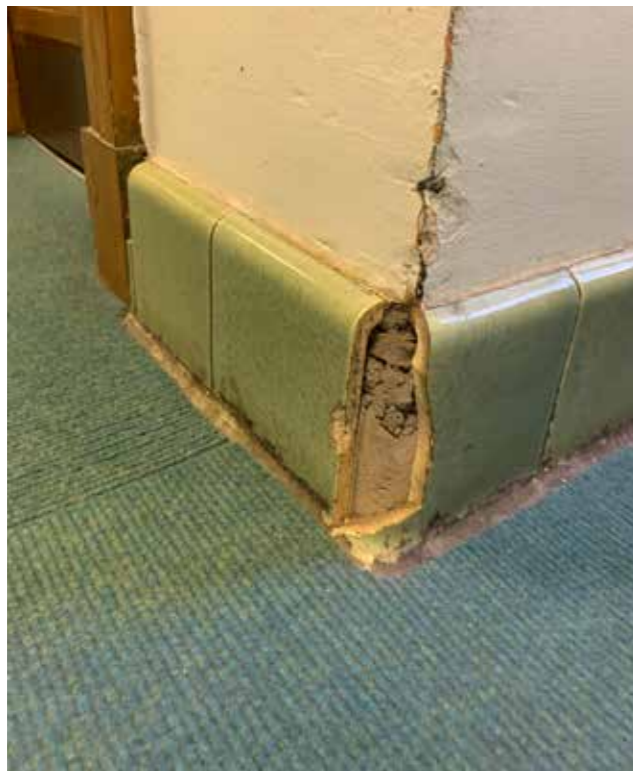
4.6.5 - Skirting to First Floor Stair Lobby (Rm.71)

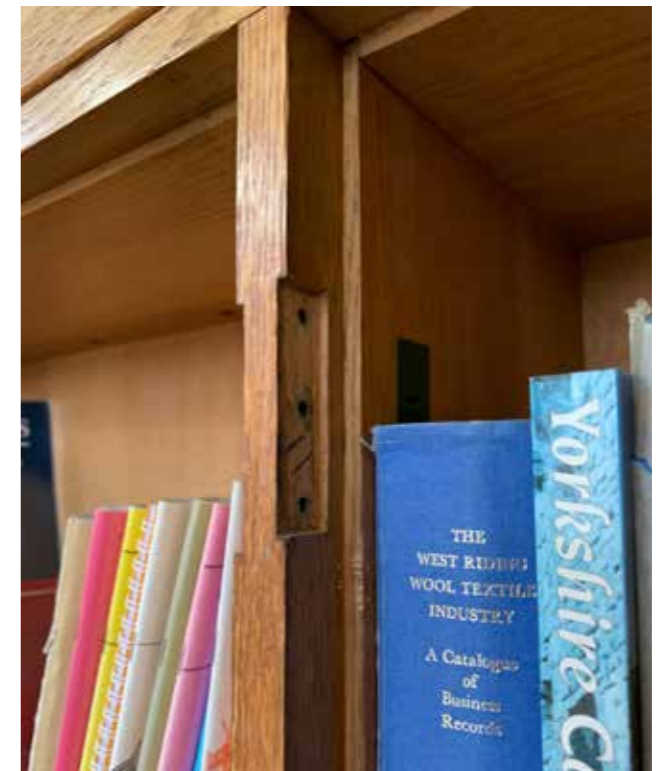
4.6.8 - Shelving to Local History Office (Rm.69)

Original open-fronted oak shelving around the room perimeter with metal vents to the head and base rise to window cill height. The remaining furniture is modern and the original counter and reading tables are not present. To the south, double doors open out into the stair well whilst a single door gives access into the Local History Office, Rm.68. To the north, a single door leads into the Reference Archive, Rm.66. All doors are original oak with oak architraves set over skirting blocks, although all have later replacement glazed vision panels inserted.

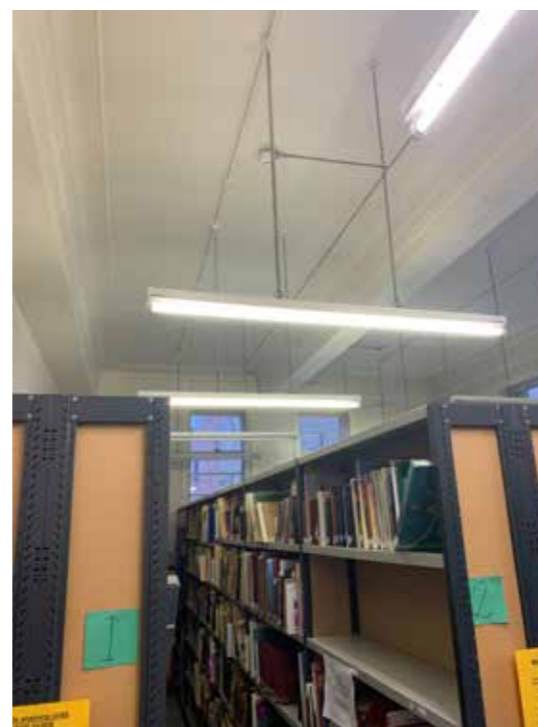
4.6.13 - Reference Archive (Rm.66)

This room is at the north-west corner of the building, located next to the Local History Library Rm.68. This room is used for archive storage however the original shelving for the space has been replaced with modern track-mounted archive shelves.

In its current form as a single space, the room has windows on three aspects, to the east, south and west. Vent grilles are evident at the window cills, indicating the presence of the ventilation system ducts behind the panelling. As with other rooms on this floor, the ceiling is divided into structural bays, each with decorative perimeter corncicing. The original lights have been replaced with modern florescent tubes set into surface-mounted reflectors.

Above the entrance doors from the Stair Lobby are the workings of an original clock, the majority of its movements of which have been removed. At the north end of the room, an original clock similar to that seen in the Local History Library survives, comprising light blue numbers at the quarter hours and strikes between on what appears to be a white acrylic or plexiglass face set over a painted timber base. A modern conduit rises to this, which may have been installed to replace the original power supply chased into the wall.

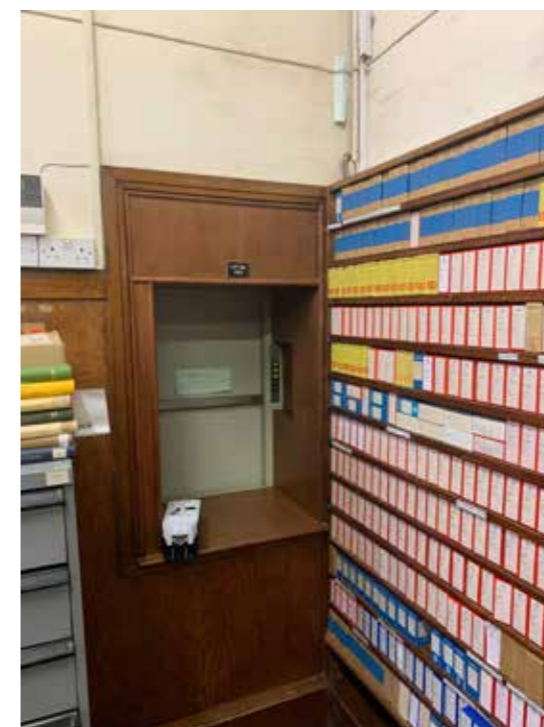
4.6.14 - Book lift in Reference Archive (Rm.66)

The floor is lined with the same modern patterned carpet found in the West Yorkshire Archive, Rm.68. At the north end, the former book lift opening has been boarded up.

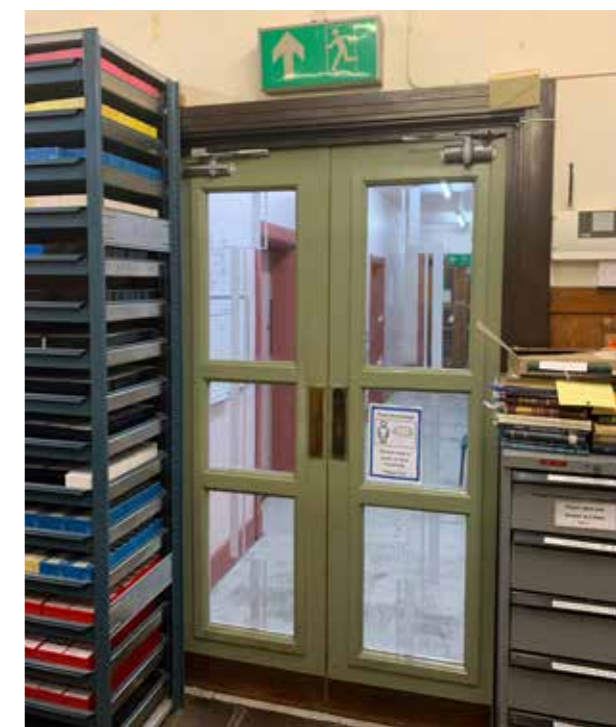
4.6.15 - Doors in Reference Archive (Rm.66)

To the southern end, the original double doors that once provided access from the short corridor into the former General Reading Room are still present. They have since been shut with shelving fitted across them on the far side of the door leaves as part of the Office fit out. To the left is a recess in the wall panelling which once contained original light switches that have since been replaced with modern brass-fronted controls.

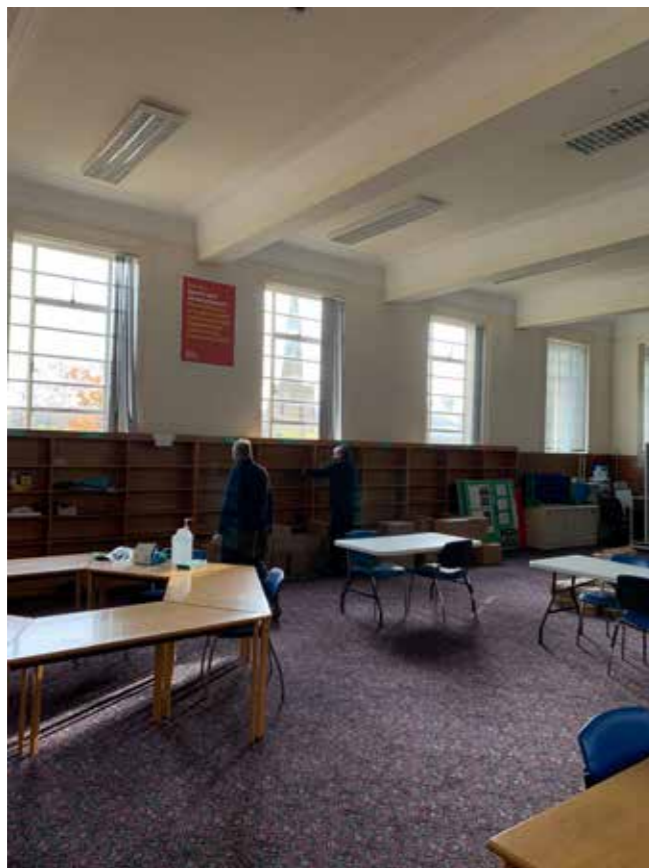
4.6.16 - Reference Library (Rm.76)

Negative Significance: Modern lighting, modern services, modern bookshelves, changes to the access corridor to form an office, modern carpet

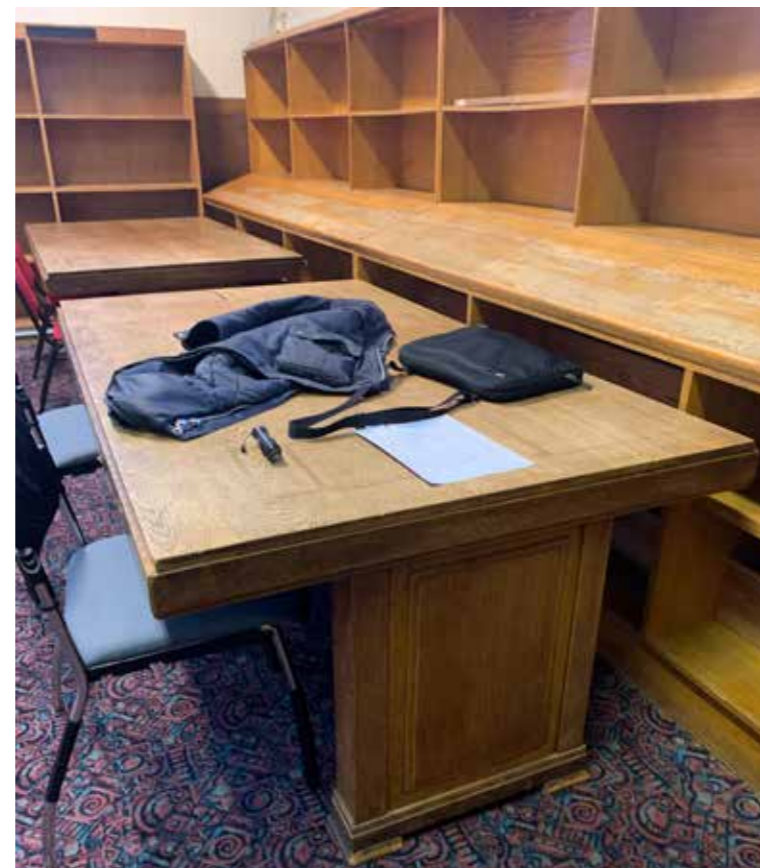
Within the room there are two original oak tables. Alongside the hat and coat stand in the Committee Room, Rm.57, these are possibly the only surviving items of original loose furniture

from the entire Library. The loose fitted perimeter bookshelves are not original and do not fit into the space well.

4.6.17 - Original oak tables in in Reference Library (Rm.76)

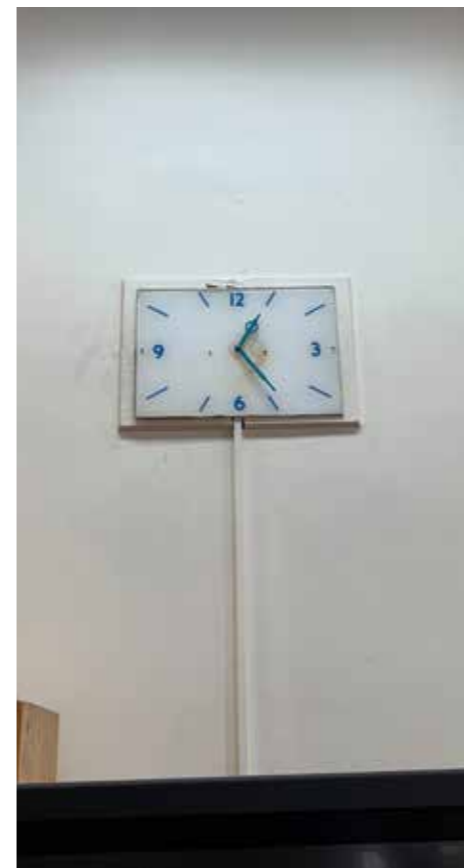
4.6.18 - Clock in Reference Library (Rm.76)
