**KIRKLEES CULTURAL HEART**  
**HERITAGE STATEMENT: VOLUME 4**  
**LIBRARY AND ART GALLERY: ASSESSMENT OF SIGNIFICANCE**

CDT430201-FCB-XX-XX-RP-A-000004  
VERSION: V2 | MARCH 2022

FEILDEN CLEGG BRADLEY STUDIOS

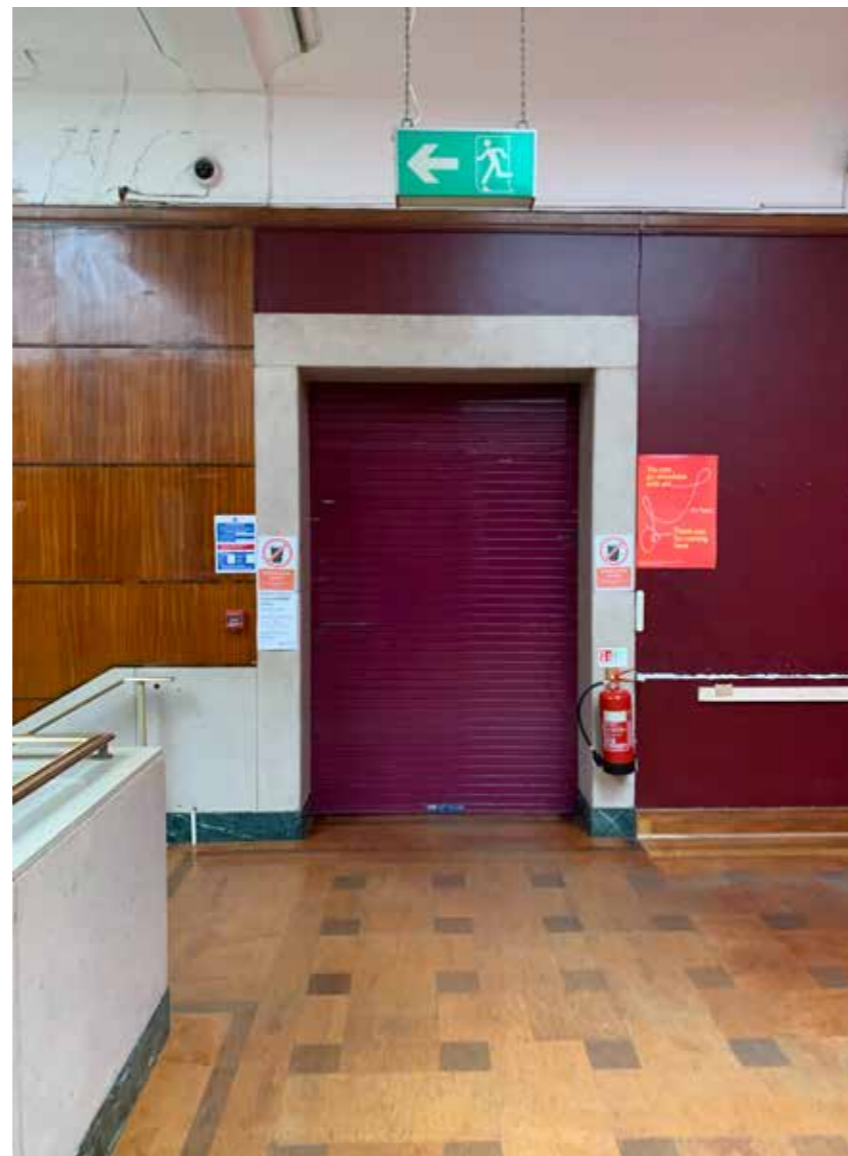
Lift and roller shutter to Gallery Entrance Lobby (Extension of Rm.91)

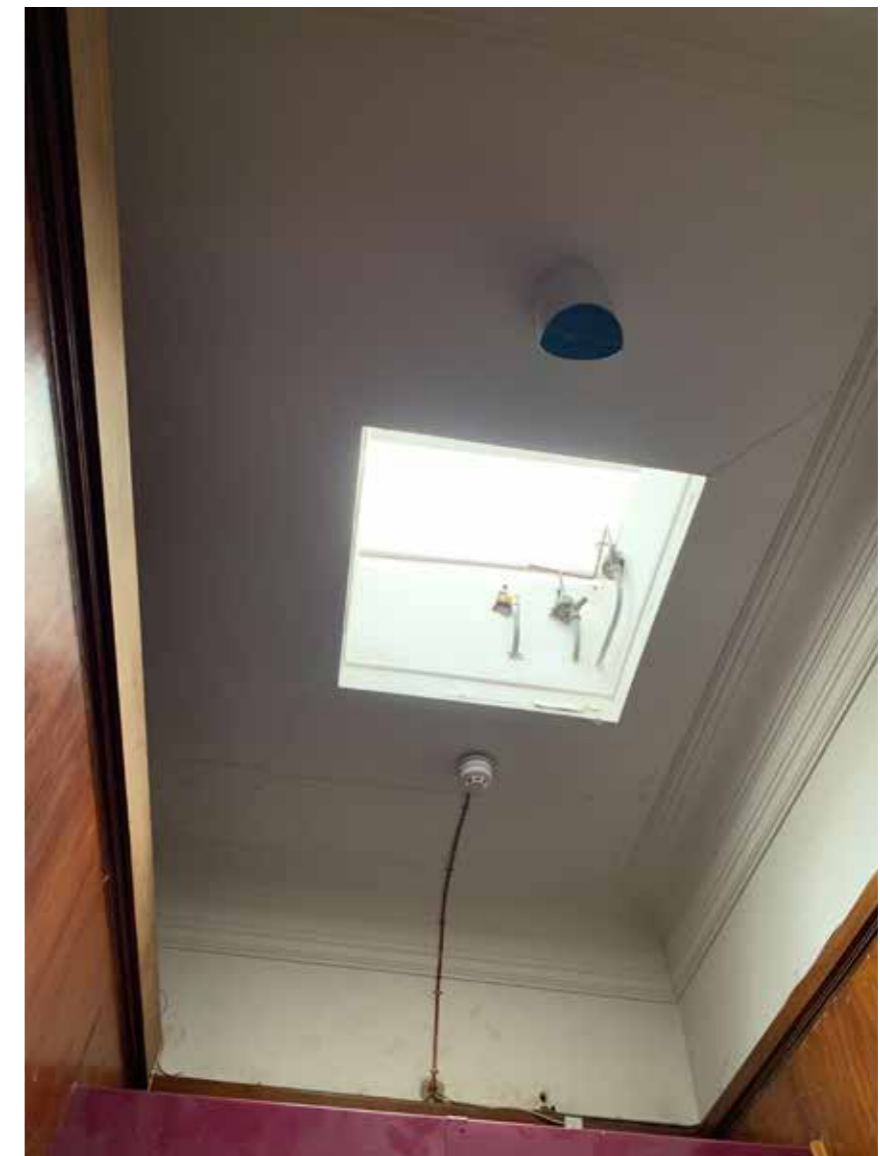
4.7.4 - Rooflight to Gallery Exit Lobby (Extension of Rm.91)

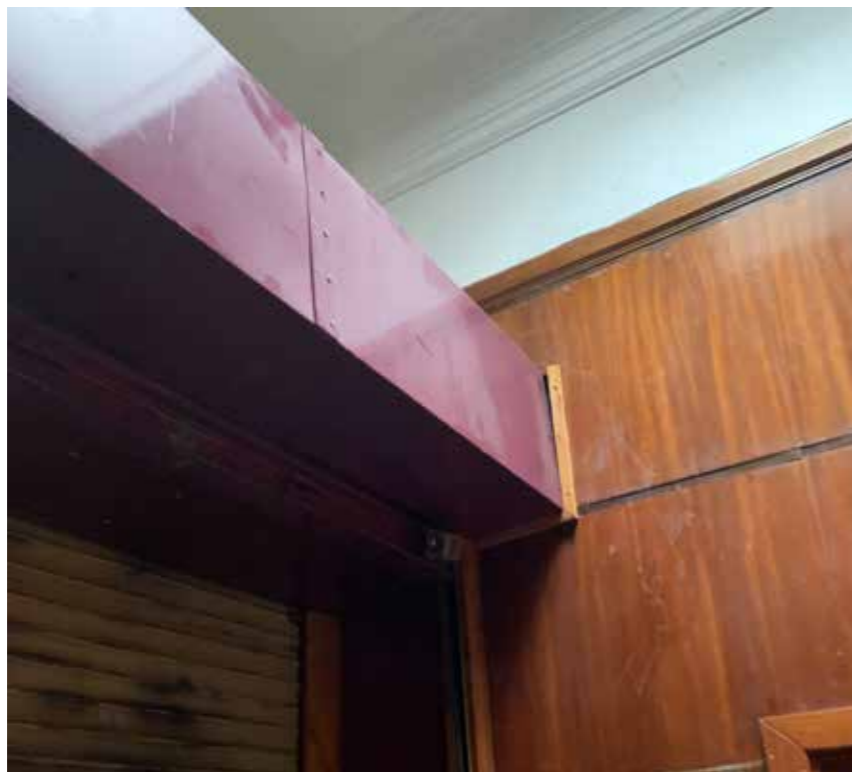
4.7.5 - Roller shutter to Gallery Exit Lobby (Extension of Rm.91)

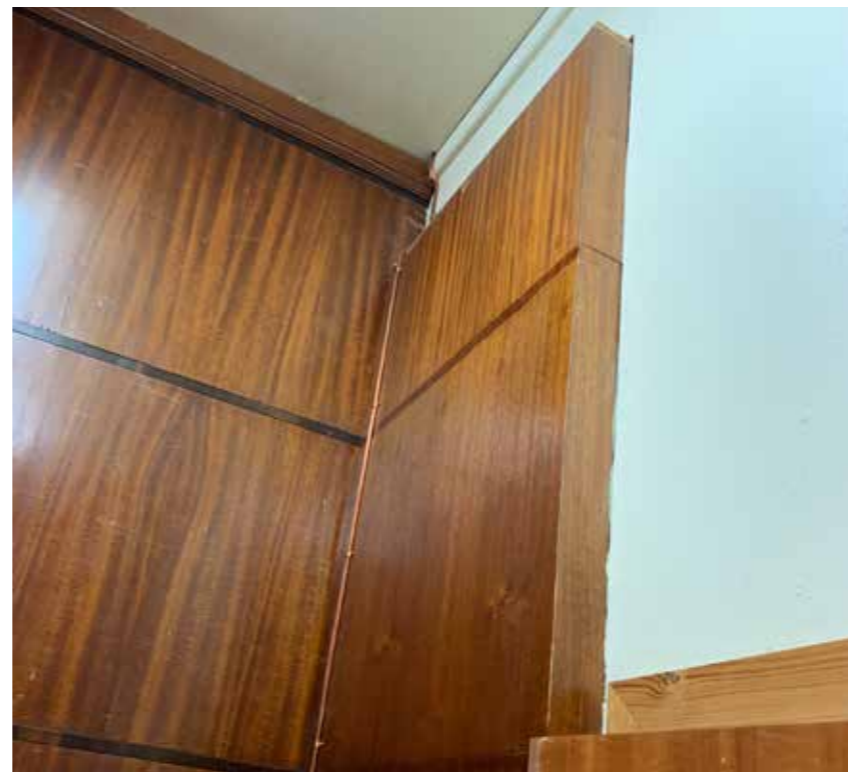
4.7.6 - Timber panelling to Gallery Exit Lobby (Extension of Rm.91)

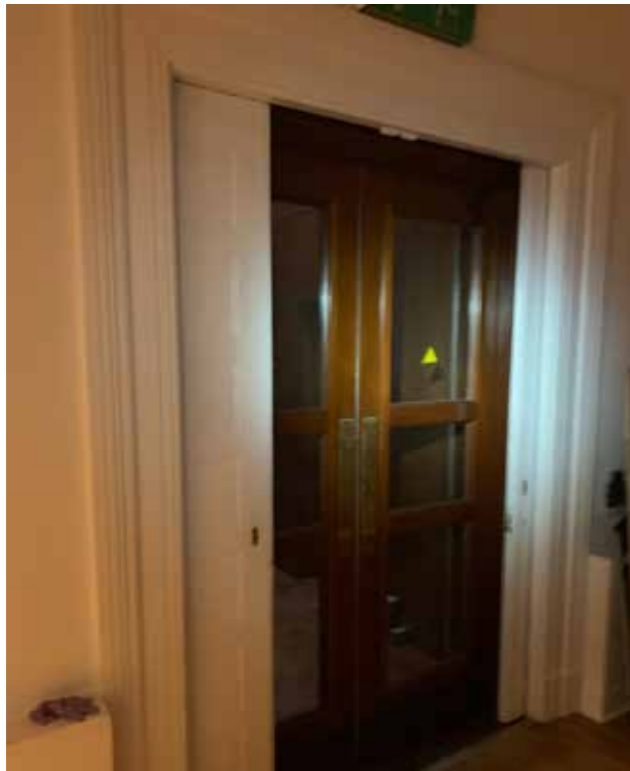
4.7.8 - Door to Gallery 1 (Rm. 87)

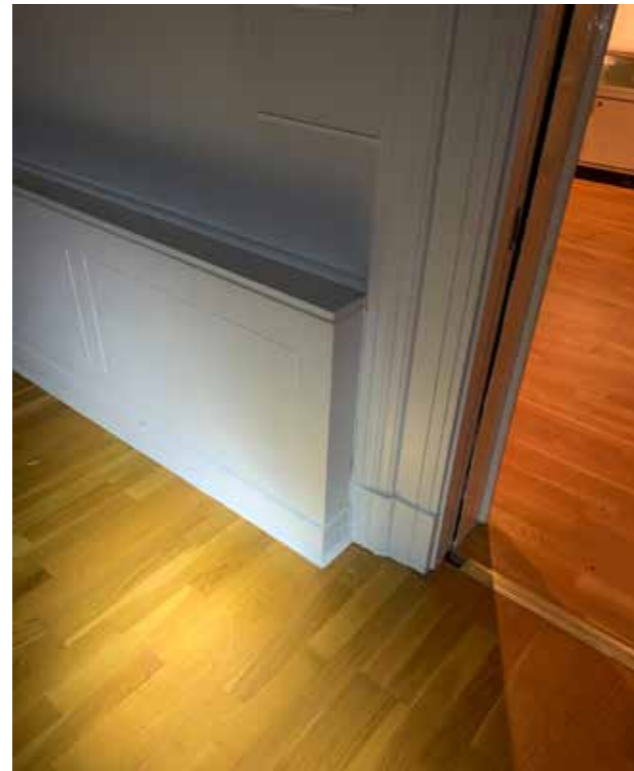
4.7.9 - Dado panelling to Gallery 1 (Rm. 87)

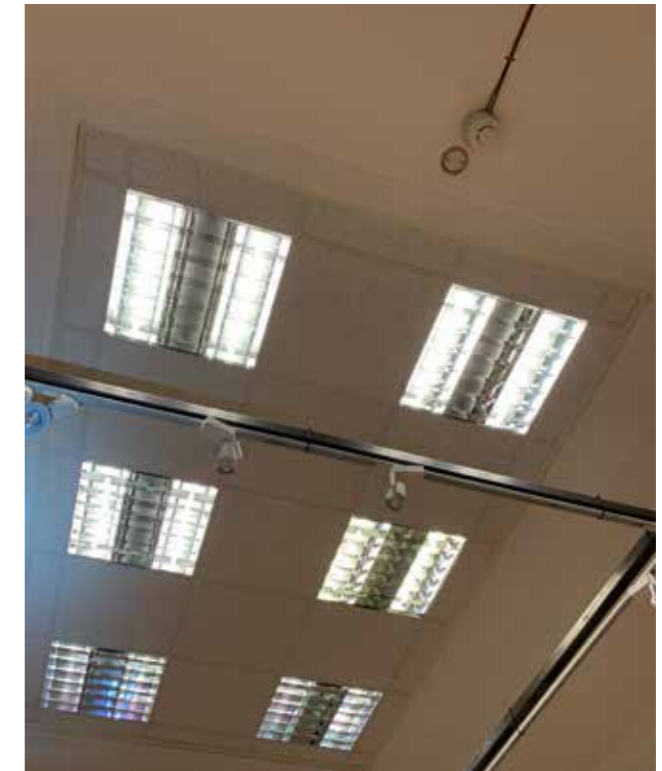
4.7.11 - Infilled rooflight opening to Gallery 1 (Rm. 87)

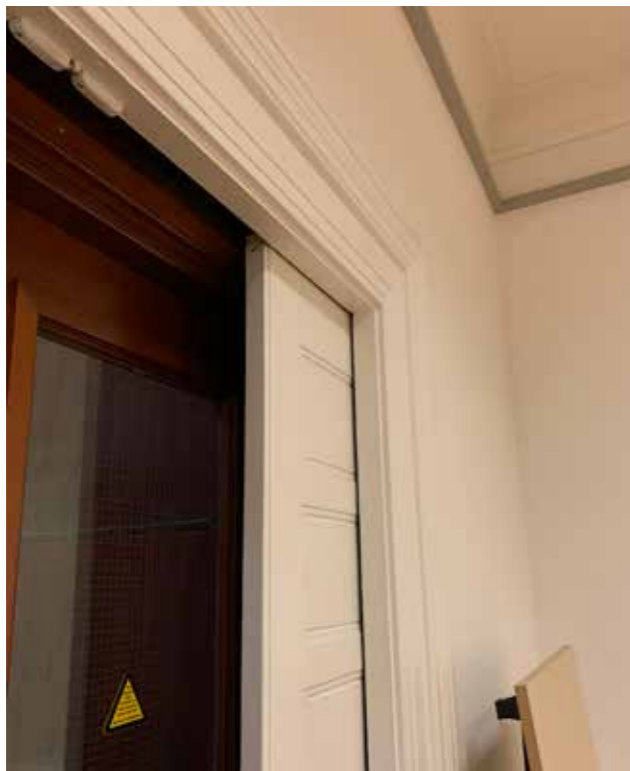
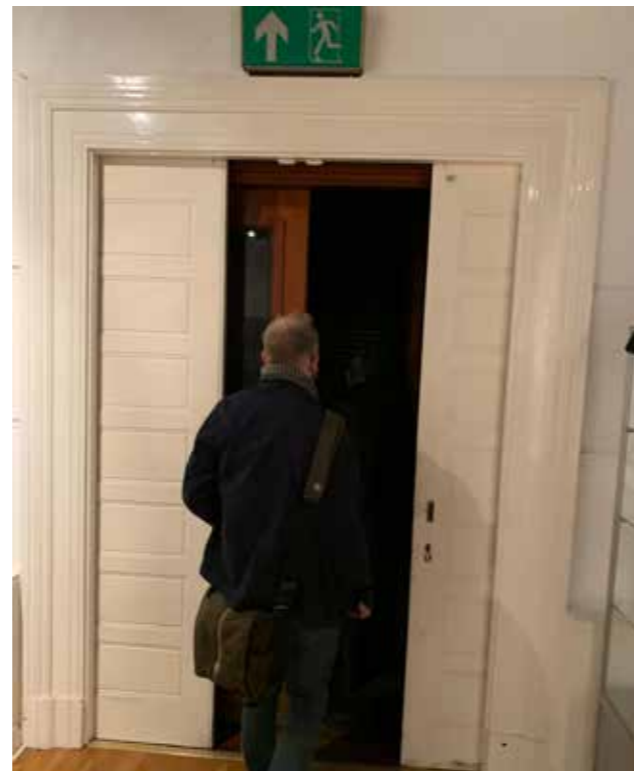
4.7.12 - Door to Gallery 6 (Rm. 93)

4.7.13 - Door to Gallery 6 (Rm. 93)

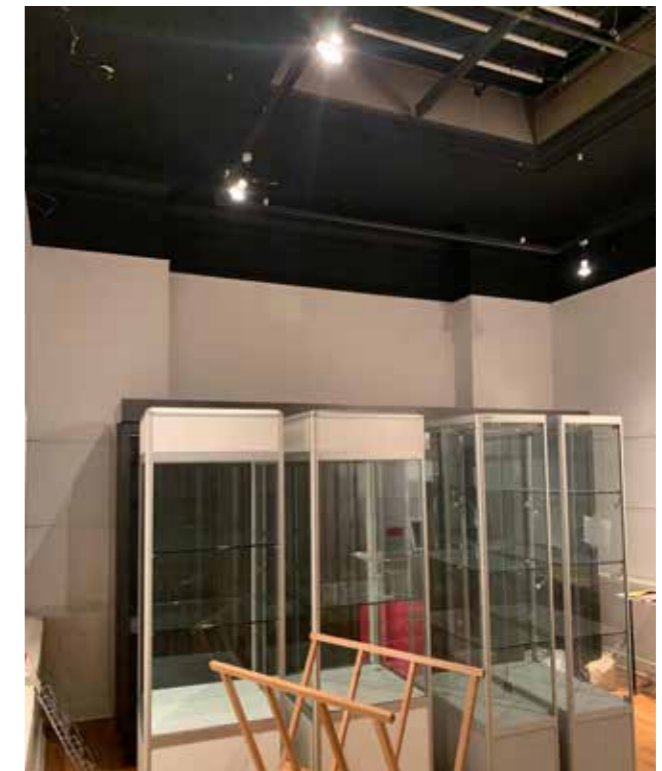
4.7.15 - Gallery 6 (Rm. 93)

the ceiling, running to lantern rooflight openings described by a simple architrave set flush into the ceiling. The ceiling and wall above the picture rail in Gallery 6 are painted black. Gallery 6 retains its original steel and glass laylight, however the rooflight opening to Gallery 1 has been infilled with a modern suspended ceiling tile grid. Externally, the original roof lanterns have been replaced or overclad by modern polycarbonate elements. It is likely that these have been installed in order to prevent rainwater ingress caused by failures in the original fabric. Lighting comprises track-mounted spotlights throughout.

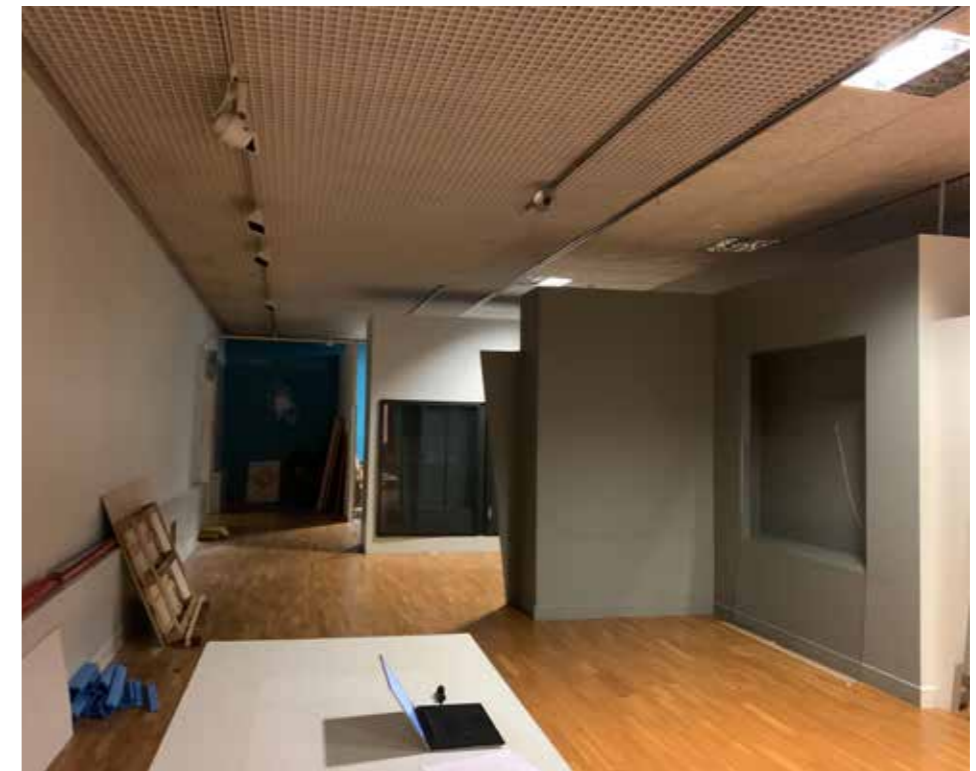
4.7.22 - Gallery 5 (Rm. 95)

Negative Significance: Suspended ceilings, laminate floor, modern surface-mounted services, blinds / covering to Gallery 5 roof lanterns, steel containment picture rail / lighting track (Gallery 2 and 5)

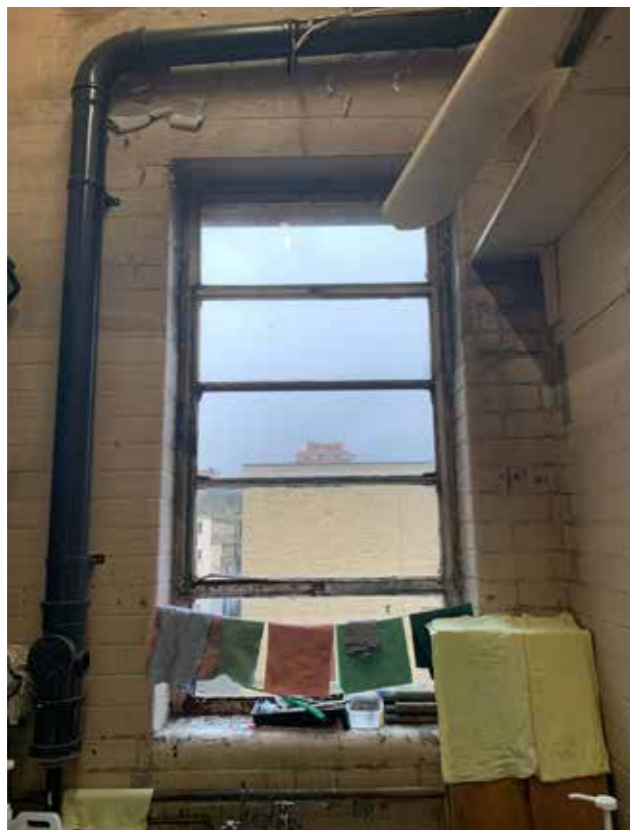
4.7.23 - Store / Service Room (Rm. 83)

This room is retained for use by the Gallery services Department. The room is largely painted brickwork with fairly modern picture racks. As with the rest of this level it has no windows but is served by a roof light. There is a plastic canopy formed above to protect the contents of the room from leaks through the roof lantern.

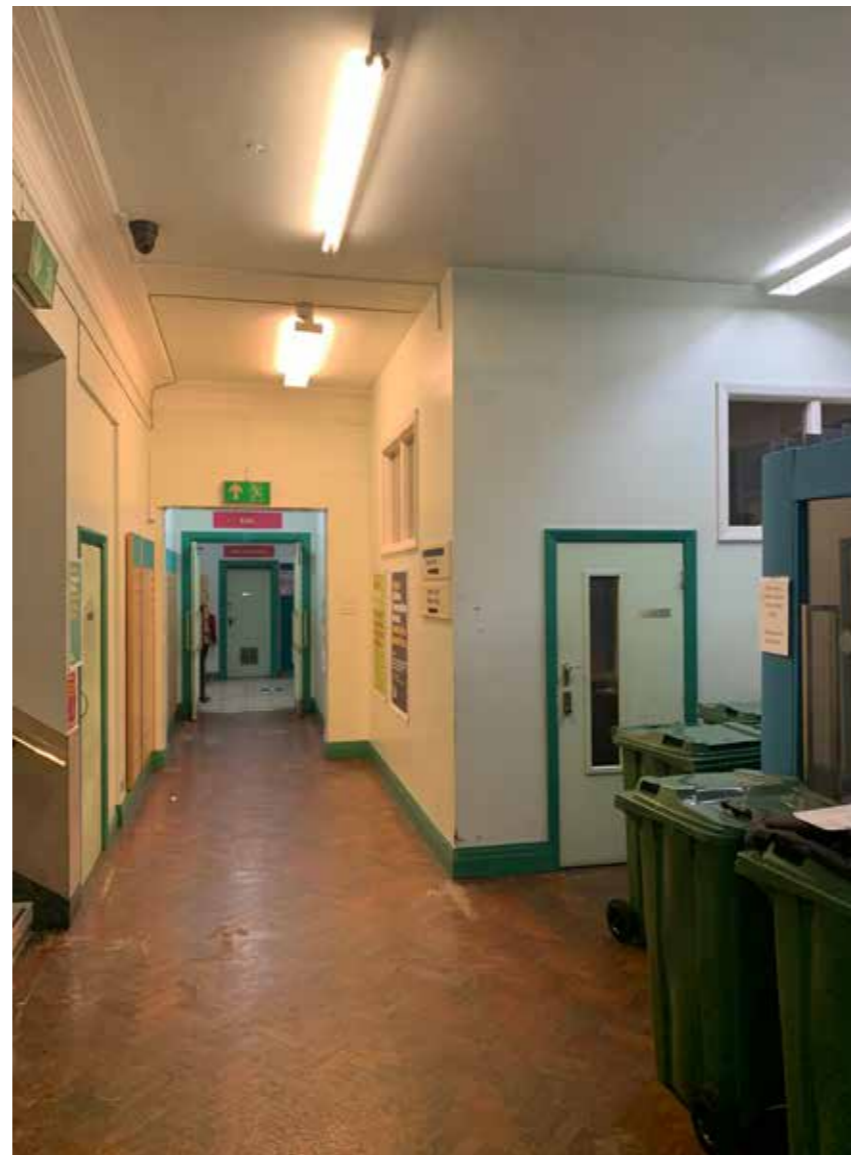
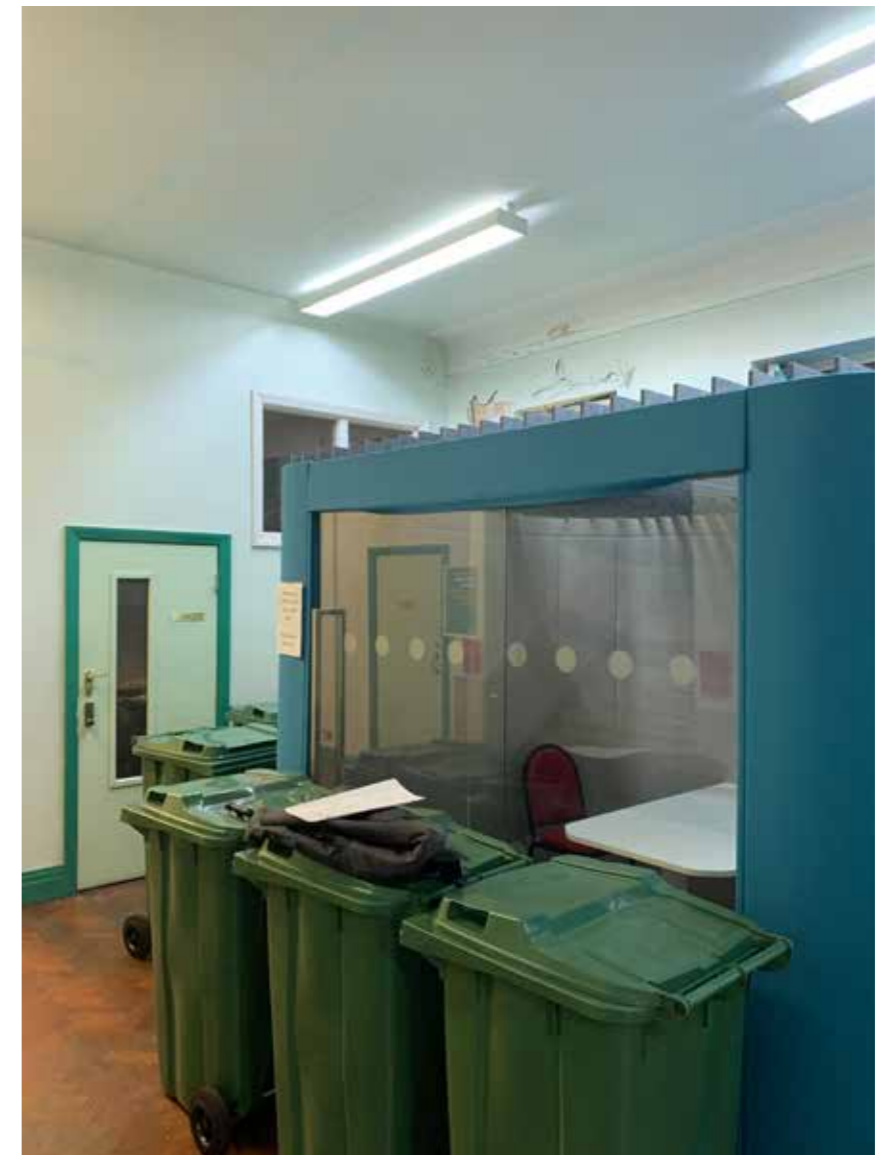
appropriated from the Store behind (Rm.19). Within the Lobby, a modern partition has been inserted to form an additional new Store (Rm.26). This adaption has disrupted the character of the Lobby, changing it from an open and symmetrical area designed with the potential for collections display into a more serviceable circulation space. This has had a large impact on the potential quality of the room.

4.8.1 - Lower Ground Stair Lobby (Rm.24) with new room on right (Rm.26)

4.8.2 - Lower Ground Stair Lobby (Rm.24) with new room on left (Rm.26) and new enclosure

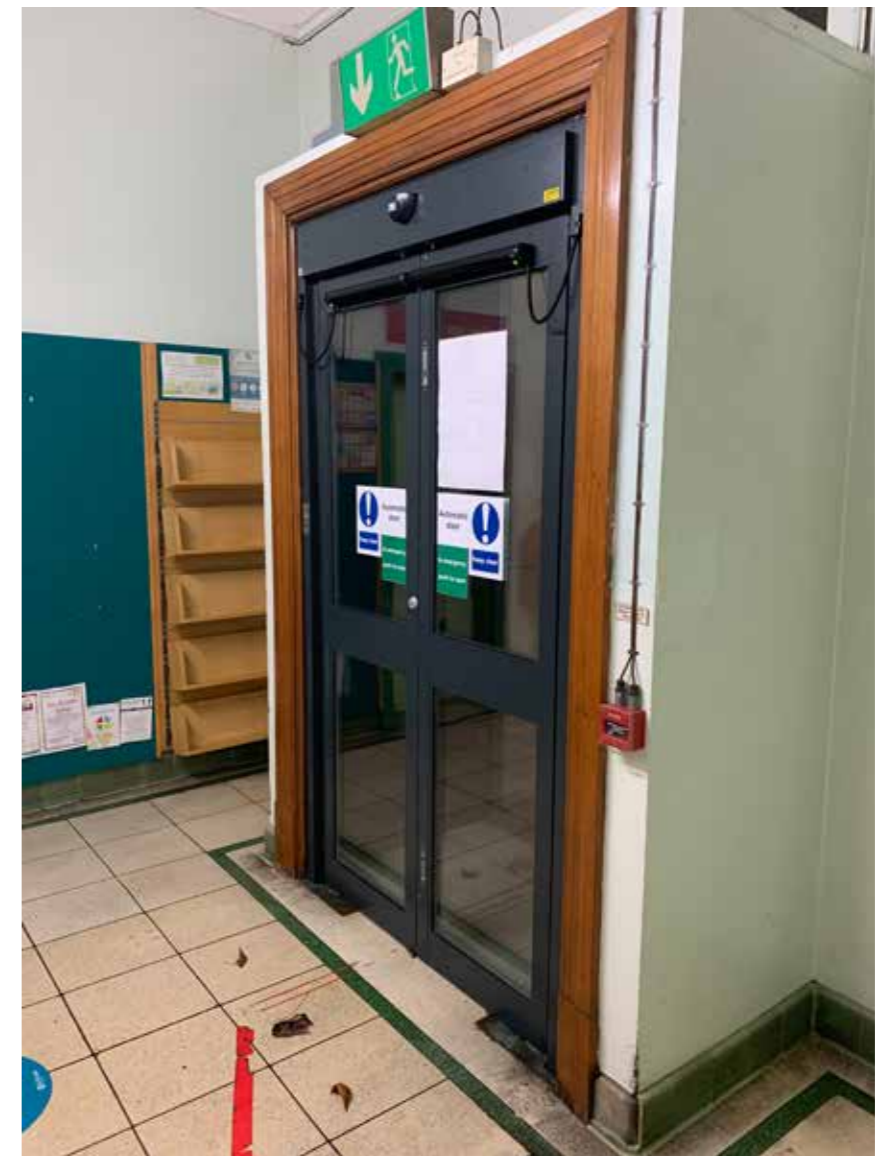
4.8.3 - East Entrance Lobby (Rm.28)

As with the main Entrance Lobby, the entrance vestibule steps into the building envelope, thereby allowing the main external doors to be held open during hours of operation. The external door appears to be original, whilst the inner doors are modern aluminium, as those found at the main Entrance Lobby. The internal door from the Lobby into the Children's Library appears to be a replacement, as it is close in form to other original doors but lacking the stepped profile found in other examples. The doors to the adjacent WC are flush and painted, although these may have original material beneath.

Modern services are present throughout in the form of new fire, security and access systems. Above the external doors, a fire sign appears to be early with the signage insert possibly over-painted and disguising an original graphic beneath. Within the same vestibule is an original recessed light, however internal light fittings are generally modern replacements.

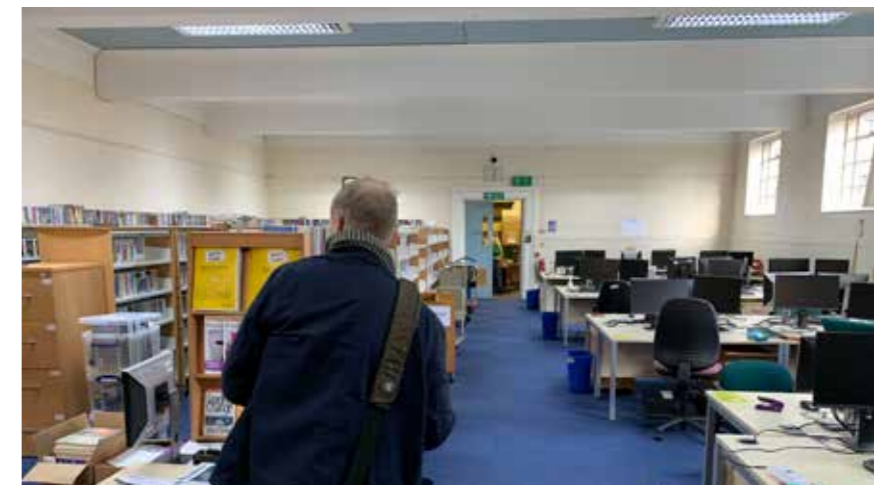
4.8.10 - Interlibrary Loans (Rm.31)

The internal door from the Lobby into the Interlibrary Loans Room is original, although it has been adapted with Georgian wired glass panels. The doors to the adjacent WC are flush and painted, although these may have original material beneath. Modern services are present throughout in the form of new fire, security and access systems. Light fittings are all modern replacements.

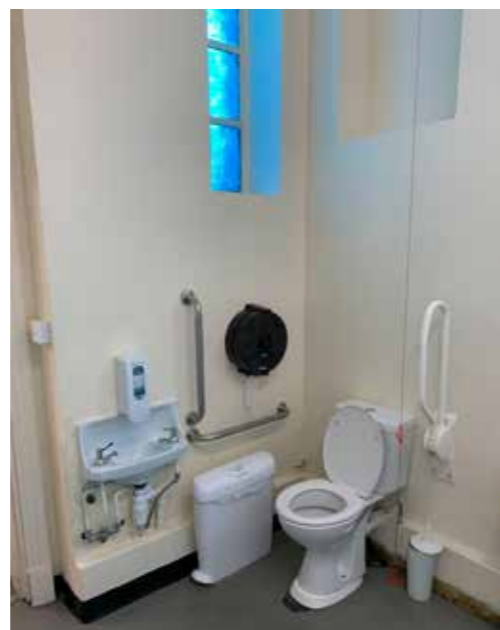
4.8.17 - Accessible WC (Rm.27)

The Accessible WC is noted as a 'Men's Public Lav' on Ashburner's original plans, whilst the adjacent room is noted as an 'Attendants Room'. Both of these functions illustrate the use of and oversight for the adjacent Newspaper Room, which was intended as an area designed for regular access by men. This 'Men's Lav' is now the Accessible WC, although nothing remains of its original finishes. The 'Attendant's Room' has become the Server Room, and has evidently functioned as a storage area for many years. It has therefore retained its earlier decorative scheme with original joinery skirtings and architraves. The floor is the original oak woodblock laid in a herringbone pattern.

The Accessible WC has no aesthetic and limited historic value. The Server Room holds some aesthetic value for its original finishes.
