Ceramic Panels – Condition Note and Repair Strategy

Issued for Planning and Listed Building Consent Approval

| Job/Drawing No | Revision |
|---|---|
| Kirklees Cultural Heart Huddersfield Library - Conservation of Artwork - Articulation in Motion Ceramic Panel 01-02 | Status S2 |

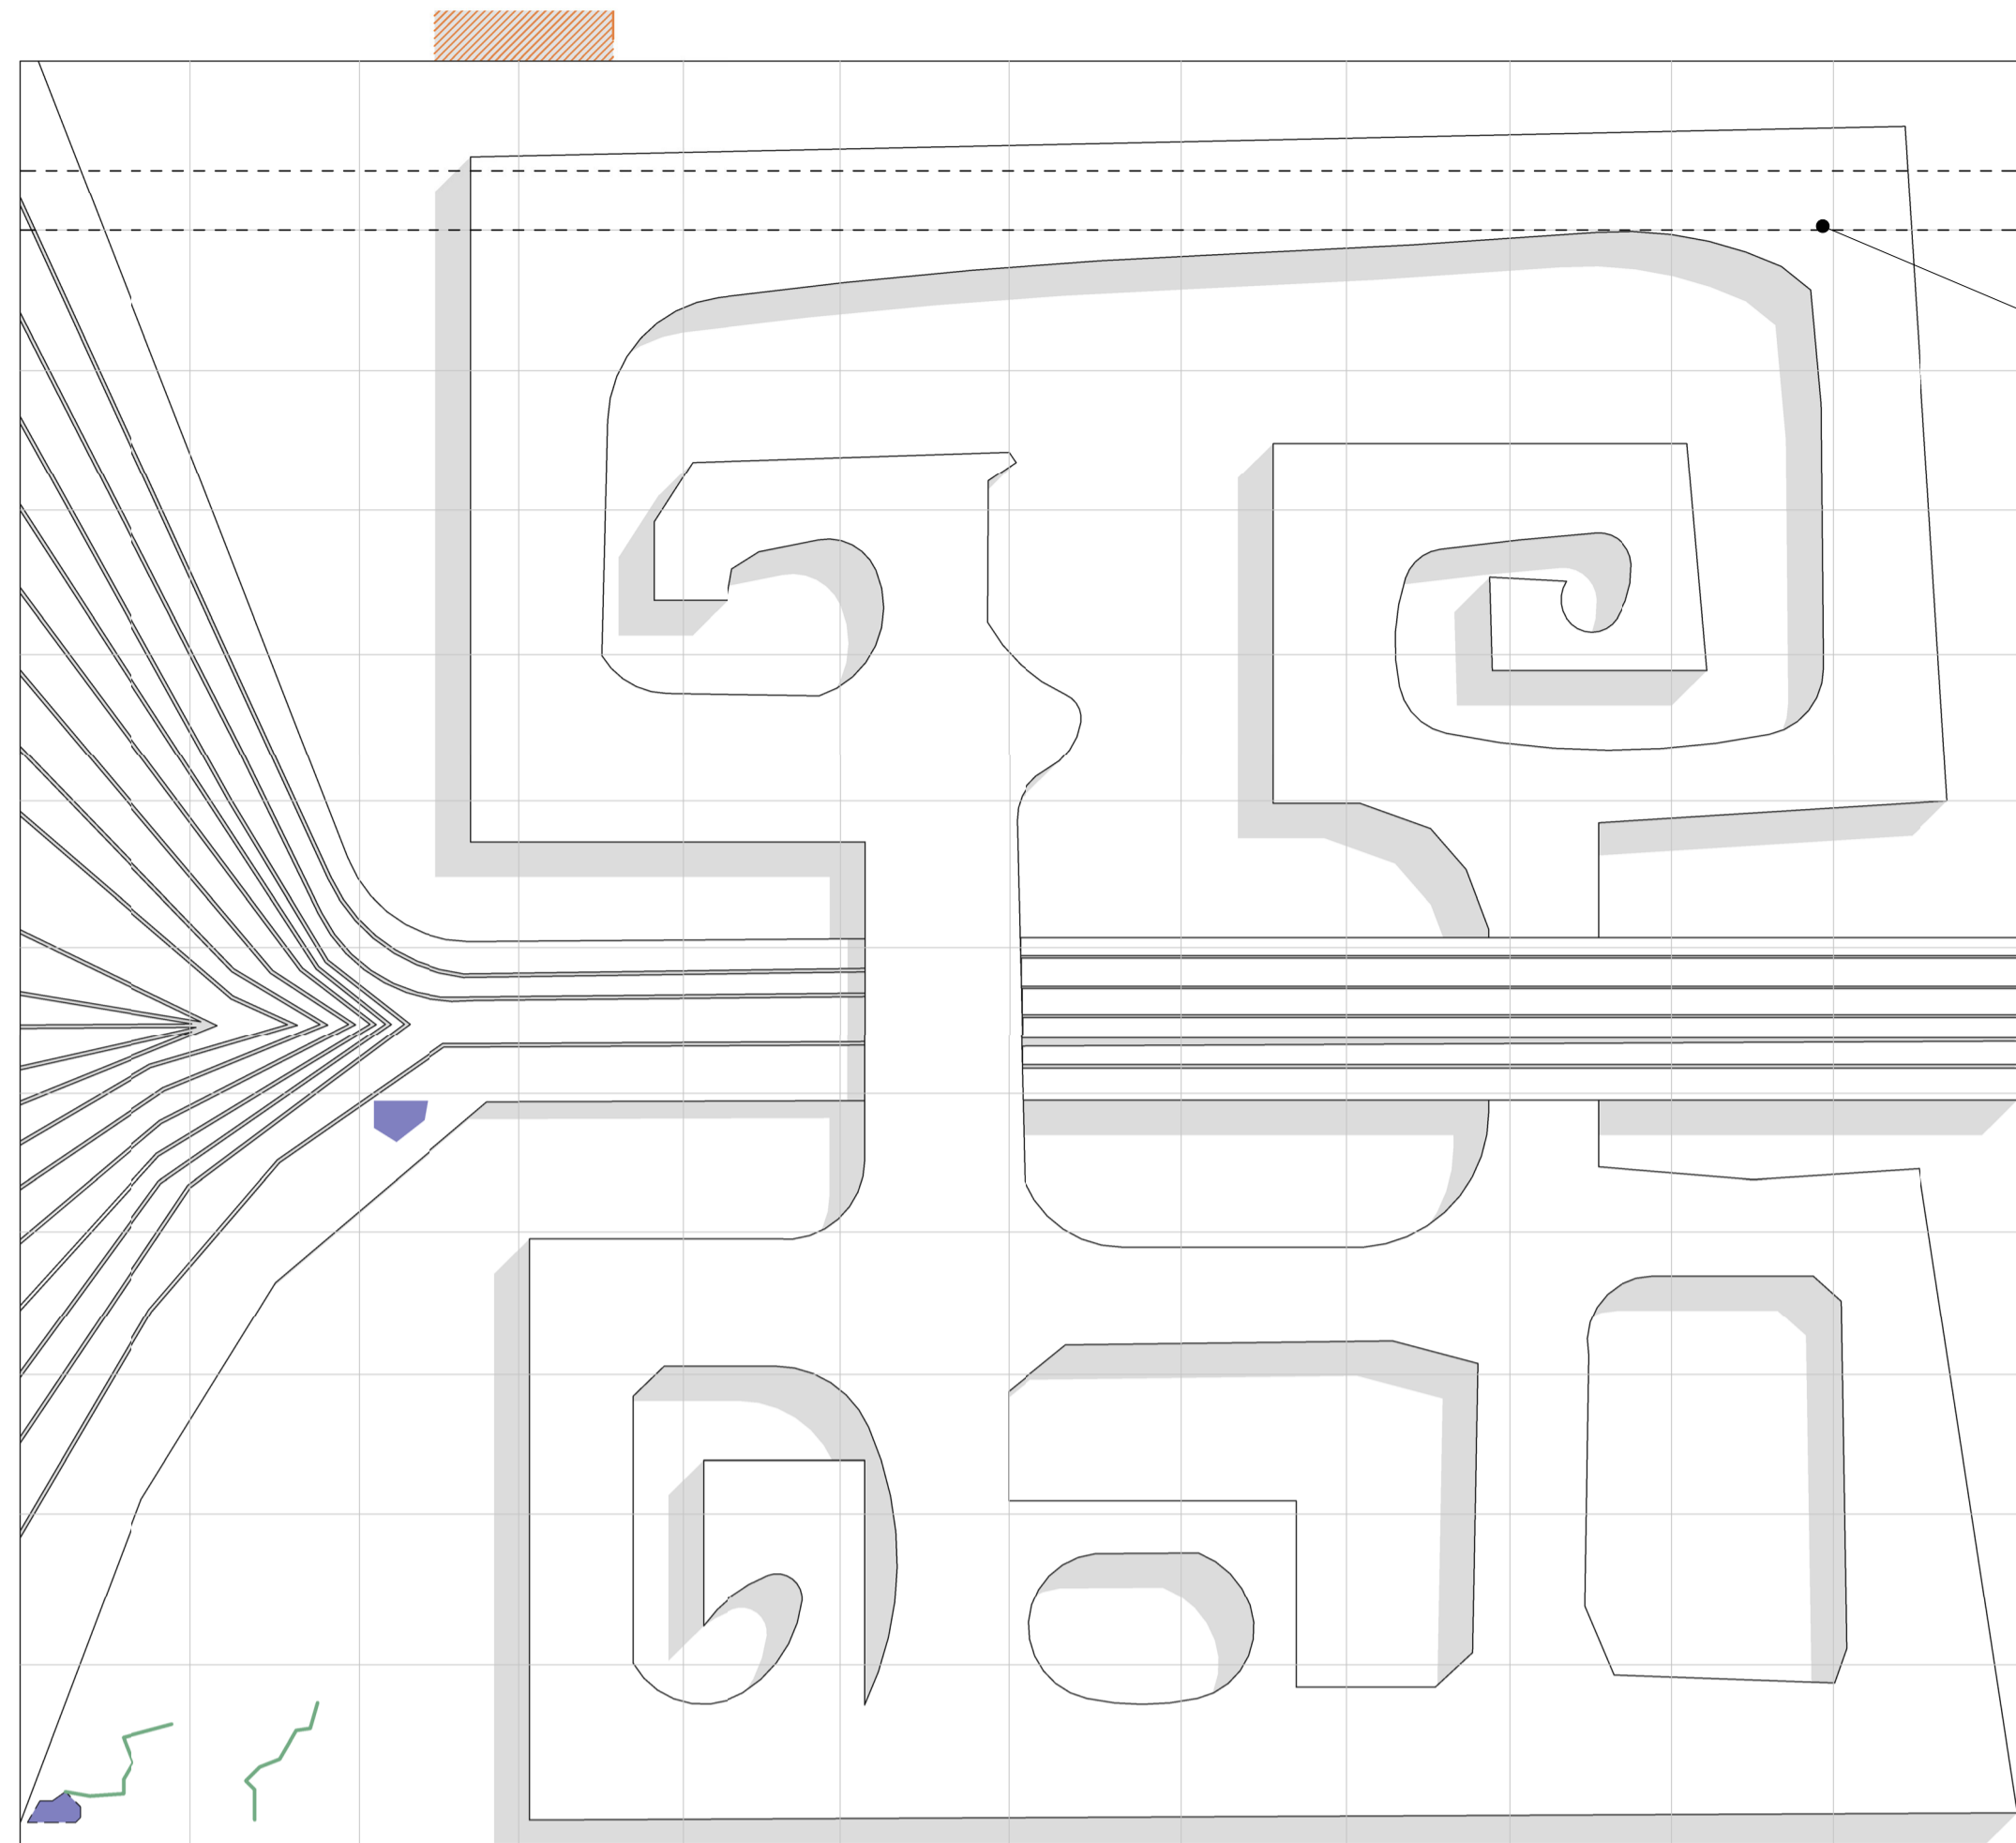
1 Main Elevation (East) - Ceramic Panel 01
1 : 20

Condition
Visual inspection has confirmed that the ceramic panels are largely in good repair with damage present but in limited volumes. There are a variety of cracks with areas of repair from different times since 1969. Many areas of cracking appear to have occurred in firing. Other cracks or broken units have been reassembled with a dark mortar like that used to bed the units. These may be units that failed in the firing or later and have been reassembled for use. A few units appear to have been mortar repaired with the mortar mixed in an attempt to match the tone of the ceramic. Some degradation in panel 10 is indicative of changes in the mix of the clay and possible lower firing temperatures. The later fabrication of this panel could offer some explanation for the difference in its condition as it is thought the original kiln had been dismantled by the time panel 10 was sculpted.

- Removal of non-original fixtures and fittings applied onto the panels
- panels to be cleaned
- failed and loose pointing to be renewed
- damaged units to be mortar renewed
- damaged unit to be mortar repaired (mix to match)
- missing elements to be investigated and where appropriate reinstated
- new lead / hard metal weathering capping to be fitted at the head

- 50% repointing
- 100% doff / thermotech cleaning
- localised mortar repairs
- 12no specialist replacement panels approx 480mm square
- remediation of corroding fixings where damage has been caused to the ceramics
