Refs 2022/93234 LBC museum, 2022/93235 LBC Queensgate Market & art gallery & 2022/93248 Piazza

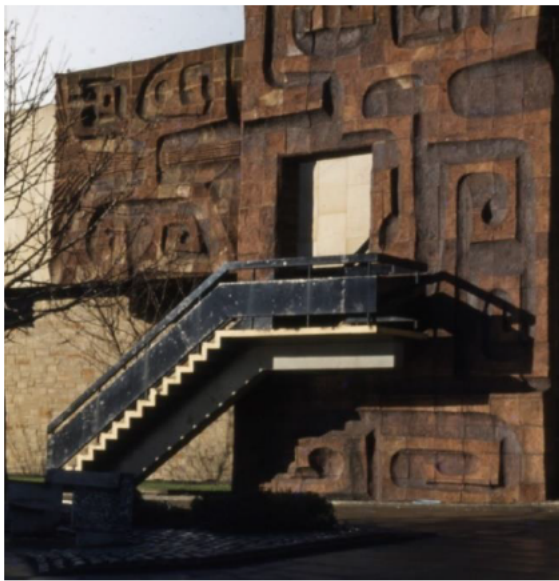
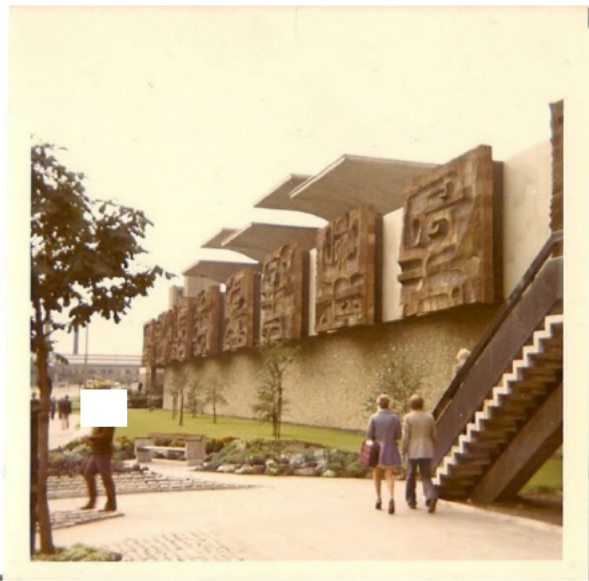
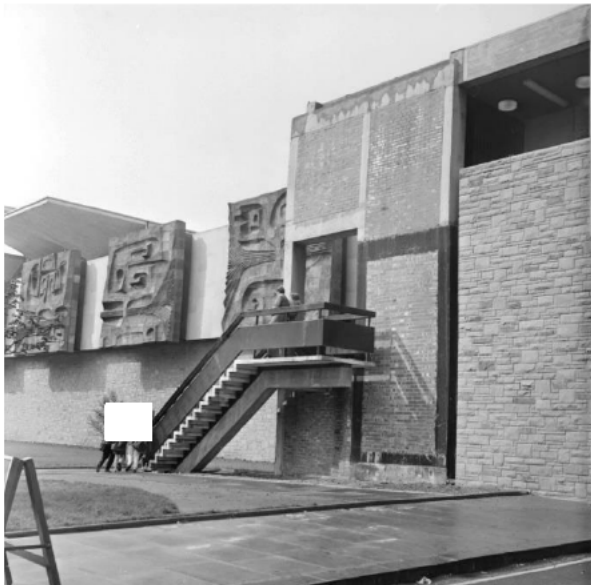
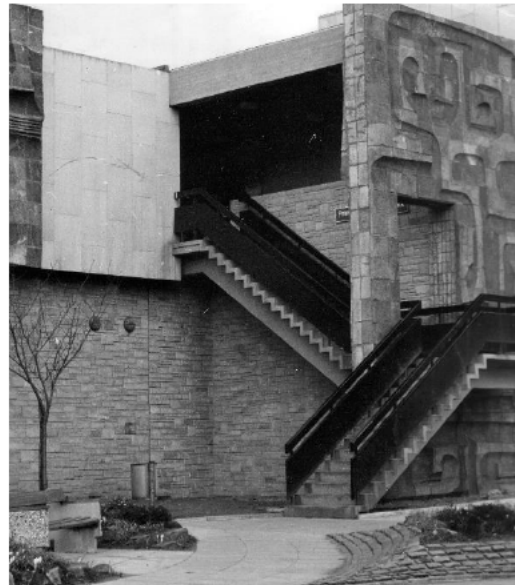
The form and geometry of the 1970 staircase was extraordinary with an apparently unsupported raw concrete stringer beam, pale Ballidon limestone with a glistening quartz-like material concrete riser and tread ends with occasional but regular ballusters bearing black profiles.

The staircase and extended quarter landing were designed and built as 'floating' cranked hidden spine-stringer supporting flights of steps with 'floating' balustrading and handrail. Achieved without newel posts or many spindles and at first sight not meeting the walls. The spindles are minimal without compromising the structure and the handrail had hidden supports to masonry.

The continuous tread and riser ends exhibit a pale zig-zag up the staircase. The balustrading and handrail 'floating above'.

Later replacement parts disregarded the visual significance of the staircase and contrast to the panel. Some really clumsy work was done. I was consulted in 2016-8. And later much of that was undone during renewal work during the pandemic but not all.

I hope restoration work can be conditioned.

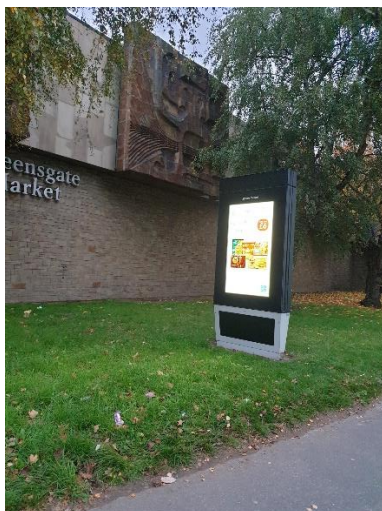
12. Not part of the application but the Queensgate advertising is vile- remove the freestanding JCDecaux panel at end of contract.

Embargo on all commercial Adshel / JC Decaux / Clearchannel advertising panels in proximity of listed buildings and on the site. They degrade and pollute the environs.
