GEOTECHNICAL REPORT

job number J3501/16/E-Rev 2	date 27.11.19
site address 24 Stringerhouse Lane Emley Huddersfield HD8 9SU	
written by R.A. Palmer	checked by S.P. Rogers
issued by R.A. Palmer

Report on a Geotechnical Investigation

Location: **24 STRINGERHOUSE LANE**
Emley, Huddersfield, HD8 9SU

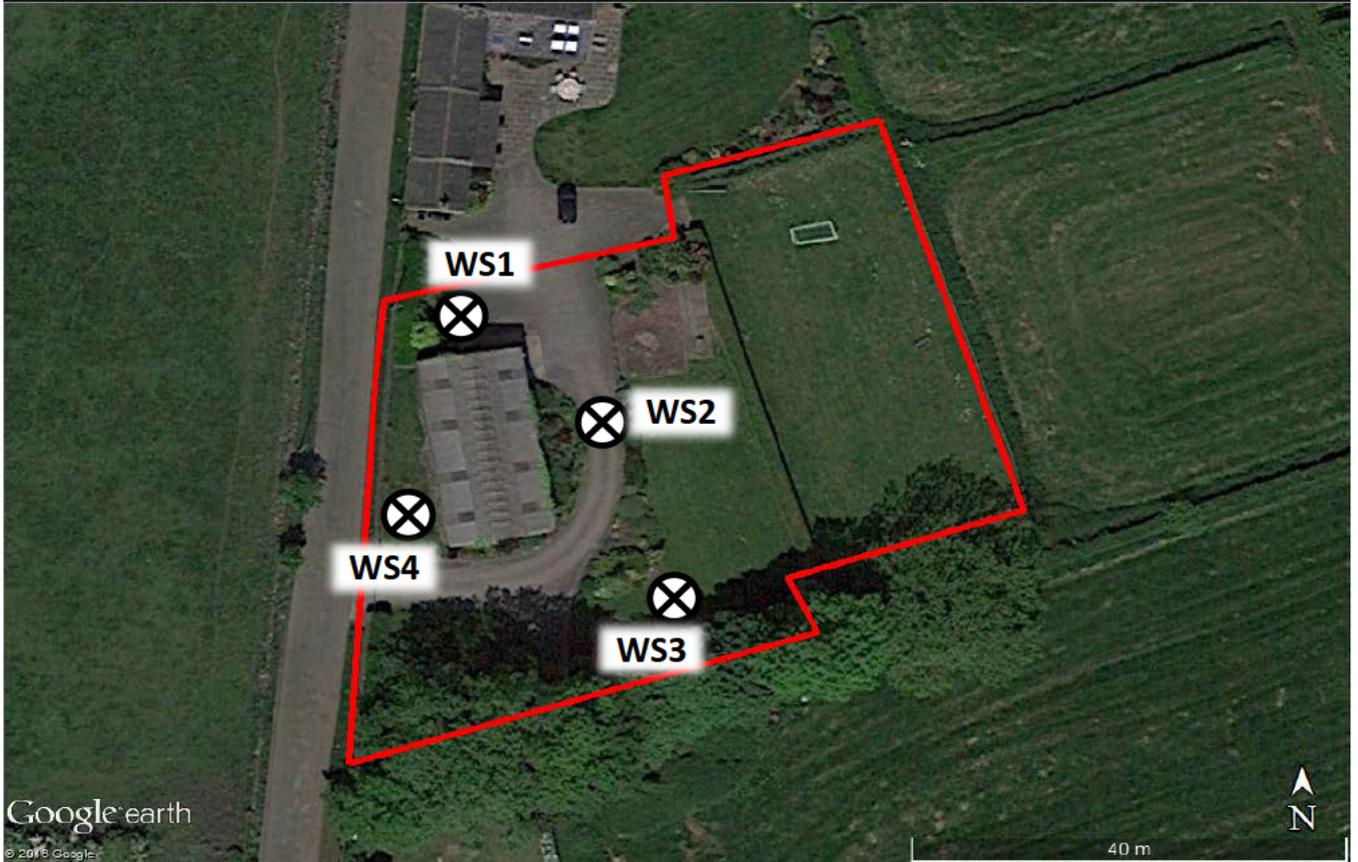
Title: **Investigation Location Plan**

Plan not to scale and investigation positions approximated from site operative's notes.

The investigatory locations are shown on the site plan which is presented in Appendix 1 to this report.
