Bat Survey to  
111 Marsh Lane  
Shepley  
Huddersfield  
HD8 8AS

2<sup>nd</sup> November 2022

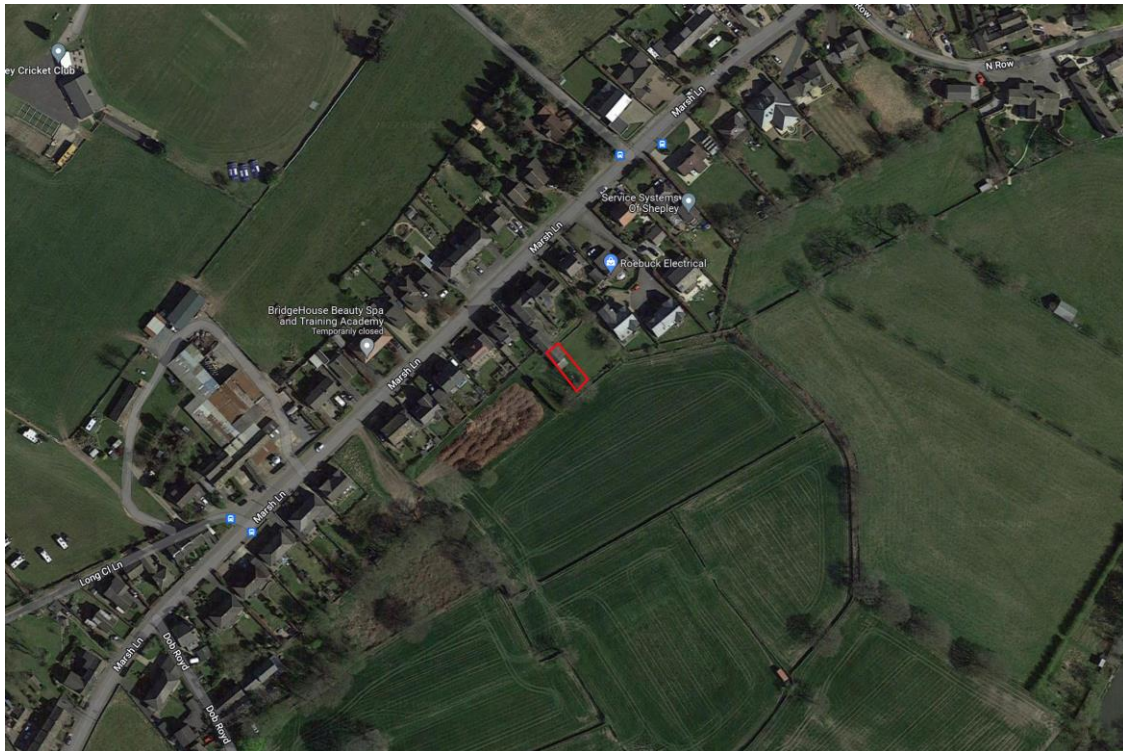
Figure 2 Aerial view of the site, surrounds and specific buildings surveyed

5.1 The site consists of a single-storey garage and outbuilding attached to the rear of a large double-height outbuilding at the rear of 111 Marsh Lane. The site is surrounded by other dwellings and pasture to the rear of the site. Foraging habitat is limited immediately surrounding the site but good foraging exists c.1000m east of the site and the site is connected to the wider landscape by a series of linear features.

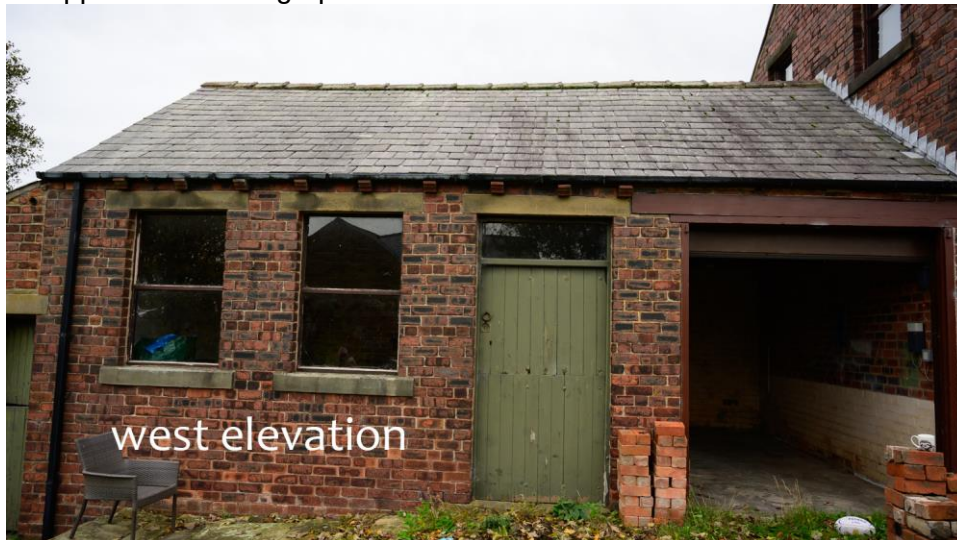
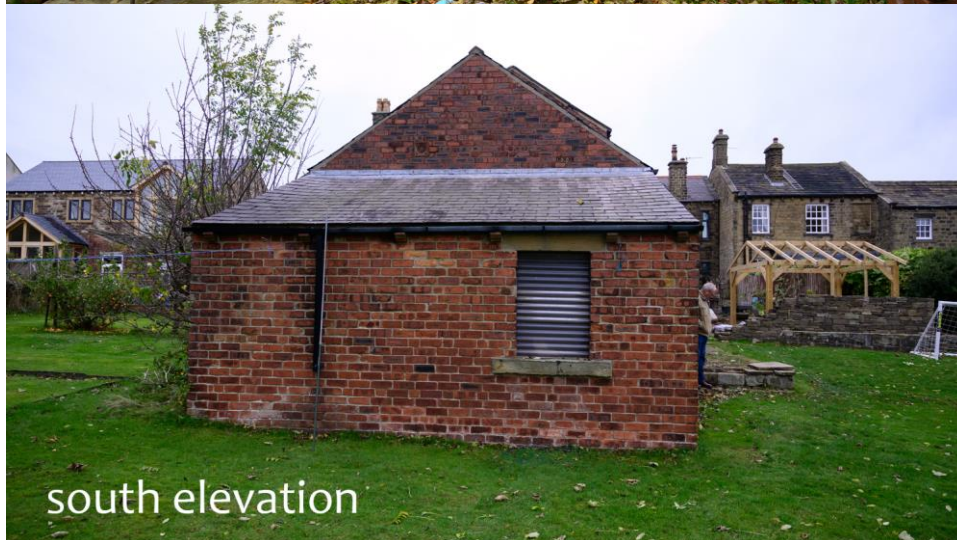
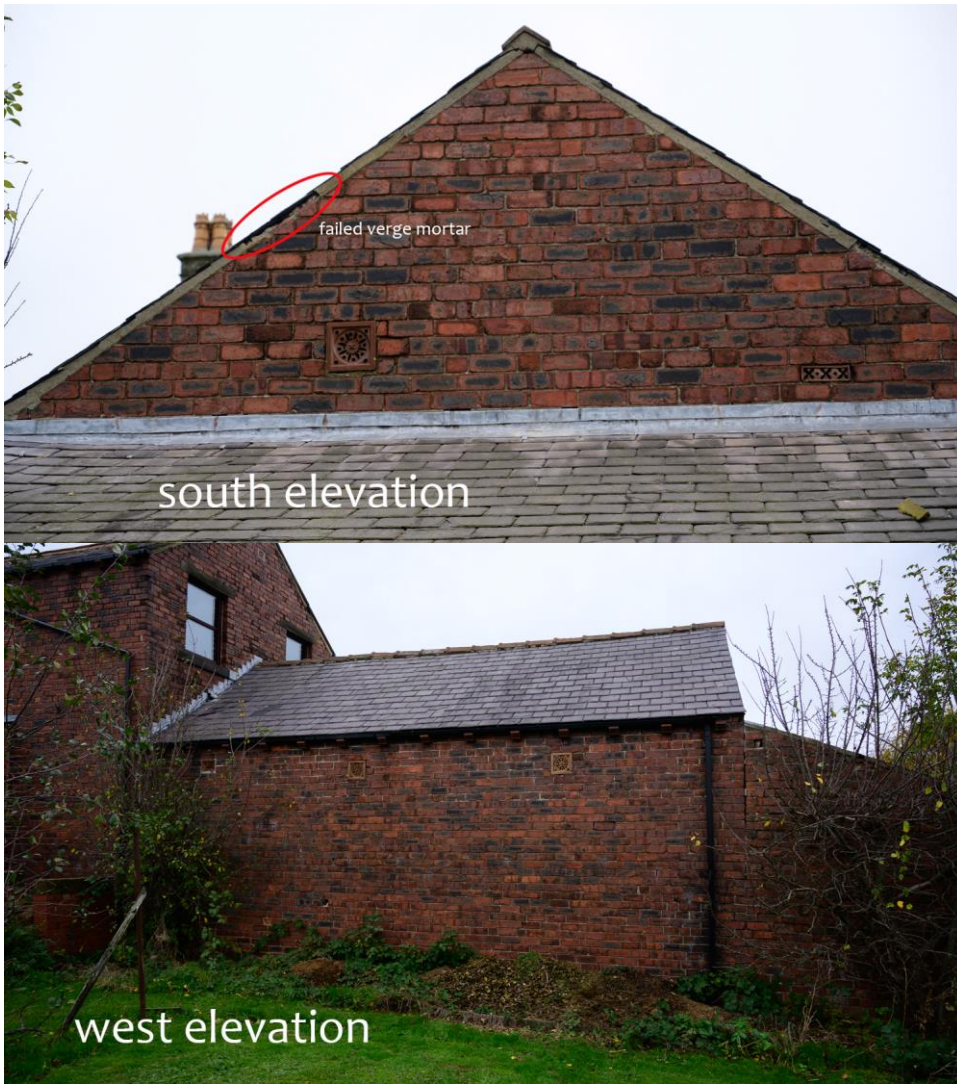
Appendix 1 Photographs of the site

The building is a single storey brick building comprising a garage and former stable and there is a lean-to building on the south elevation. The roof is covered with blue slate and is sound and without missing or slipped tiles and all ridge tiles are present though there are small sections of failed mortar. The internal section above the garage is unlined and shows no signs of use by bats. The interior of the former stable is lined with wooden boards and is sealed at the ridge. There are no signs of bats inside the building; no droppings, scattered prey remains, or staining was noted.

The walls are built from large industrial bricks arranged in a header and stretcher style and. Therefore, there is no wall cavity. The walls are sound and have no structural gaps or cracks that would potentially allow bats to roost. The wooden casement and stable doors offered no roost potential and there are no fascia boards or soffits. The single verge to the south elevation of the roof has a section of failed mortar but the resulting gap is quite large and likely to appeal to sparrows and other birds.

- All roof tiles to be removed by hand, especially ridge and edge tiles. This should be done during the winter period (Nov-March inclusive) when bats are less likely to be present.
- A bat box will be erected on an adjacent building prior to the removal of the roof tiles so that if a bat is found it can be placed in a safe environment.
- In the unlikely event of a bat being found during the work, work will cease, and advice be sought from a qualified ecologist. Bats will only be removed by the appropriately qualified ecologist.

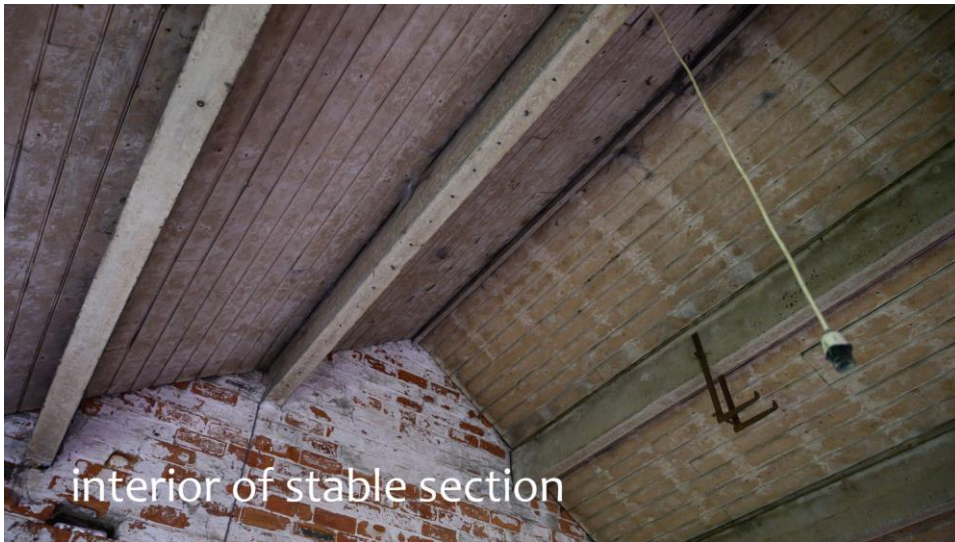
interior of stable section

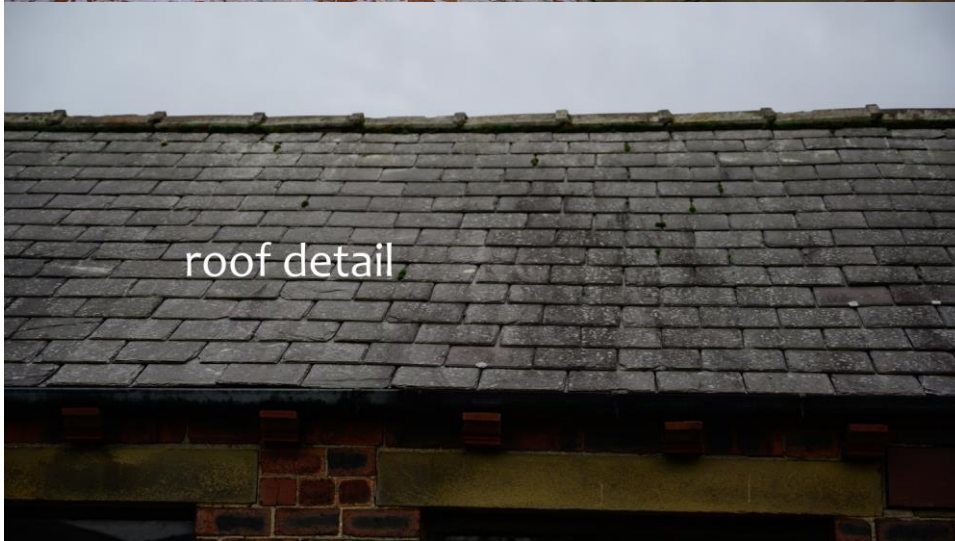
roof detail

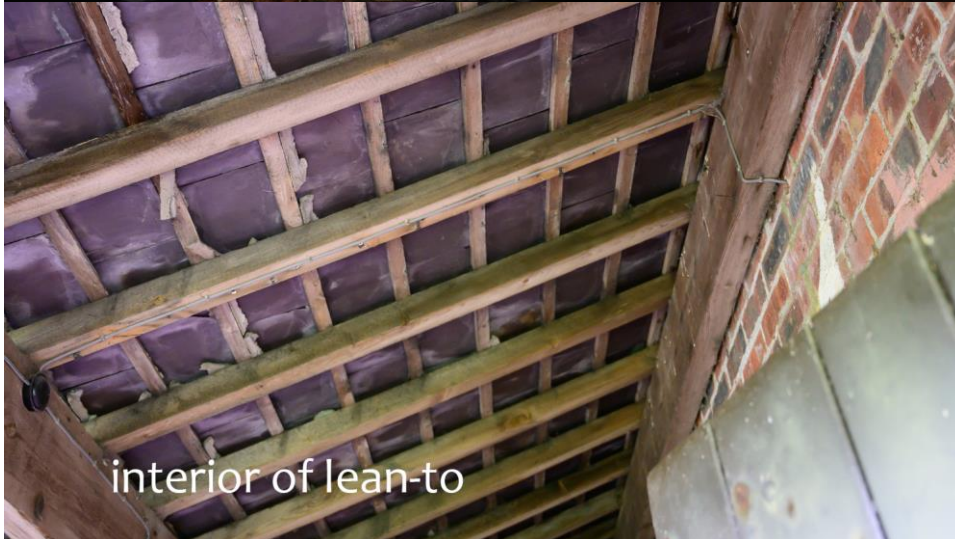
There is a lean-to attached to the south elevation which has the same style of solid wall and blue slate roof. This section is unlined and not likely to appeal to bats. There is a minor gap between to the bricks where the lean-to joins the stable, but this was easily inspected and showed no use by bats.

interior of lean-to
