# Hoyle Ing, Linthwaite

## Phase 2 Geo-Environmental Investigation

For: Redwaters Yorkshire Ltd

Ref: 3836-02  
Job: 3836  
Rev: -  
By: AJ

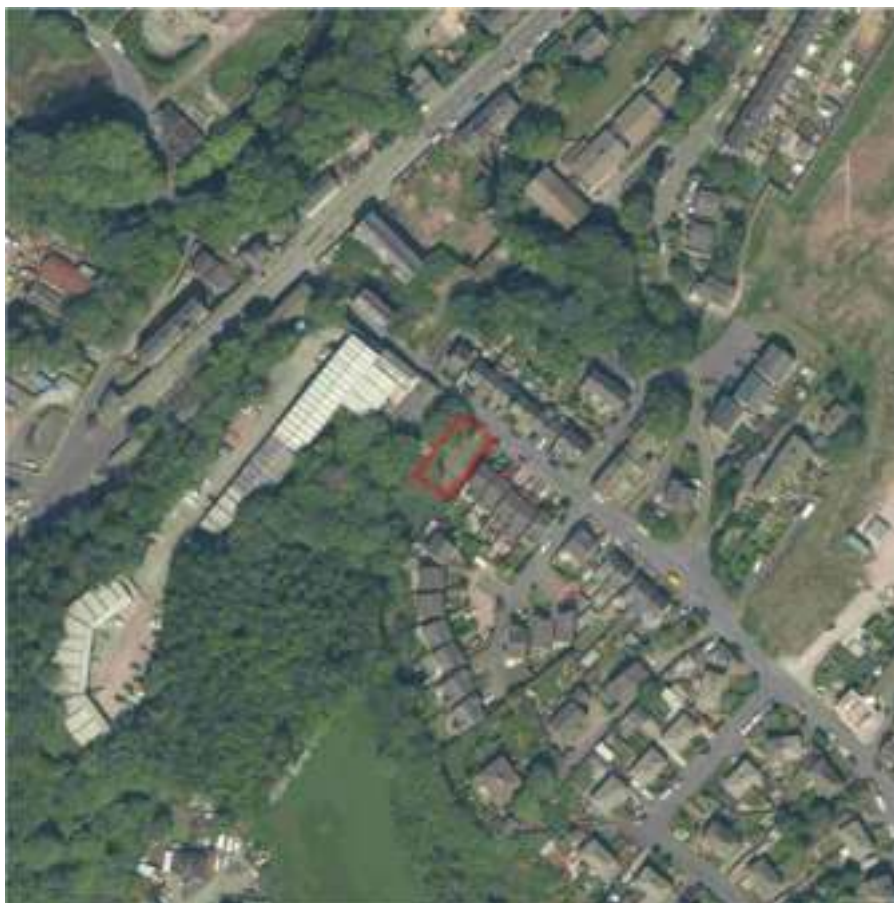
The site currently comprises a small disused car park which is bound by Hoyle Ing along the northeastern boundary, residential properties to the southeast and established trees along the southwest and northwest boundaries. An aerial photo of the site is included below:

*Figure 1: Aerial image of the site dated May 2021.*

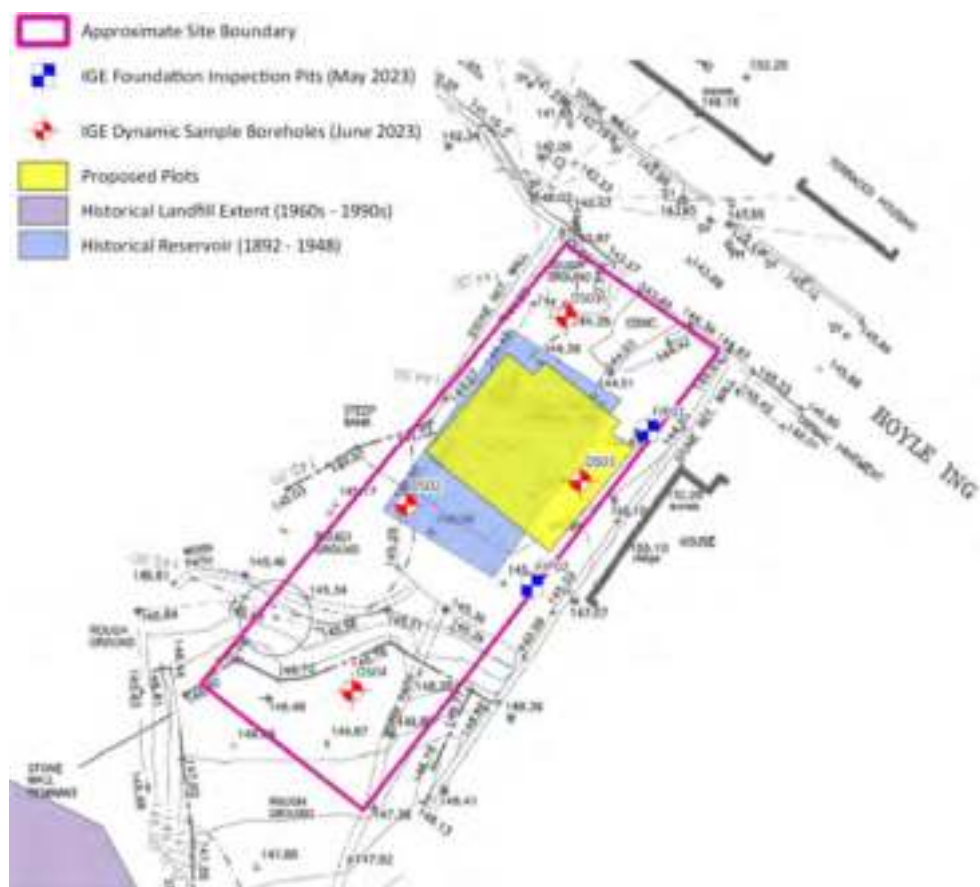
An extract of the exploratory hole location plan is included below for reference. The exploratory hole location plan is contained in Appendix 2.

Figure 3: Extract of the exploratory hole location plan (Ref: SI-05)

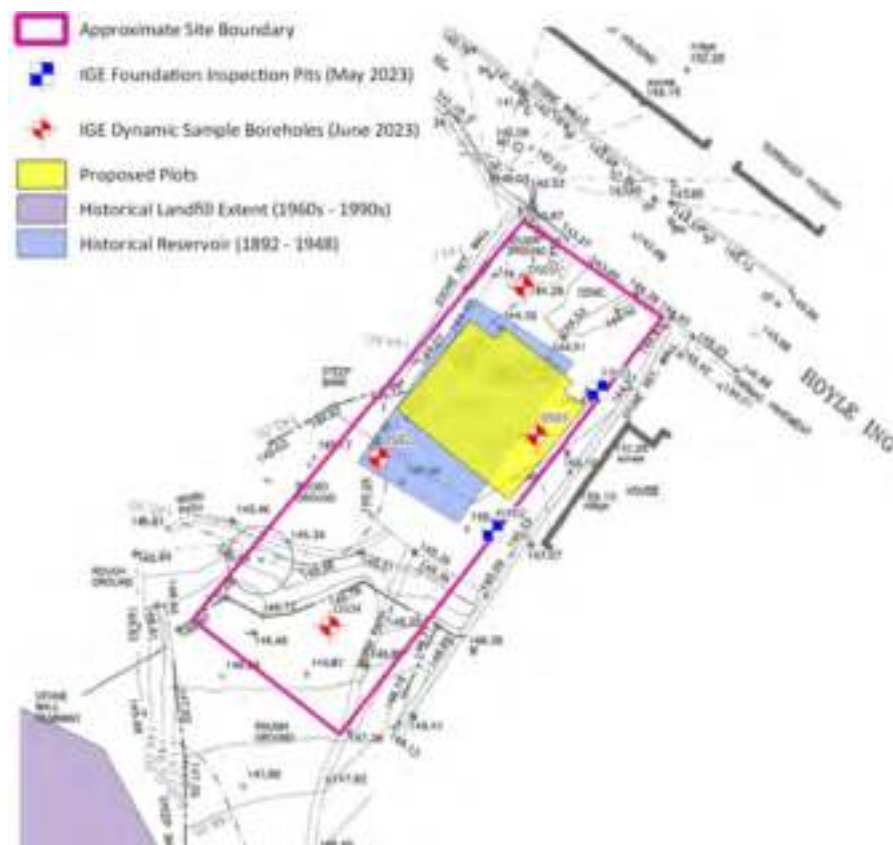
The ground gas monitoring wells were also placed spatially to target sources. DS04 was placed in the southern site section nearer the off-site landfill and DS01 and DS03 were placed targeting deep Made Ground in-line with BS8576 (2013) Section 8.4. Given the very small size of the site, a low-risk area was not identified on-site to determine background concentrations. An extract of the exploratory hole location plan is included below for reference:

Figure 4: Extract of the exploratory hole location plan (SI-05)

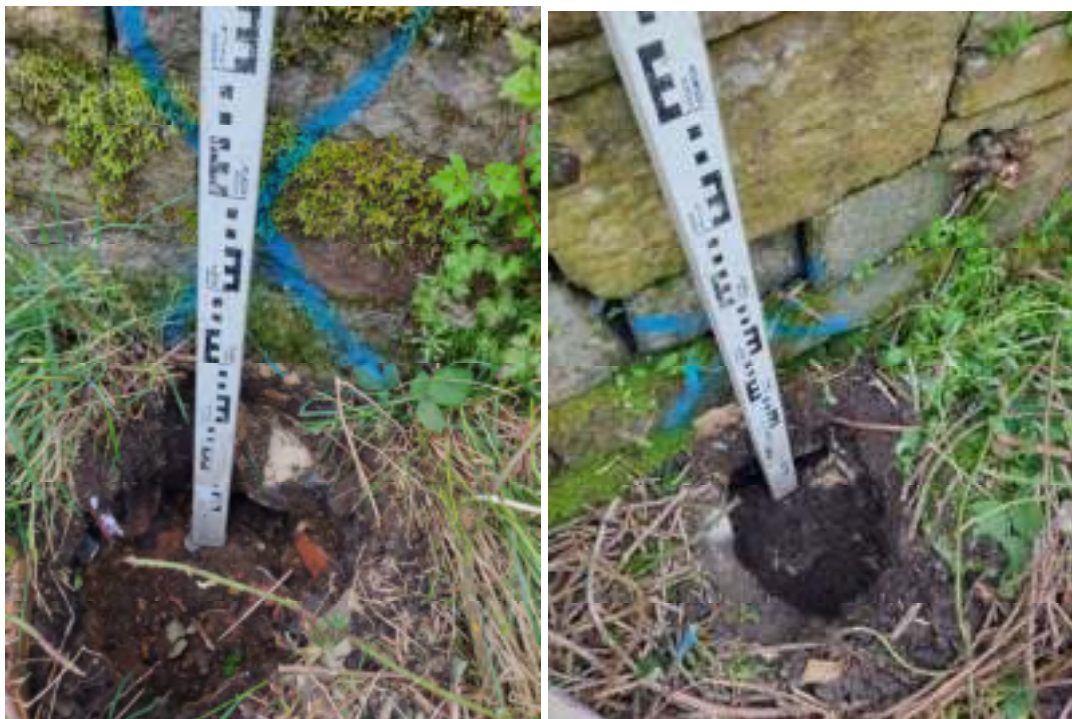
FIP01 encountered a foundation to a depth of 300mm bgl, protruding 100mm from the face of the retaining wall. FIP02 encountered a foundation to a depth of 250mm, protruding 50mm from the face of the retaining wall.

The foundation inspection pits were undertaken to depths of 0.40m (144.97m AOD) and 0.30m (144.96m AOD) respectively and were terminated beneath the base of the foundations. The foundations were constructed of sandstone cobbles / boulders which is in-line with the retaining wall construction. Photographs are included below for reference, additional details are included on the foundation inspection pit logs in Appendix 4.

Figure 5: Photographs of FIP01 (left) and FIP02 (Right).

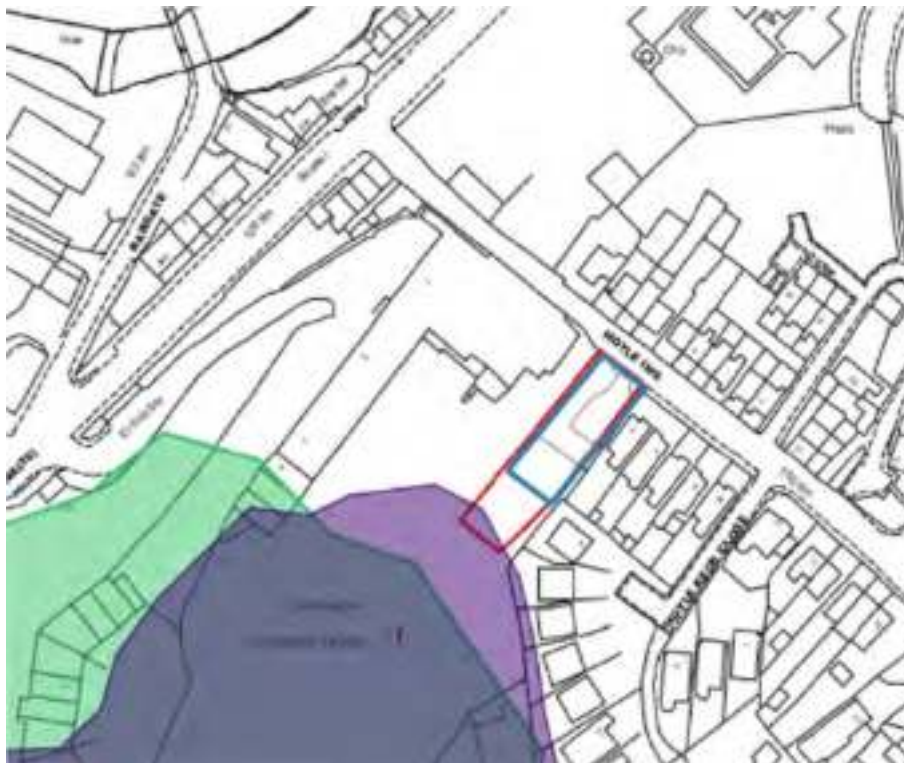
**Following consultation with the Local Authority including the receipt of the available information regarding the extent of the off-site landfill (shown below) as well as an updated site boundary, the landfill is now deemed to be off-site, as per the below extract. This was confirmed by the lack of Made Ground in DS04 located in the southern site section.**

*Figure 6: Extract of the landfill extents plan as provided by the Senior Technical Officer (purple and green hatched areas), the former incorrect site boundary (red) and the amended site boundary (blue)*

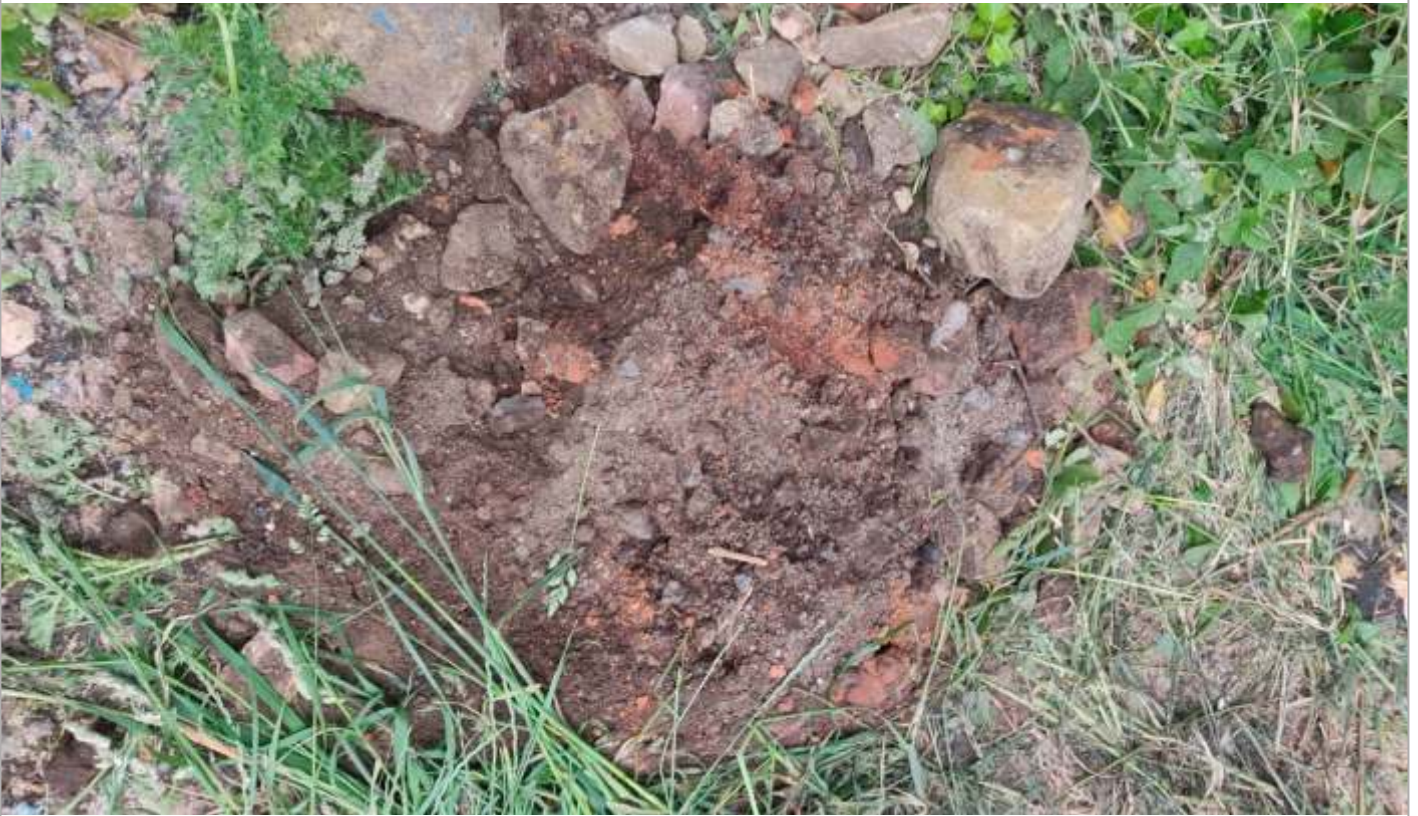
**Image 1.** DS01 Hand Dug Pit:  
Viewed left to right, top to bottom.  
0.00m - 1.20m bgl.

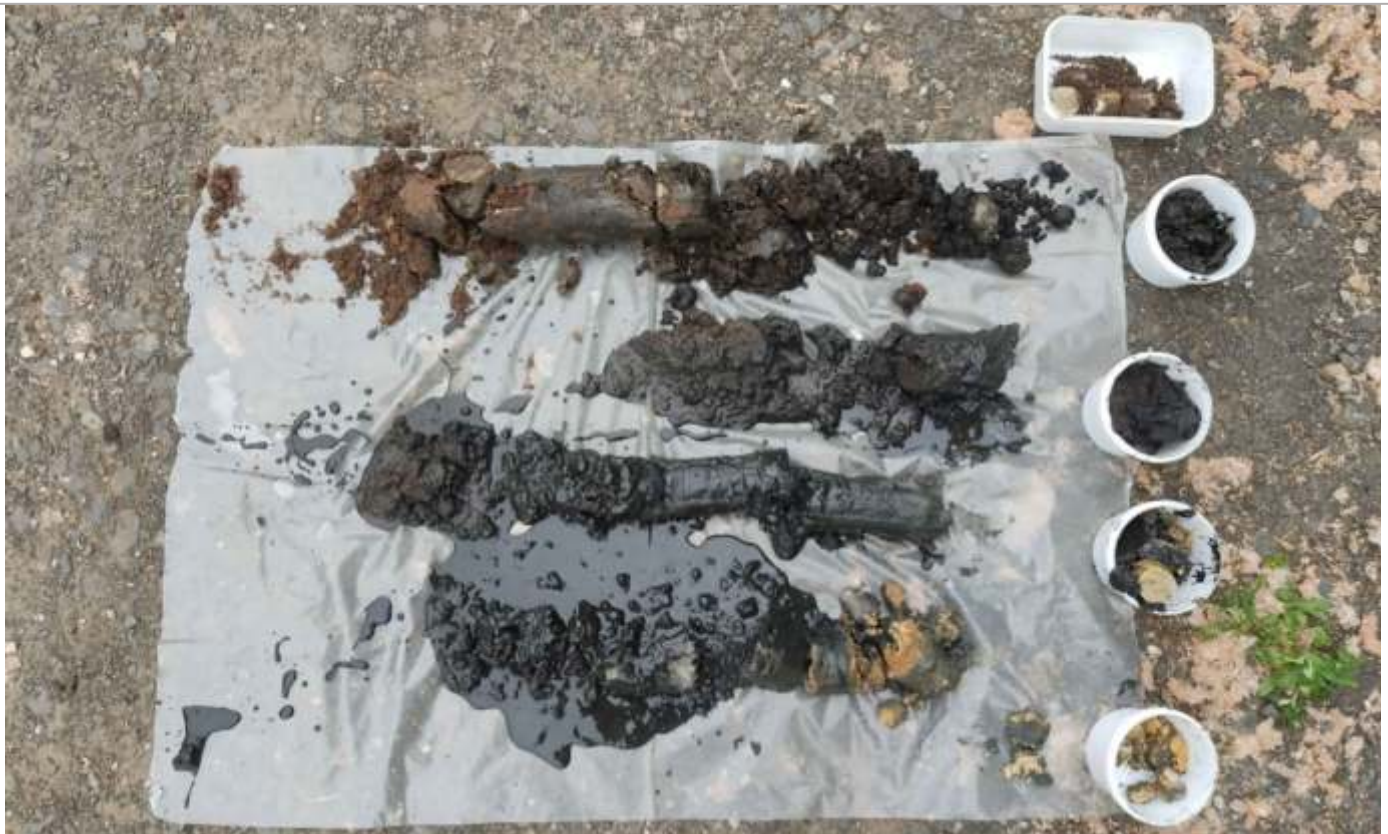
- A hydrocarbon odour was noted in Made Ground in DS01 between 1.70m and 3.50m bgl (142.50m - 140.70m AOD). PID readings of between 0.00ppm - 0.30ppm were recorded within the stratum. A sample of this stratum (2.30m bgl) was sent for chemical analysis.
- A hydrocarbon odour was noted in Made Ground in DS02 between 3.00m and 3.45m bgl (142.10 - 141.65m AOD). A PID reading of 0.60ppm was recorded within the stratum. A sample from this stratum could not be analysed due to the very small sample volume obtained from the SPT and lack of recovery from the barrel, however, a sample from the underlying stratum at 4.70m bgl was sent for chemical analysis.

**Image 2.** DS01 Sample:  
Viewed left to right, top to bottom.  
1.20m - 2.00m bgl.  
2.00m - 3.00m bgl.  
3.00m - 4.00m bgl.  
4.00m - 4.90m bgl.

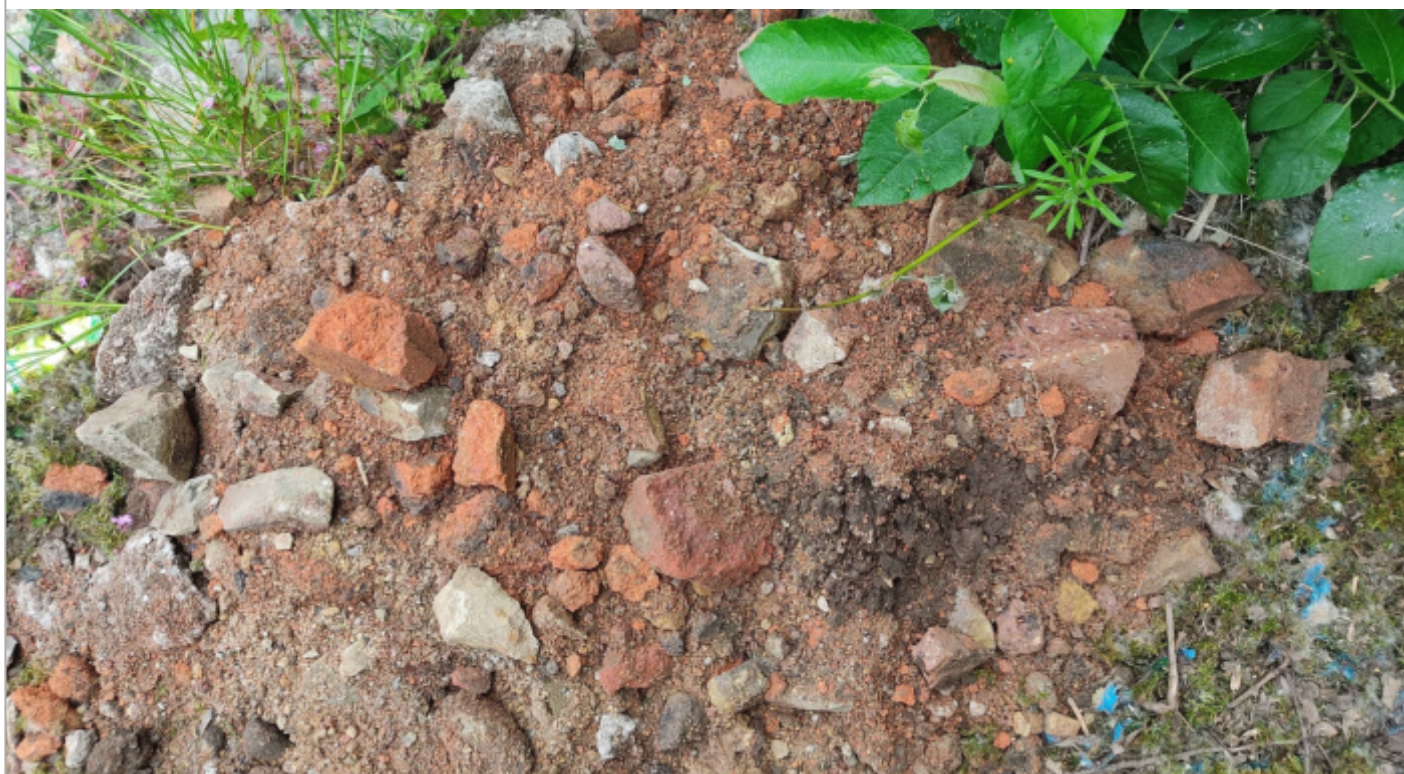
**Image 1.** DS02 Hand Dug Pit:  
Viewed left to right, top to bottom.  
0.00m - 1.20m bgl.

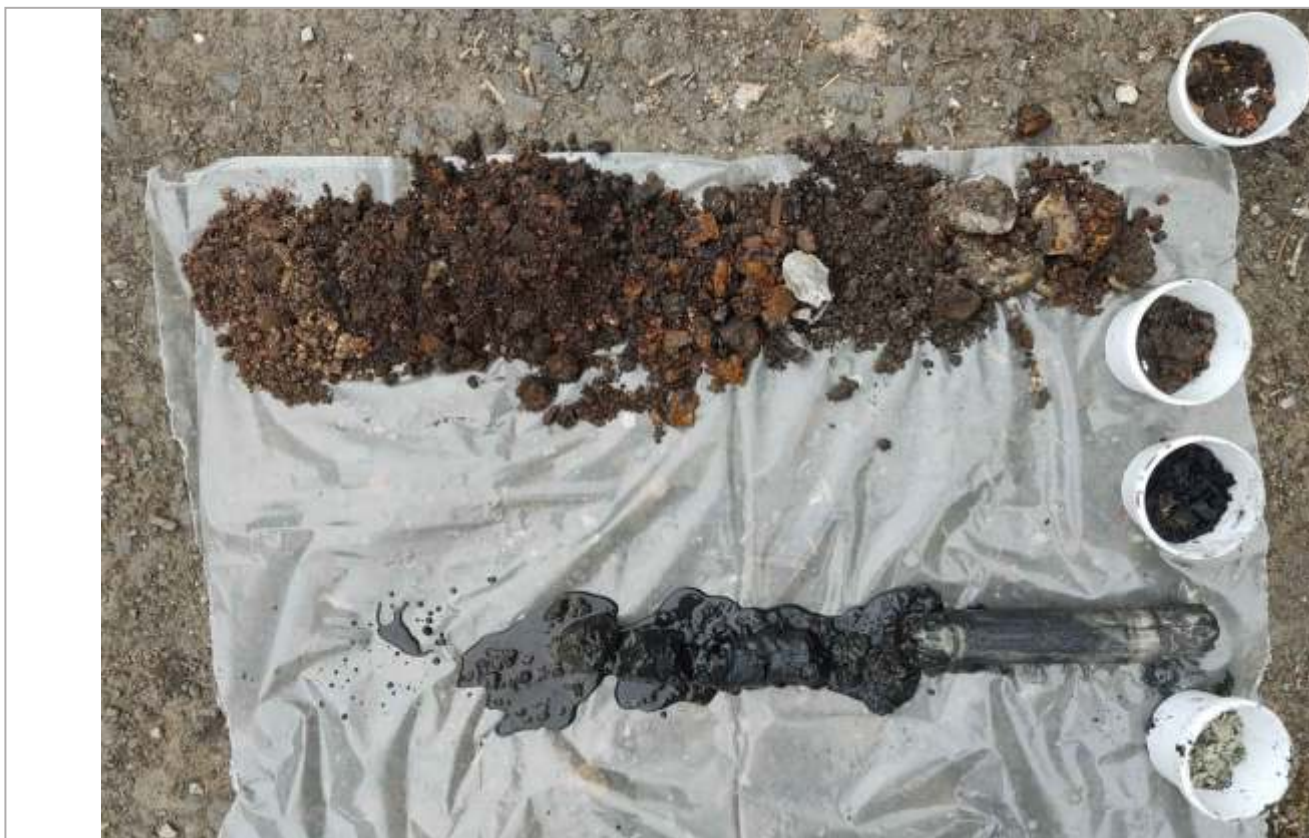
**Image 2.** DS02 Sample:  
Viewed left to right, top to bottom.  
1.20m - 2.00m bgl.  
4.00m - 5.00m bgl.

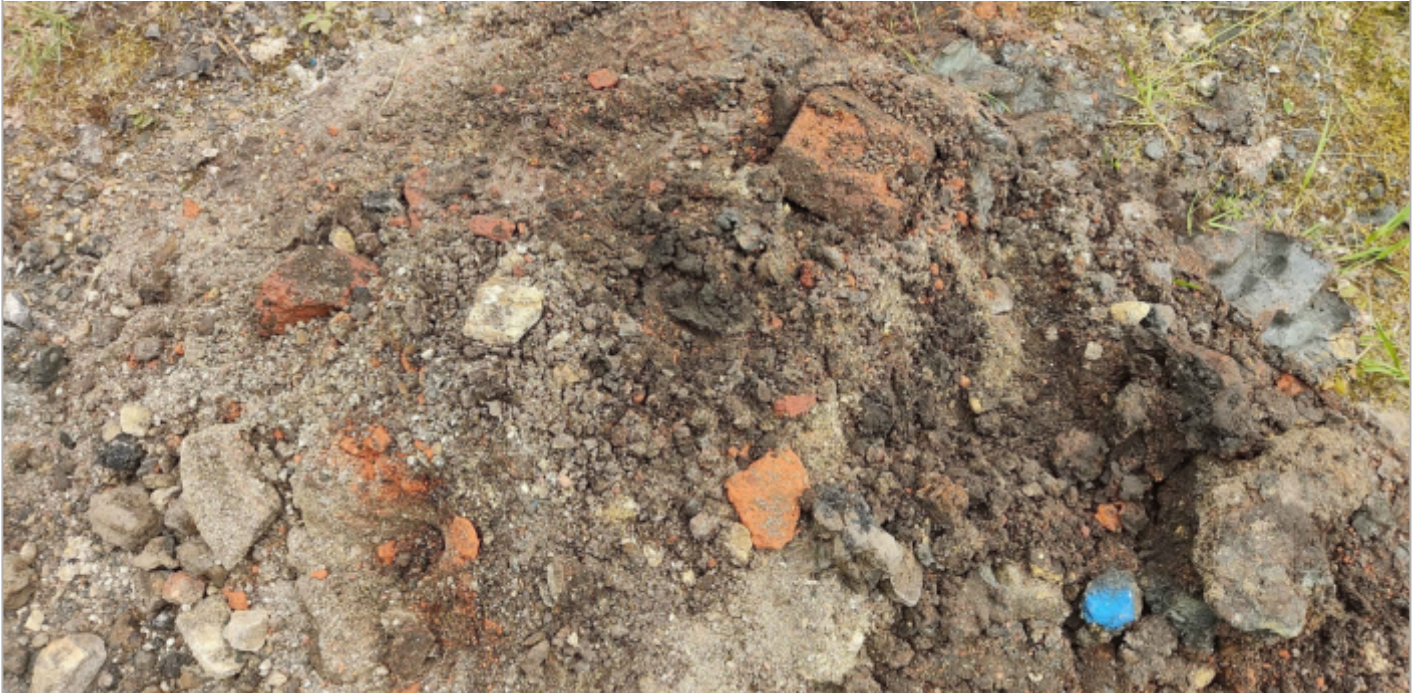
**Image 1.** DS03 Hand Dug Pit:  
Viewed left to right, top to bottom.  
0.00m - 1.20m bgl.

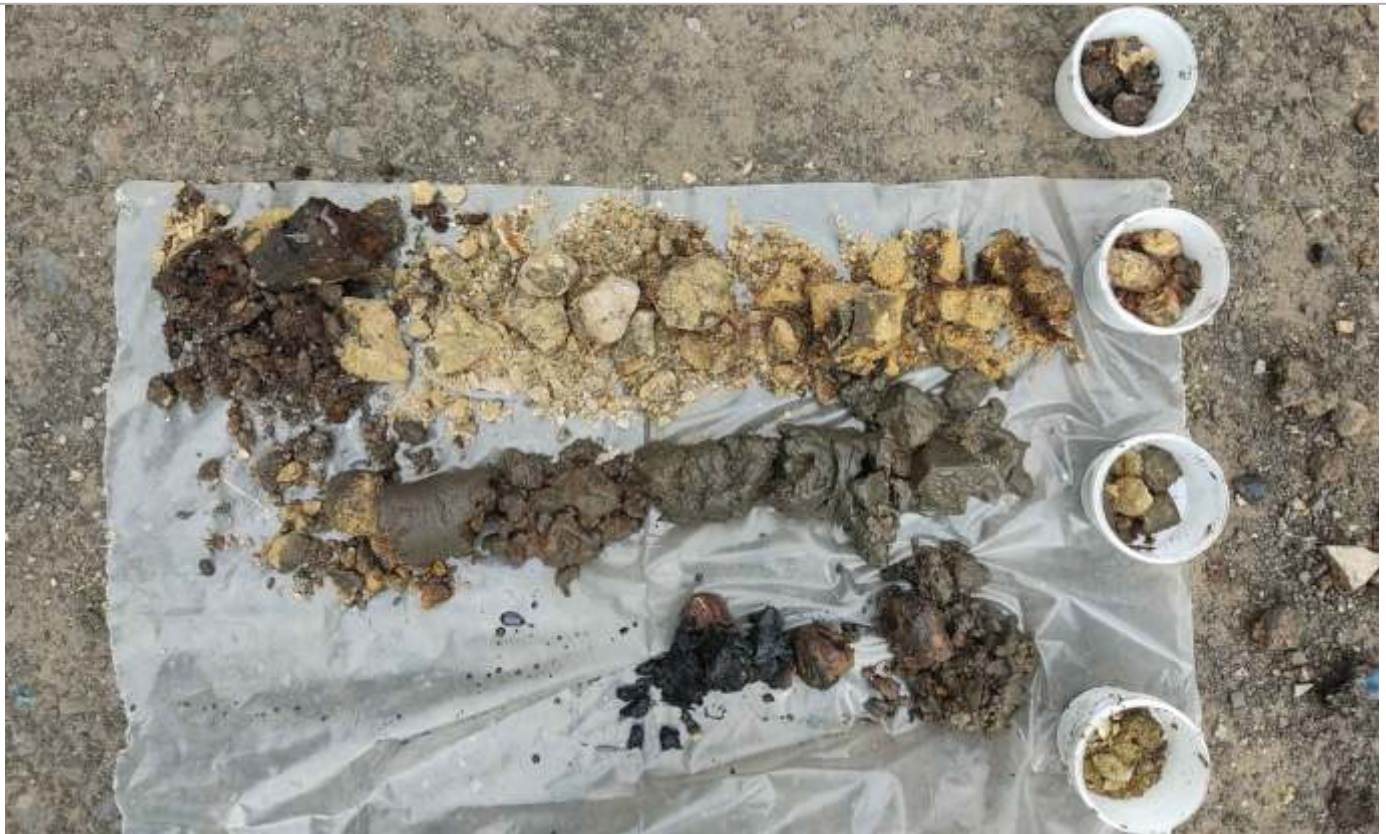
**Image 2.** DS03 Sample:  
Viewed left to right, top to bottom.  
1.20m - 2.00m bgl.  
2.00m - 3.00m bgl.  
3.00m - 3.60m bgl.

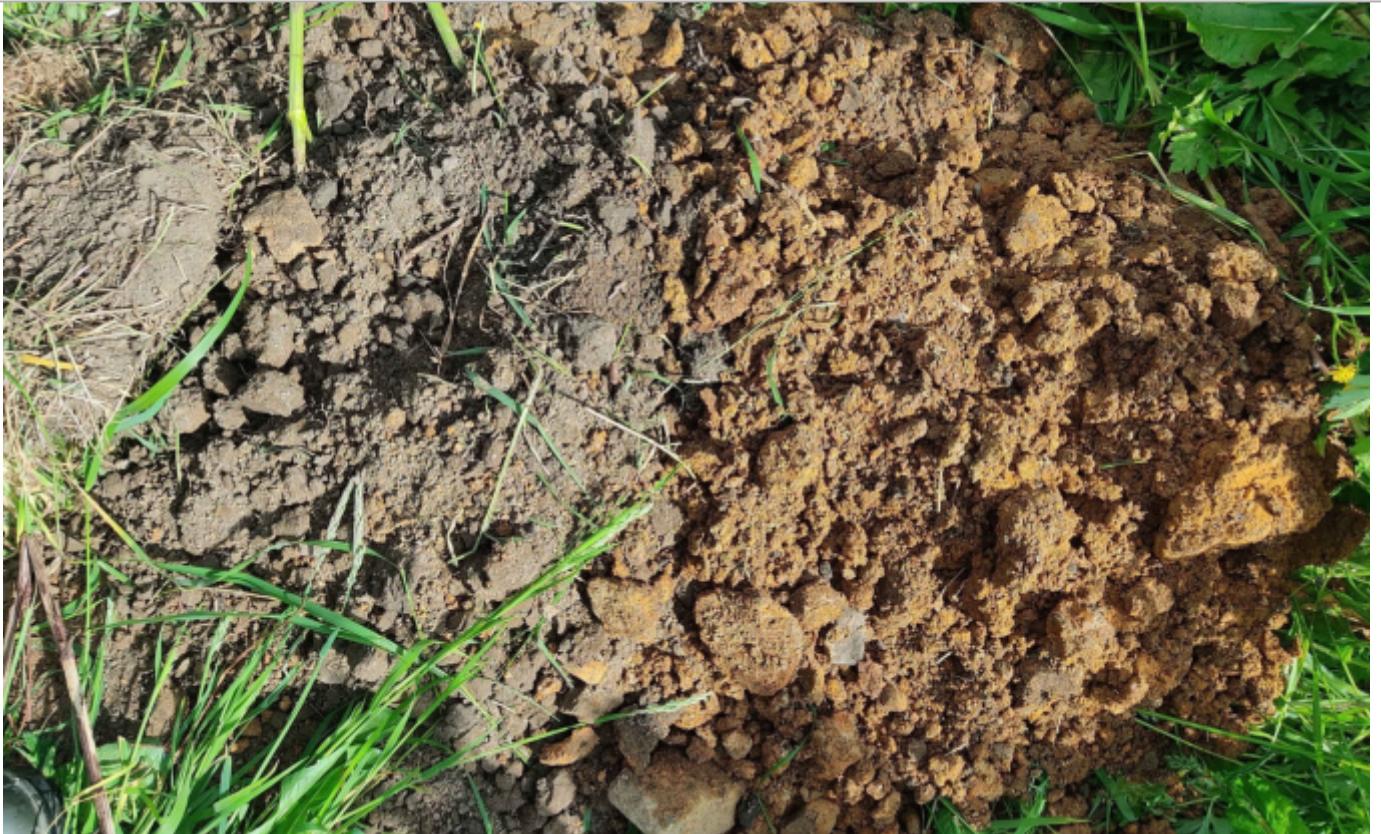
**Image 1.** DS04 Hand Dug Pit:  
Viewed left to right, top to bottom.  
0.00m - 1.20m bgl.

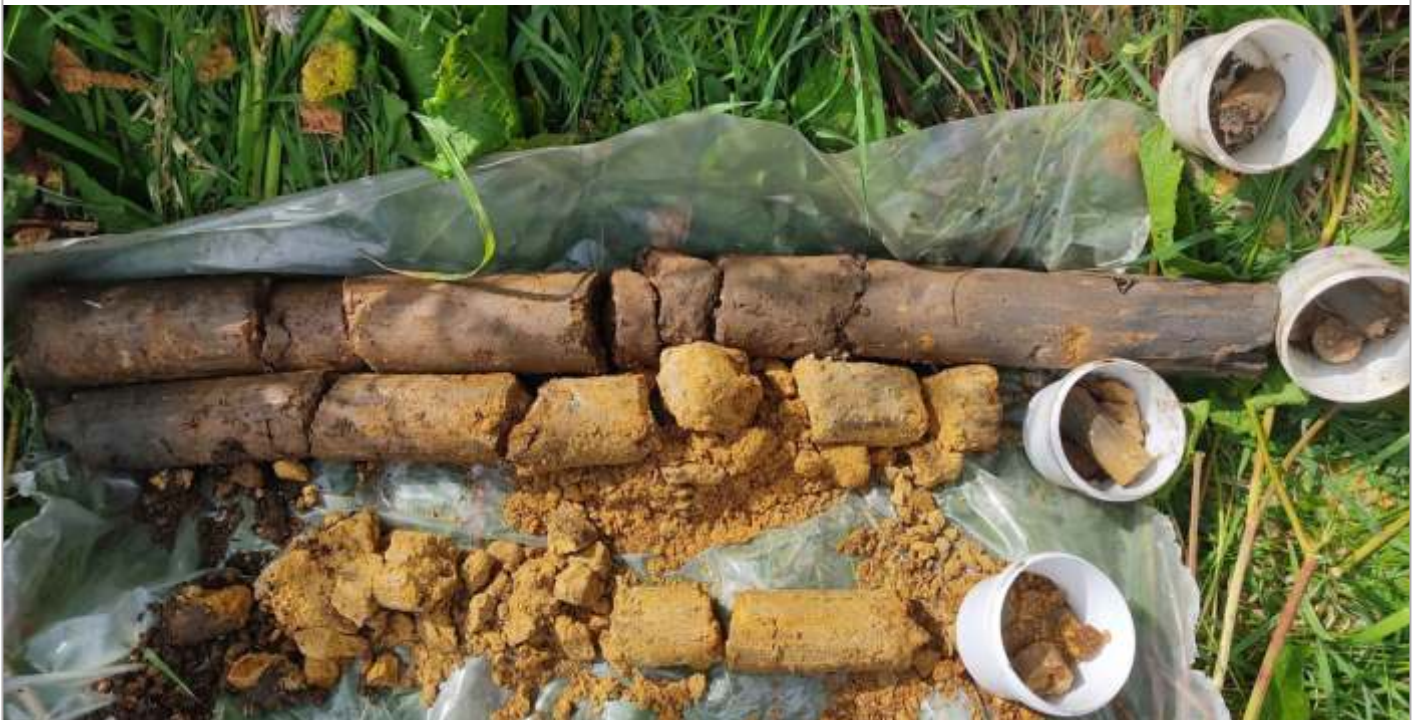
**Image 2.** DS04 Sample:  
Viewed left to right, top to bottom.  
1.20m - 2.00m bgl.  
2.00m - 3.00m bgl.  
3.00m - 3.50m bgl.

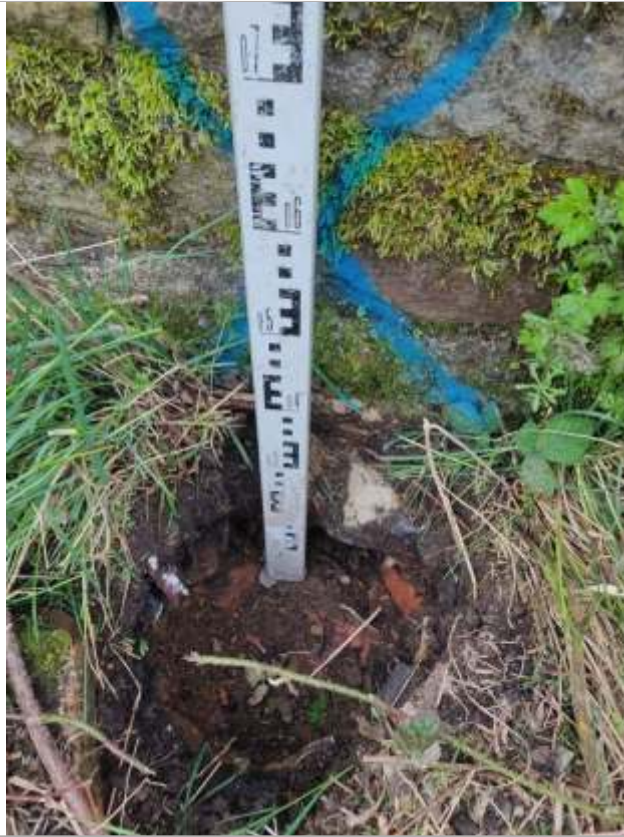
**Image 1.** HDP01 Pit

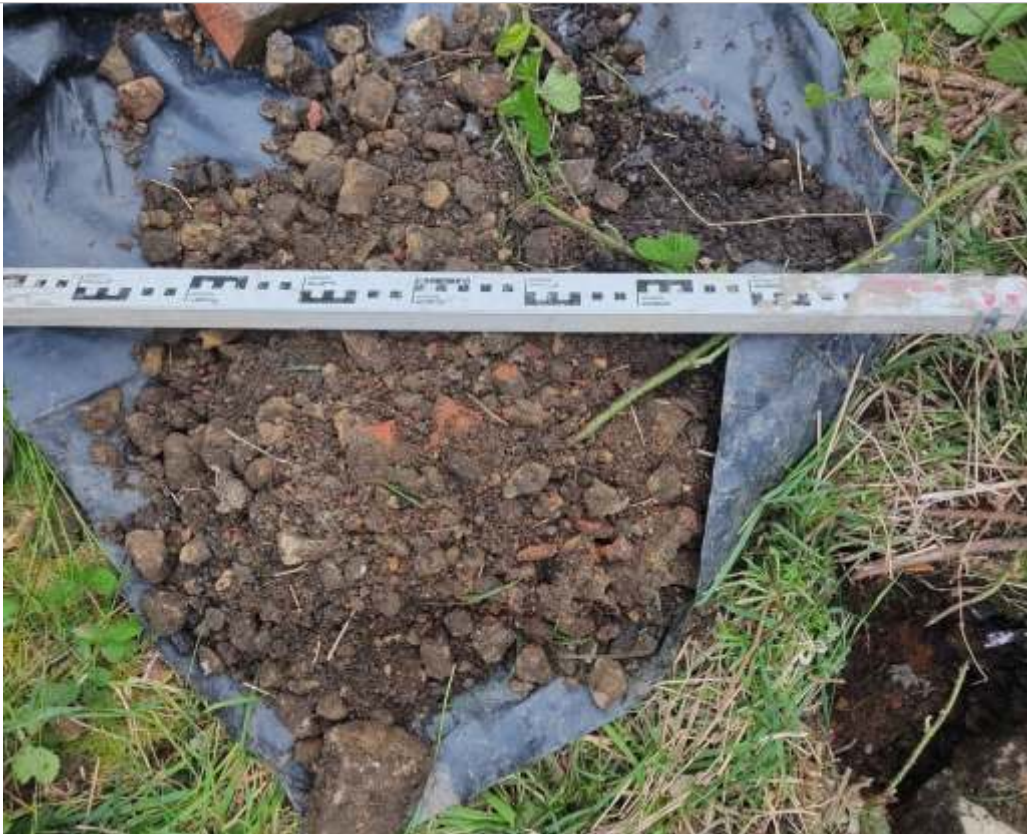
**Image 2.** HDP01 Spoil

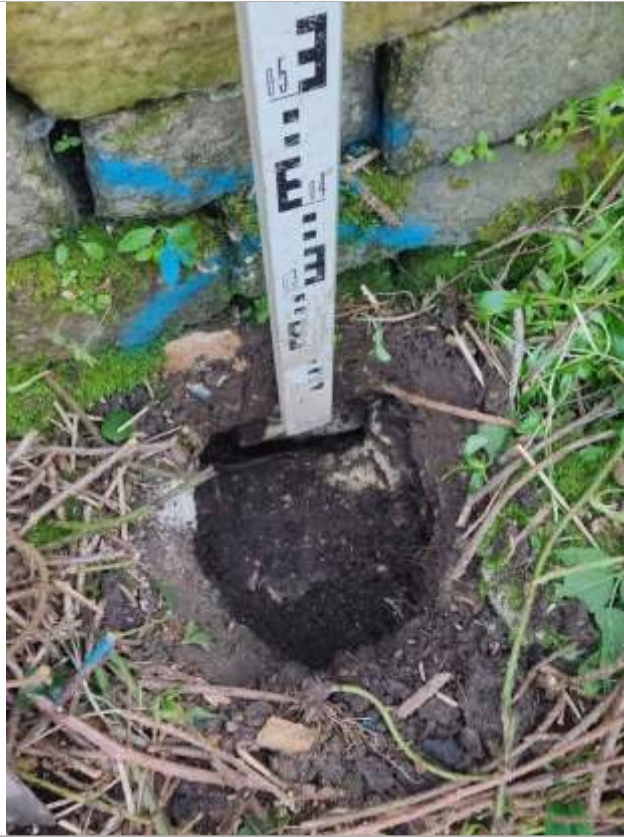
**Image 1.** HDP02 Pit

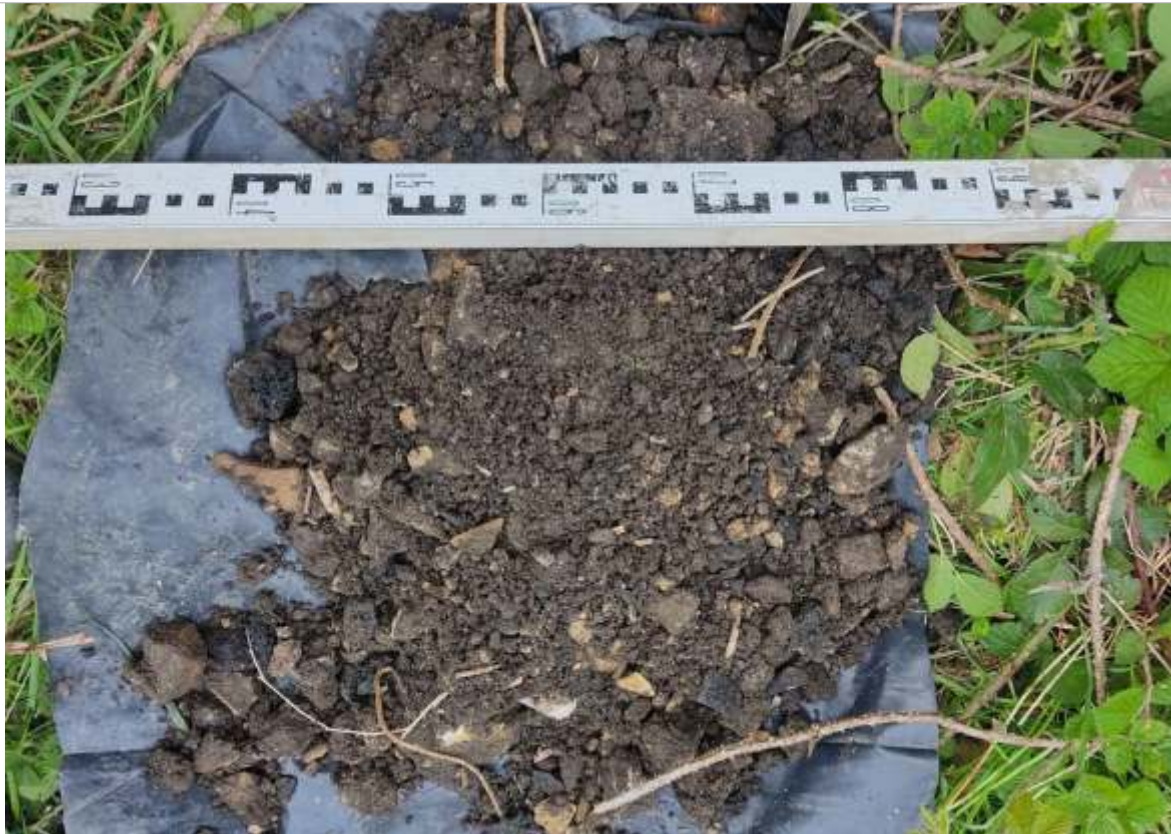
**Image 2.** HDP02 Spoil
