Block A Level 00 Layout Demolition  
 1 : 100

Kirklees Council  
 The George Hotel  
 Huddersfield, HD1 1JA

Sheet Name: Level 00 Demolition

Drawing No: 8662-BOW-ZZ-00-DR-A-P105

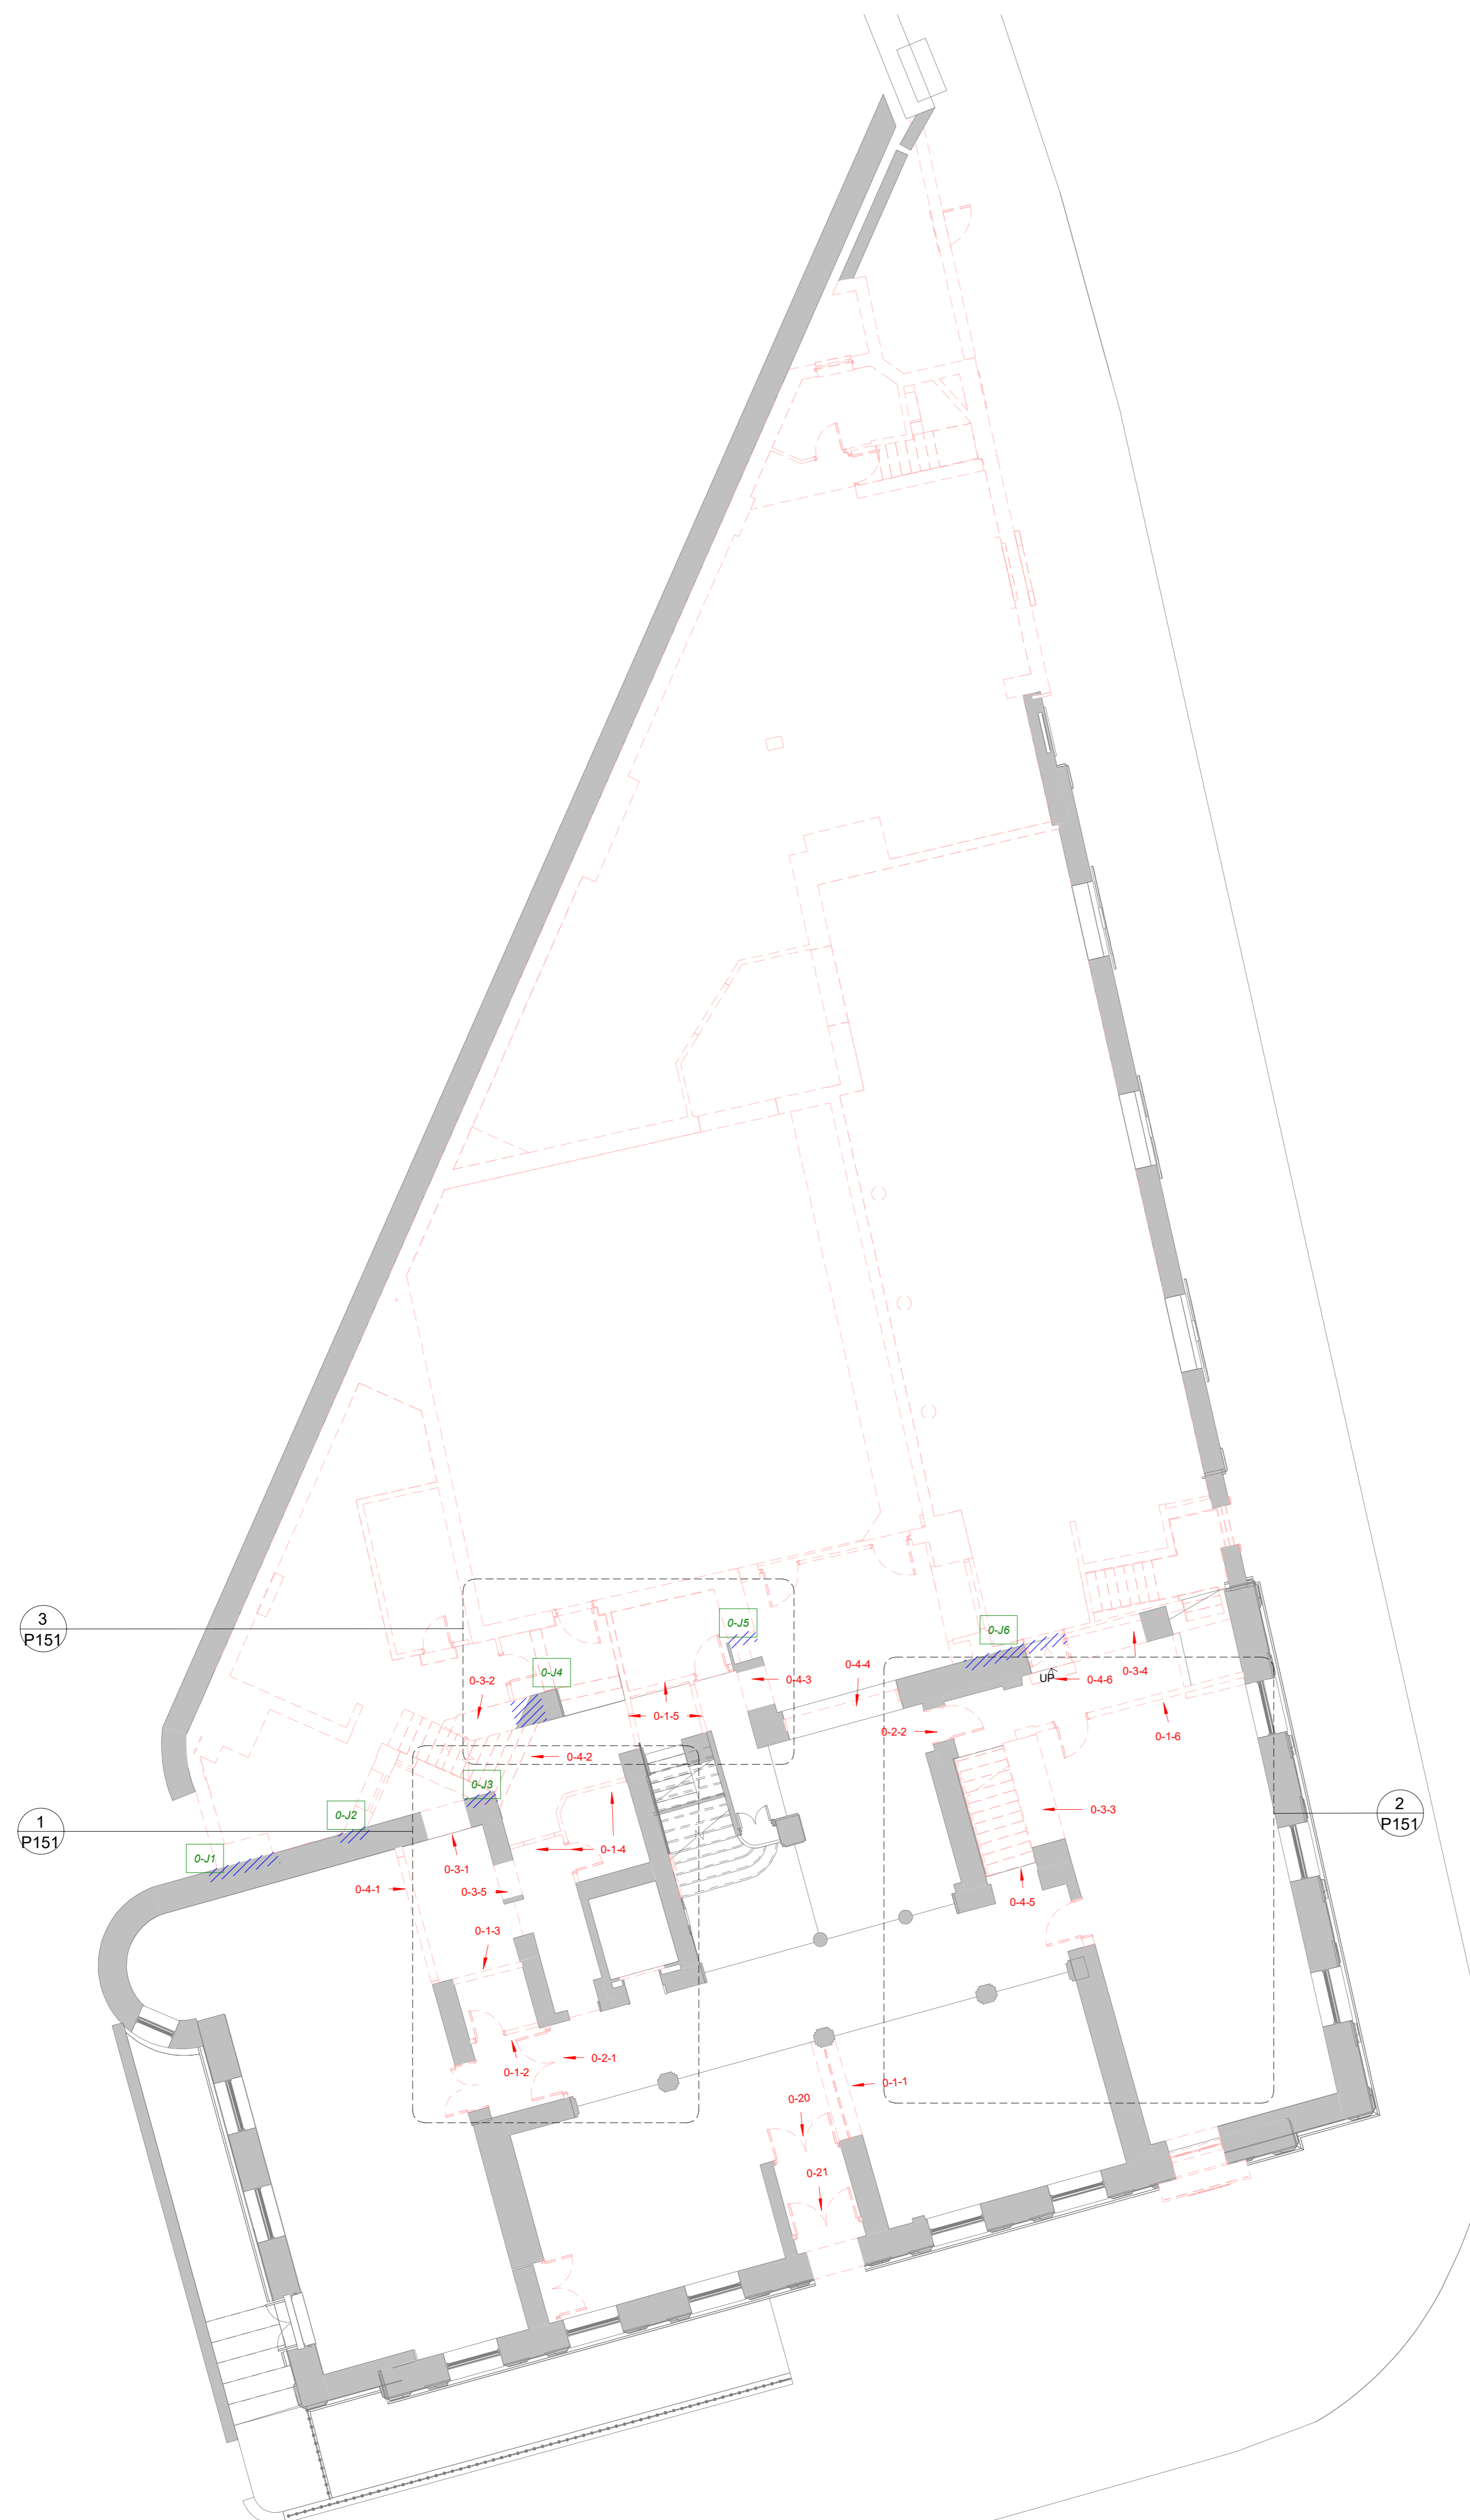
**BLOCK B & C**  
 Areas as shown to be demolished. External walls as shown to be retained, Block B, boundary wall. Block C, John William Street facade.

**BLOCK A**  
**00 Ground Floor Level**  
**Walls Removed:**  
 0-1-1 Phasing:1960's Significance:Detrimental  
 0-1-2 Infill partition Phasing:Phase 5 to present day Significance:Low  
 0-1-3 Infill partition Phasing:Phase 5 to present day Significance:Low  
 0-1-4 Internal partition Phasing:1930's Significance:Detrimental  
 0-1-5 Phasing:1930's Significance:Detrimental  
 0-1-6 Phasing:1930's Significance:Detrimental

**Doors Removed:**  
 0-2-1 Double Doors to be removed. Refer to photo.  
 0-2-2 Existing door and blanking panel to be removed. Architrave and frame to be retained. Refer to photo.

**Openings formed:**  
 0-3-1 Phasing:1851 Significance:High  
 0-3-2 Phasing:1851 Significance:High  
 0-3-3 Phasing:1851-74 Significance:Moderate, Fireplace to be removed (later).  
 0-3-4 Phasing:1851 Significance:High  
 0-3-5 Phasing:Phase 5 to present day Significance:Detrimental

**Demolition - other:**  
 0-4-1 Bar and bar above, sliding partition to be removed. Refer to photo.  
 0-4-2 Internal staircase to be removed. Refer to photo.  
 0-4-3 Existing full height service riser (later) and fabric in existing wall to be removed to form new opening.Phasing:1851 Significance:High  
 0-4-4 Existing staircase to be removed. Refer to photo.  
 0-4-5 Existing staircase to be removed. Refer to photo.  
 0-4-6 Existing staircase and double door to be removed. Refer to photo.

**BLOCK A**  
**00 Ground Floor Level**  
 0-J1 Existing building to be removed. Wall to be made good.  
 0-J2 Existing building to be removed. Wall to be made good.  
 0-J3 Existing building to be removed. Wall to be made good.  
 0-J4 Existing building to be removed. Wall to be made good.  
 0-J5 Existing building to be removed. Wall to be made good.  
 0-J6 Existing building to be removed. Wall to be made good.
