Kirklees Council
 The George Hotel
 Huddersfield, HD1 1JA

Sheet Name: Level 03 Demolition

Drawing No: 8662-BOW-ZZ-03-DR-A-P108

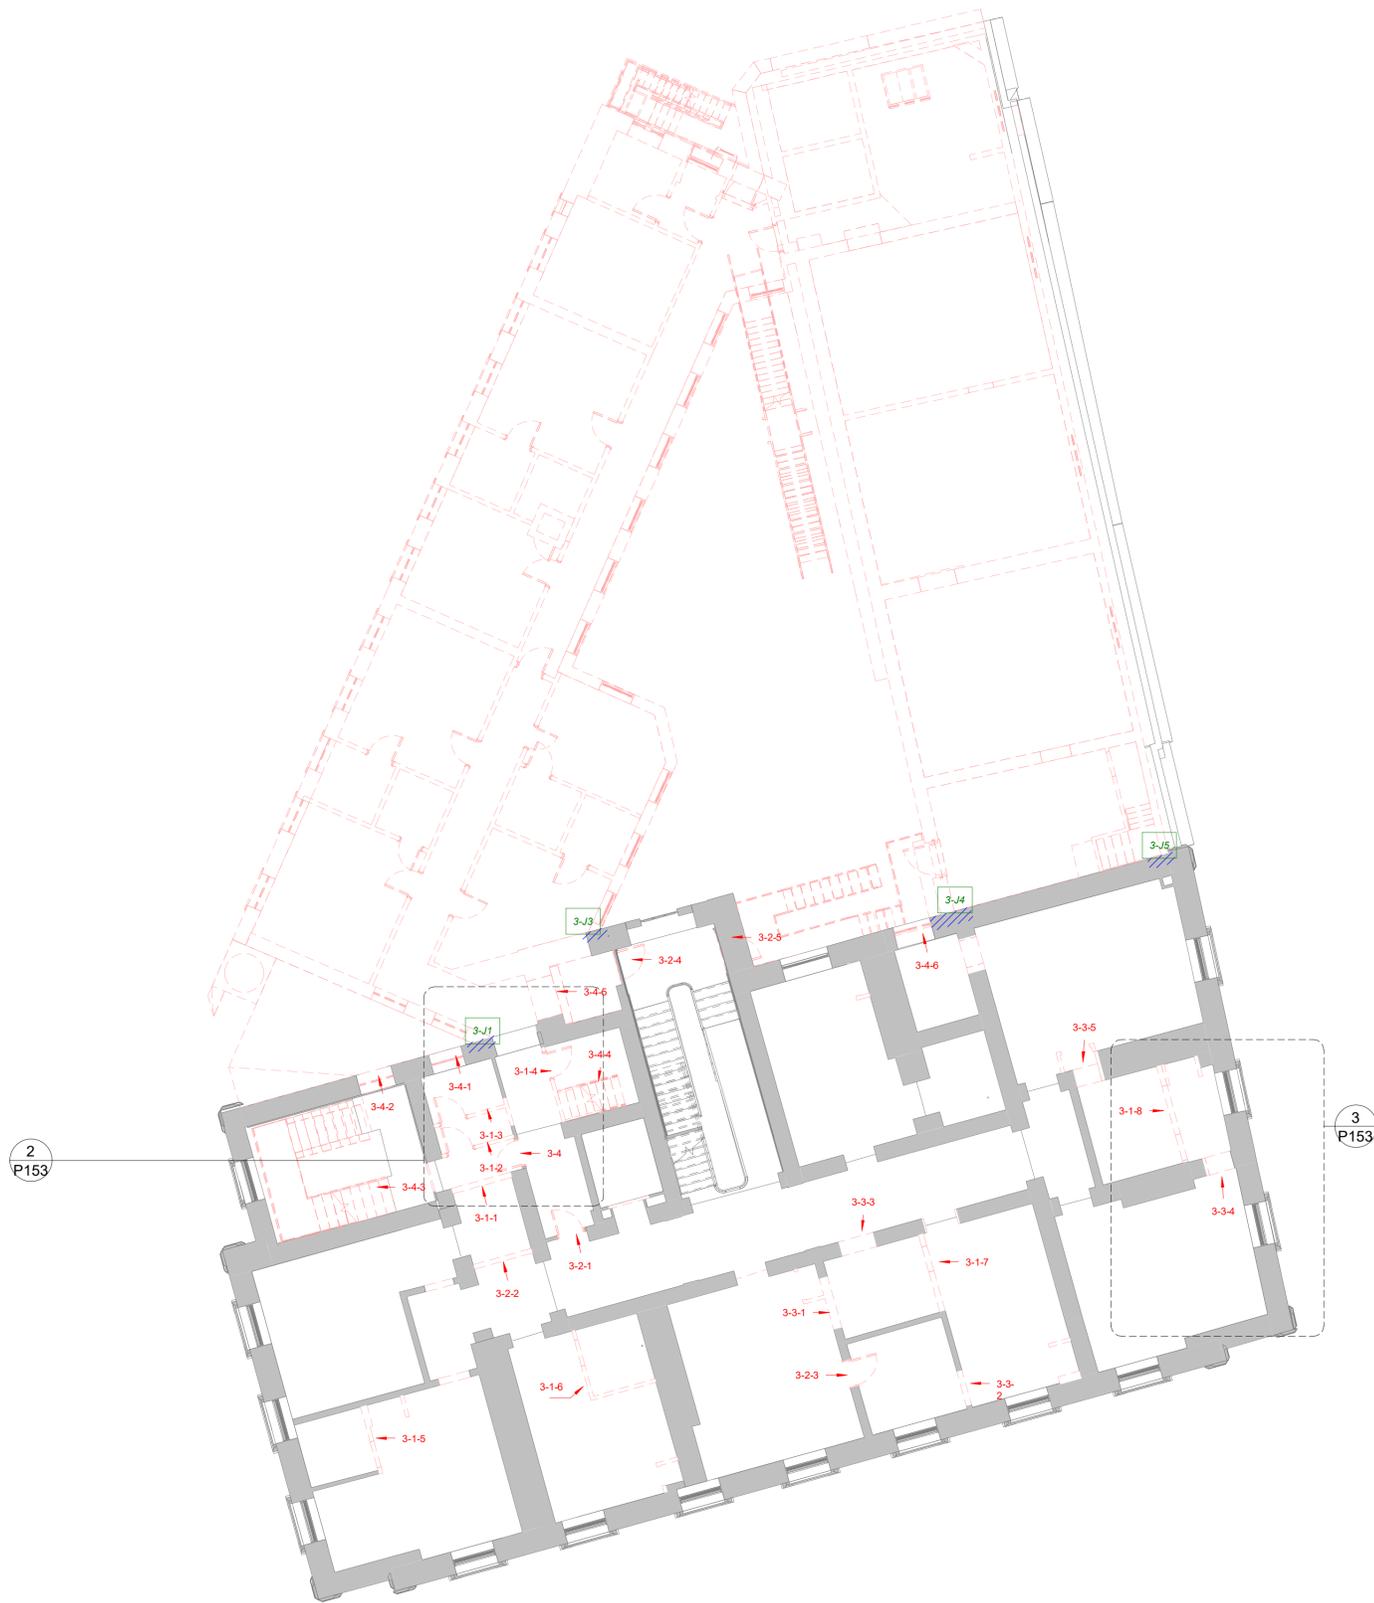
Level 03 Demolition
 1 : 100

BLOCK B & C
 Areas as shown to be demolished. External walls as shown to be retained, Block B, boundary wall. Block C, John William Street facade.

BLOCK A
03 Third Floor Level
Walls removed
 3-1-1 Phasing:Phase 5 to present day Significance:Detrimental
 3-1-2 Phasing:Phase 5 to present day Significance:Detrimental
 3-1-3 Phasing:Phase 5 to present day Significance:Detrimental
 3-1-4 Phasing:Phase 5 to present day Significance:Detrimental
 3-1-5 Phasing:Phase 5 to present day Significance:Detrimental
 3-1-6 Phasing:Phase 5 to present day Significance:Detrimental
 3-1-7 Phasing:Phase 5 to present day Significance:Detrimental
 3-1-8 Phasing:Phase 5 to present day Significance:Detrimental
Doors removed
 3-2-1 Existing door to be removed. Refer to photo.
 3-2-2 Internal door to be removed. Refer to photo.
 3-2-3 Existing door to be removed. Refer to photo.
 3-2-4 Existing door to be removed. Refer to photo.
 3-2-5 Existing door to be removed. Refer to photo.
Openings formed
 3-3-1 Phasing:1851 Significance:High
 3-3-2 Phasing:Phase 5 to present day Significance:Detrimental

3-3-3 Phasing:1851 Significance:High
 3-3-4 Phasing:1851 Significance:High
 3-3-5 Phasing:1851 Significance:High
Demolition - other
 3-4-1 Existing window to be removed. Refer to photo.
 3-4-2 Existing window to be removed. Refer to photo.
 3-4-3 Existing metal staircase to be removed. Refer to photo.
 3-4-4 Internal timber staircase to be removed. Refer to photo.
 3-4-5 Existing staircase to be removed.
 3-4-6 Existing window to be removed. Refer to photo.

BLOCK A
03 Third Floor Level
 3-J1 Existing building to be removed. Wall to be made good.
 3-J2 Existing building to be removed. Wall to be made good.
 3-J3 Existing building to be removed. Wall to be made good.
 3-J4 Existing building to be removed. Wall to be made good.
 3-J5 Existing building to be removed. Wall to be made good.
