Land off Leeds Road, Huddersfield

Bat Roost Suitability Assessment

27/03/2023

Reality Income Limited

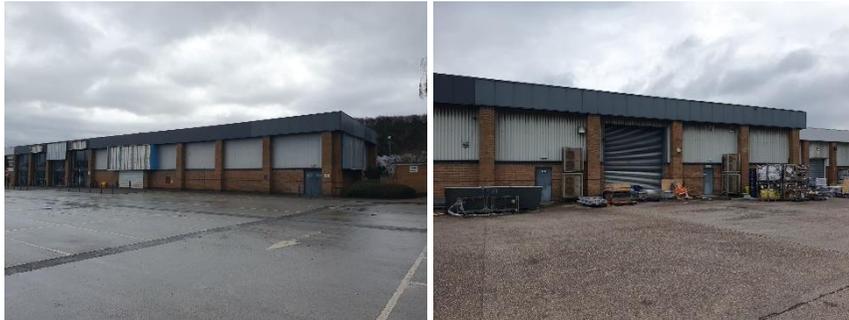
Figure 3 Showing typical view of northern (left) and southern (right) elevations.

15. Units are of a similar structural design, both being a typical two-storeys in height and having a flat roof, capped along its perimeter by well-sealed metal trim. No points of ingress for bats were noted across the roof.
16. Walls across the property consist of a redbrick base with piers running the height of the building every c.5m. Brickwork is in good condition with mortar well-sealed.
17. The upper section consists of metal panel cladding (curtain walls) which terminate at a large metal boxed soffit. Cladding is in largely fine condition, being well sealed against the brickwork beneath, with the few gaps noted deemed too small to support roosting bats.

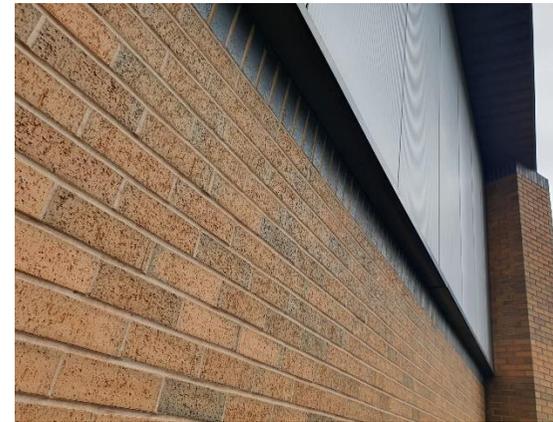
Figure 4 Showing typical condition of metal cladding.

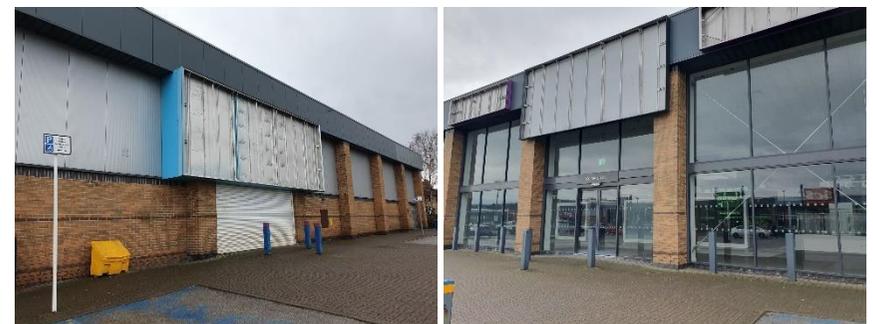
18. The frontages of the two units differ, the western being of a consistent design with the rest of the property with a metal shutter entrance, and the eastern having large windows running the height of the building. Metal window and door frames sit flush within surrounding masonry, with no potential roost features (PRFs) noted.
19. Signage mounts are fitted above the two entrances, none of which possess any features suitable for roosting bats.

Figure 5 Showing the two differing frontages.

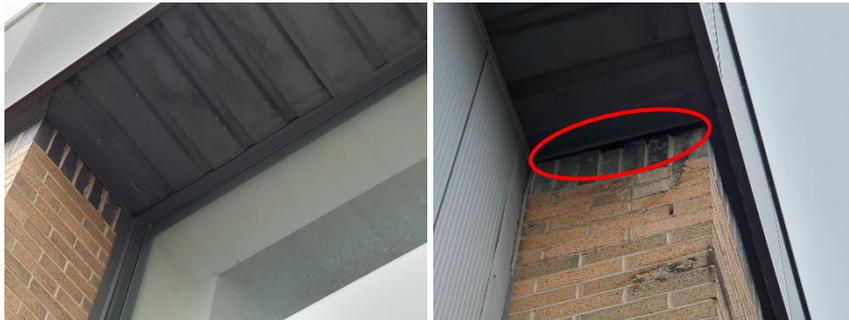
20. A large metal box soffit runs along the perimeter of the property. For the most part this is well-sealed. However, a single exception is noted along the northern elevation where a gap is evident with the adjacent brick pier.
21. The suitability of this feature to support roosting bats is deemed negligible, given its location within a well-lit car park and the poor insulating qualities of the metal soffit, leading to fluctuating temperatures internally. There is no evidence of its use by bats.

Figure 6 Showing small gap to metal soffit (left) and single larger gap (right).

22. Based on the features present, the two retail units at land off Leeds Road, Huddersfield are both assessed as providing negligible bat roost suitability.
23. No further survey work is recommended in support of this conclusion.
