PHASE 2 GEO-ENVIRONMENTAL REPORT

job number C1913/21/E/2940	date 12/08/2021
site address Westfield Farm Barnsley Road, Flockton, Wakefield, West Yorkshire, WF4 4DW	
written by C. R. Campion	checked by S. Alexander
issued by C. R. Campion

Report on a Phase 2 Geo-environmental Investigation

Location: Westfield Farm,
Barnsley Road, Flockton, Wakefield, West Yorkshire, WF4 4DW

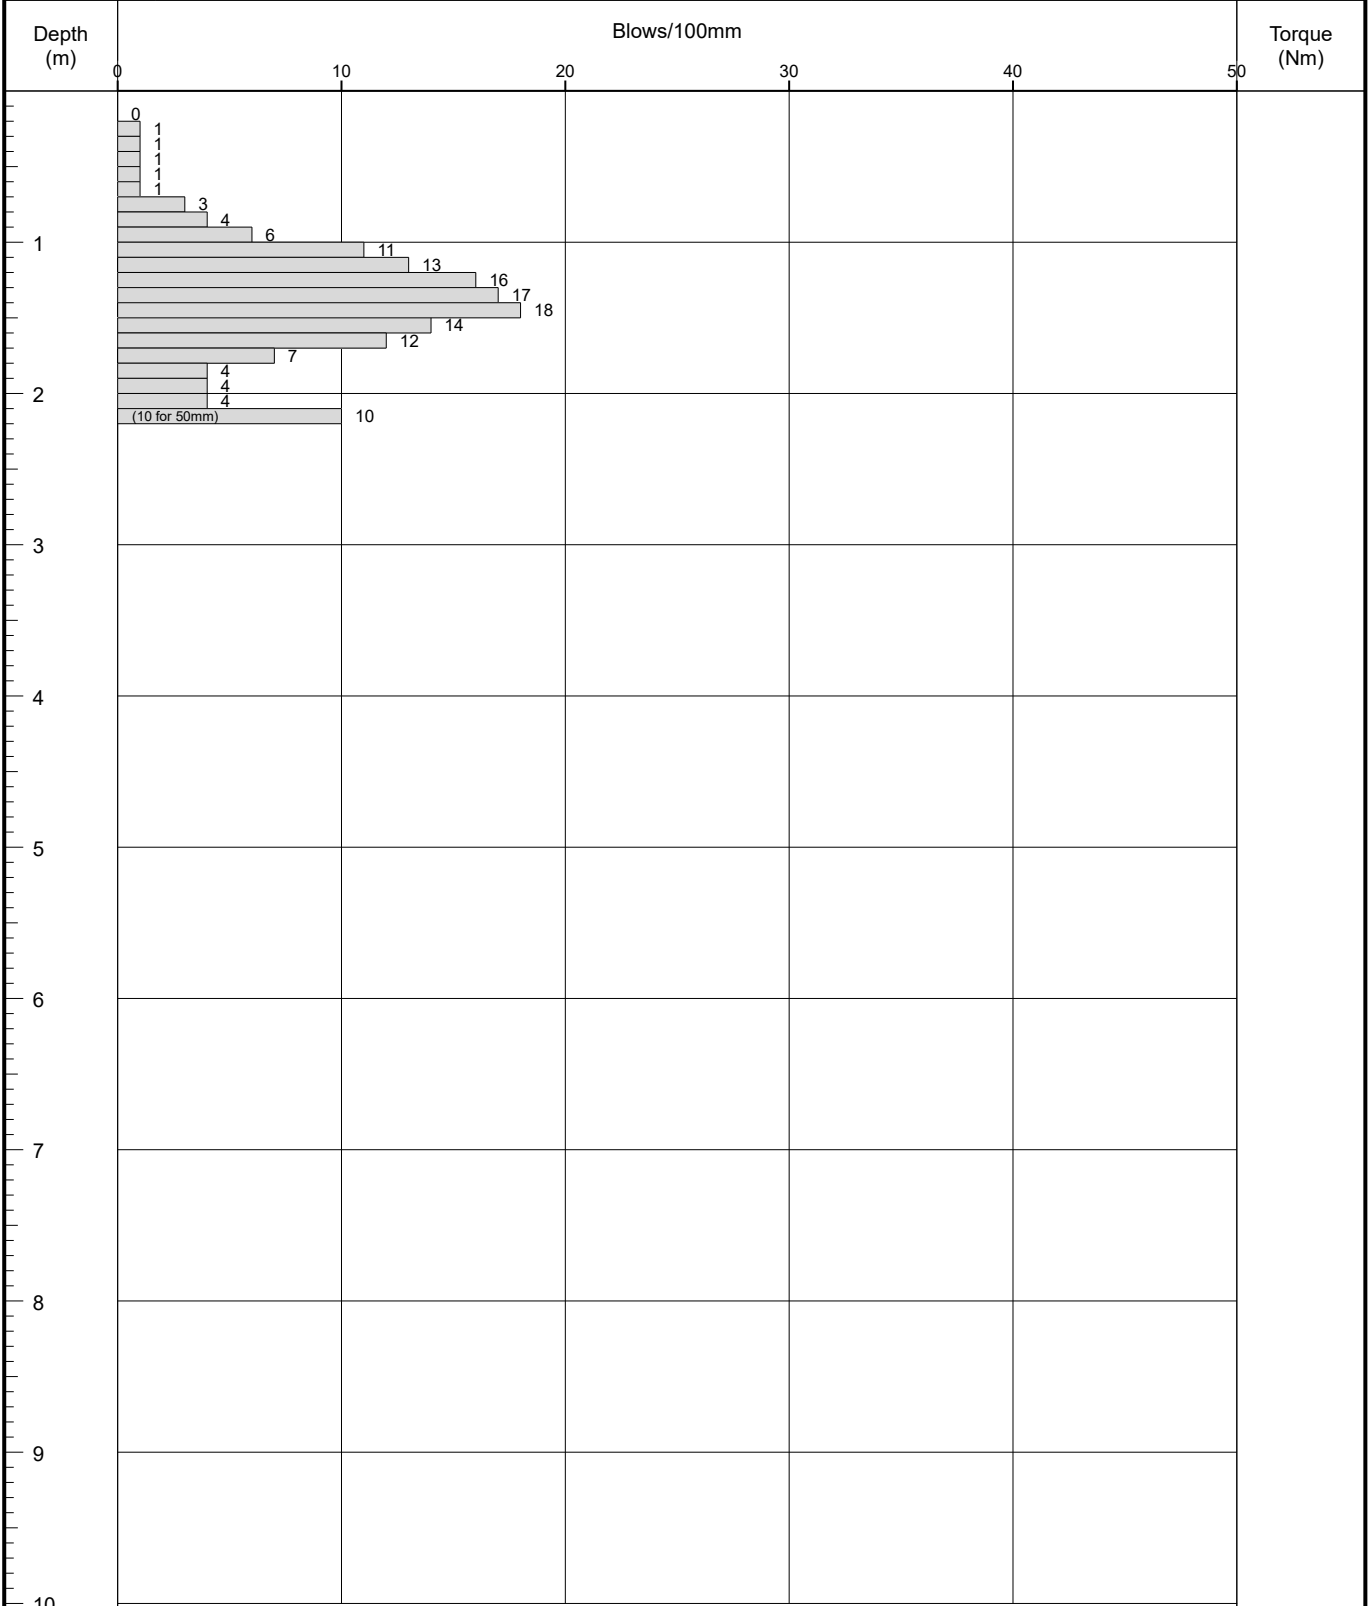
Remarks:
Abrupt refusal.

Fall Height 750mm
