PHASE 2 GEO-ENVIRONMENTAL REPORT

job number C2213/21/E/3374	date 08.07.2022
site address Site B - Yew Tree Road/Burn Road Birchencliffe, Huddersfield, HD2 2EQ Planning ref: 2021/61/91933/W	
written by C. Mason	checked by R. A. Palmer
issued by R. A. Palmer

Report on a Phase 2 Geo-environmental Investigation

Location: Site B - Yew Tree Road/Burn Road
Birchencliffe, Huddersfield, HD2 2EQ

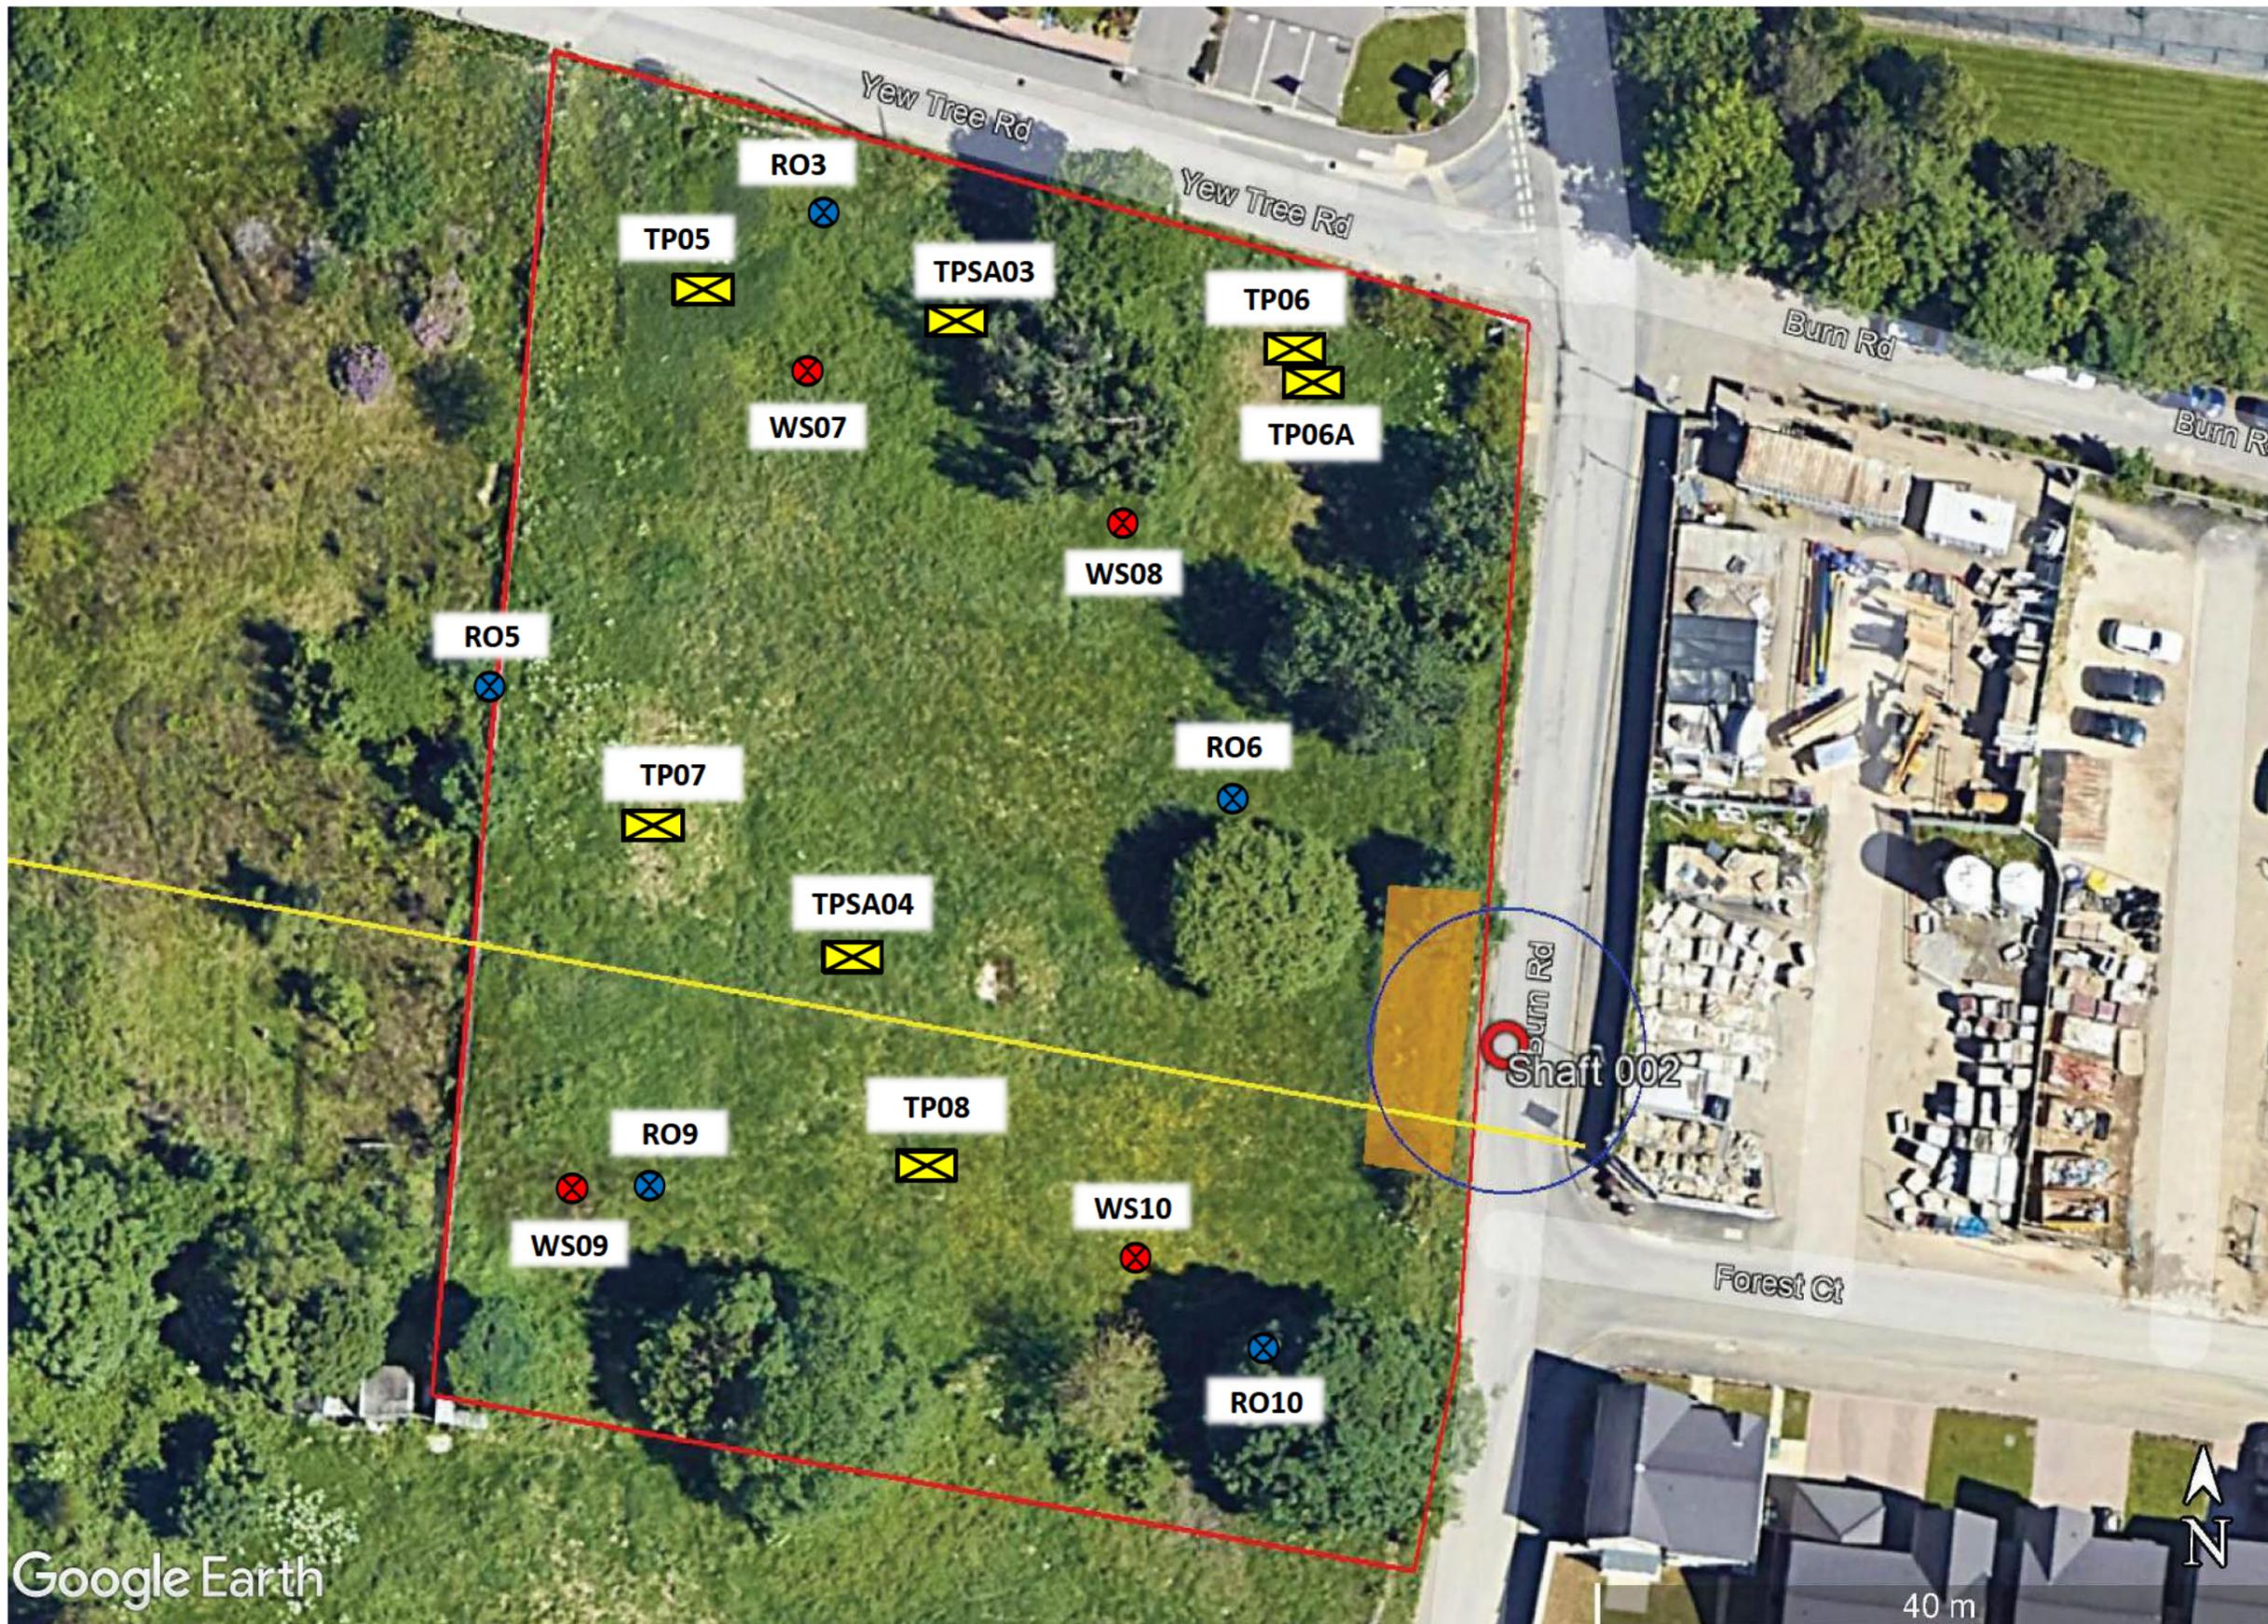
Site Plan

Notes:
Investigation positions approximated from site operative's notes.

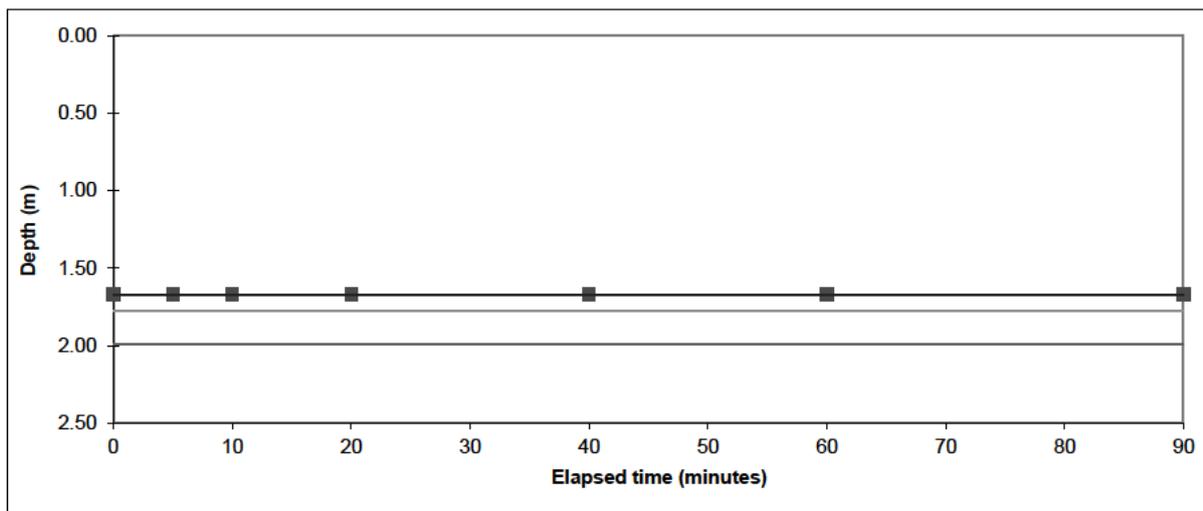
Trial Pit No:	TPSA03	Test No:	1	Date:	07/06/2022
Length (m):	1.800	Datum Height:		0.00 m agl	
Width (m):	1.50	Granular infill:	None		
Depth (m):	2.10	Porosity of infill:	1	(assumed)

Start water depth for analysis (mbgl):	1.67		
75% effective depth (mbgl):	1.78	Elapsed time (mins):	#N/A
50% effective depth (mbgl):	1.89		
25% effective depth (mbgl):	1.99	Elapsed time (mins):	#N/A
Base of soakage zone (mbgl):	2.10		
Volume outflow between 75% and 25% effective depth (m ³):			
Mean surface area of outflow (m ²):			4.09
(side area at 50% effective depth + base area)			
Time for outflow between 75% and 25% effective depth (mins):

Soil infiltration rate (m/s):	Test incomplete as 25% effective depth not achieved. Unable to reliably determine soil infiltration rate.
--------------------------------------	--

During the soakaway tests the water level did not achieve a fall from 75% to 25% of the effective depth of the storage volume. On this basis, the tests could not be completed within the scope of the method provided in BRE Digest 365 due to the poor soakage rate of the exposed soils. Due to the negligible water movement it was not possible to extrapolate the results obtained in order to obtain a soil infiltration rate.

In areas of the site where residual cohesive soils were encountered at depths rational for soakaway construction, practically impermeable drainage characteristics were recorded, such that soakaways cannot be recommended for these areas. As such, an alternative drainage system will need to be designed for the discharge of surface water.

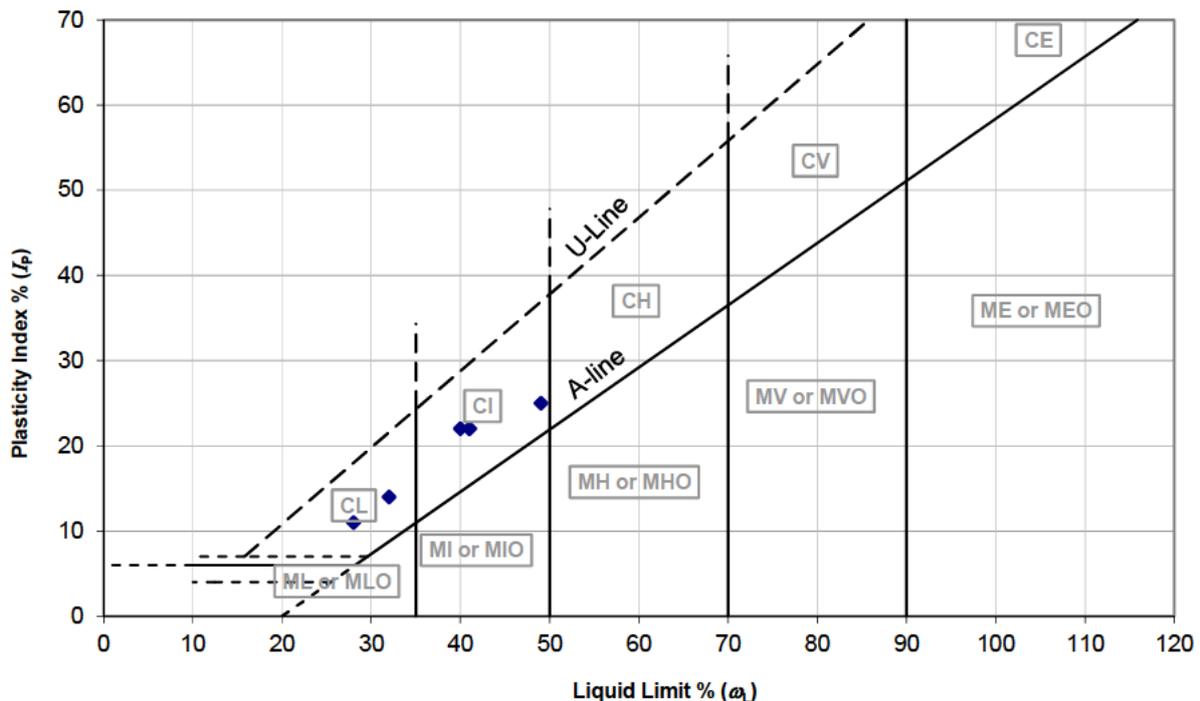
Location	Depth (m)	Moisture Content (w) (%)	Liquid Limit (wL) (%)	Plastic Limit (wP) (%)	Plasticity Index (IP) (%)	Retained by 0.425mm (%)	Modified (w) (w') (%)	Modified (IP) (IP') (%)	Liquidity/ Consistency		Casagrande Class	N.H.B.C Class (%)
									(IL) (%)	(IC) (%)		
WS01	1.20	16	41	19	22	2	16	22	-0.1	1.1	C I	MEDIUM
WS03	1.20	19.8	41	19	22	2	20	22	0.0	1.0	C I	MEDIUM
WS04	1.00	12.7	40	18	22	0	13	22	-0.2	1.2	C I	MEDIUM
WS05	0.50	19	49	24	25	1	19	25	-0.2	1.2	C I	MEDIUM
WS07	2.20	26.5	32	18	14	0	27	14	0.6	0.4	C L	LOW
WS10	2.50	10.8	28	17	11	32	16	7	-0.6	1.6	C L	*

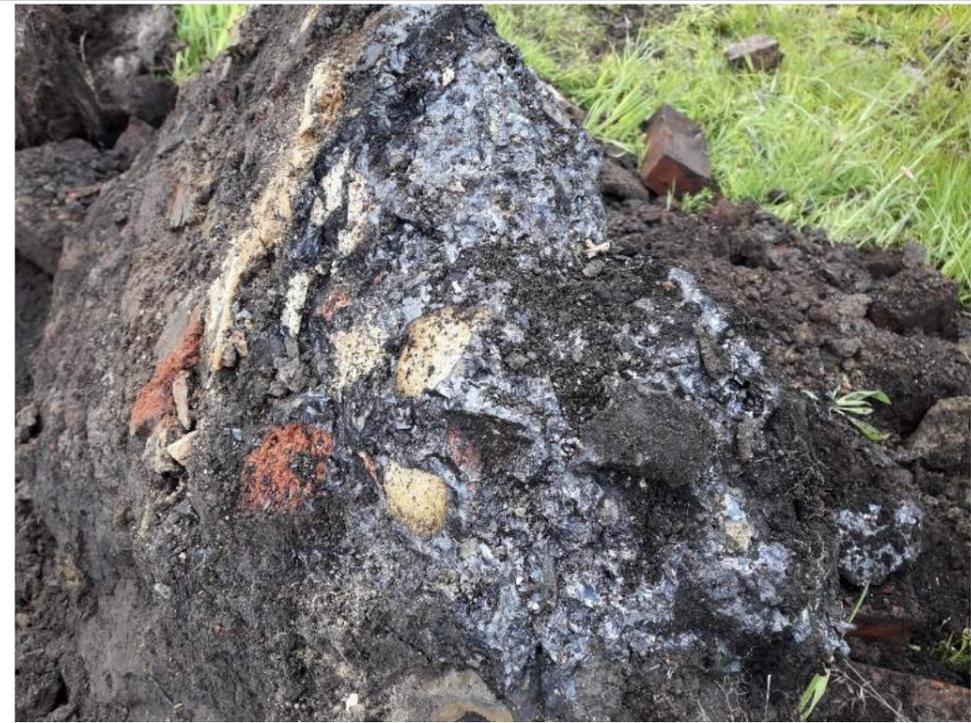
Photo 2: Bound macadam material recovered in TP06A.

Firstly, it should be appreciated that within the location of TP06 and TP06a, evidence of previous structures was observed, and comprised 'bound macadam', anticipated to have a tar binder, as well as a series of brick sets. Furthermore, evidence of a sump was observed at the location of TPSA 04 (Brick wall in west of the pit running with clean water, trial pit expanded to observe deposits and thought to be infilled waste sump. Odour of decomposition from the sump. Concrete block up to 0.30m depth in NW corner of trial pit).

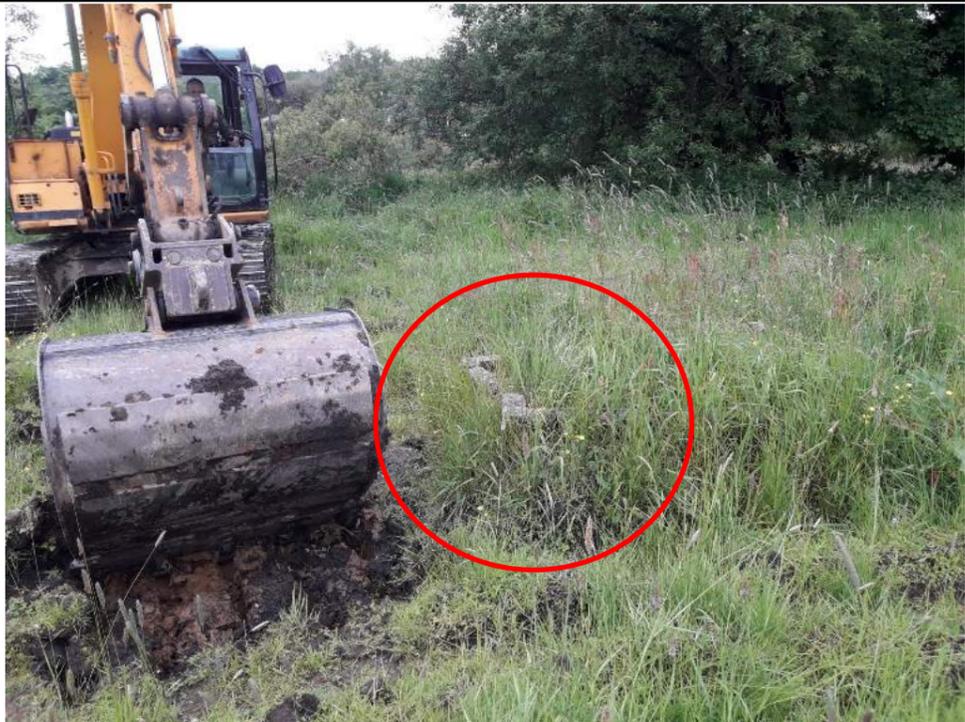
Photo 3: Brick lined feature.

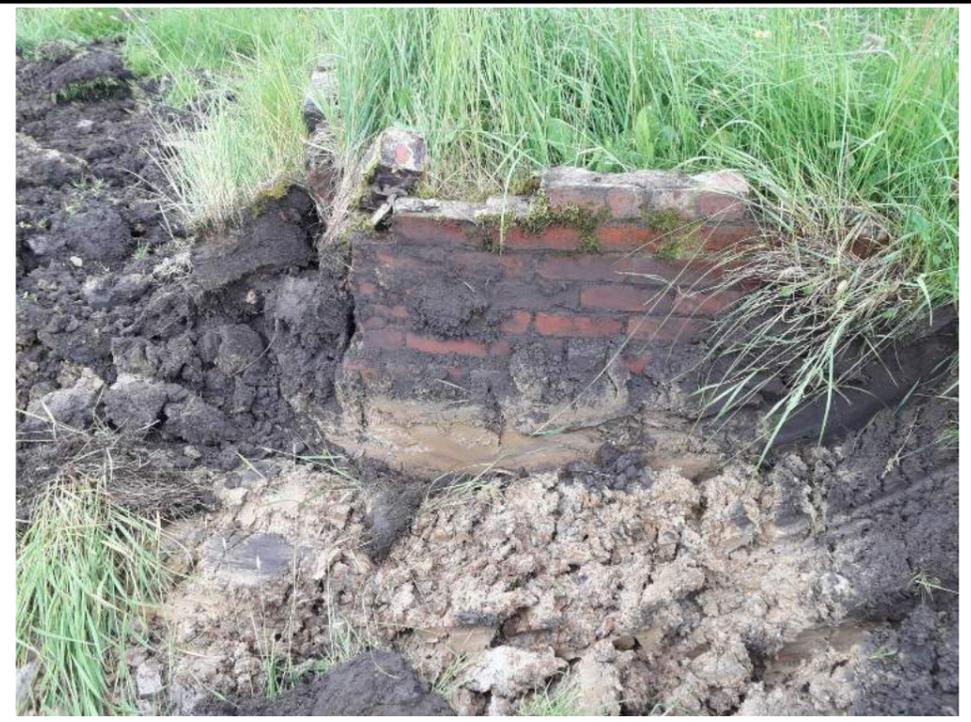
Photo 4: Feature had no distinct foundation and the inside was filled with soil.
