**Whitcher Wildlife Ltd.  
Ecological Consultants.**

**2 BROAD LANE, UPPERTHONG.**

**BAT SURVEY.**

**Ref No:- 180268.**

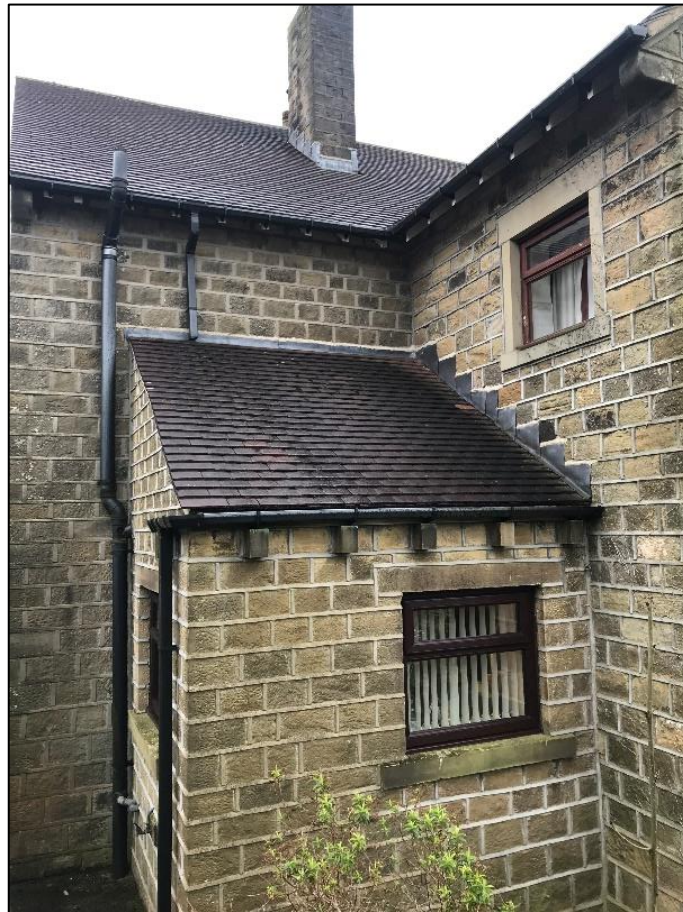
3.3.4. The single storey section of the building is a lean to roof with one gable end on the northern elevation which is well pointed and tight fitting with no gaps or crevices suitable for roosting bats. The roof of the single storey section is also covered with Rosemary tiles which are all tight fitting with no gaps or crevices suitable for roosting bats. The eaves of the single storey section are tight fitting with no gaps or crevices suitable for roosting bats.

3.3.5. The photograph below shows the north western corner of the property that will be affected by the proposed works.

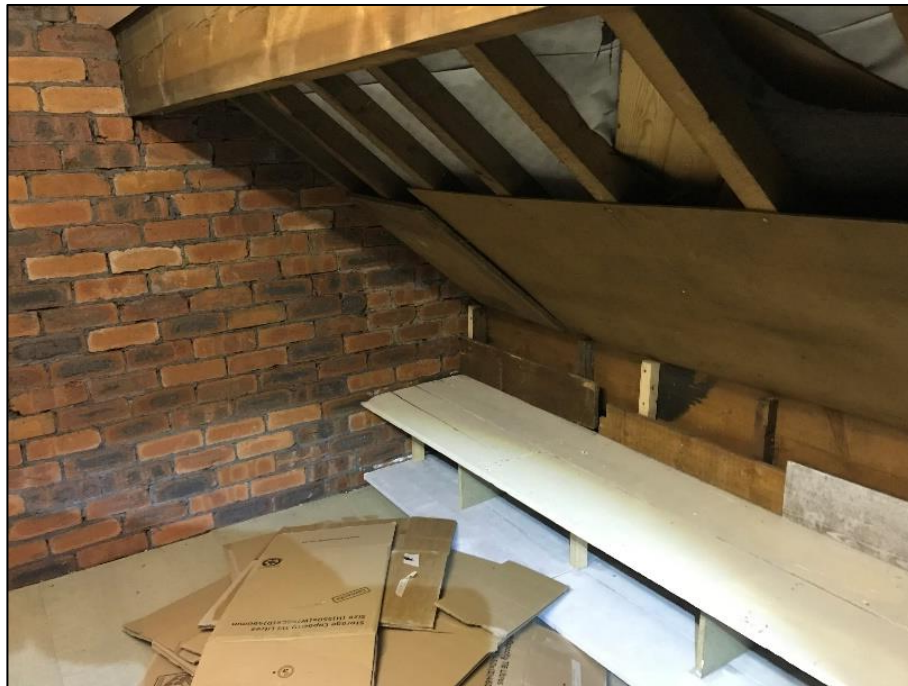
3.3.6. Internally the loft space in the two-storey section has a standard rafter and purlin frame which is lined with a breathable membrane throughout and wooden boarding in several sections. There is no access for bats into the loft space from the external aspect of the building.

3.3.8. The photograph below the loft space in the two-storey section of the building.

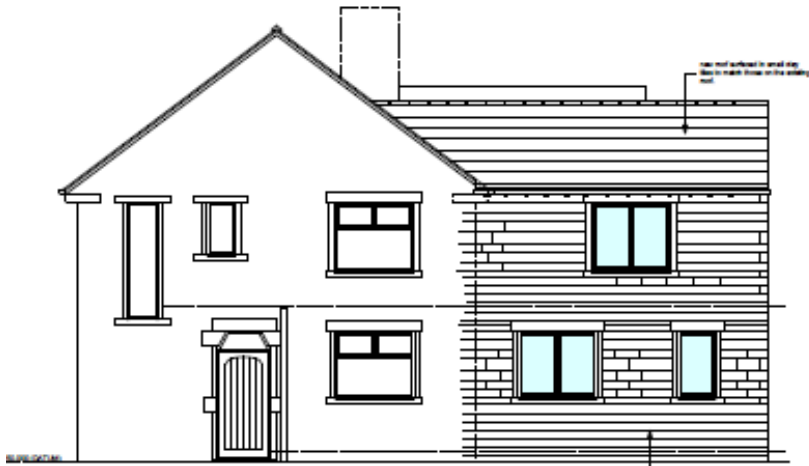
North Elevation

new external walling constructed with an outer leaf of red brick and inner leaf of white render to match that of the existing walling
