**PHASE II / GROUND INVESTIGATION
AND UPDATED RISK ASSESSMENT
REPORT**

**LAND ADJACENT TO NO. 7, TOWN
GATE, SCHOLES**

Report Reference: GES 2371-22 PII

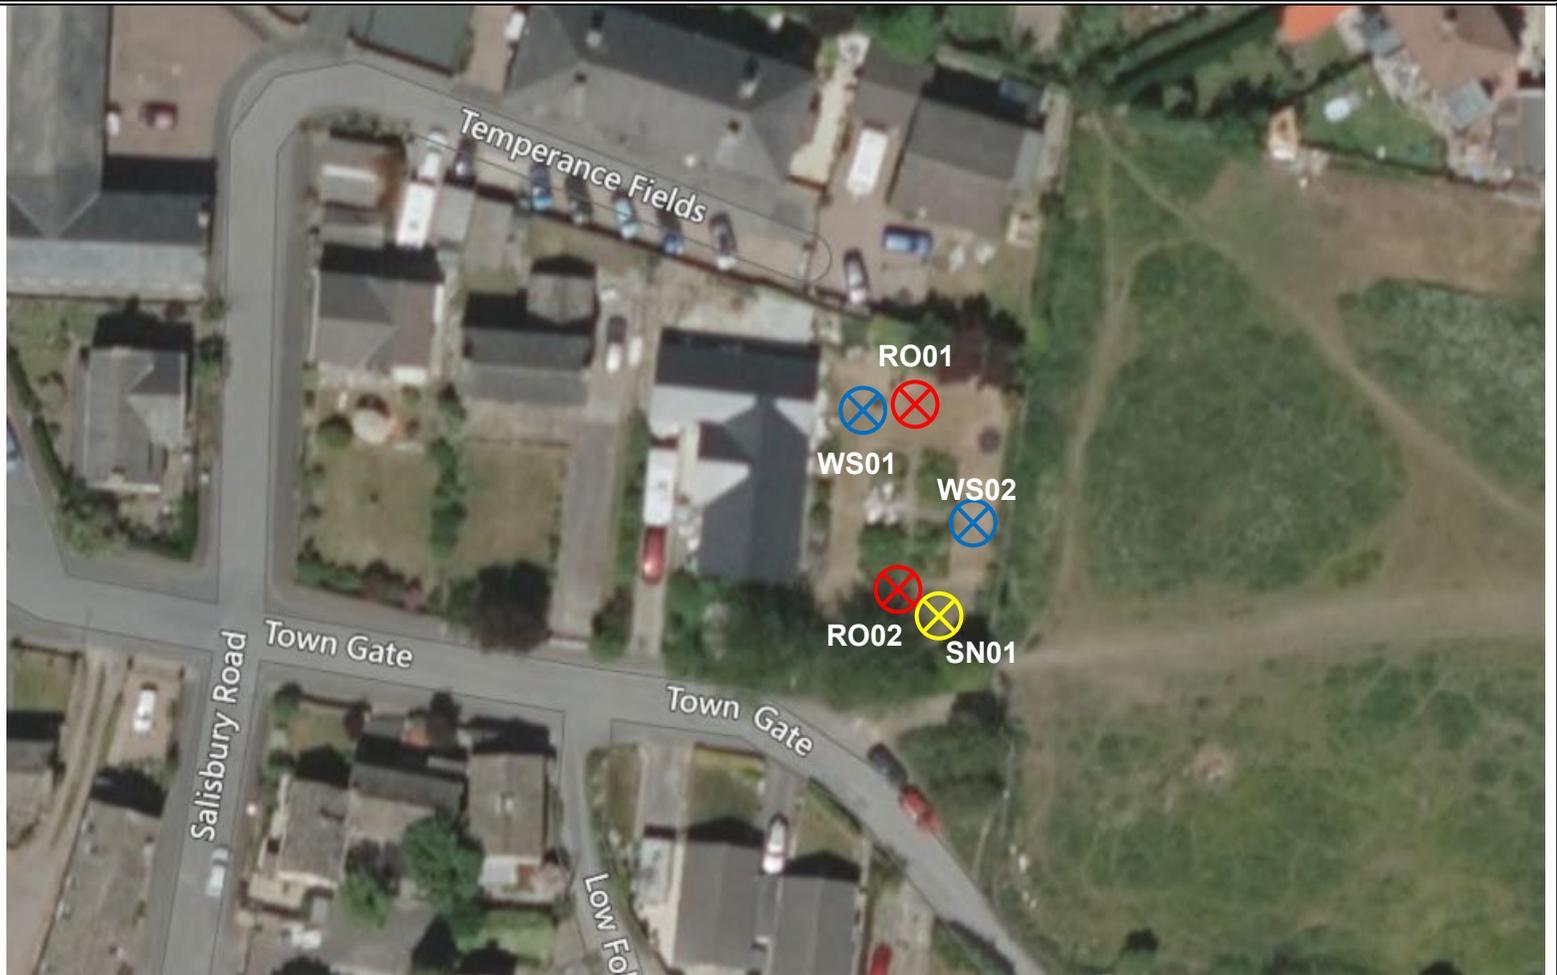
Location Plan Scale 1:1000

Rotary Borehole Location

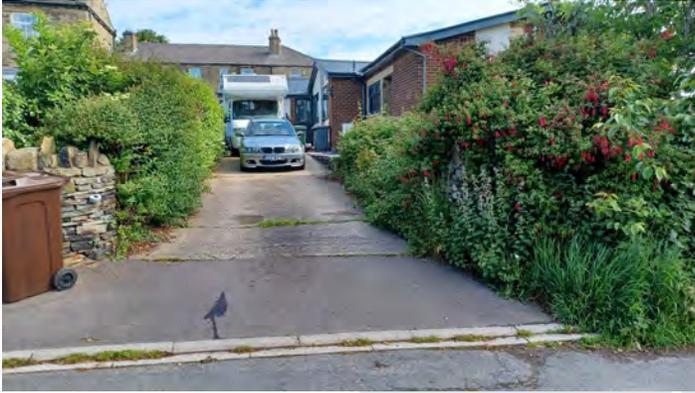
- A. Facing north, view of site access.
- B. Facing northeast, view of central site area.
- C. Facing south, view of eastern site boundary.
- D. Facing north, view of southern site boundary from Town Gate.
