Arboricultural Impact Assessment, Arboricultural Method Statement & Tree Protection Plan

Corby, Birkby Road, Huddersfield, HD2 2DR

June 2023

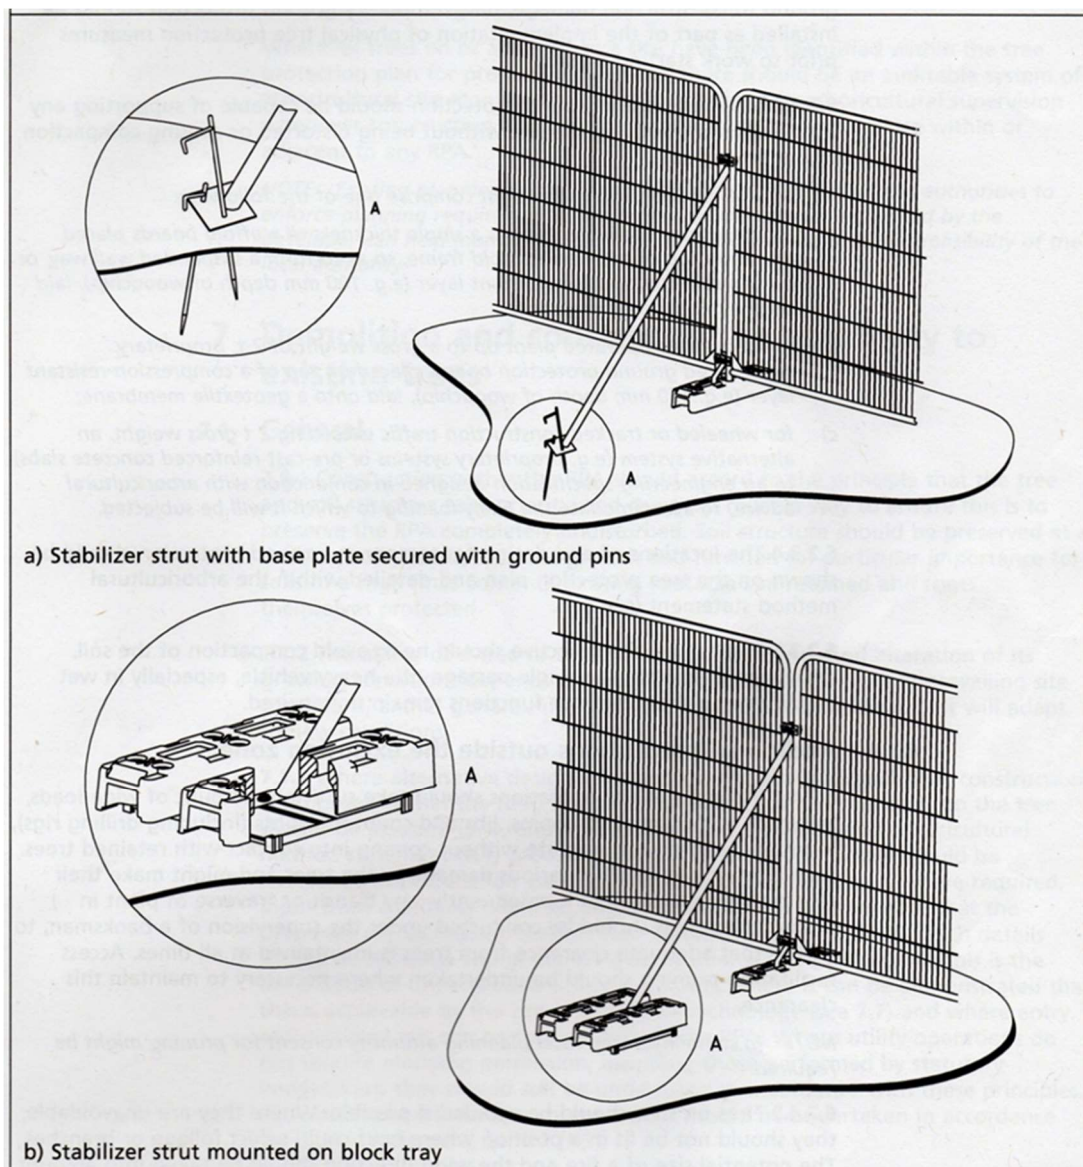
Paragraph 6.2.2 and Fig. 3 of BS5837 details the appropriate fencing specification. The appropriate fencing is shown below. The support poles should be inside the fence line/ CEZ, the side closest to the retained/protected tree.

Protective fencing should be erected as shown on the Tree Protection Plan. The area inside this fence line becomes the 'Construction Exclusion Zone' (CEZ).

Fencing will prevent construction activity that could cause damage occurring close to retained trees. No plant, equipment or vehicles should operate within the protective fencing.

Laminated and securely fixed signs with the words 'CONSTRUCTION EXCLUSION ZONE – NO ACCESS' to be attached to the outside/site side of the Tree Protective Fence line every 6m. Replace when weathered or lost.

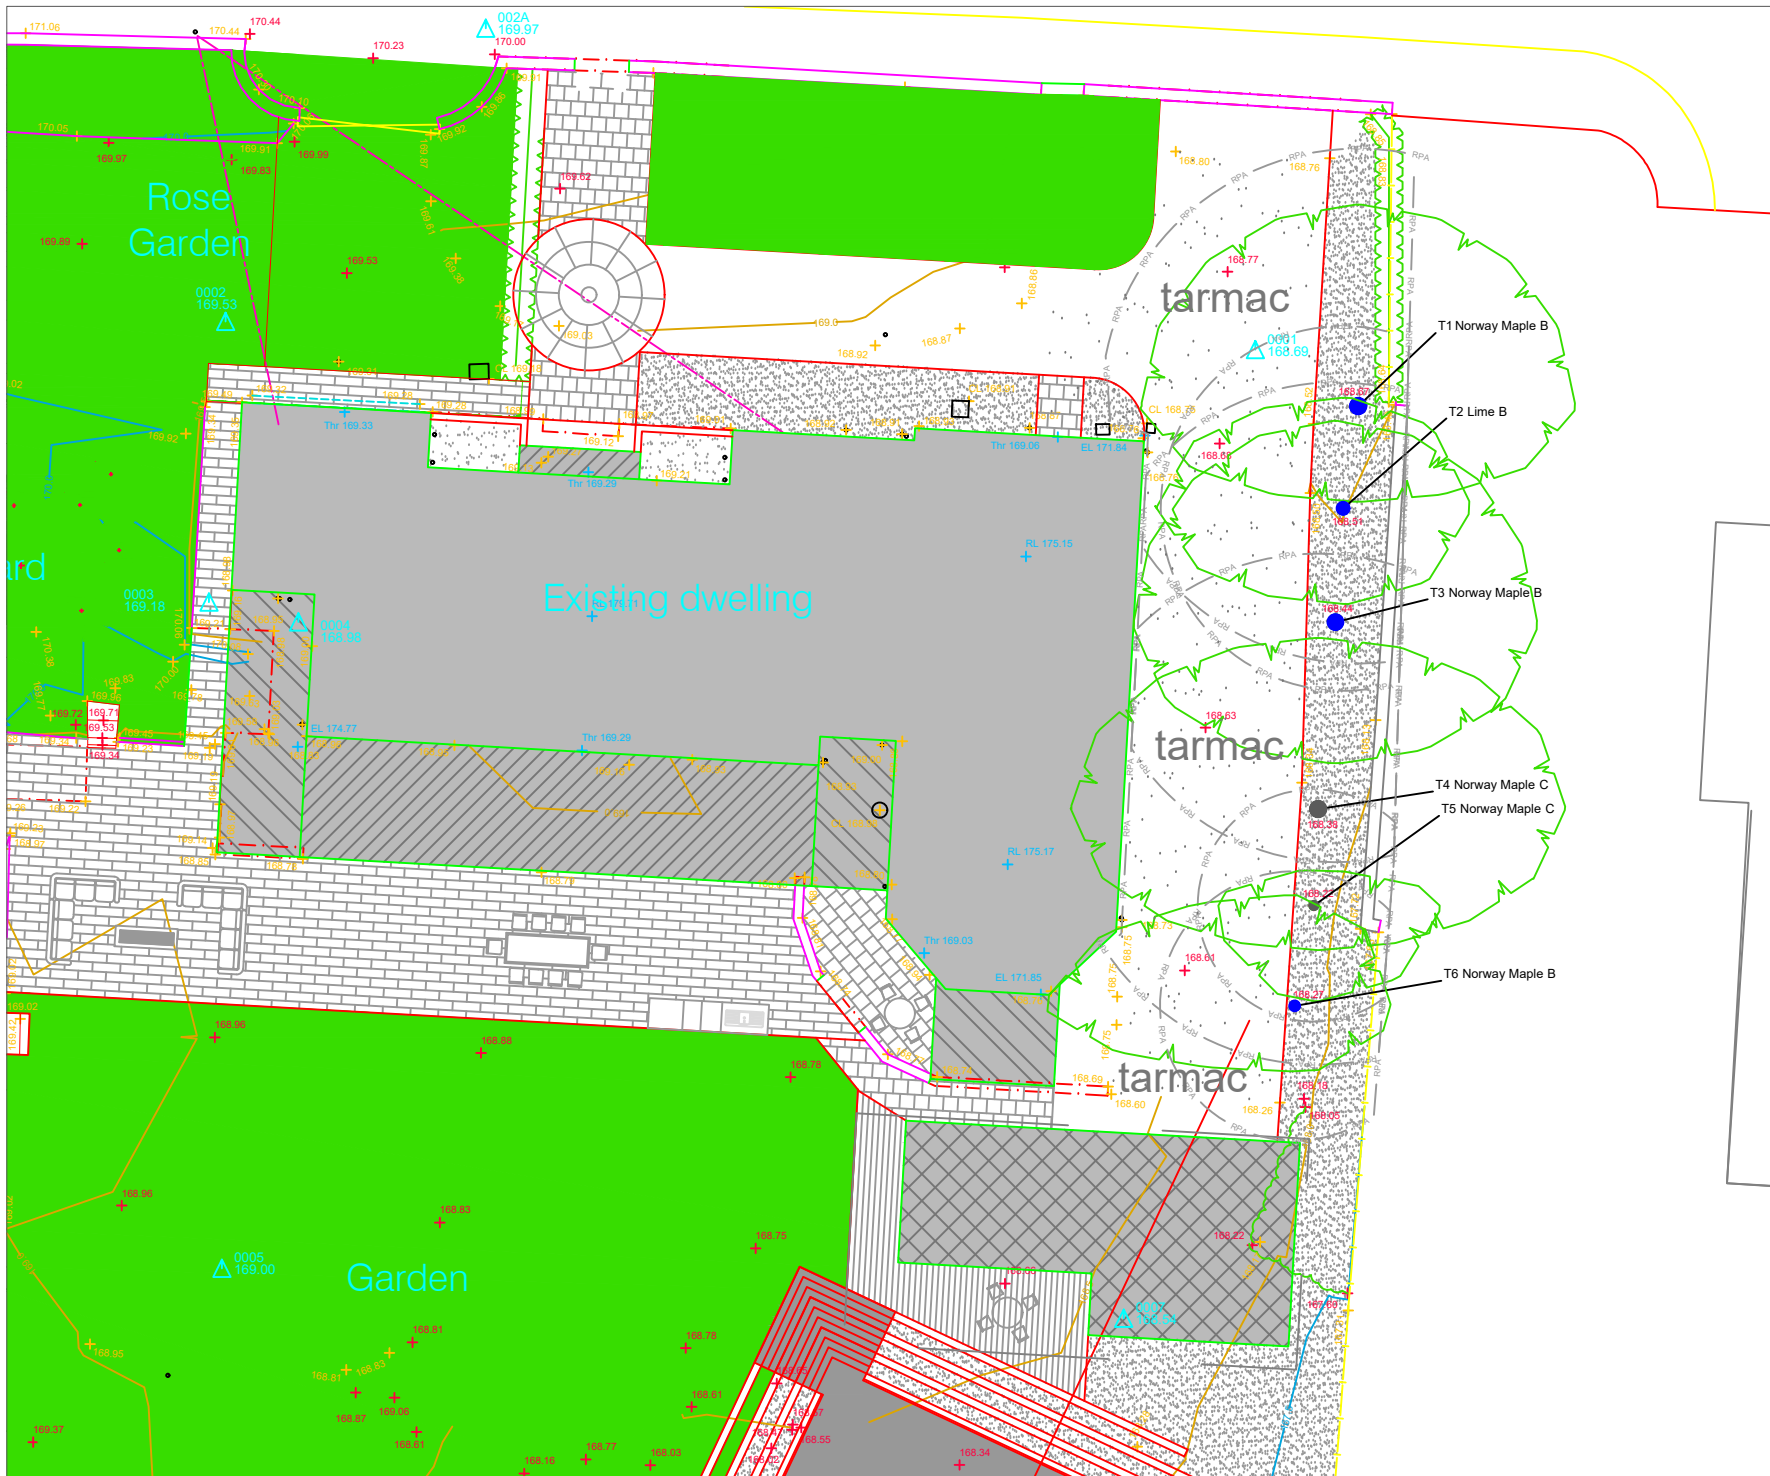
PLAN 2 OF 3

Plan Title Tree Impact Plan

The proposed site and the recorded trees are shown on a Tree Impact Plan, also in Appendix 3.

See Tree Impact Plan in Appendix 3

- No trees need to be pruned or removed to enable the construction of the garage
- An existing tarmac driveway already surfaces the approach to the location of the proposed garage. This driveway is proposed for retention in its current form. Contractor build access to the rear garden and garage build can utilise the current driveway area, already hard surfaced and historic without any additional detriment to the recorded trees
- The proposed garage will be constructed outside the root protection areas of the protected trees, there is a need to extend the current tarmac by 1.5m, surfacing the periphery of one tree, T6. This area was formally hosting roots from a tree, now removed so the impact of T6 is anticipated to be low
