Introduction

The following photographic pre-commencement survey has been carried on 4/10/23 & includes a snapshot of the present condition of all elements along Blake Lea Lane & the public footpath col/195/10 including footway surfacing, verges, kerbs, edgings, street lighting, signing and white lining. Weather - dry, following rain the previous day.

Blake Lea Lane pre-condition survey – Section 1

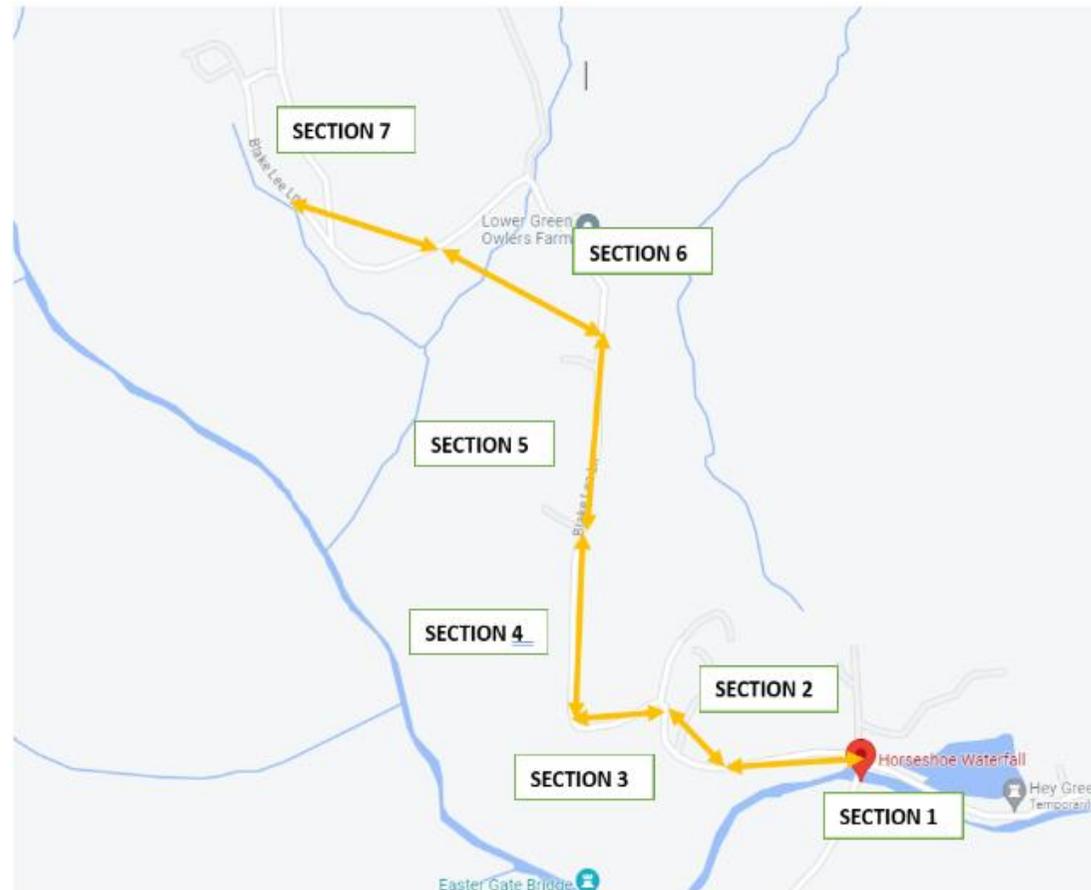
Key to sections along Blake Lea Lane / public footpath

The plan below details seven sections along the route for reference.

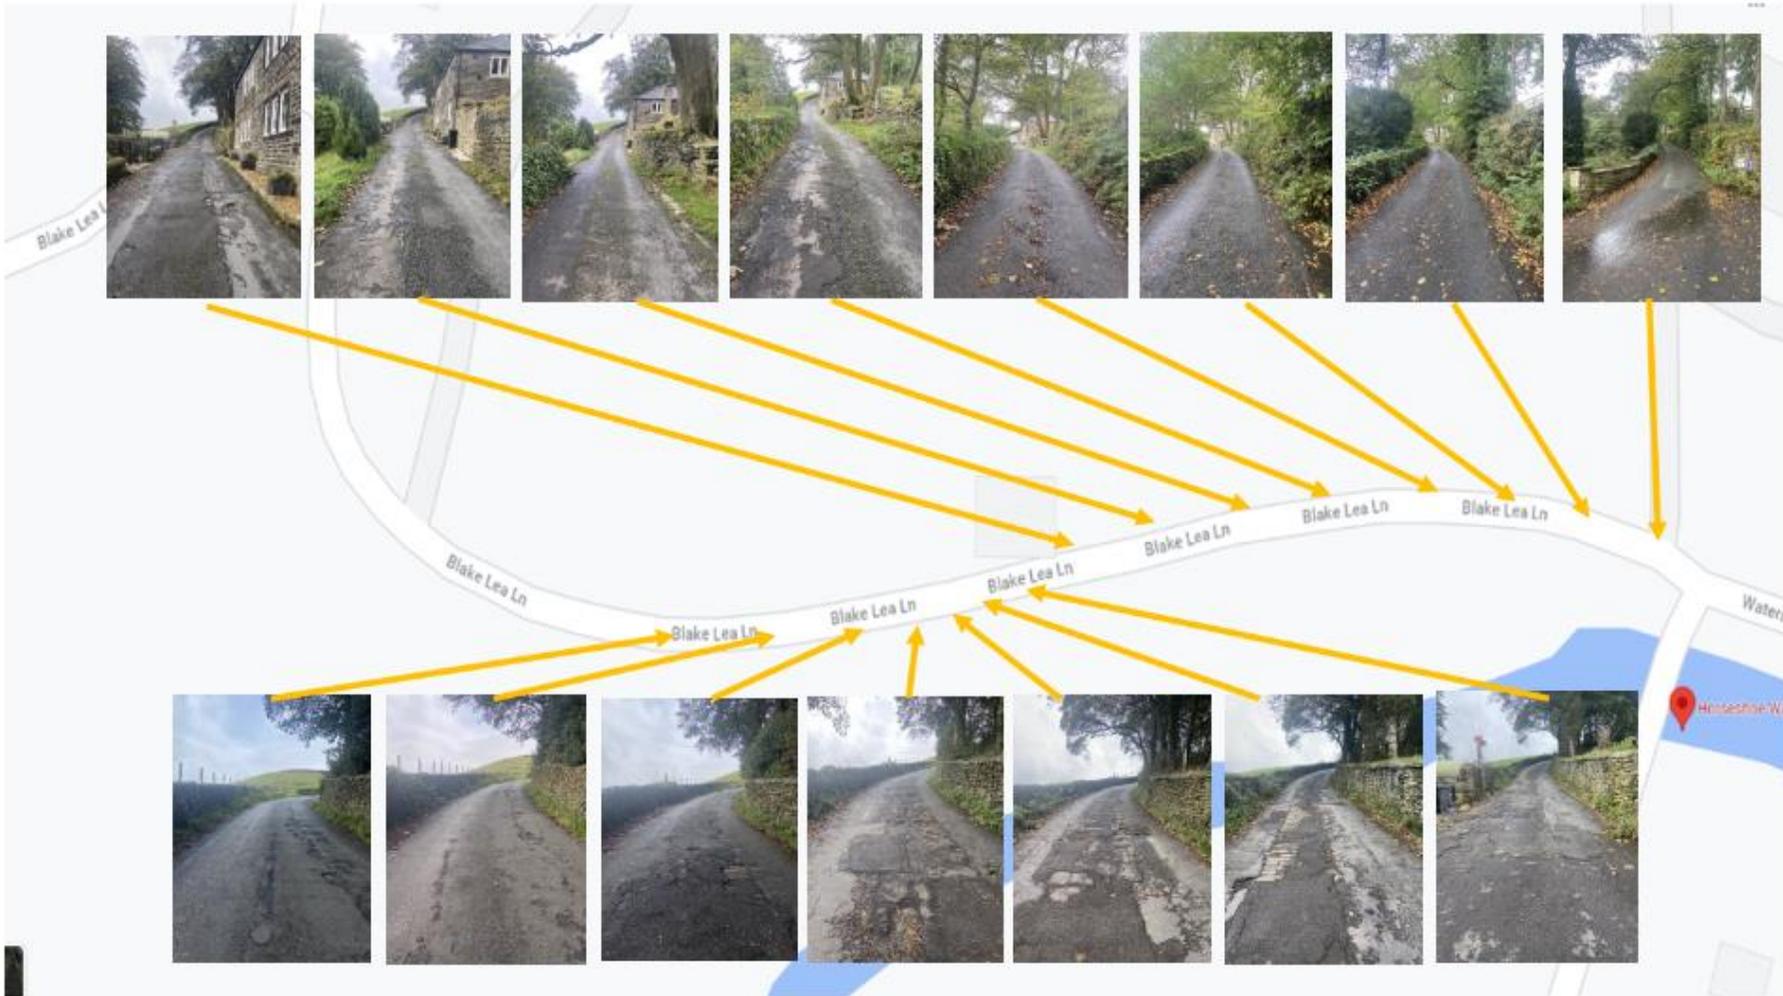
The roadway is in generally fair condition but failing in localised areas with frequent potholes occurring as detailed. In some areas stone sets are visible due to the surfacing failing mainly on the steeper gradients. Grass is visible in the middle of the road in places. The road has previously been patch repaired also in localised areas. There are no road gully's to facilitate drainage & run off, onto the road is apparent during heavy rain. Dry stone walls will be covered on a separate report. There are no edgings, street lighting, signing or white lining on Blake Lea Lane
