CANAL & RIVER TRUST
REDBROOK RESERVOIR (NORTH)
BASELINE HABITAT AND
PEAT DEPTH MAPPING REPORT

REDBROOK RESERVOIR (NORTH)

BASELINE HABITAT AND PEAT DEPTH MAPPING REPORT

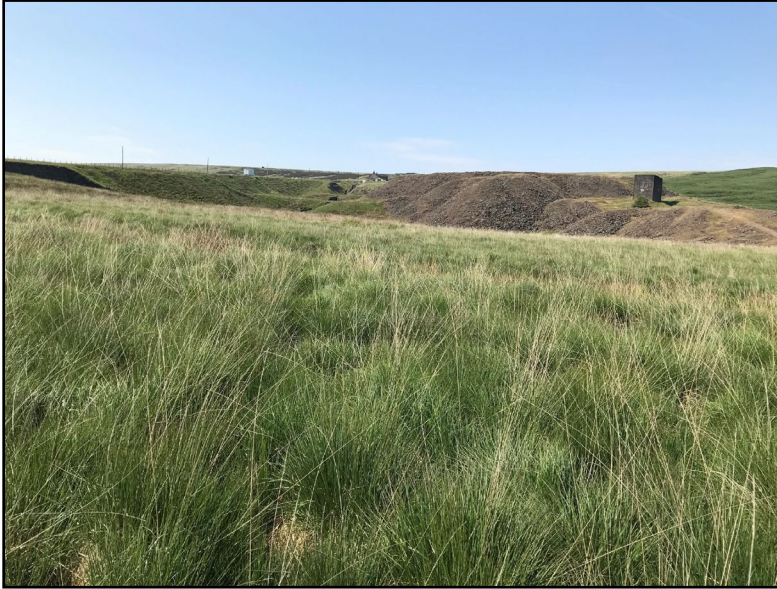
- Area 1 - flatter area of purple moor-grass-dominated habitat readily accessible from adjacent access tracks. Purple moor-grass is 90% dominant across the area with few other plant species present (see Table 1 for plant species list). The habitat is likely to have developed over peat of variable thickness depending on underlying topography. There are two artificial moorland drains crossing the area that appear unmanaged and are now largely re-vegetated, although they are likely to still drain water from the Site under period of wet weather/high rainfall. Boundary walls (defunct) are present and the area as likely formerly enclosed. Identified as suitable for enhancement using purple moor-grass diversification techniques and possible ditch blocking;

Photograph 1
Area 1 – purple moor-grass-
dominated degraded blanket
bog

- 4.11 The areas selected for enhancement will be flailed to decrease the vigour of the grass tussocks. The most effective way to achieve this is likely to be using a machine-mounted flail set at a height of approximately 20 to 15cm above ground level. This will cut the top off the majority of tussocks, immediately reducing their vigour. The type of flail and machine would be a decision made by a contractor or CRT. The Site is uneven with slopes and as such could present challenges for the use of some machinery.

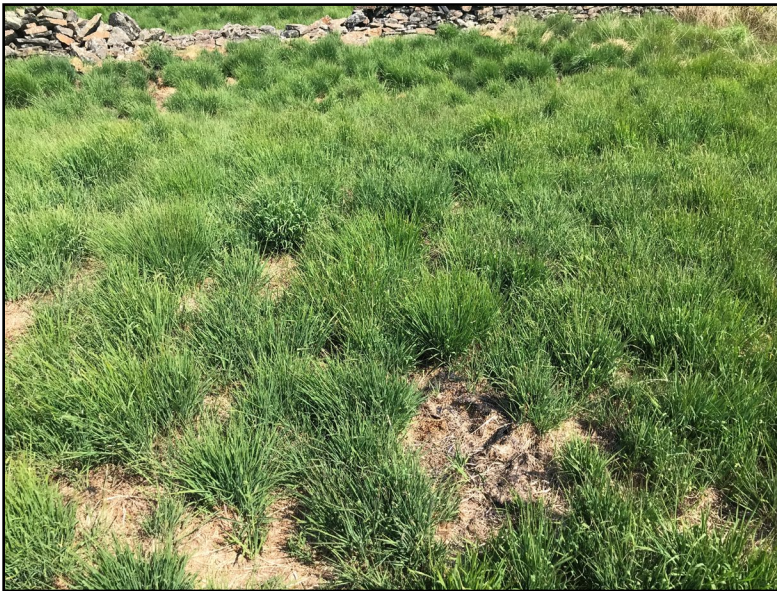
- 3.4 Across all ten quadrats, there is consistent purple moor-grass cover of 90% with on average a 3.6% cover of heath plait-moss and <1% cover of other species recorded. Litter was on average at 27.5% cover and generally formed a dense layer between low grass tussocks with any moss found beneath.
- 3.5 These results confirm the areas as being very species-poor, with the number of plant species per quadrat ranging from one to four, with an average of 2.5 species. Peat depth was on average calculated as 72.9cm deep across the dataset, somewhat deeper than the minimum depth of 40cm typically defined as blanket bog.
- 3.6 All other areas within the survey boundary were considered unsuitable for the proposed enhancement measures.

Photograph 2
Area 1 – close-up of species-
poor purple moor-grass-
dominated vegetation

- 4.19 Planting plug plants of cross-leaved heath (*Erica tetralix*), crowberry (*Empetrum nigrum*) and occasional cowberry (*Vaccinium vitis-idaea*) would significantly diversify the dwarf shrubs on Site. Seed introduction would also be possible, but the overall success rate is likely to be lower for these species.

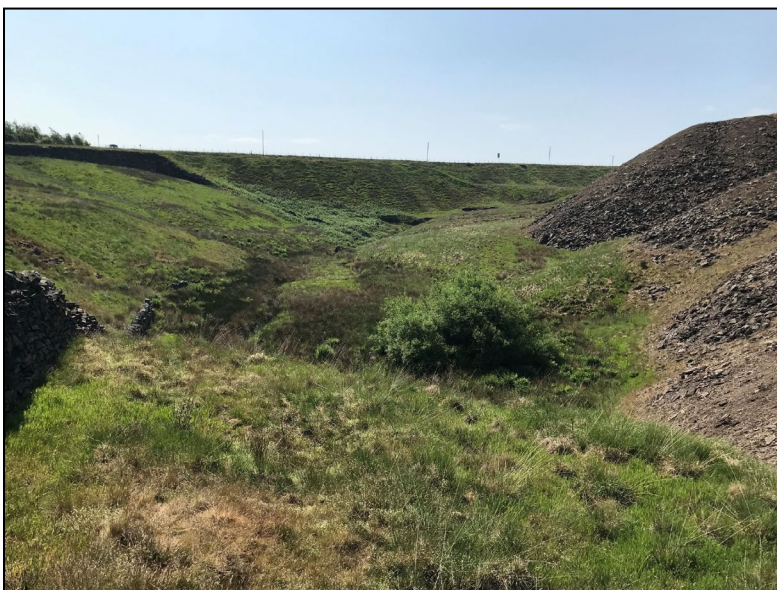
- Area 5 – variable habitat, largely comprising steeper heather and bilberry¹²-dominated slopes with some purple moor-grass leading down to the Red Brook stream valley. Dry acid grassland, rocky outcrops and bracken are also present in this area. Area has some intrinsic habitat value and overlaps with features of historic value, rendering it unsuitable as a habitat enhancement/compensation area;

Photograph 3
General view looking
southeast up Red Brook
Stream valley, showing steep
slopes either side (Areas 4
and 5, with Area 7 to the
right)

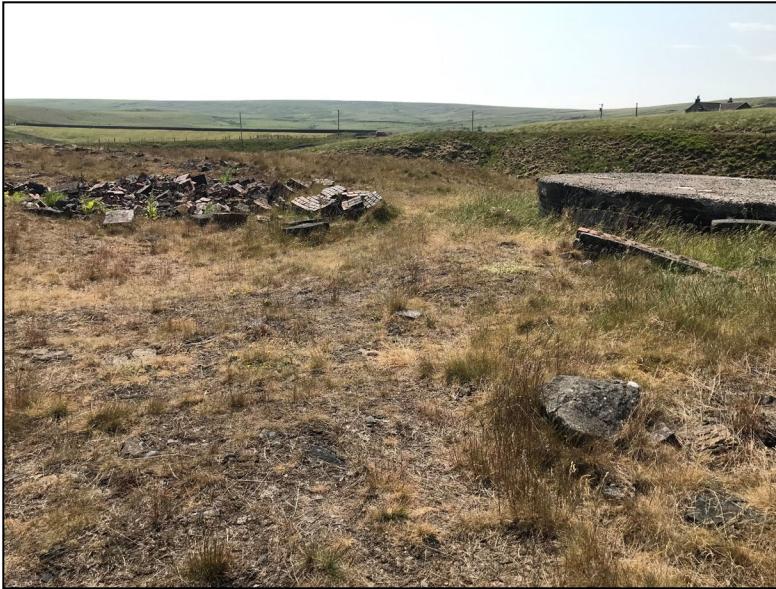
- Area 7 – spoil areas with steep slopes and friable ground, dominated by bare ground with sparse acid grassland species such as fescue (*Vulpia* sp.) and wavy hair-grass (*Avenella flexuosa*) and including small amounts of heath bedstraw (*Galium saxatile*) and heather. On the flatter tops the habitat has less grass coverage and become more dominated by bare ground and skeletal soils, with lichens, mosses, broad buckler fern (*Dryopteris* sp.), foxglove (*Digitalis purpurea*) and cat's-ear (*Hypochaeris radicata*) becoming occasional to locally frequent (see Table 1). The area has intrinsic habitat value, unstable ground condition with steep slopes and overlaps with features of historic value including the setting of the Grade II listed Engine House. It is, therefore, unsuitable as a habitat enhancement/compensation area, and;

Photograph 4
Flatter top of spoil heaps
(Area 7) with sparse
vegetation, including
mosses and lichen

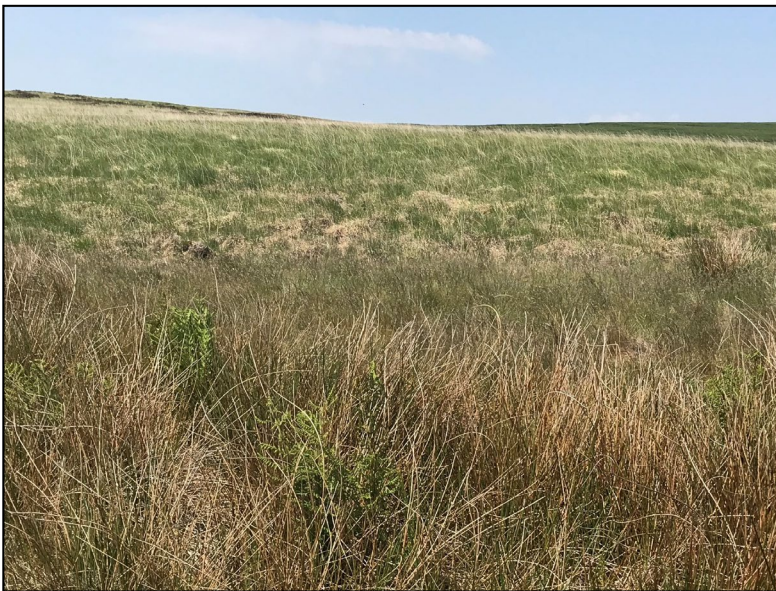
- Area 6 – flatter area of purple moor-grass-dominated habitat readily accessible from adjacent access tracks. Purple moor-grass is 90% dominant across the area with few other plant species present (see Table 1 for plant species list). The habitat likely to have developed over peat of variable thickness depending on underlying topography. The

Photograph 5
Area 6 – species-poor purple
moor-grass-dominated
vegetation

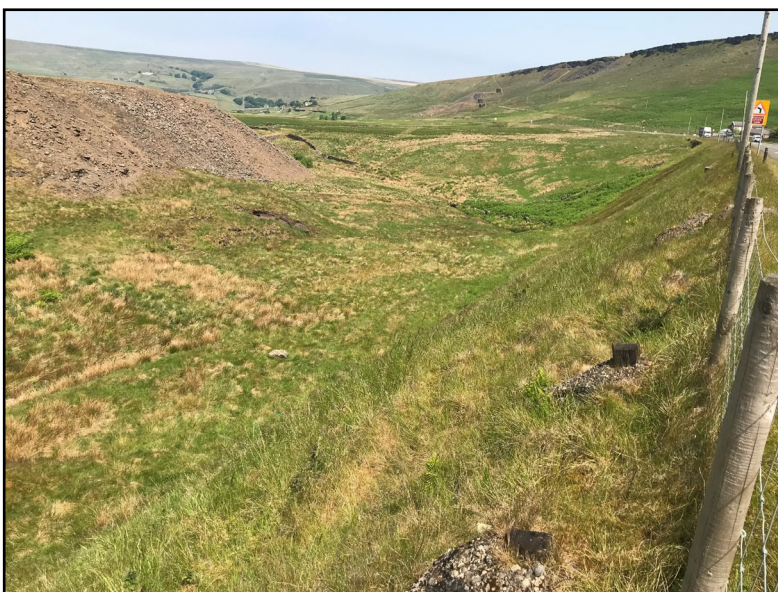
- Area 3 – mixed acid grassland including wetter lower lying areas with soft-rush and purple moor-grass plus localised dense bracken patches. This area follows along the line of the Red Brook stream valley, resulting in ground that is sloping with dips and hummocks making access for machinery problematic, along with risk of unintended pollution if working close to the watercourse. Area overlaps with historic feature Roman Road (MWY5127) and other local features on historic interest. Mosaic of habitats has intrinsic value. Unsuitable as a habitat enhancement/compensation area;

Photograph 6
General view of the upper
section of Red Brook Stream
valley (Area 3), from Thieves
Clough footpath
