**ARBORICULTURAL IMPACT ASSESSMENT
to BS 5837:2012
at
Land at Primrose Lane
Liversedge
West Yorkshire**

Client:
Jones Homes
(Yorkshire) Limited

JCA Ref:
21600-A/AJB

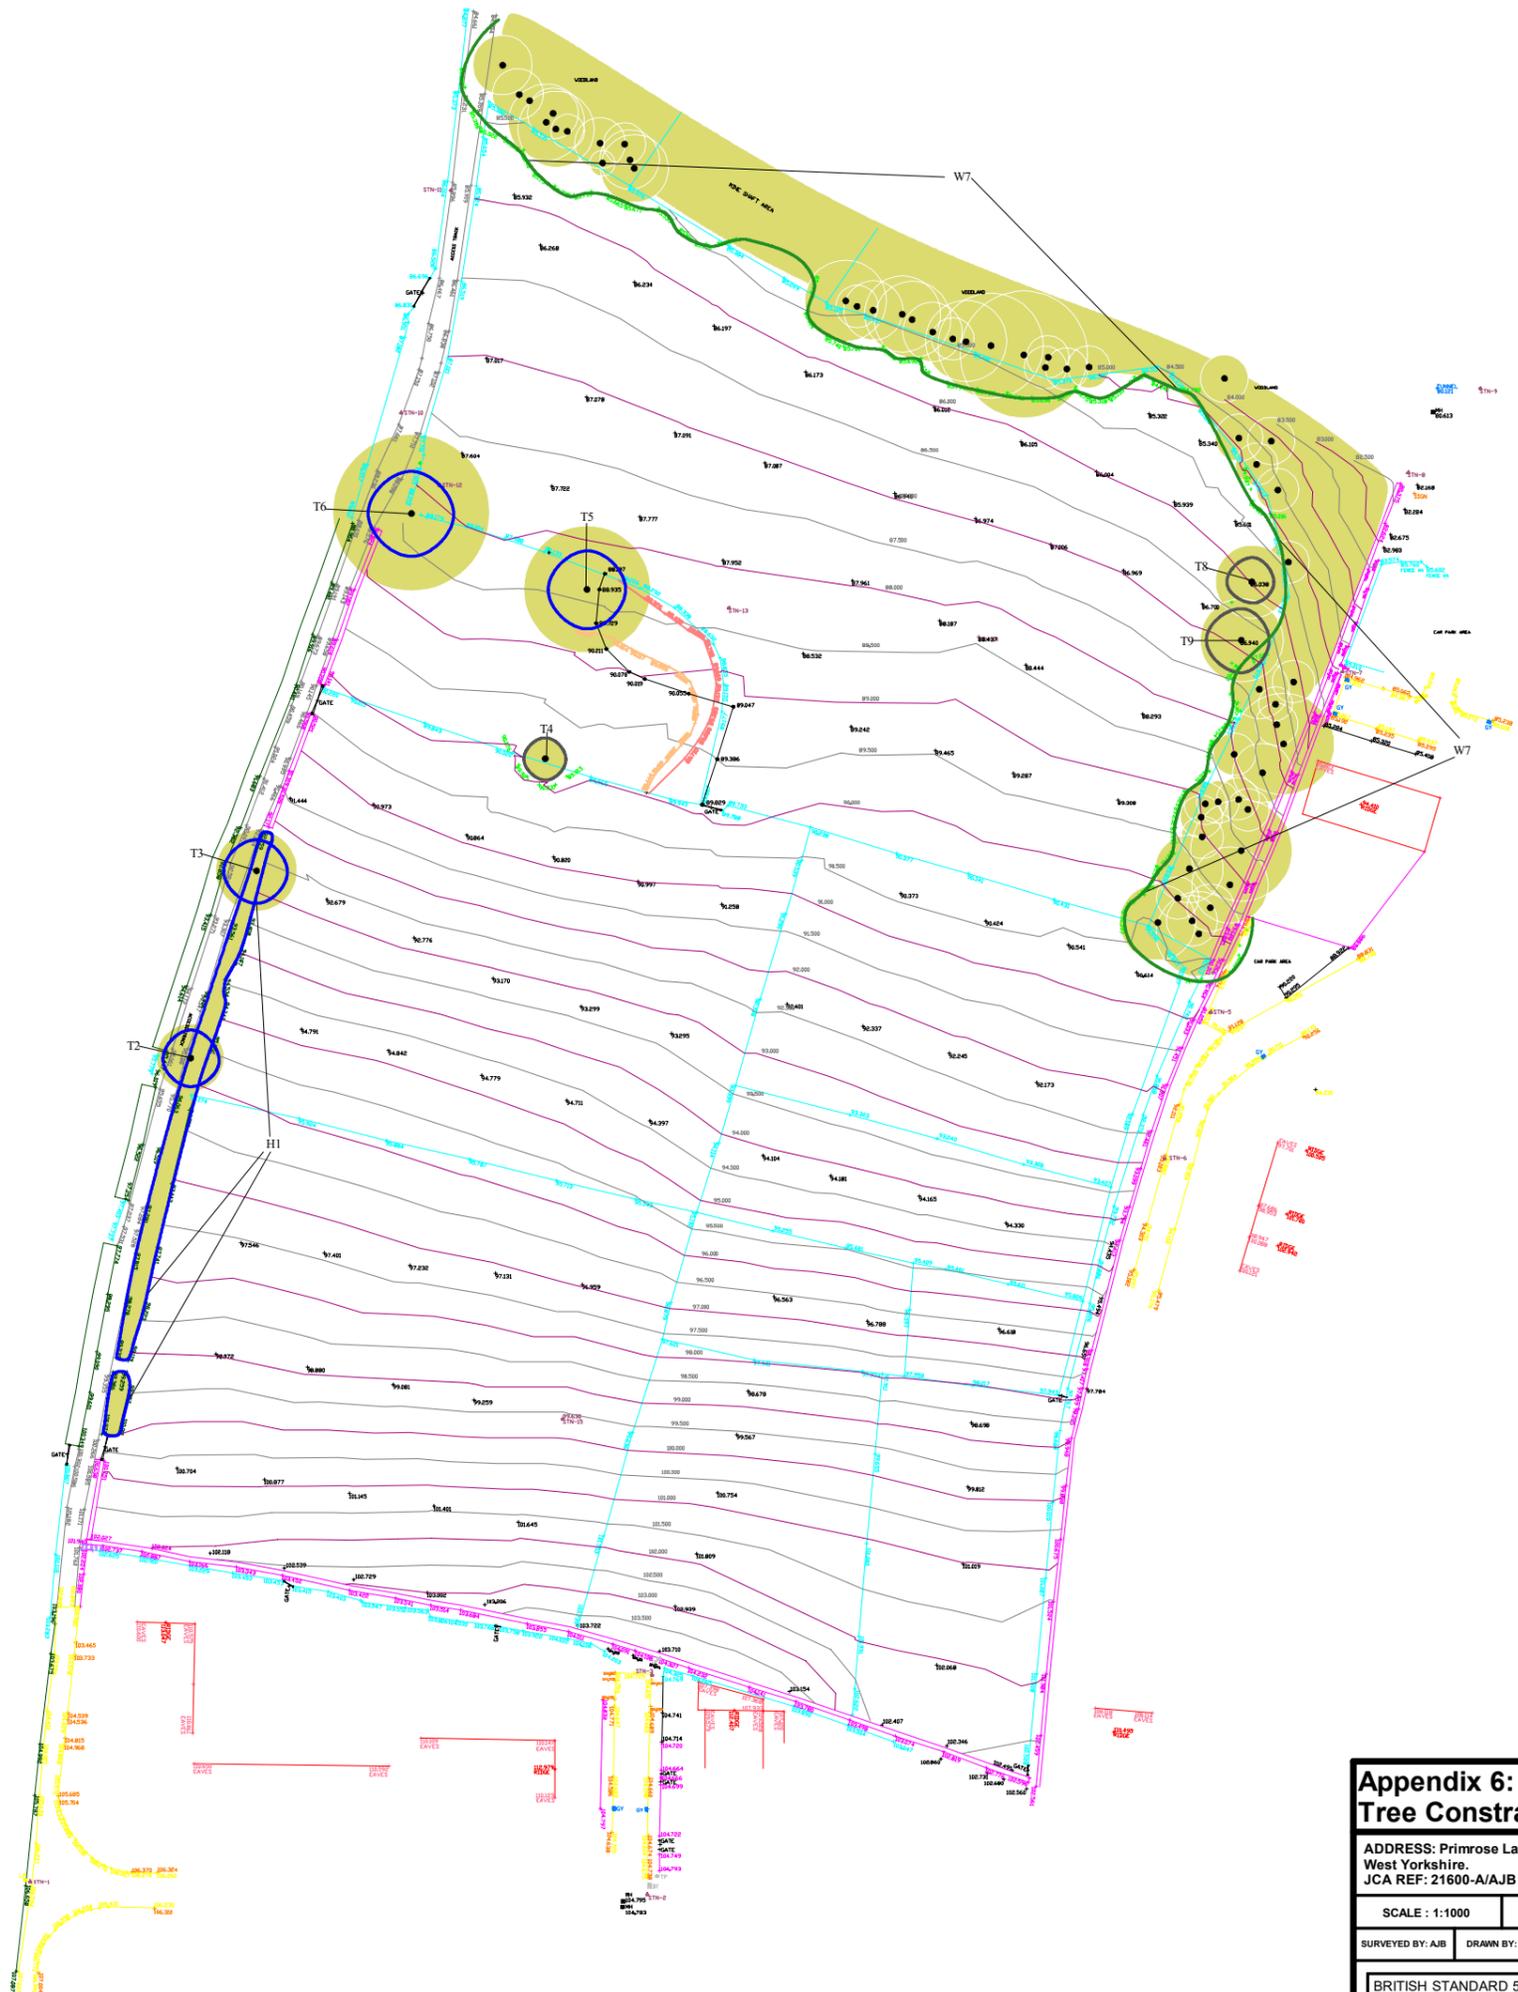
Appendix 6: Tree Constraints Plan

Root Protection Area: RPA

THE ROOT PROTECTION AREA SHOULD IDEALLY REMAIN UNDISTURBED IF THE TREE IS TO BE RETAINED.

THE DEVELOPMENT PROPOSALS SHOULD THEREFORE BE DESIGNED TO AVOID THE RPA OF ANY TREE WHICH IS TO BE RETAINED.

IF IT IS NECESSARY FOR THE DEVELOPMENT TO ENCRUSH INTO THE RPA OF A TREE WHICH IS TO BE RETAINED THEN SPECIALIST CONSTRUCTION TECHNIQUES AND MATERIALS MUST BE CONSIDERED.

- 2.1 The tree information recorded during the original survey is detailed in the tables at **Appendix 1**. A full explanation of the tables can be found at **Appendix 2**. Please refer also to the Tree Constraints Plan at **Appendix 5** for tree locations.

- 4.6 The protection of retained trees can be achieved by the creation of a Construction Exclusion Zone based on the Root Protection Area of a tree. The Root Protection Area of each tree or group is marked on the Tree Constraints Plan at **Appendix 5**.
