**ARBORICULTURAL IMPACT ASSESSMENT  
to BS 5837:2012  
at  
Land at Primrose Lane  
Liversedge  
West Yorkshire**

**Client:**  
Jones Homes  
(Yorkshire) Limited

**JCA Ref:**  
21600-E/AJB

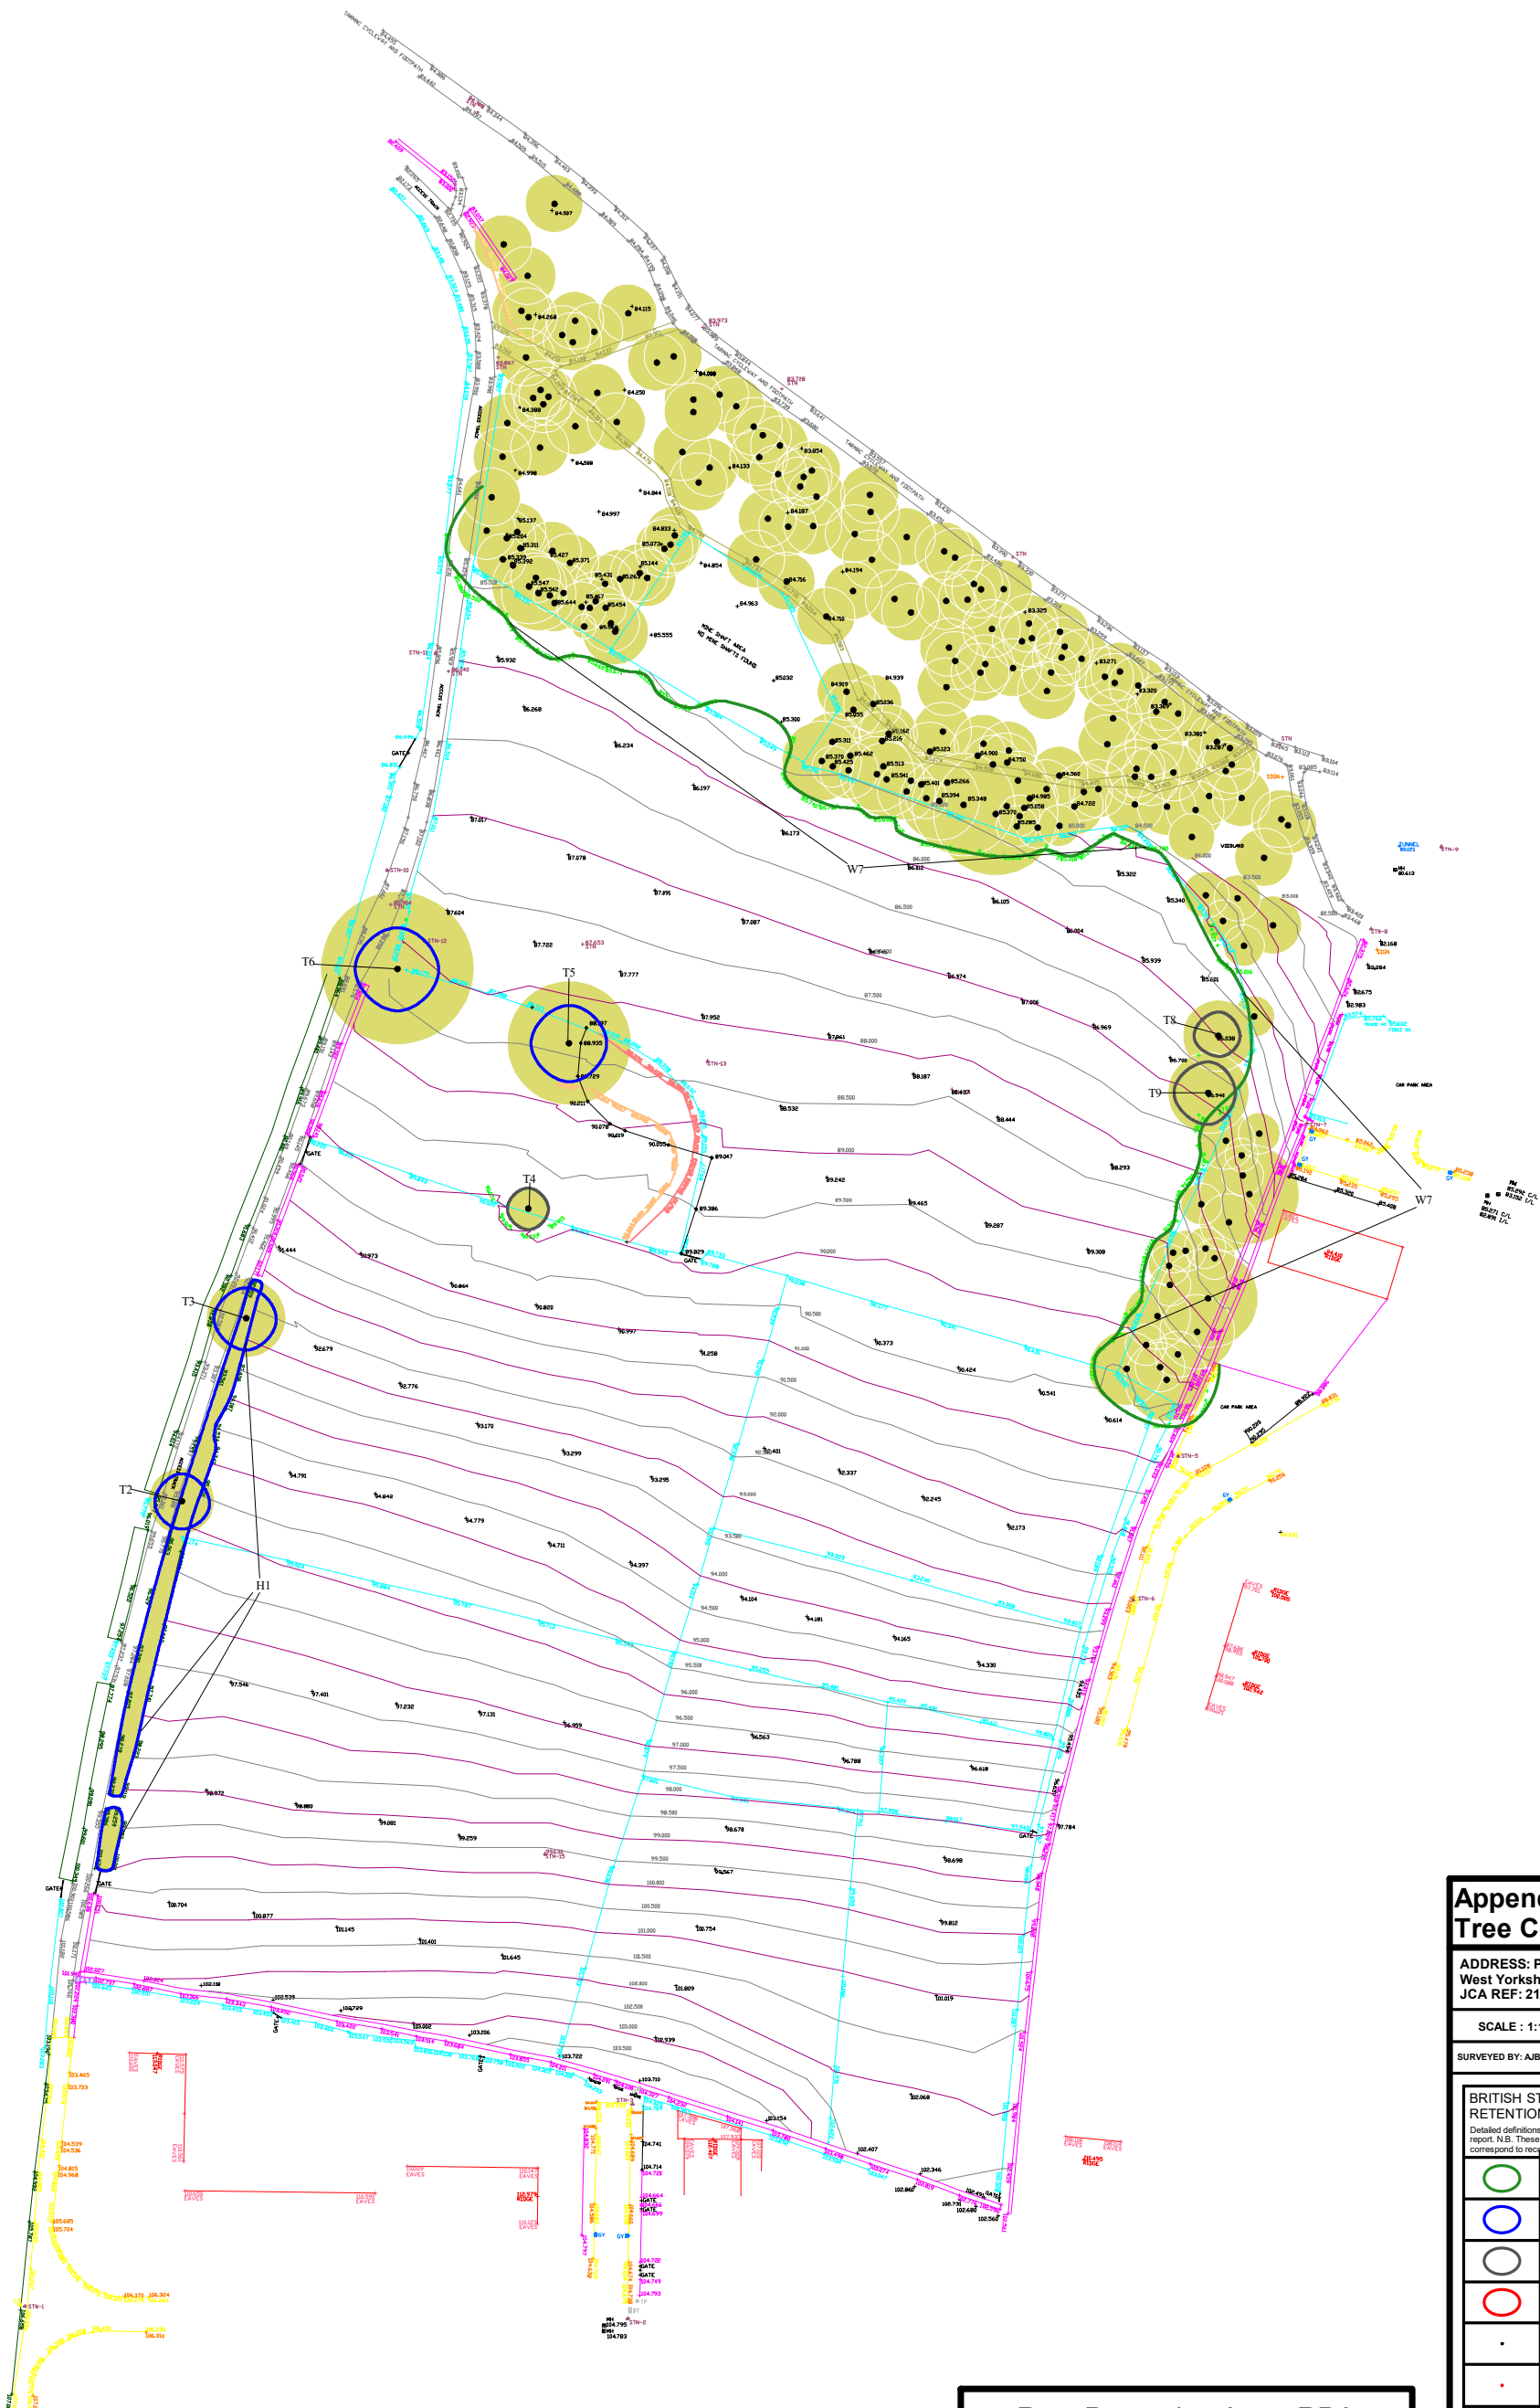
**Appendix 6:  
Tree Constraints Plan**

THE ROOT PROTECTION AREA SHOULD IDEALLY REMAIN UNDISTURBED IF THE TREE IS TO BE RETAINED.

THE DEVELOPMENT PROPOSALS SHOULD THEREFORE BE DESIGNED TO AVOID THE RPA OF ANY TREE WHICH IS TO BE RETAINED.

IF IT IS NECESSARY FOR THE DEVELOPMENT TO ENCROACH INTO THE RPA OF A TREE WHICH IS TO BE RETAINED THEN SPECIALIST CONSTRUCTION TECHNIQUES AND MATERIALS MUST BE CONSIDERED.

- 2.1 The tree information recorded during the original survey is detailed in the tables at **Appendix 1**. A full explanation of the tables can be found at **Appendix 2**. Please refer also to the Tree Constraints Plan at **Appendix 5** for tree locations.

- 4.6 The protection of retained trees can be achieved by the creation of a Construction Exclusion Zone based on the Root Protection Area of a tree. The Root Protection Area of each tree or group is marked on the Tree Constraints Plan at **Appendix 5**.
