ST PETERS CHURCH, HUDDERSFIELD,  
WEST YORKSHIRE.

REPORT ON AN  
ARCHAEOLOGICAL WATCHING BRIEF

OSA REPORT NO: OSA21WB12

July 2021

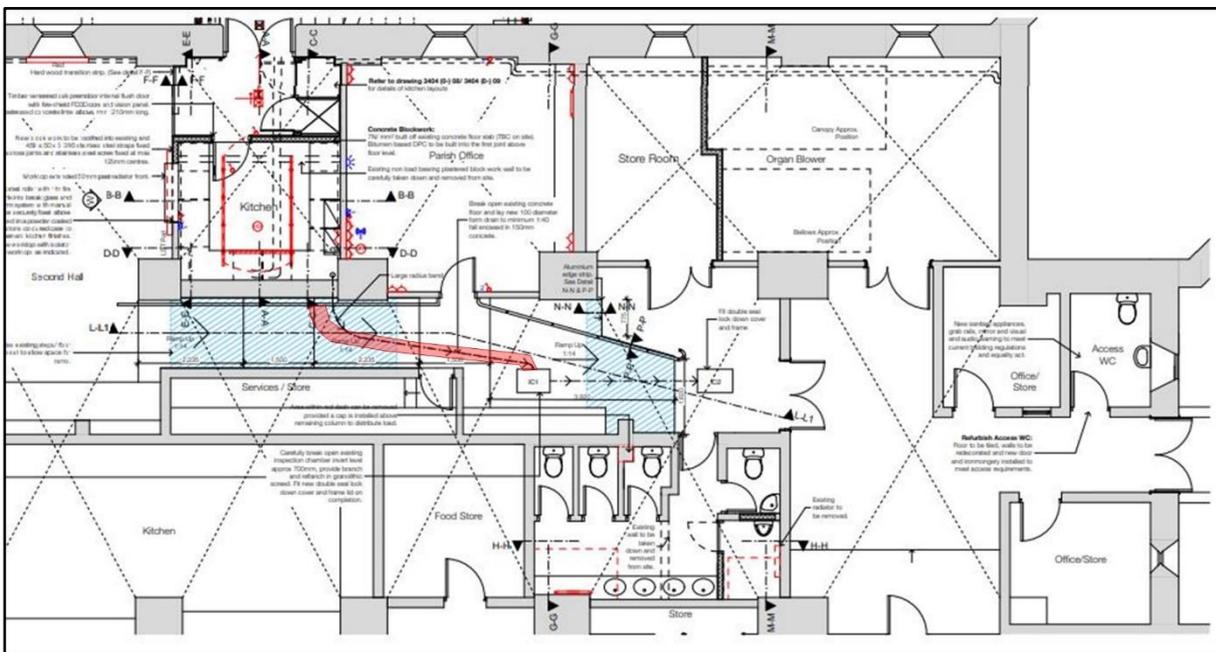
The watching brief comprised the monitoring of the hand excavation of a drainage trench required to service a new kitchen facility within the crypt (Figure 3), in order to establish the presence/absence, nature, extent and preservation of any archaeological remains and to ensure that any archaeological deposits encountered could be recorded.

Figure 3. Watching brief area, monitored area shaded red.

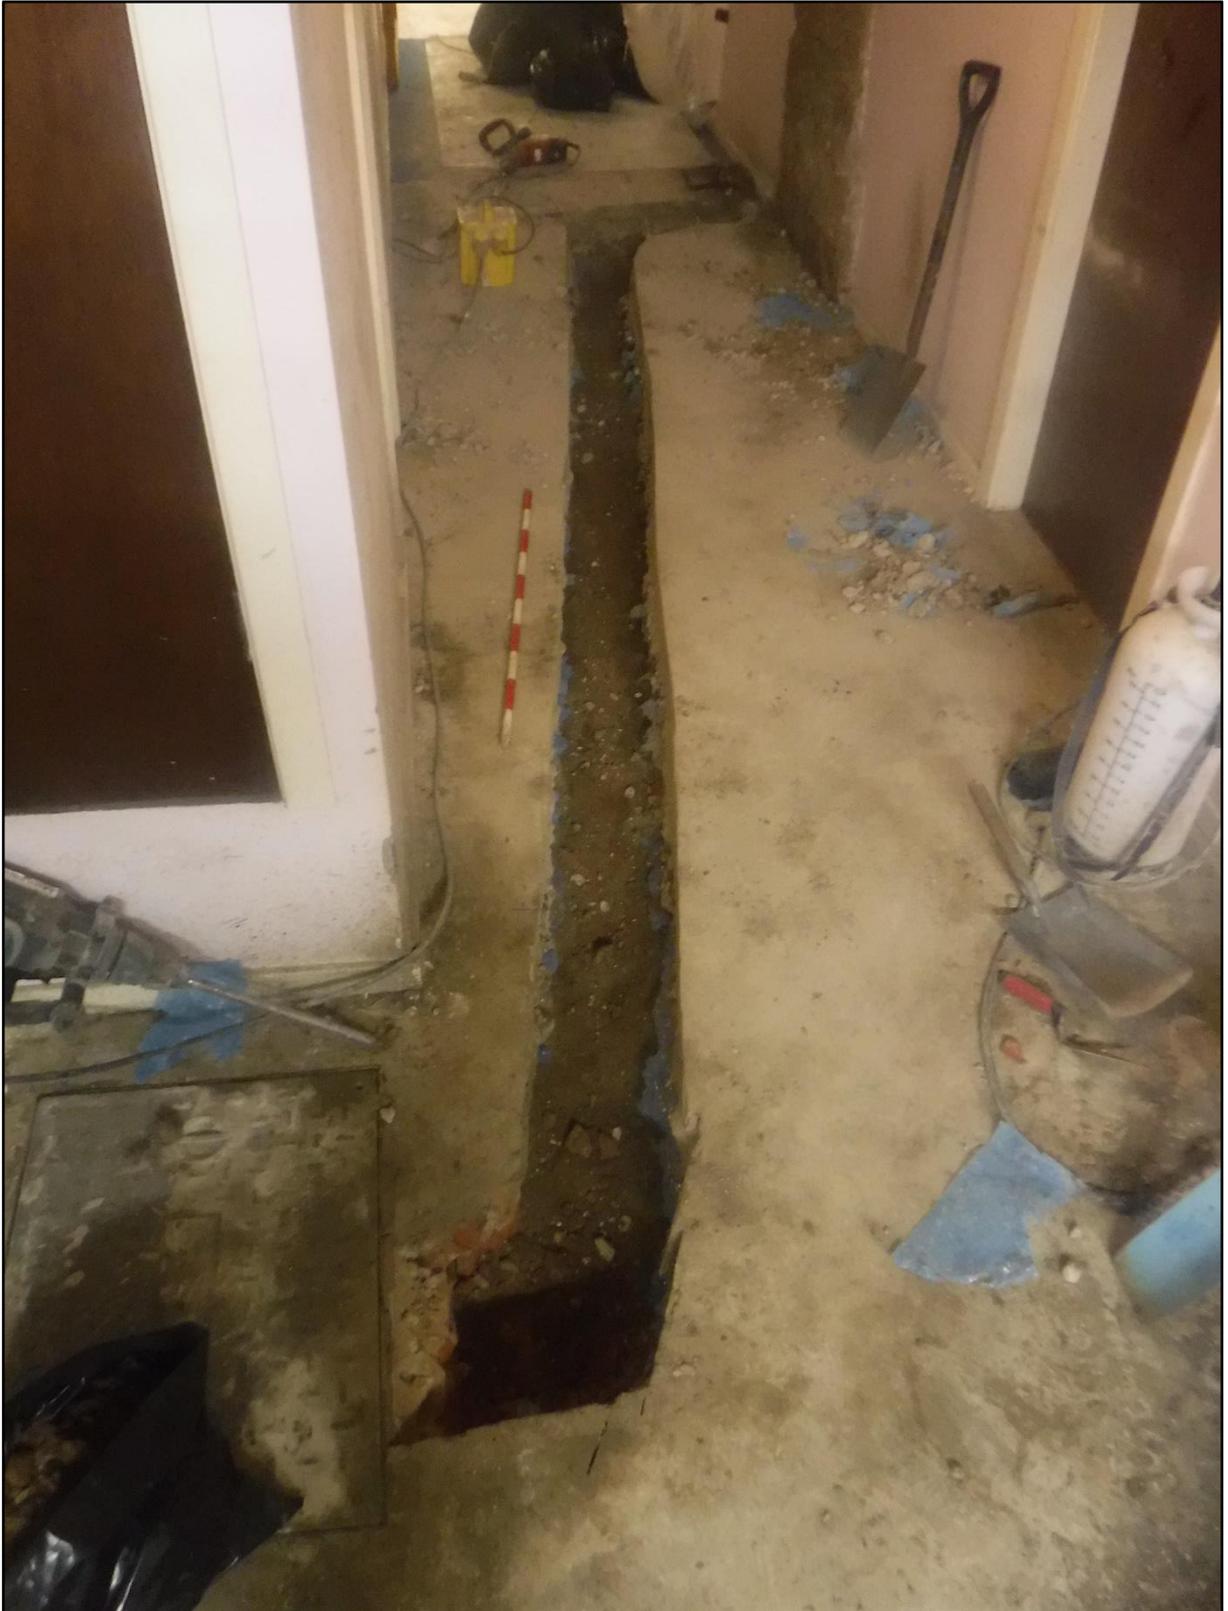
The monitored drainage trench (Plate 1) measured 0.25m wide and between 0.25m and 0.35m deep (to allow for adequate fall). The modern ground covering consisted of a slab of concrete (100) which measured 0.10m thick. Directly beneath the concrete slab was a layer of compacted stone, levelling deposit (101) which was 0.08m thick. The compacted stone sealed a layer of blue plastic sheet (102) which had presumably been placed to prevent the stone layer from mixing with the deposits beneath. Directly below the plastic sheet was a layer of brownish grey, loose sand mixed with frequent fragments of stone rubble and fragments of CBM (103) which was 0.12m thick. The deposit appeared to be another layer of made

ground. Finally the earliest deposit within the sequence was discovered at the base of the trench, consisting of a compacted dark greyish brown clayey silt with occasional stone inclusions (104). The deposit extended beyond the base of the trench and did not contain any identifiable archaeological material. It is possible that the deposit represented the original burial horizon, however, an absence of human bone makes the interpretation inconclusive. With the exception of one modern brick-built inspection chamber (which the monitored drain was intended to connect to) at the western end of the trench, no features were observed, and no pre-modern artefacts were present.

*Plate 1. General view of foundation trench looking west.*
