**GROUNDTECH**  
CONSULTING

**Job title:** Cherry Tree Surgery

**Report type:** Geo-Environmental Appraisal

| Document Control Form | |
|---|---|
| REPORT REFERENCE | GRO-22384-4134 |

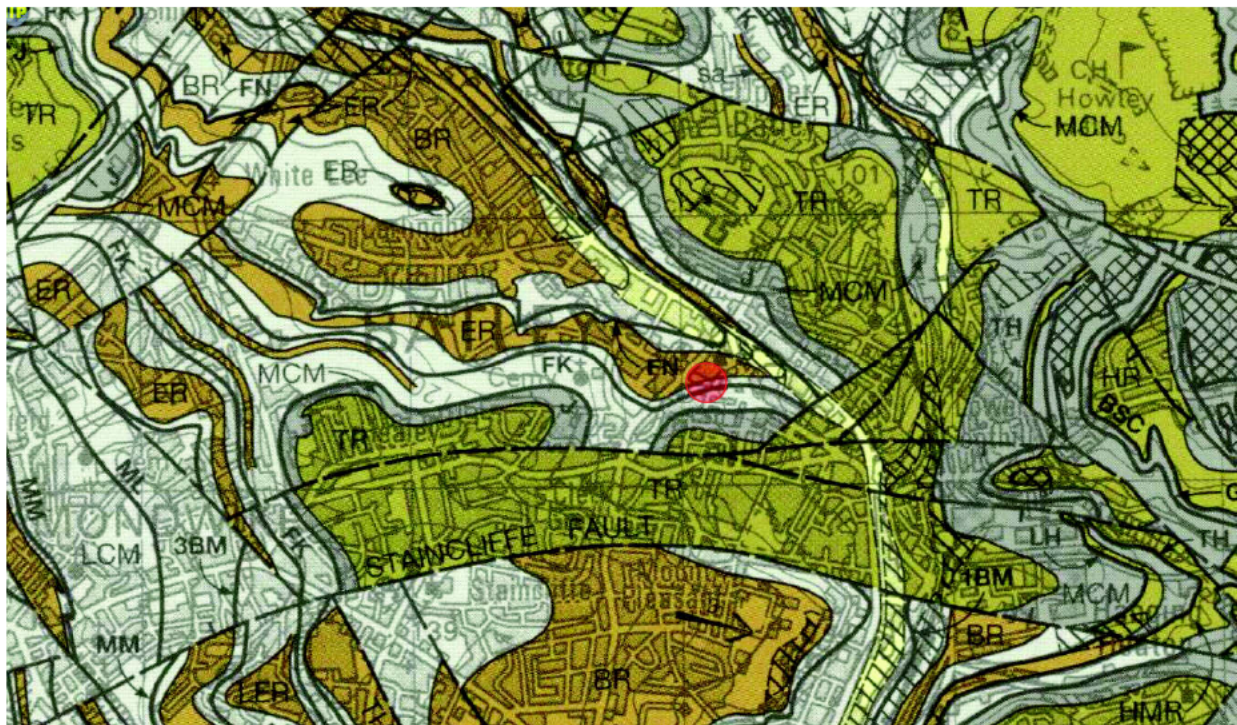
Geological Map – Solid Geology

The bedrock deposits are indicated to be the Emley Rock Formation comprising sandstone within the northern area of the site and the Pennine Lower Coal Measures Formation which typically consists of mudstone, siltstone, sandstone and coal seams beneath the central and southern parts.

The Flockton Thick coal seam, which is 0.3m to 1.5m in thickness, is shown outcropping beneath the extreme southern part of the site. Based on the age of the strata in the area, the Flockton Thick coal seam dips to the south away from the proposed development area.
