**BROMLEY FARM QUARRY EXTENSION  
CUMBERWORTH LANE,  
LOWER CUMBERWORTH,  
HUDDERSFIELD, HD8 8PD**

**UPDATED PHASE 2 GEO-ENVIRONMENTAL INVESTIGATION REPORT**

**SILKSTONE ENVIRONMENTAL LTD**

**Report Ref: 22007/P2/1**

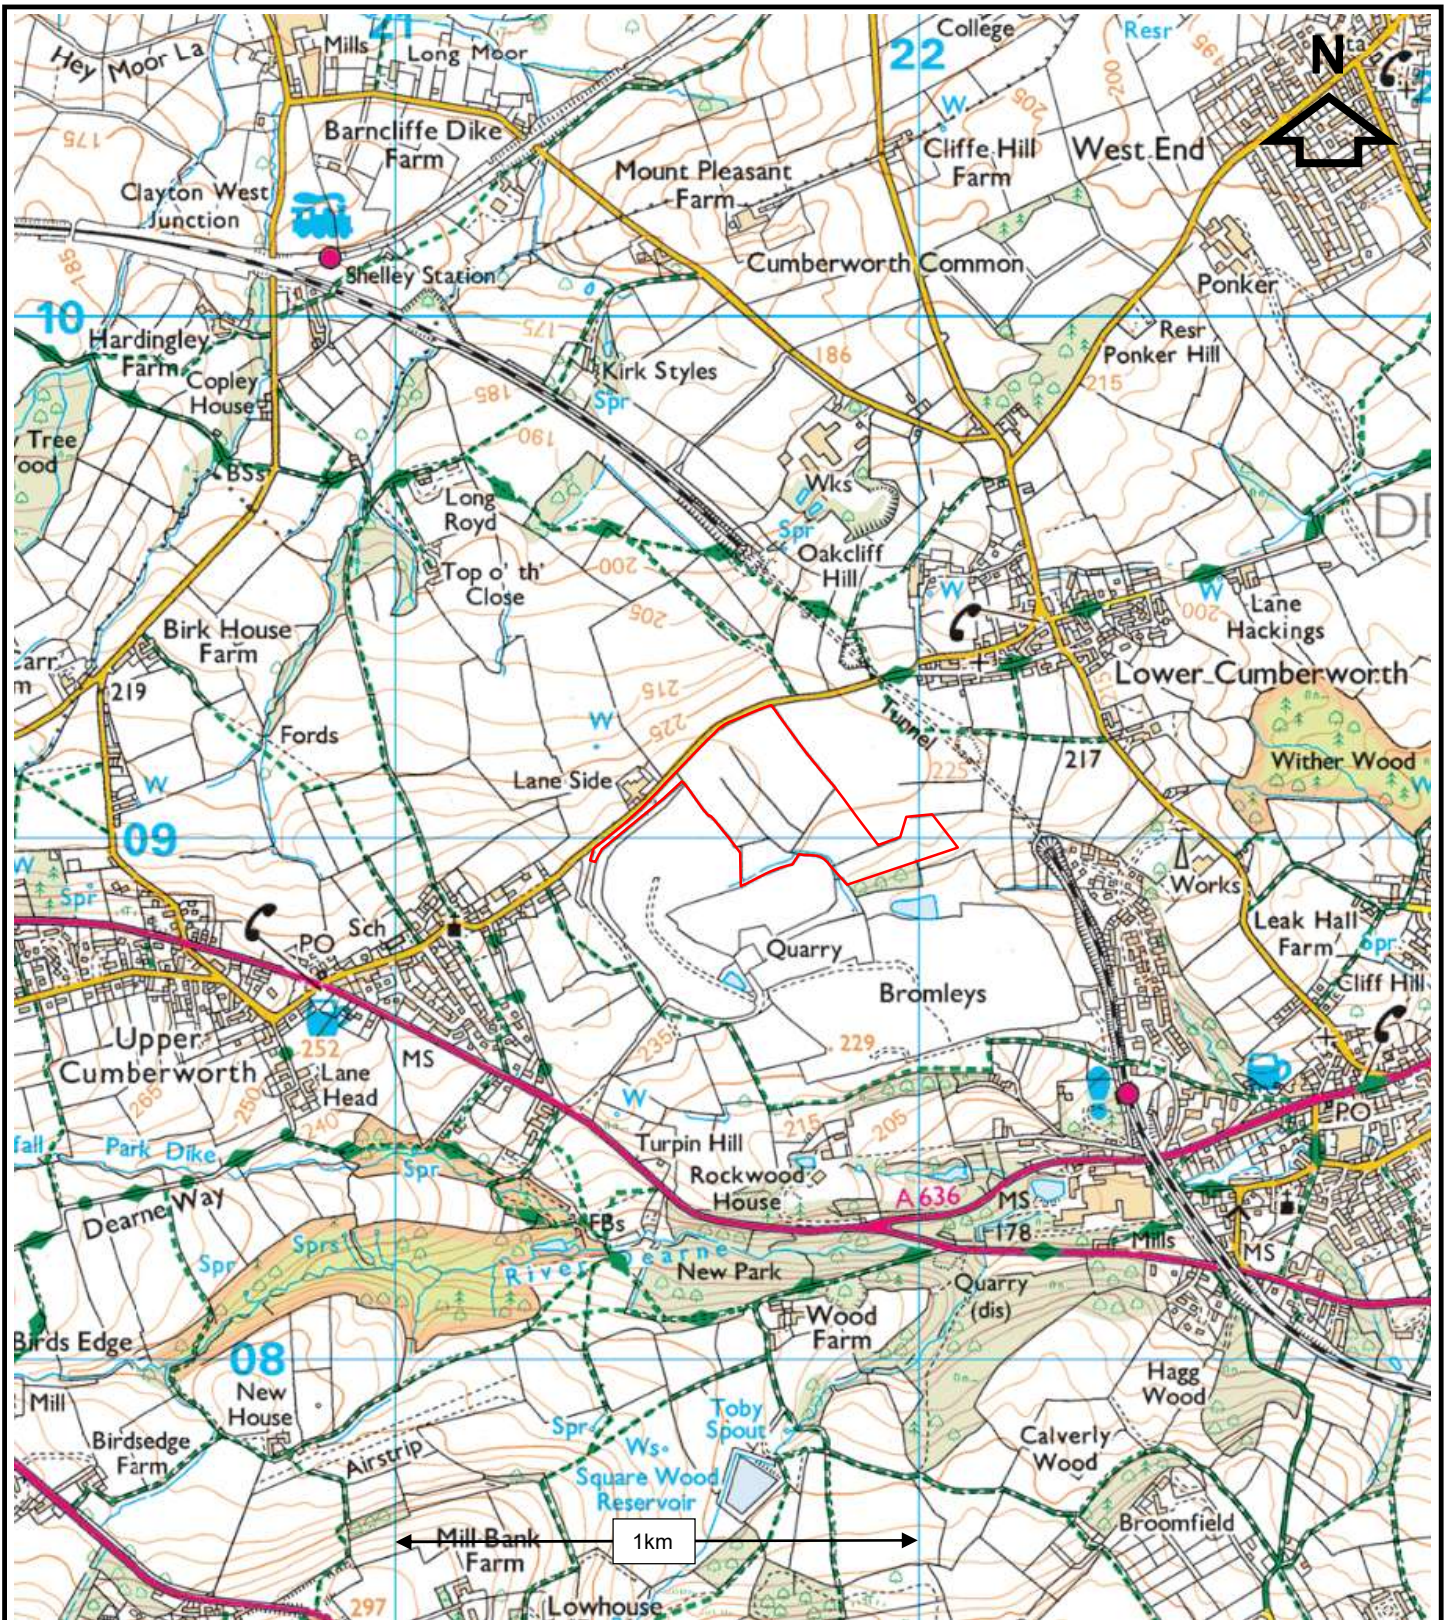
Drawing no. 22007/515/1 *Contaminated Soils Area and Storage*, dated February 2024

The proposed location of the segregated stockpile is at the end of the proposed screening mound on the eastern side of the application area as shown on the drawing provided in Appendix A. The elevated concentrations in lead and thiocyanate in the soil at WS01 have not been found to be potentially leachable into groundwater at concentrations considered to be harmful to the environment (see below). However, in view of the small sample dataset for this part of the site, it is proposed that a layer of site sourced clay will be placed at the base of this stockpile area as a precautionary measure to prevent leaching of contaminants.

At the time of overburden removal, it is recommended that the soils from within the south western part of the site are stockpiled separately from the soils removed from the remaining area of the site.

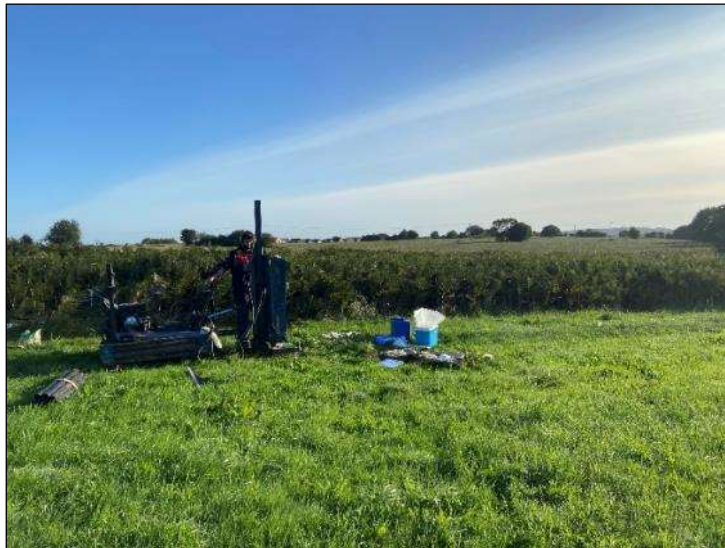
Photo 1: WS01 – Position of the first window sampling location on eastern part of historic landfill.

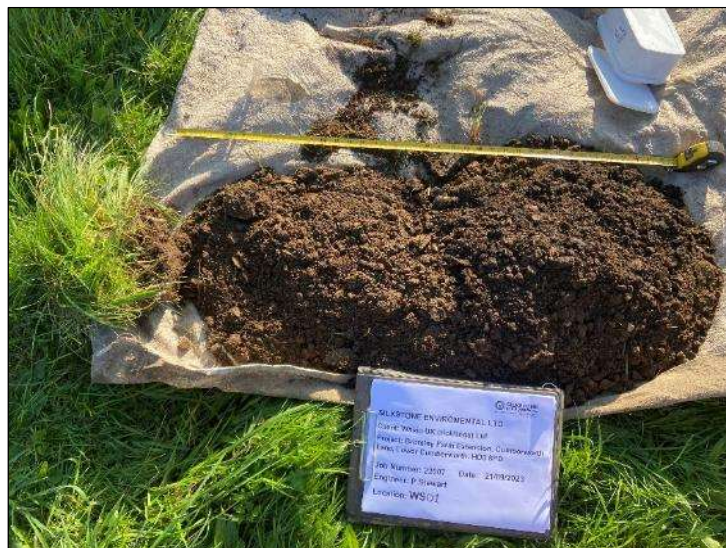
Photo 2: WS01 – Made Ground (Topsoil) arisings from hand dug inspection pit (depth progressing from left to right).

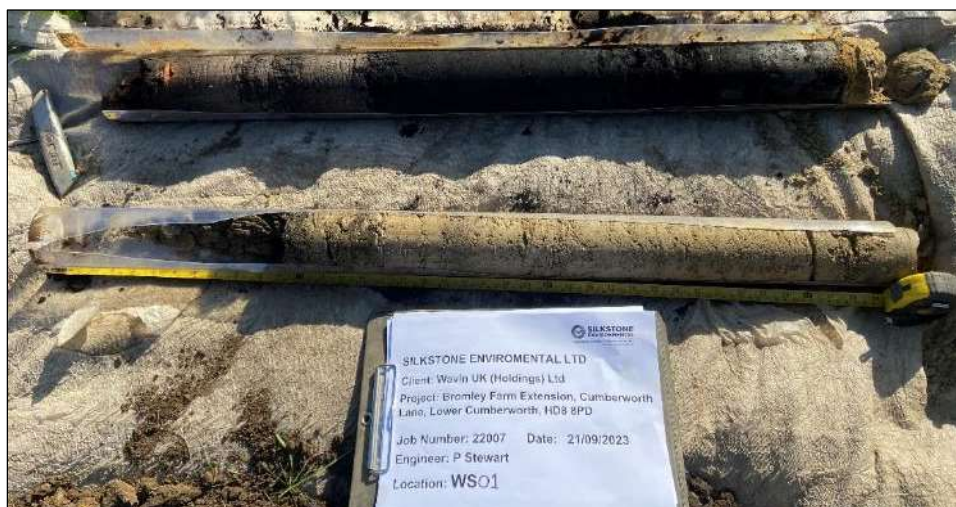
Photo 3: WS01 – Recovered soil core following penetration to sampler refusal at 2.80m begl (depth progressing from left to right and top to bottom).

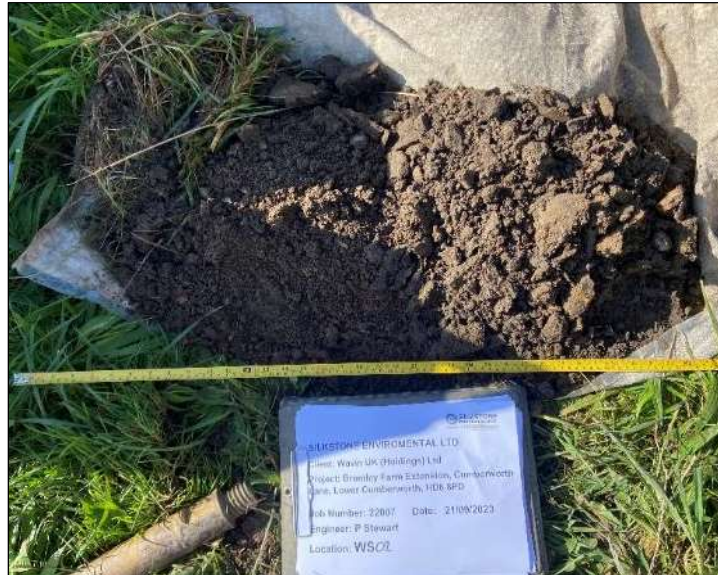
Photo 4: WS02 – Made Ground (Topsoil) arisings from hand dug inspection pit (depth progressing from left to right).

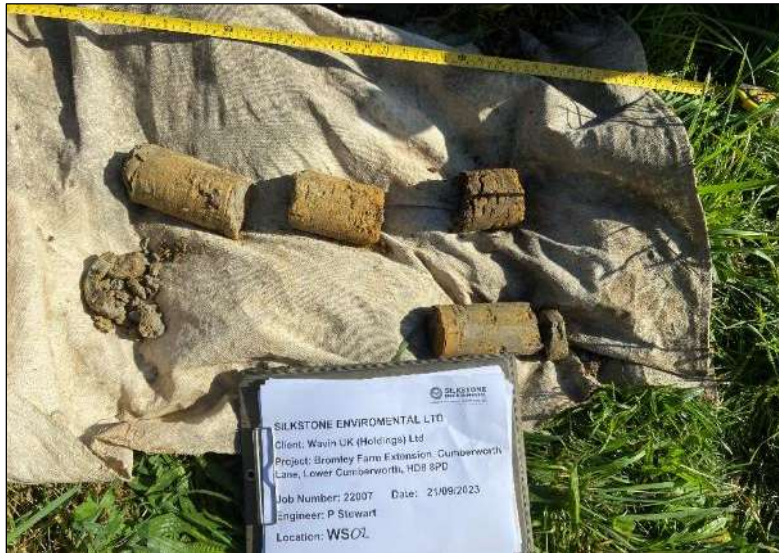
Photo 5: WS02 – Recovered soil core following penetration to sampler refusal at 1.20m begl (depth progressing from left to right and top to bottom).

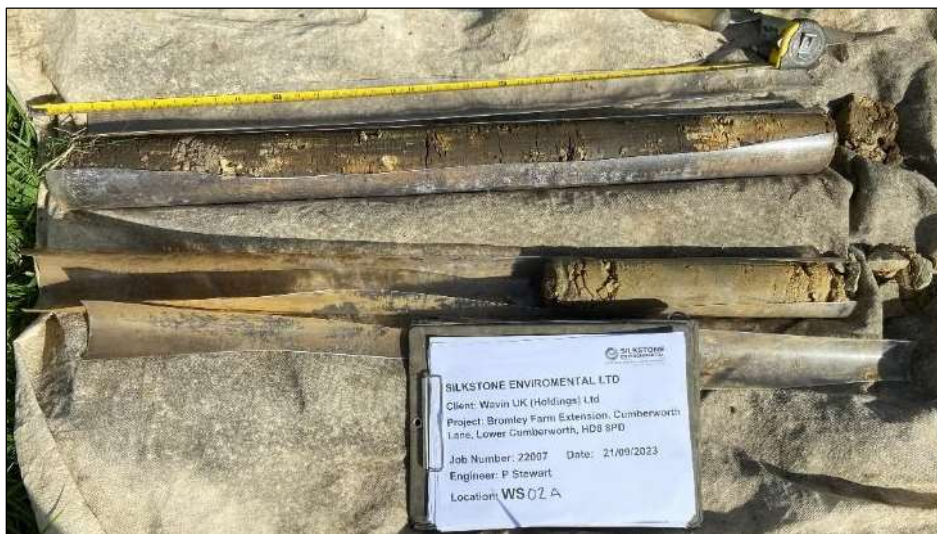
Photo 6: WS02A – Recovered soil cores following penetration to sampler refusal at 1.40m begl (depth progressing from left to right and top to bottom).

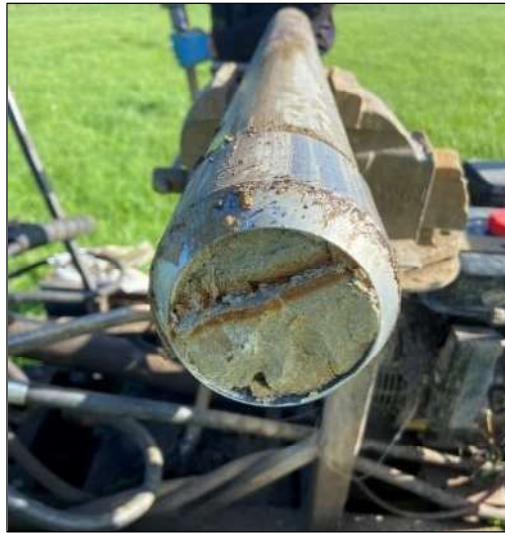
Photo 7: WS02 – Close up of the weathered siltstone at the base of the exploratory hole.

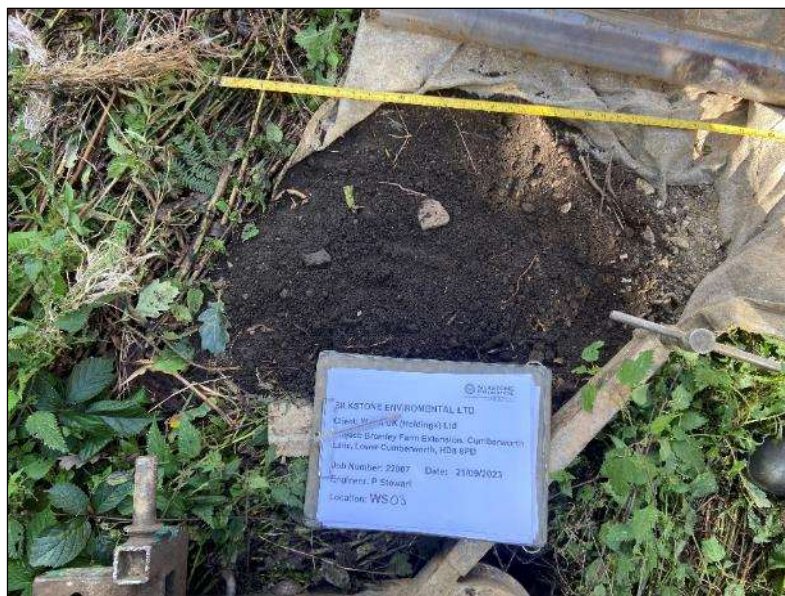
Photo 8: WS03 – Made Ground (Topsoil) arisings from hand dug inspection pit (depth progressing from left to right).

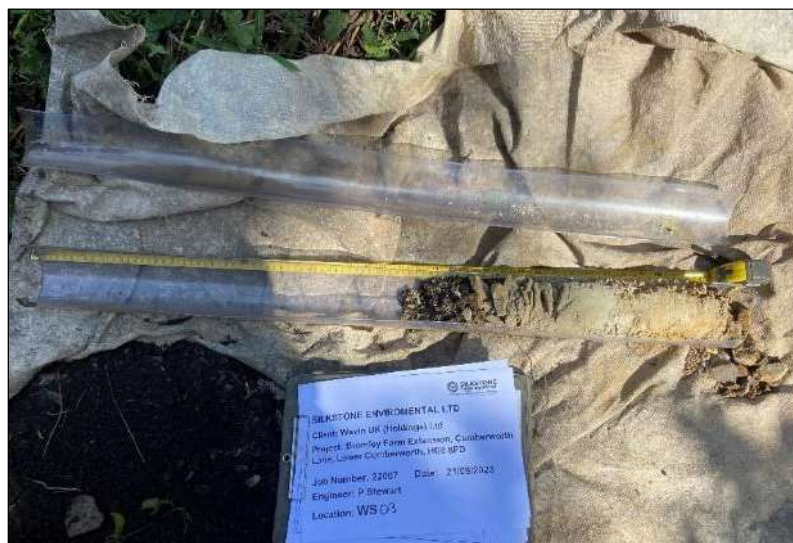
Photo 9: WS03 – Recovered soil core following penetration to sampler refusal at 1.00m begl (depth progressing from left to right).

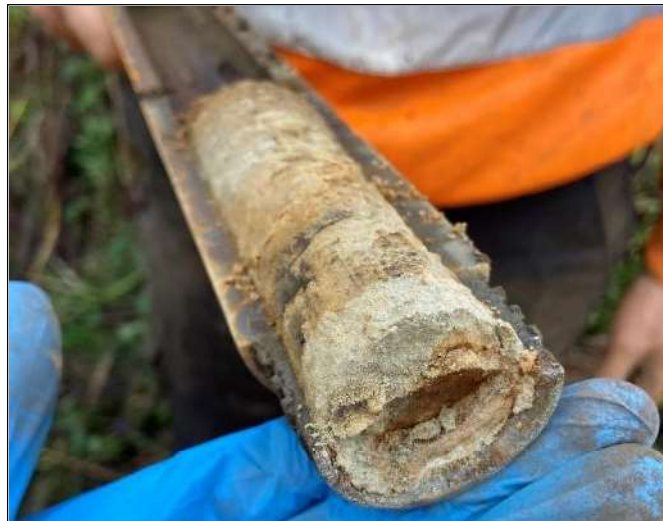
Photo 10: WS03 – Close up of the weathered siltstone at the base of the exploratory hole.

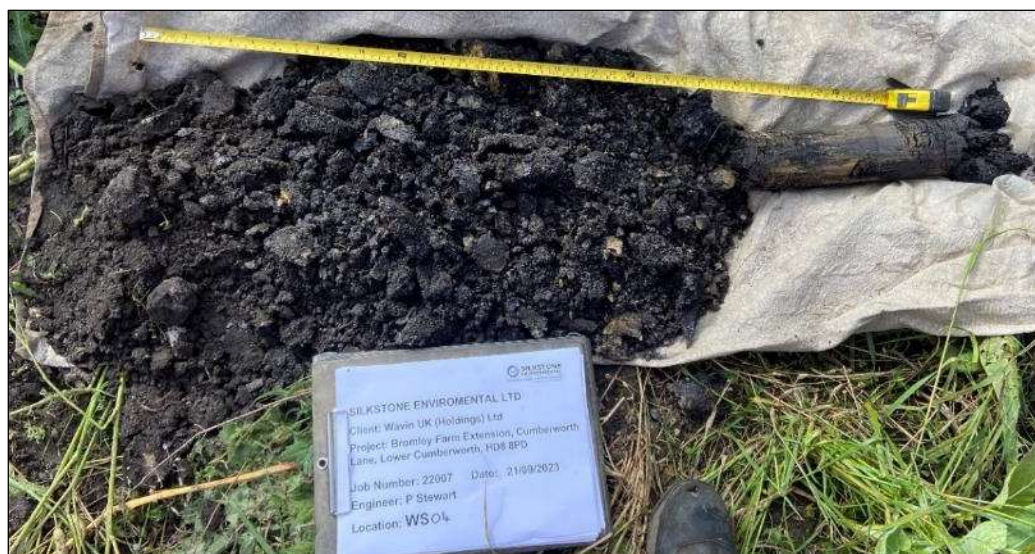
Photo 11: WS04 – Made Ground (Topsoil) arisings from hand dug inspection pit and window sampling (depth progressing from left to right).

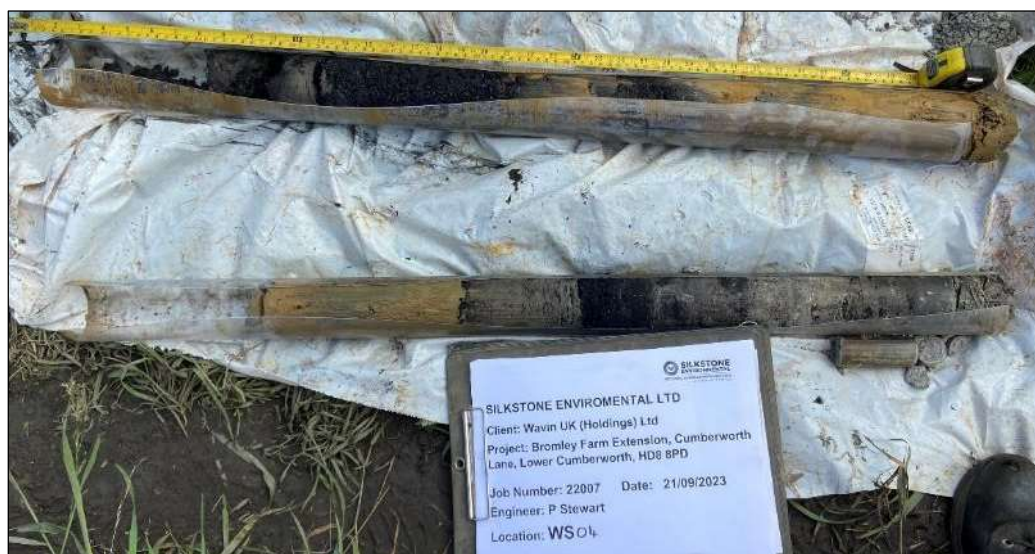
Photo 12: WS04 – Recovered soil cores following penetration to sampler refusal at 2.70m begl (depth progressing from left to right and top to bottom).

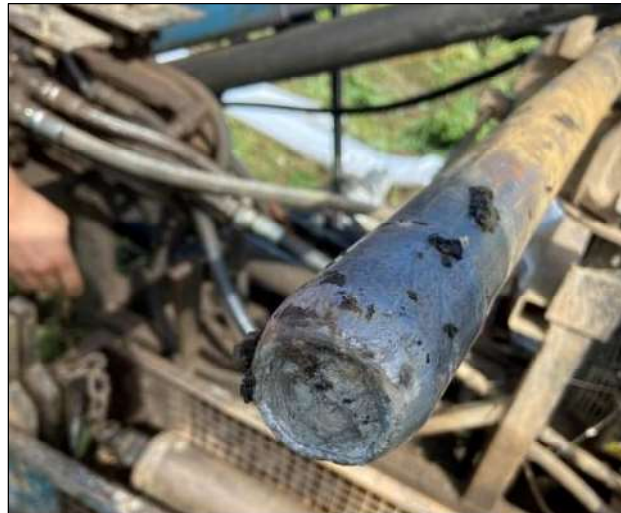
Photo 13: WS04 – Close up of the weathered siltstone at the base of the exploratory hole.

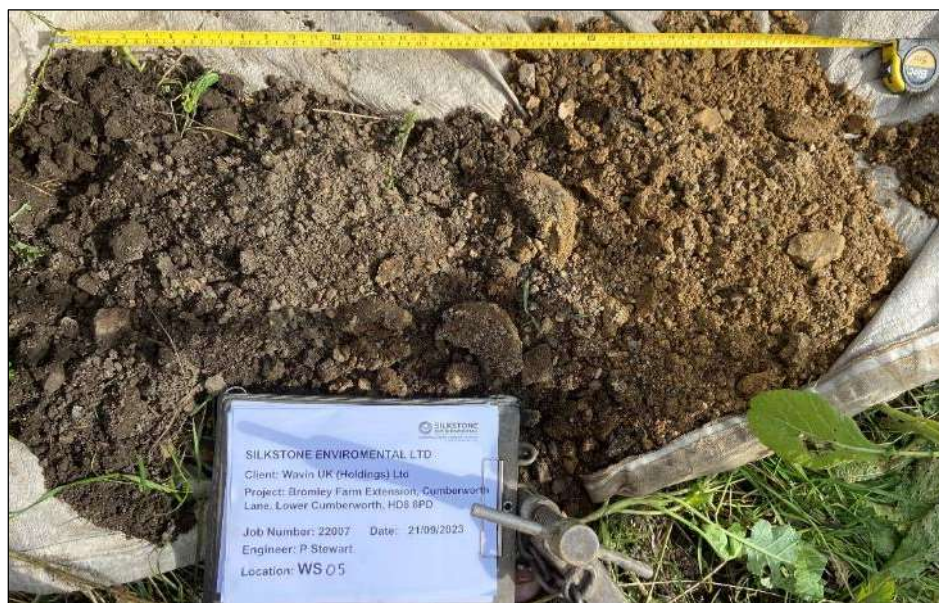
Photo 14: WS05 – Made Ground (Topsoil) and natural soil arisings from hand dug inspection pit (depth progressing from left to right).

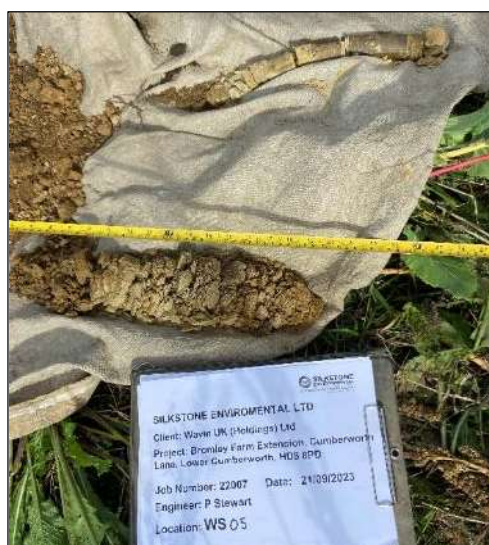
Photo 15: WS05 – Recovered soil core (bottom) and SPT split spoon sample (top) following penetration to sampler refusal at 1.45m begl (depth progressing from left to right and bottom to top).

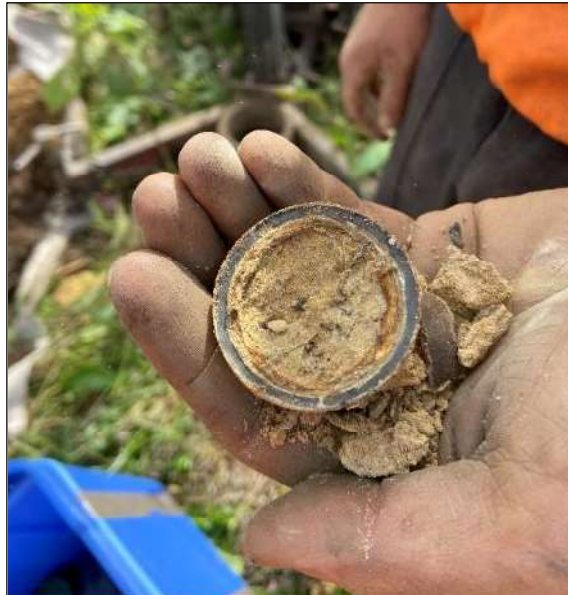
Photo 15: WS05 – Close up of weathered sandstone at the base of the exploratory hole.

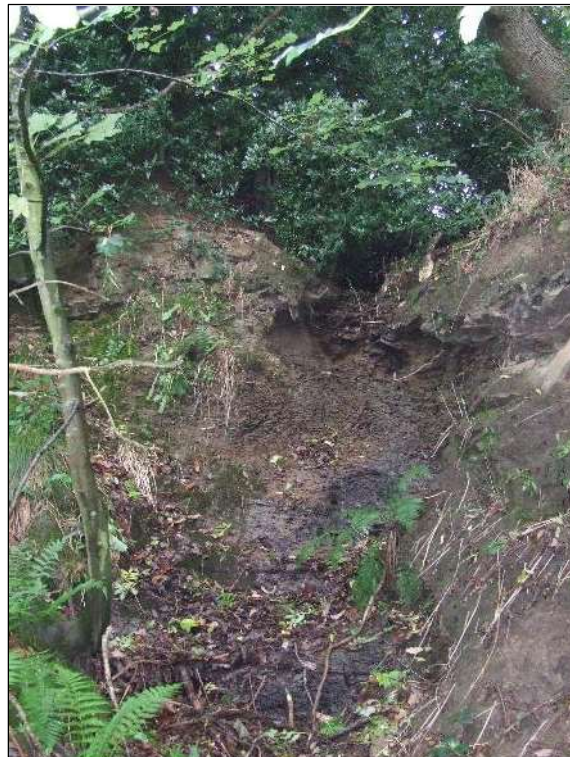
Photo 16: Dry section of East Hill Beck downstream from sampling point.

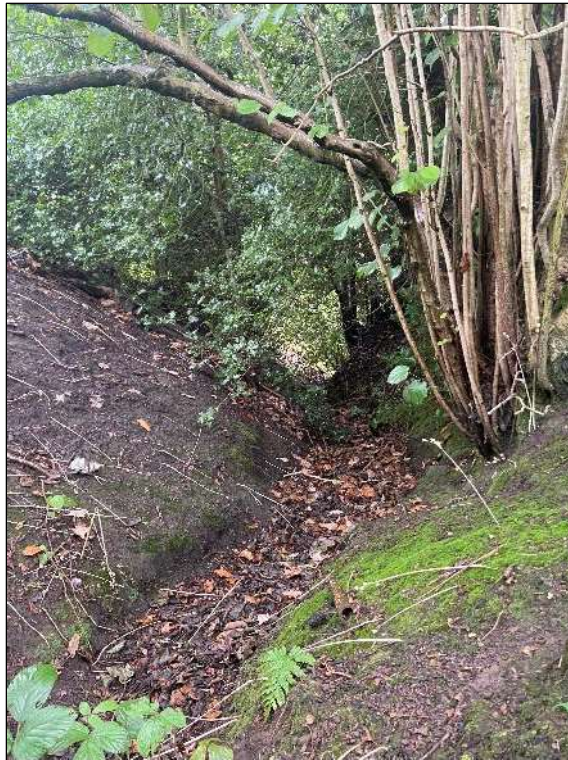
Photo 17: Dry section of East Hill Beck downstream from sampling point.

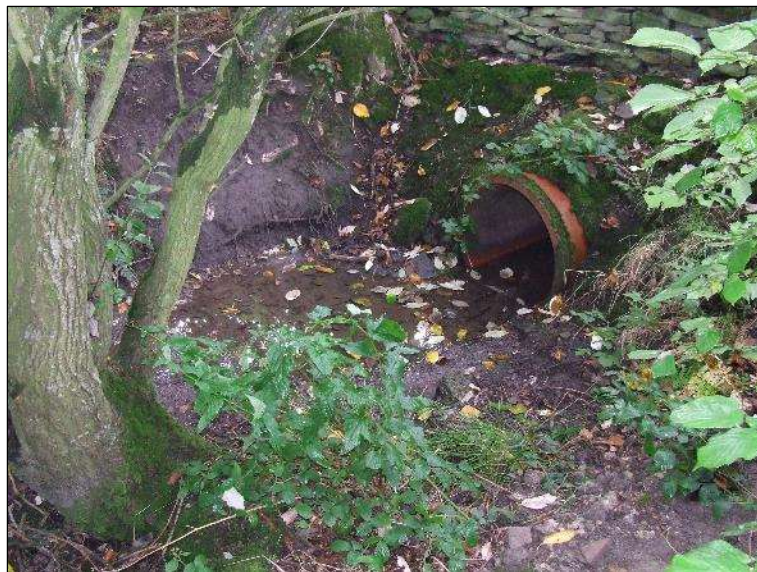
Photo 18: Sampling point SW02 from East Hill Beck. The pipe represents the entrance to a short culverted section of the beck.

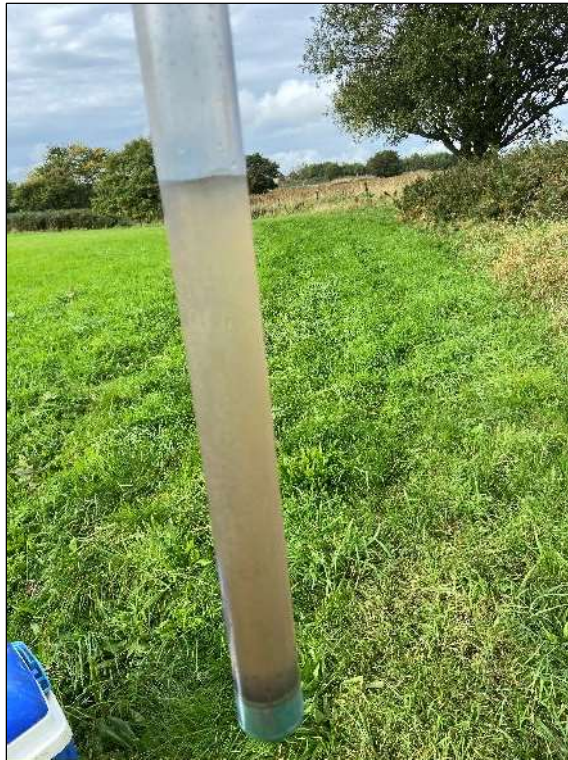
The pH of the groundwater from WS01 was also found to be strongly acidic with a pH of pH5.2. Whilst this is outside the desired range of pH6.5-10, this is a drinking water standard and is therefore only a guide. The groundwater pH determined at WS01 is also similar to the soil pH at the same location and is consistent with soil pH values that have been determined from the natural soils across the site. The acidic groundwater at WS01 is not manifesting in East Hill Beck or in the nearby pond where pH levels are neutral.

Photo 19: Groundwater sampled for chemical testing from WS01 on 02/10/2023.
