**BROMLEY FARM EXTENSION,  
CUMBERWORTH LANE,  
LOWER CUMBERWORTH,  
WEST YORKSHIRE, HD8 8PD**

**COAL MINING RISK ASSESSMENT**

Prepared by  
**SILKSTONE ENVIRONMENTAL LTD**  
For  
**WAVIN UK LTD**

**Report Ref: 22007CMRA/0**

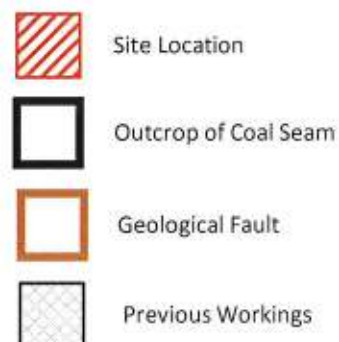
**SITE GEOLOGY**

#### GENERALISED VERTICAL SECTION

- 3.7 Seven Bromley Farm piezometers, installed by the client, record superficial deposits as topsoil underlain by boulder clay 0.6m thick.
- 3.8 On-line records indicate that bedrock present on site consists of Pennine Lower Coal Measures Formation strata, comprising mudstones, siltstones and sandstones with occasional coals, Langsettian (Westphalian A) in age, lying stratigraphically around and below the Cumberworth Thick (Whinmoor) coal seam. The mudstones and seatearth mudstones of this sequence of rocks have been extensively worked in the past for their fireclay and brickshale.

- 3.9 BGS records an east south east/west south west trending fault, crossing the northernmost part of the site, down-throwing strata to the north by <5m.

- 3.10 Recorded mine workings indicate that strata across the majority of the site dips at 1-2° to the north east. North of the fault strata dips at 5° to the north.

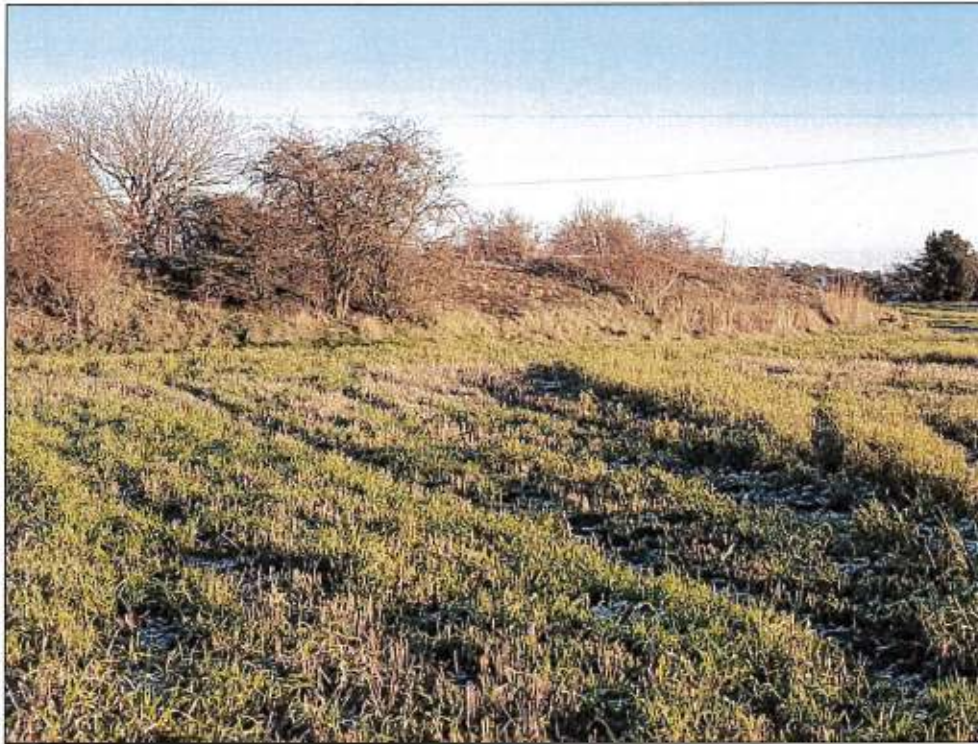
Photo E: Mound 100m east of the site.

- 5.4 The only property adjacent to the site is Lane Side Farm, adjacent to the north west perimeter.
- 5.5 A grassed mound is located approximately 150m east of the site, the location of which does not correspond with the location of any recorded mine entries.
