PROPOSED NORTH EASTERN  
EXTENSION, BROMLEY FARM  
QUARRY, UPPER CUMBERWORTH,  
WEST YORKSHIRE

HYDROGEOLOGICAL IMPACT  
ASSESSMENT

December 2022  
Ref:033/56/bfqext/1222

**S M Foster Associates Limited**  
*Hydrological and Hydrogeological Consultants*

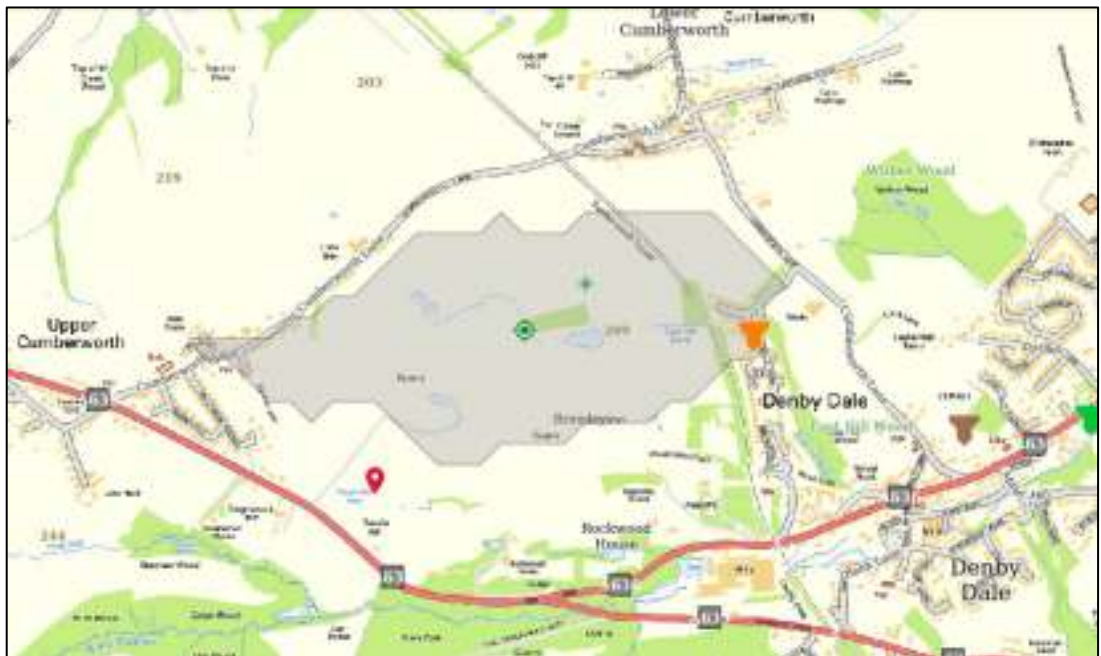
**Figure 3: FEH catchment boundary for East Hill Beck adjacent to the application Site**

- 2.4 Flood Estimation Handbook (FEH) catchment models confirm that, downstream of the Site, East Hill Beck drains a catchment area of 0.5km<sup>2</sup>, including the majority of the application Site. The East Hill Beck catchment area is indicated on Figure 3.

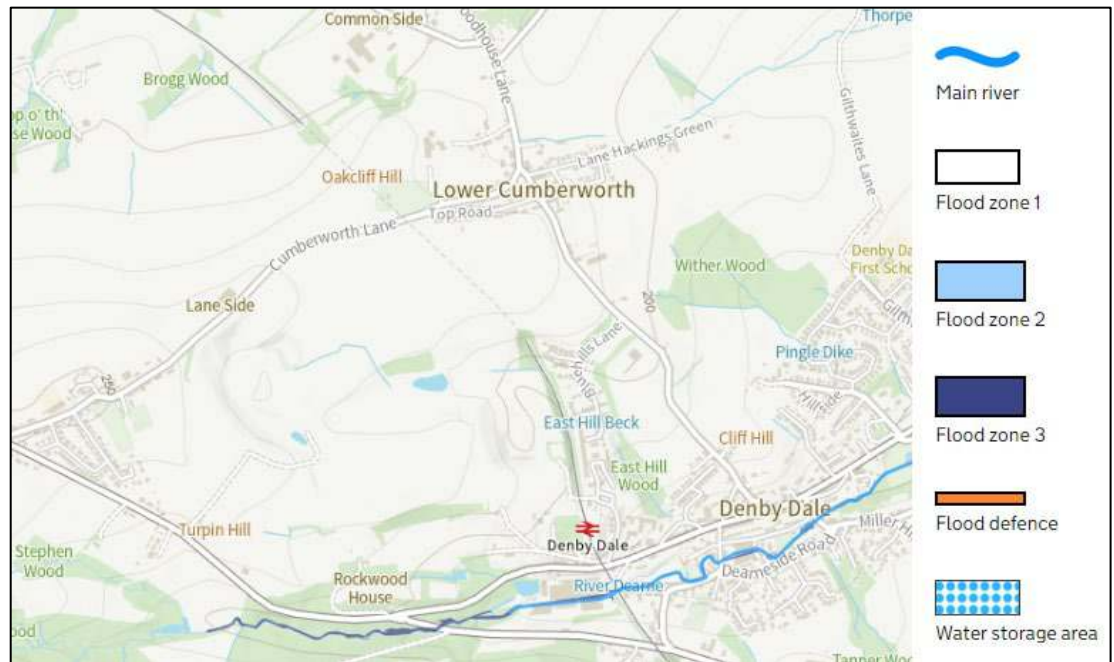
**Figure 4: Flood Map for Planning extract** © Environment Agency

- 2.6 The elevated location of the Site ensures that it is at low risk of fluvial flooding, as shown on the Environment Agency Flood Map for Planning, an extract from which is included as Figure 4, and also at low risk of surface water flooding as indicated on the Environment Agency Long Term Flood Risk Map, included as Figure 5. Reference to Defra's Magic map application confirms that the Site is not within a source protection zone and is not subject to any surface water or groundwater quality designation.

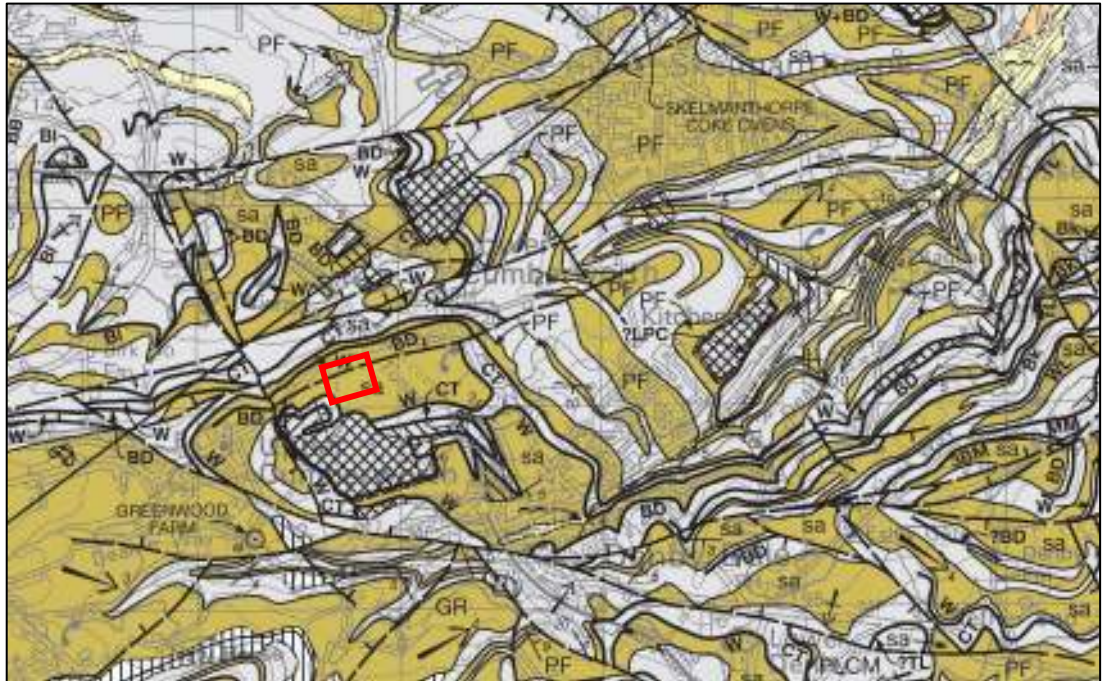
**Figure 6: Local geology © BGS**

- 2.8 British Geological Survey (BGS) mapping of the area indicates that the Site is underlain by Lower Coal Measures bedrock consisting of mudstone with subordinate sandstones and thin coals. Quarry workings would be primarily established in a weathered mudstone formation with two relatively thin sandstone units and thin coal horizons. There is no record of superficial deposits above the bedrock. The geology of the Site and surrounding area is indicated in Figure 6.

- 2.9 Regional geological mapping, as shown in Figure 6, indicates the presence of a Lower Coal Measures sandstone, above the Black Band Seam (BD), beneath the majority of the Site. Boreholes drilled at the Site demonstrate that this sandstone occurs at shallow depth and is underlain by a thick sequence of Lower Coal Measures mudstone. As shown on Figure 6, the area is extensively faulted. The Kirkburton Fault, trending north west to south east, is located close to the western boundary of the former Bromley Farm Quarry workings and the Holm Fault runs west to east approximately 500m to the south. Geological mapping indicates the presence of a south west – north east trending fault through the northern part of the application Site. The fault is downthrown to the north west. Site-specific ground investigation suggests that downthrow on this fault is approximately 3m.

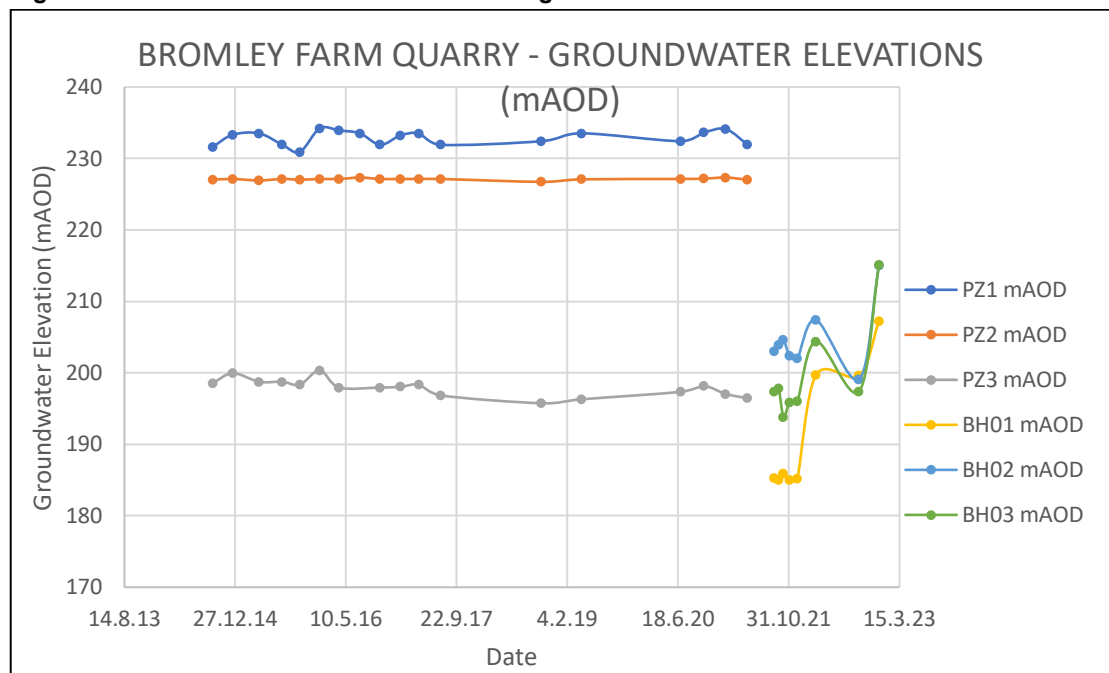
**Figure 7: Groundwater levels in Site monitoring boreholes**

(BH01, BH02 & BH03) since August 2021. Groundwater levels are shown graphically in Figure 7.

- 2.18 PZ3 is located close to BH01 and there is reasonable consistency between observed groundwater levels at both locations, at 195mAOD-200mAOD, once levels at BH01 stabilised. Observed groundwater levels at BH02 and BH03 are slightly higher but exhibit the same seasonal response suggesting that they are likely to be monitoring the same system. In contrast, the observed groundwater levels at PZ1 and PZ2 are significantly higher at around 230mAOD. It is notable that there is no seasonal variability in PZ2. Reference to the borehole logs for PZ1 and PZ2 demonstrates that the response zone in both boreholes is restricted to the mudstone below the lower sandstone. It is therefore likely that observed groundwater levels in these boreholes reflect accumulation of water in the borehole, from mudstone seepage, with a potential threshold at the elevation of the coal seam/void. Groundwater levels in PZ1 and PZ2 are not therefore indicative of groundwater levels in the coal measures sandstones.

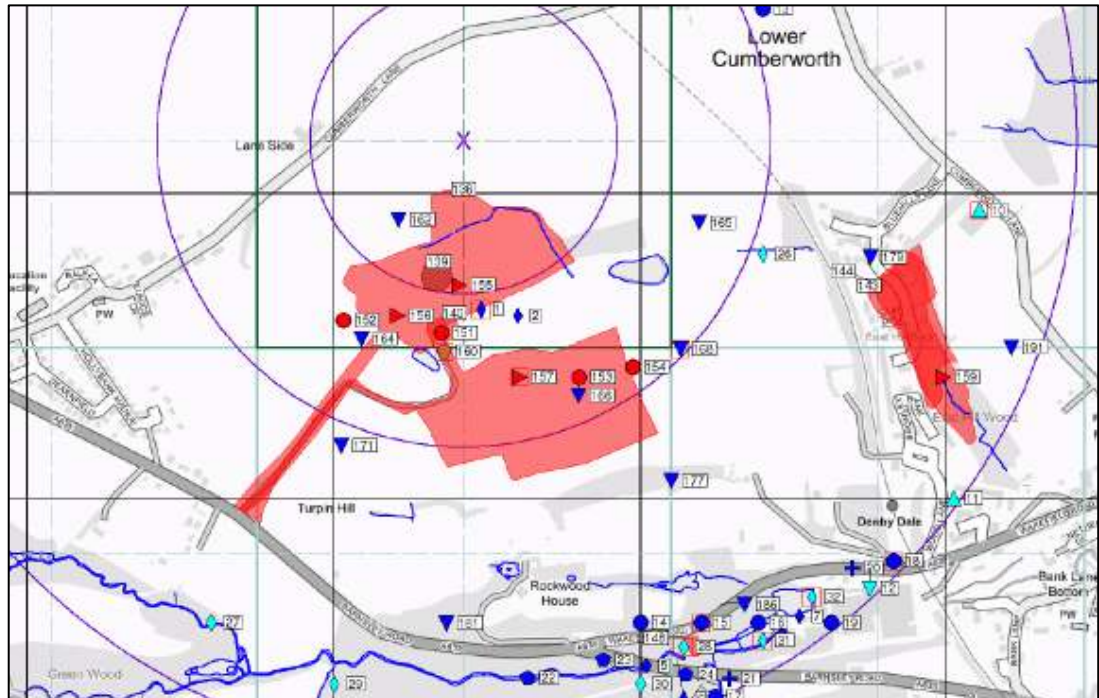
**Figure 8: Land use in the vicinity of the application Site**

- 2.21 As confirmed on Envirocheck datasheets at Appendix A, substantial areas of land to the south and south east of the application Site have previously been subject to mineral extraction and subsequent infilling with waste materials. An extract from the datasheet is included for reference as Figure 8.

- 2.22 The shaded red areas on Figure 8 represent former mineral workings that are registered as historic landfill sites. Comparison of groundwater flow directions, as shown on Drawing 033/56/02, with Figure 8, demonstrates that historic landfill areas are situated down-gradient of the application Site and may obstruct groundwater flow in a south and south easterly direction. It is considered likely that the sandstone units will have been worked through in historic mineral workings, removing potential for down-gradient drainage through sandstone units. On the basis of available evidence it is considered that the most likely receptor of any groundwater flowing in the sandstone units beneath the application Site is backfilled land in former mineral workings. There may remain potential for seepage to East Hill Beck upstream of the railway line during periods when groundwater levels are elevated.
