# Flint Street North Highways Offices, Huddersfield

## Bat Survey Report

8<sup>th</sup> June 2023

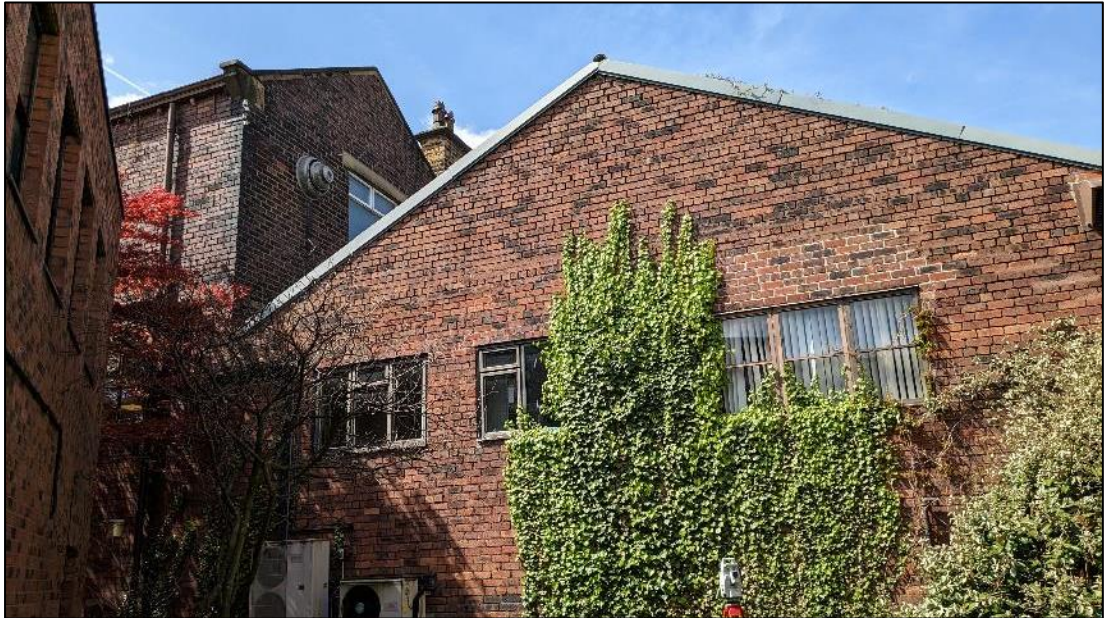
**Plate 1. East gable of B1**

- 5.2.3 Building 1 comprised a single-storey brick-built building/offices with a dual-pitched corrugated asbestos-cement sheet covered roof with an asbestos/cement ridge and metal verge capping (Plates 1 & 2). Windows comprised a mix of plastic and metal framed single and double-glazed units.
- 5.2.4 Potential roosting features on the exterior of B1 included gaps beneath verge capping at the gable apexes, with occasional open joints on the west elevation.

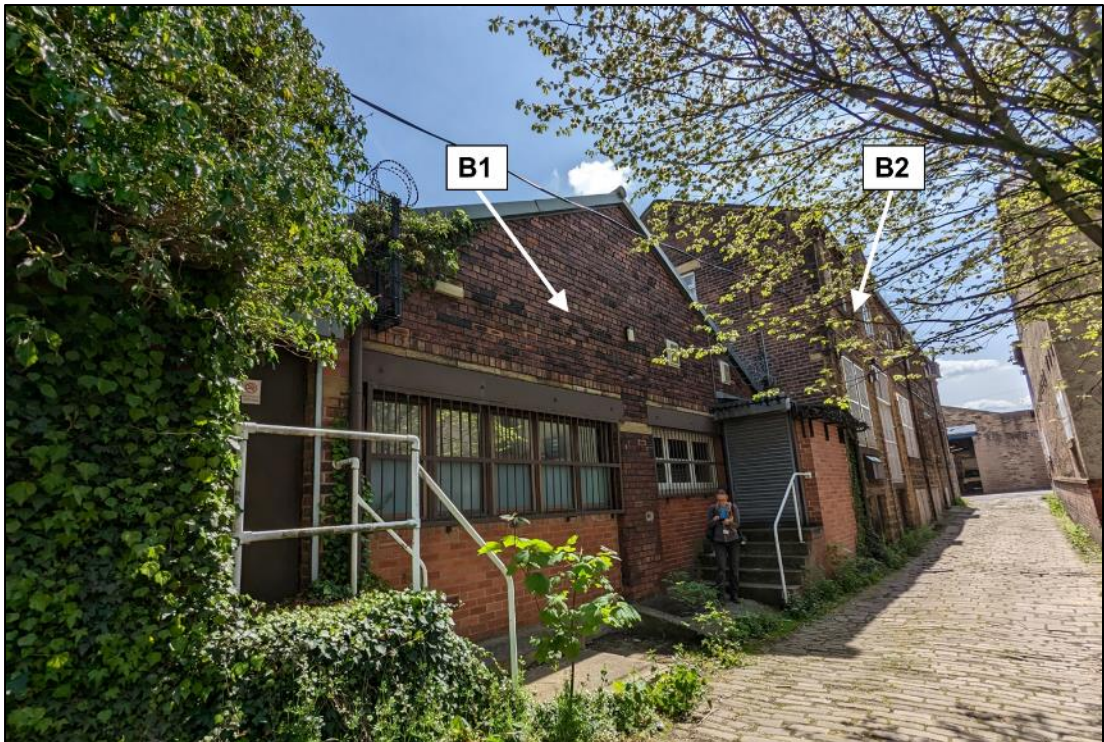
**Plate 2. East elevations of B1 & B2**

- 5.2.7 Building 2 comprised a late 1800s/ early 1900s built two-storey brick and stone-built building with multi-pitched grey slate covered roofs. The roofs have skylights on the eastern most pitch, clay ridge tiles and stone copings. Two stone chimneys were incorporated into the north and south elevations. Cast iron guttering was present together with a mix of metal and plastic framed single and double-glazed windows. Flashing was present at the base of chimneys.
- 5.2.8 Potential roost features noted from the exterior of B2 included: gaps in ridge bedding mortar, occasional lifted slates, gaps beneath stone coping, potential bat access to wall tops and occasional open joints in masonry.

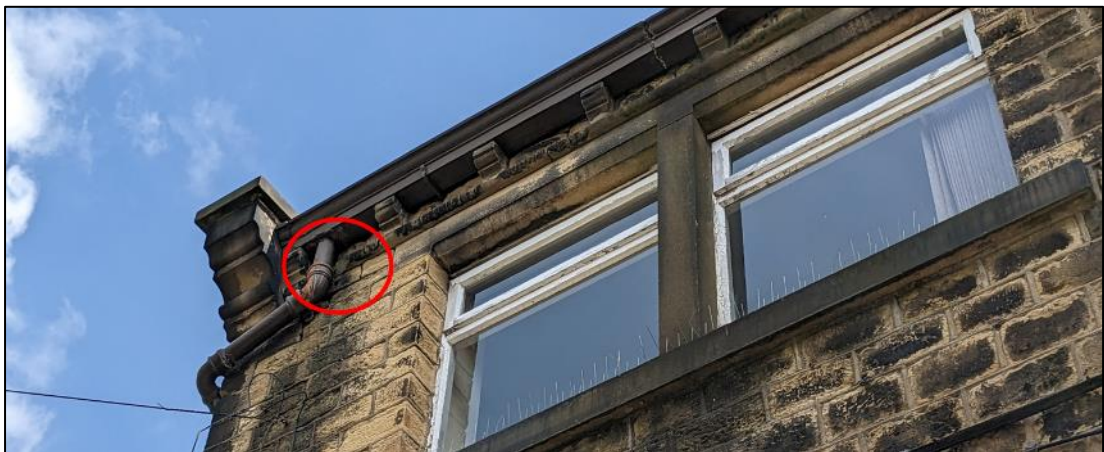
Plate 4. Example of open joints in B2

- 5.2.9 Several different sections of roof were present in B2. The southern end of the western roof was unlined and suspended on purlins, rafters, a ridge beam and battens (Plate 4). Approximately 100 mm of glass-fibre insulation was present on the ceiling with a few mouse *Mus musculus* droppings noted, together with quite dense cobwebs in places. Part of the northern end of the western roof void was boarded out with composite boards used as sarking. Within the eastern roof space, a small inaccessible void was present above skylights, with the ceilings lowered to a height below the skylights in more recent times (Plate 5).
- 5.2.10 Building 2 was considered to display a moderate level of bat roost suitability.

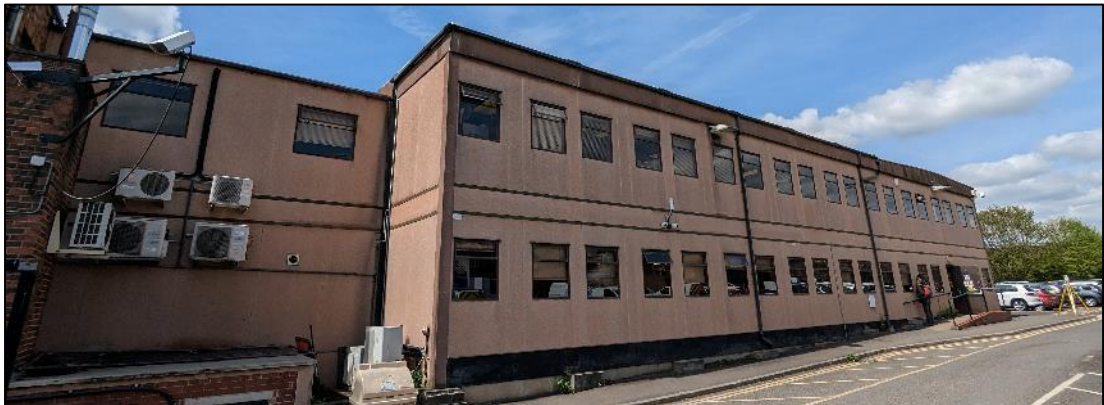
#### **Plate 7. East elevation of B5**

- 5.2.19 Building 5 comprised a 1990s two-storey and largely prefabricated office block with a flat roof (Plate 7). A deep fascia board was present with insect meshing between this feature and the exterior wall panelling. A pebble dash finishing was present on the wall panels.
- 5.2.20 In places c.1 cm spaces were present between mesh panels, themselves located between the fascia and wall (Plate 8). These access points were expected to lead into a low void between the flat roof and suspended ceiling in this building. In addition, the fascia board was warped resulting in an additional wider gap between this board and the insect mesh.

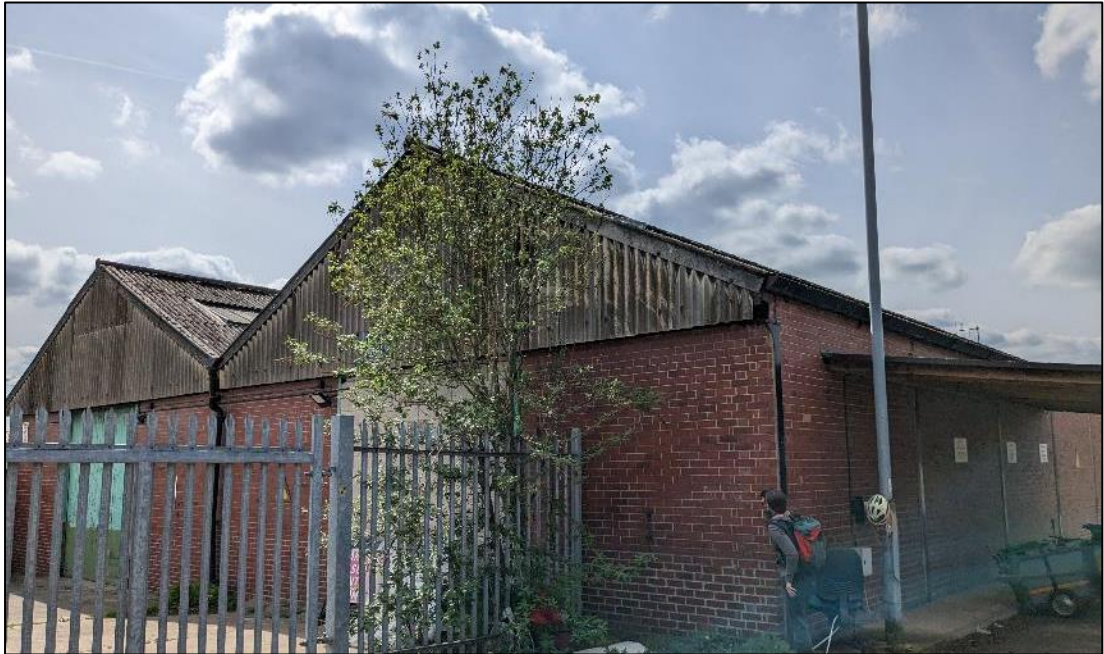
**Plate 10. Northeast corner of B9**

- 5.2.35 Building 9 comprised a large single-storey brick-built garage with a multi-pitched roof covered in corrugated asbestos-cement sheets with asbestos-cement verge capping and cladding panels on the triangular sections of the gables (Plate 10). Roller shutter doors were present on the west elevation. A single-storey open sided lean-to was present on the north elevation.
- 5.2.36 Occasional lifted sections of asbestos-cement sheeting were present on the exterior. In addition, it was noted that bats could potentially roost between the flat-backed metal gutter and wall on the north and south elevations.

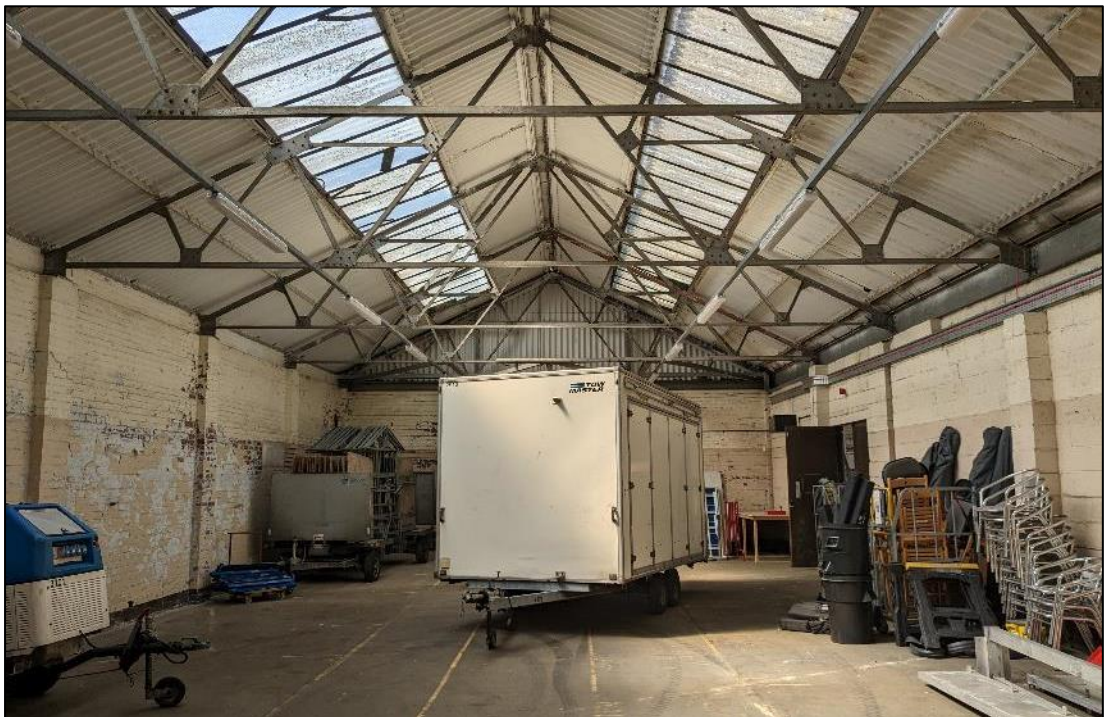
**Plate 11. Interior of B9**

- 5.2.37 Internally the roof was open to the underside of the roof sheets, with the sheeting suspended on steel trusses and purlins (Plate 11). No roof voids were present, skylights were located in the roof pitches and as a result the interior of the building was light and open.
- 5.2.38 Building 9 was considered to display a low level of bat roost suitability.

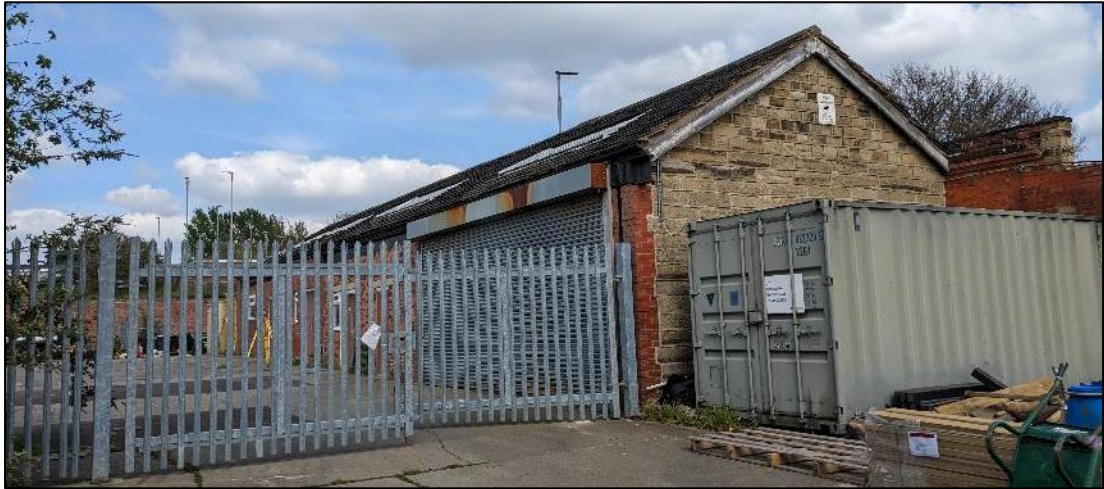
**Plate 12. Southwest corner of B10**

- 5.2.39 Building 10 comprised a range of single-storey brick and stone built workshops/garages with a dual-pitch stone-slate covered roof with integrated skylights (Plate 12). The verges were mortar-filled and the windows uPVC-framed and double-glazed.
- 5.2.40 Bat roost potential on the exterior of Building 10 was largely limited to the typical range of crevice spaces between stone roof slates (which differ slightly in depth) and between these slates and the sarking.

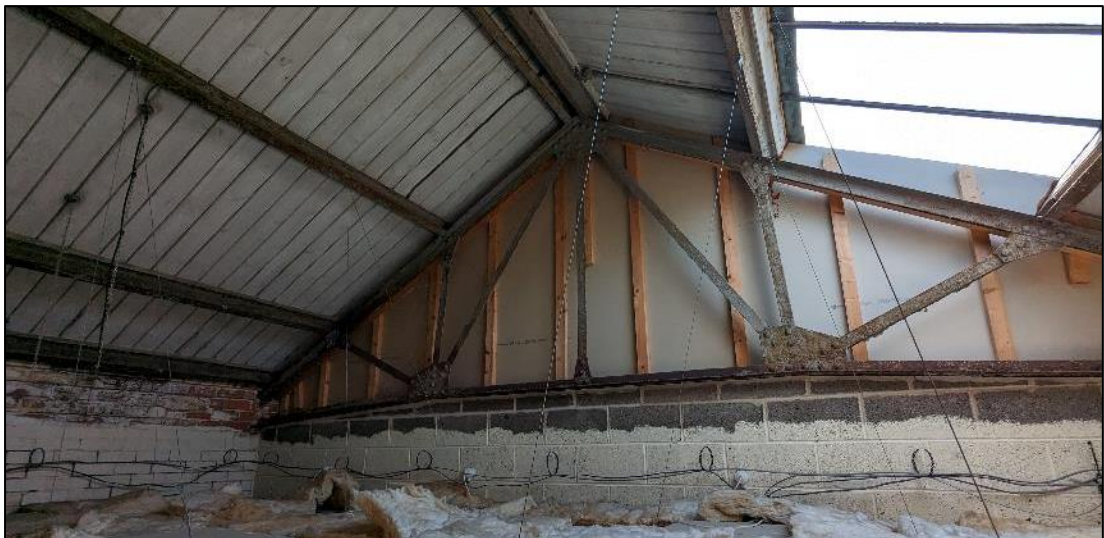
**Plate 13. Example section of roof void from B10**

- 5.2.41 Internally the roofs of B10 were underdrawn with timber sarking and suspended on steel trusses and purlins (Plate 13). One section of the roof was open with no void present, whilst two other sections had 2 or 3 m high voids created by false ceilings. In all cases roof spaces were light as a result of skylights and in common with other buildings surveyed on site, no signs of bat roosting were recorded.
- 5.2.42 Building 10 was considered to display a moderate level of bat roost suitability.

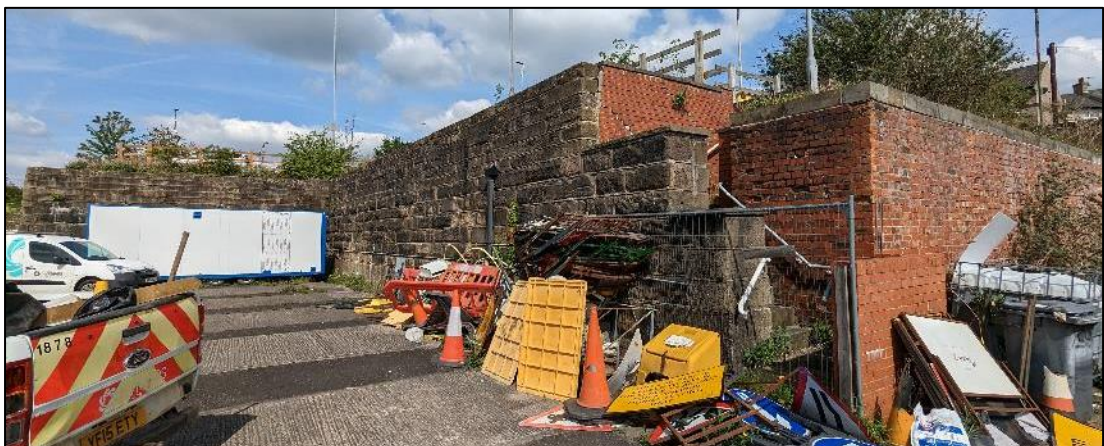
**Plate 14. Retaining wall viewed from south**

- 5.2.43 No trees on site displayed features offering more than a negligible level of bat roost suitability.
- 5.2.44 A retaining wall at the northern end of the site was mainly quite well pointed (Plate 14), although a section comprised stacked waste stone and stone sleepers (Plate 15). Where the wall comprised stacked materials component crevices were inspected.

Whilst these crevices were superficially suitable for bat roosting, they were open and exposed with no signs of bats noted. Overall, the wall was considered to display no more than a negligible level of bat roost suitability.
