# Land at Thomas Street Lindley, Huddersfield

## Ground Investigation

22052/1 revision 1

**THOMAS STREET, LINDLEY  
HUDDERSFIELD, HD3 3JJ**

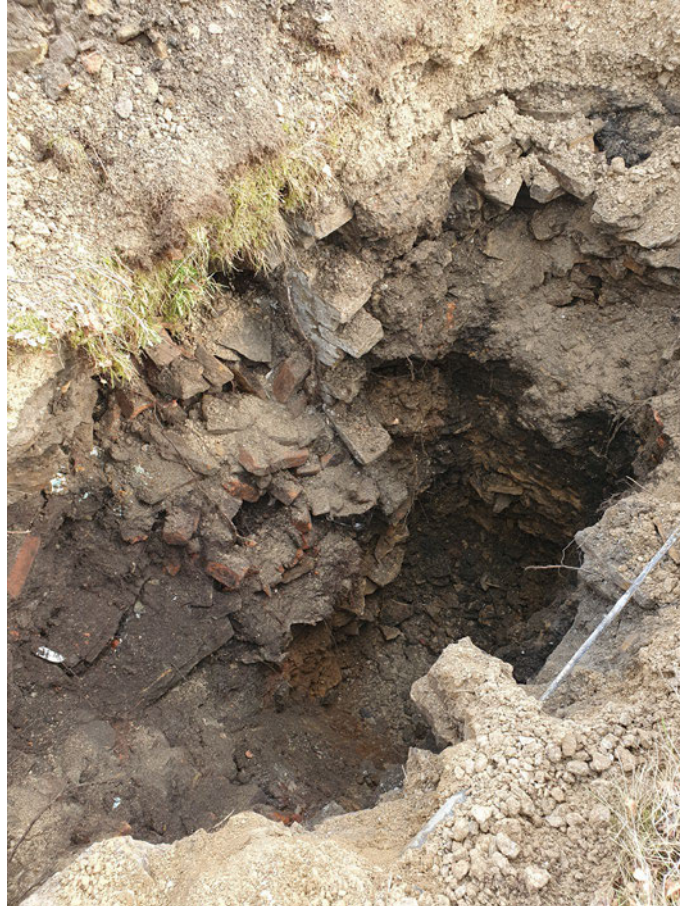
Date: 23 March 2022	Site: Thomas Street, Lindley, Huddersfield
Trial Pit No. TP1	Depth: 3.4 m begl
Co-ords: 411642, 418258	Equipment: JCB 3CX

View of exposed strata and buried walls in TP1 looking north-east.

G.L to 0.40 m; MADE GROUND: Light yellowish brown sandy gravel.

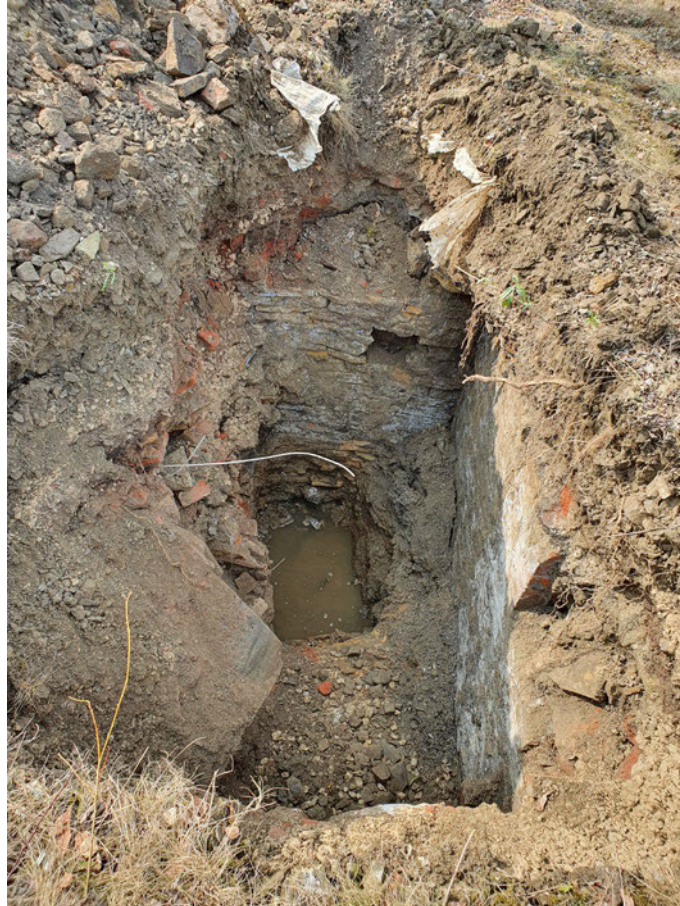
Date: 23 March 2022	Site: Thomas Street, Lindley, Huddersfield
Trial Pit No. TP5	Depth: 3.3 m begl
Co-ords: 411661, 418270	Equipment: JCB 3CX

View of exposed strata and buried walls in TP5 looking west.

G.L to 0.20 m; MADE GROUND: Dark brown clayey gravelly sand. Gravel is sandstone, brick and coal.

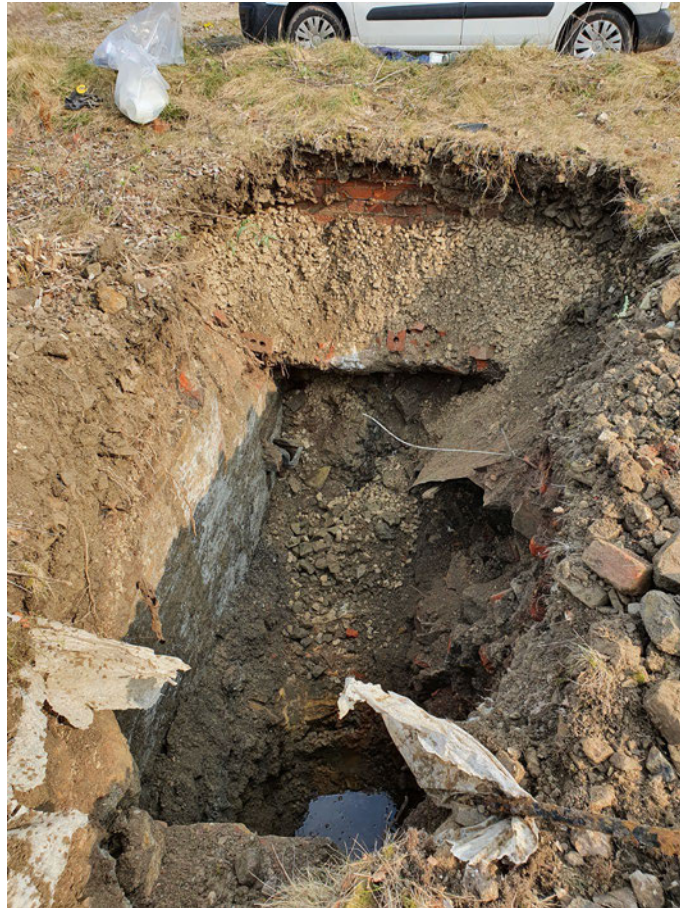
Date: 23 March 2022	Site: Thomas Street, Lindley, Huddersfield
Trial Pit No. TP5	Depth: 3.3 m begl
Co-ords: 411661, 418270	Equipment: JCB 3CX

View of exposed strata and buried walls in TP5 looking east.

G.L to 0.20 m; MADE GROUND: Dark brown clayey gravelly sand. Gravel is sandstone, brick and coal.

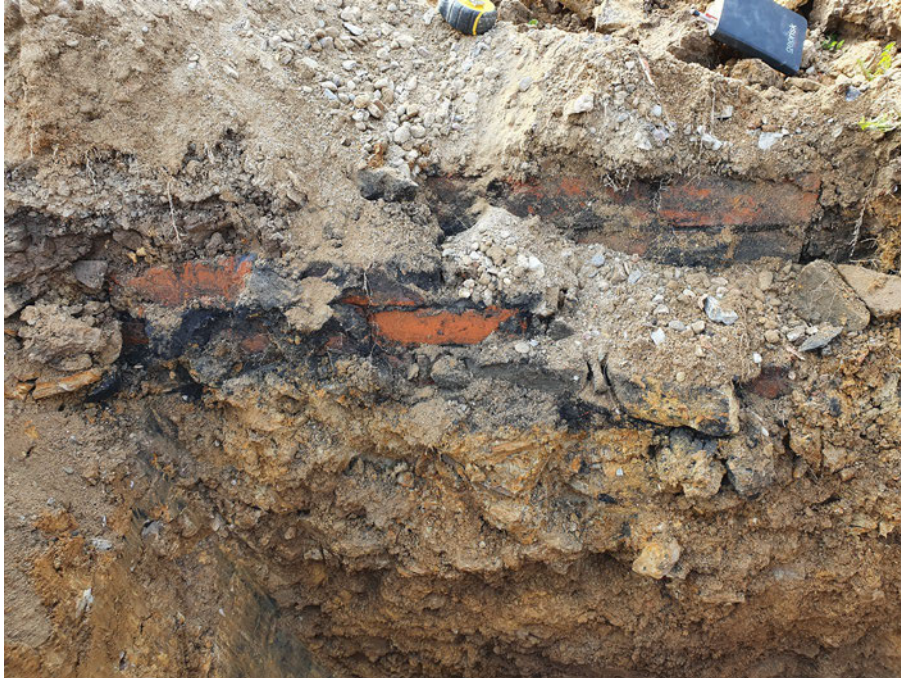
Date: 23 March 2022	Site: Thomas Street, Lindley, Huddersfield
Trial Pit No. TP7	Depth: 1.3 m begl
Co-ords: 411666, 418278	Equipment: JCB 3CX

View of exposed strata and buried walls in TP5 looking west.

G.L to 0.20 m; MADE GROUND: Light brown silty gravelly sand and red brick.

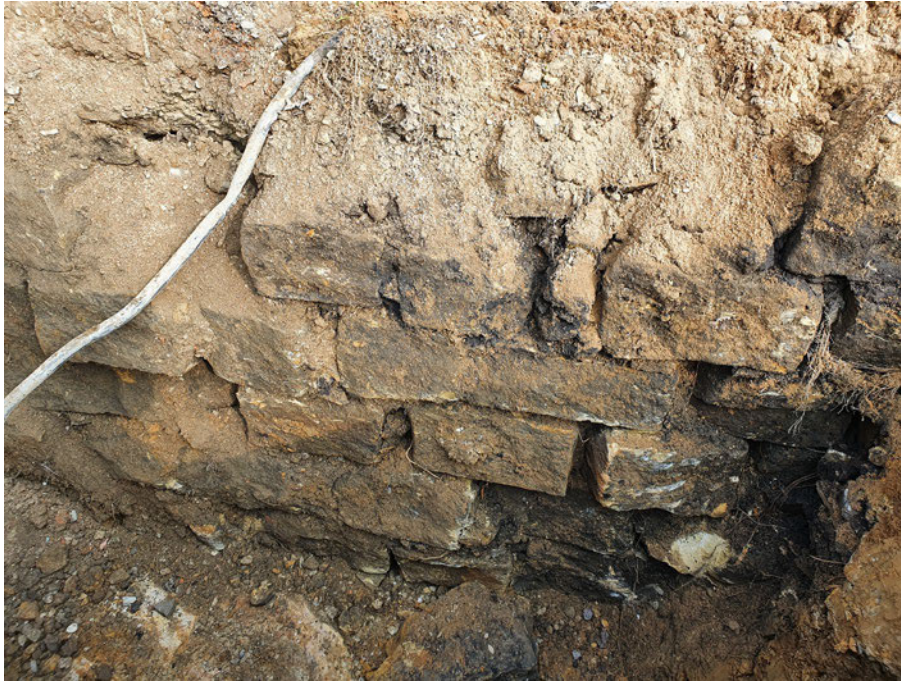
Date: 23 March 2022	Site: Thomas Street, Lindley, Huddersfield
Trial Pit No. TP7	Depth: 1.3 m begl
Co-ords: 411666, 418278	Equipment: JCB 3CX

View of exposed strata and buried walls in TP7 looking east.

G.L to 0.20 m; MADE GROUND: Light brown silty gravelly sand.
